WCAP-14447

Repair Boundary for Parent Tube Indications
Within the Upper Joint Zone of
Hybrid Expansion Joint (HEJ) Sleeved Tubes

September 1995

WESTINGHOUSE ELECTRIC CORPORATION
NUCLEAR SERVICES DIVISION
P.O. BOX 158
MADISON, PENNSYLVANIA 15663-0158

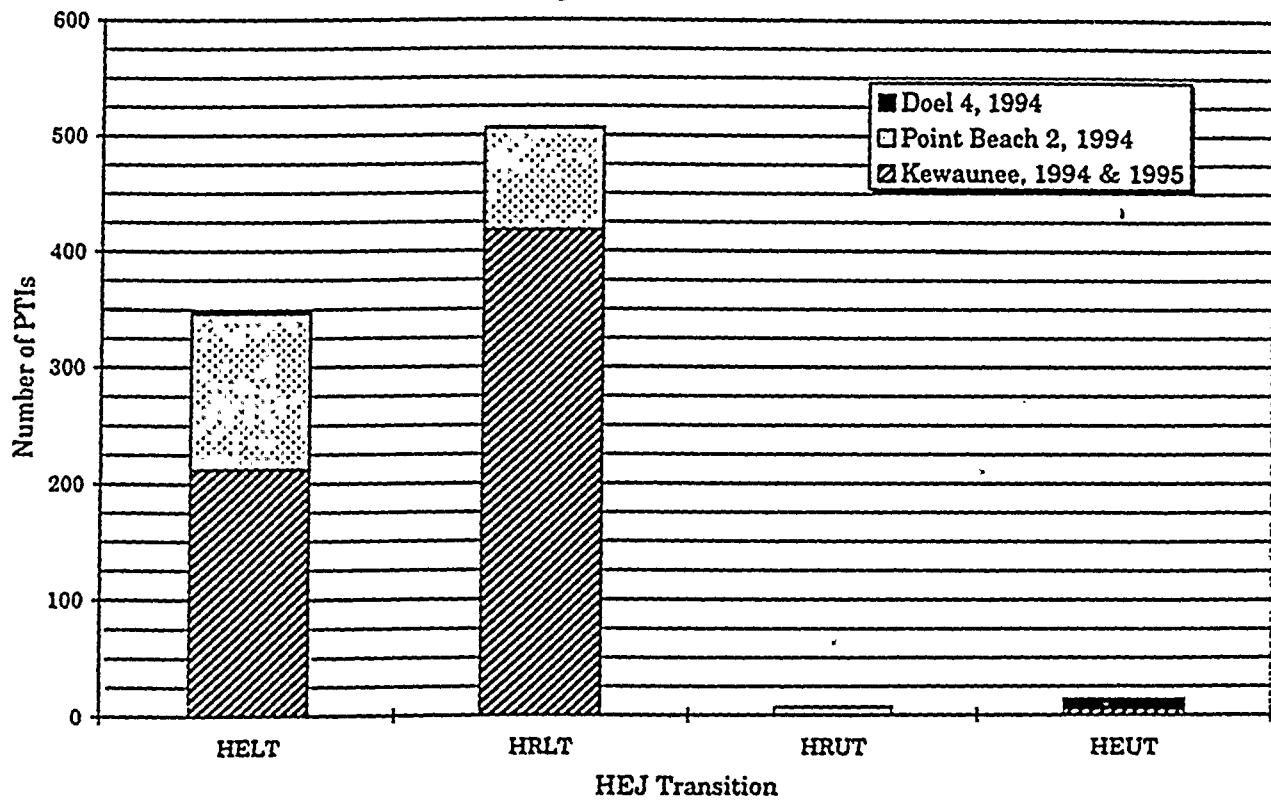
Figure 4-1

Distribution of Circumferential
PTIs by HEJ Transition

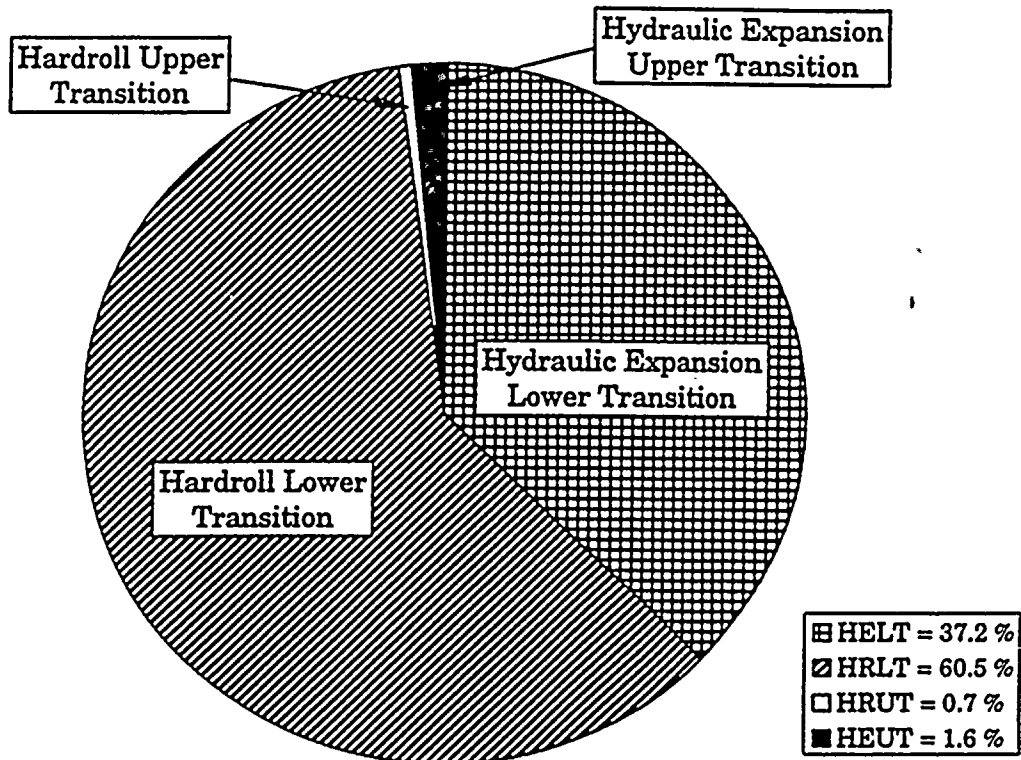
Figure 4-2

Distribution of All Circumferential PTIs by Transition

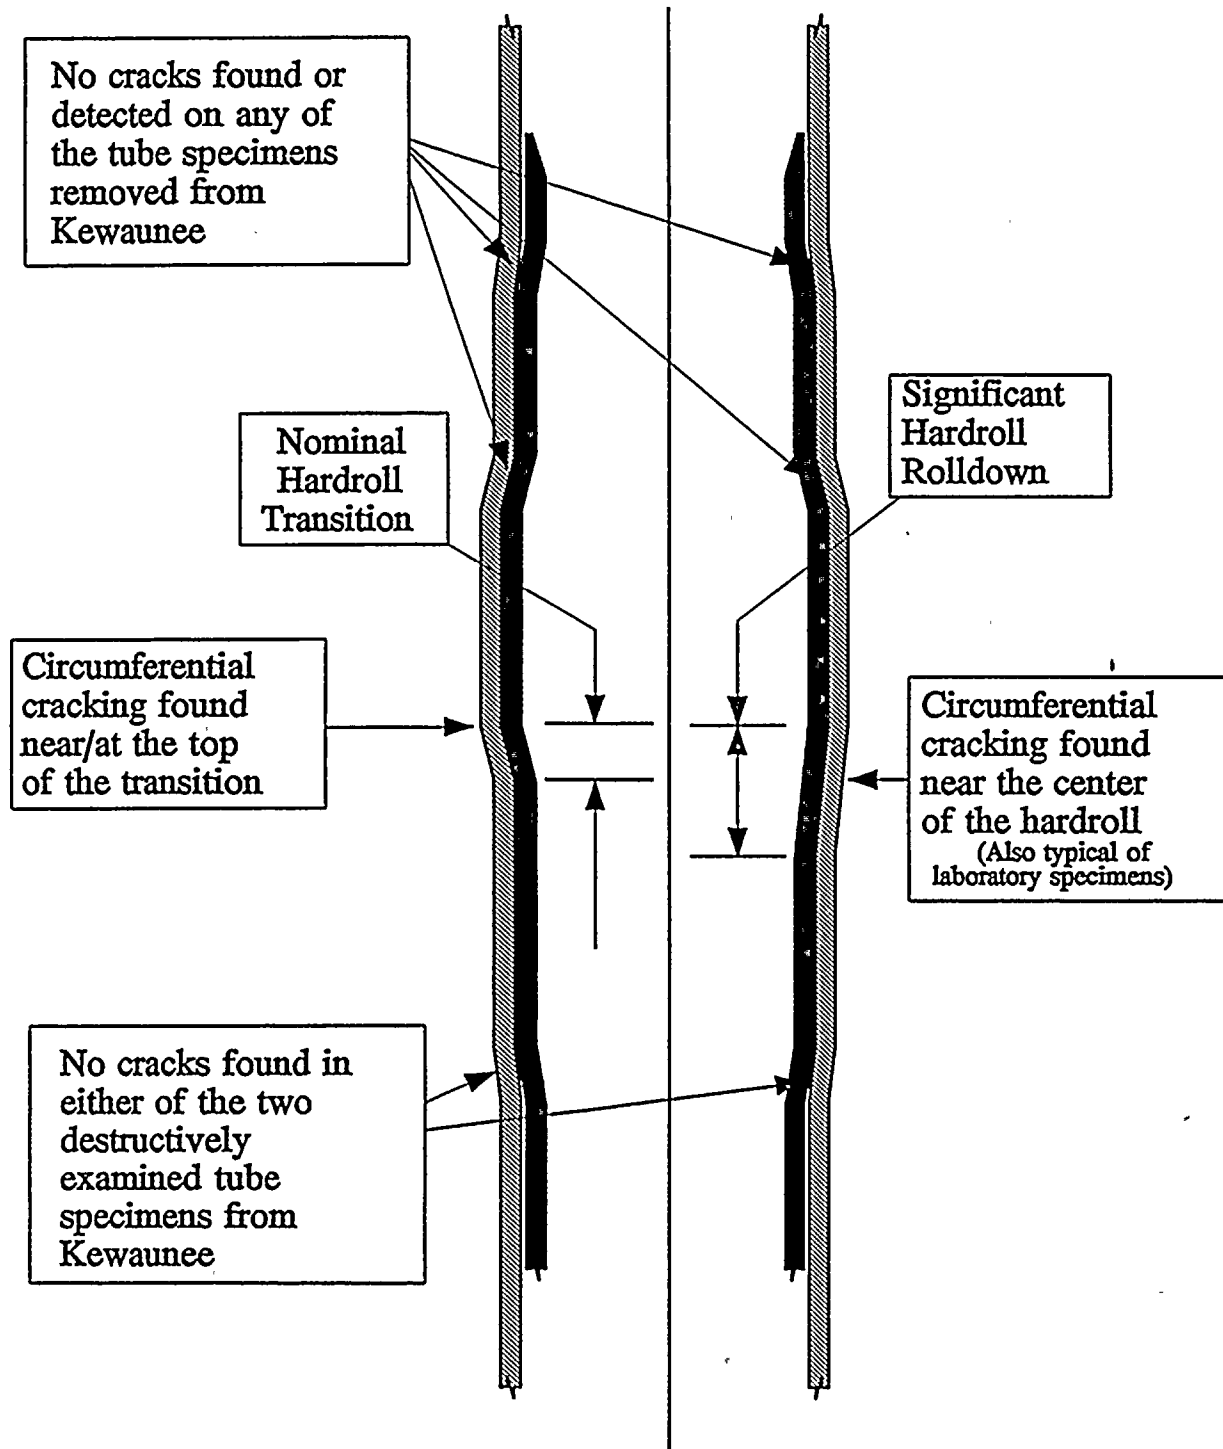
Figure 5-1

The radiographic laboratory examination detected a 270 to 360° circumferential band of short semi-continuous circumferential indications in the upper portion of the HRLT of the tube, just below the HR region in tube R2C32. These cracks were confined to a very narrow zone, less than 0.05" high, such that the individual cracks appeared to occur head-to-toe. In addition, a shorter (approximately 300° long) band of cracks was observed approximately 0.1" below the main band of cracks. tube R2C54 had two to three similar bands of short semi-continuous circumferential cracks that occurred over 350° from the mid- to upper portion of the HRLT. Tube R2C61 had one band of short semi-continuous circumferential cracks that occurred over 360° in the mid-portion of the HRLT.

All intergranular corrosion was confined to and located in the HRLT regions. In the case of tube R2C32 the cracking was at the upper portion of the HRLT and in the case of tube R2C54 the cracking was located from the mid-portion of the HRLT to the upper portion of the HRLT. The fracture faces both had a maximum depth of 92% throughwall, with average depths ranging from 61% (tube R2C32) to 60% (R2C34) throughwall and with microcrack lengths that were 360° long. At some ID locations adjacent to the fracture faces, a few short circumferential microcracks were observed parallel to the fracture face. These microcracks appeared to be simple cracks, morphologically speaking, in that the near absence of oblique angle cracks and blunting was noted. This morphology is more typical of PWSCC than of secondary side corrosion that typically occurs in caustic crevices.

Location of Cracks in HEJ Sleeved Tubes Removed from Kewaunee
