SUBJECT: Submits info re RV head penetration alternate repair technique.

Donald C. Cook Nuclear Plant Units 1 and 2  
REACTOR VESSEL HEAD PENETRATION ALTERNATE REPAIR TECHNIQUE

ALTERNATIVE REPAIR PROCEDURE

EMBEDDED FLAW REPAIR FOR COOK NUCLEAR PLANT

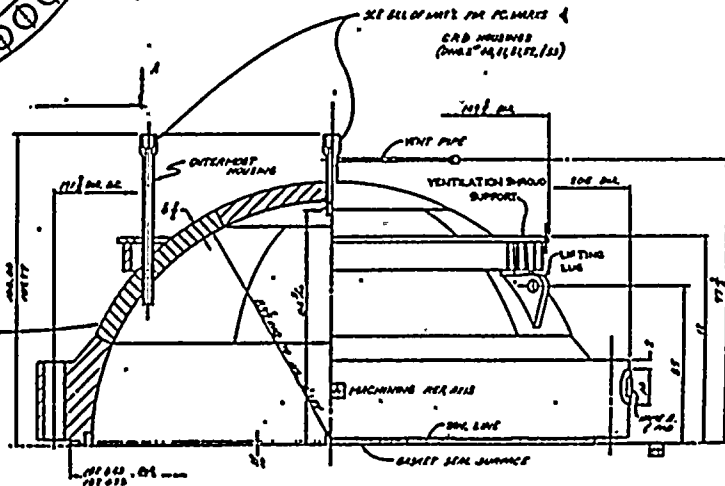
COOK. UNIT 2

DRAWING 68-3262		
Ring	Penetration Nos.	Description
Initial Sample Group (1)		
Outer Most	74, 75, 76, 77 & 78	4" Thermocouple Column (non-sleeved)
Expanded Group (2)		
Select Inner Penetrations	66, 60, 58	4" Control Rod Drive (sleeved)
	64	4" Head Adapter Plug (non-sleeved)

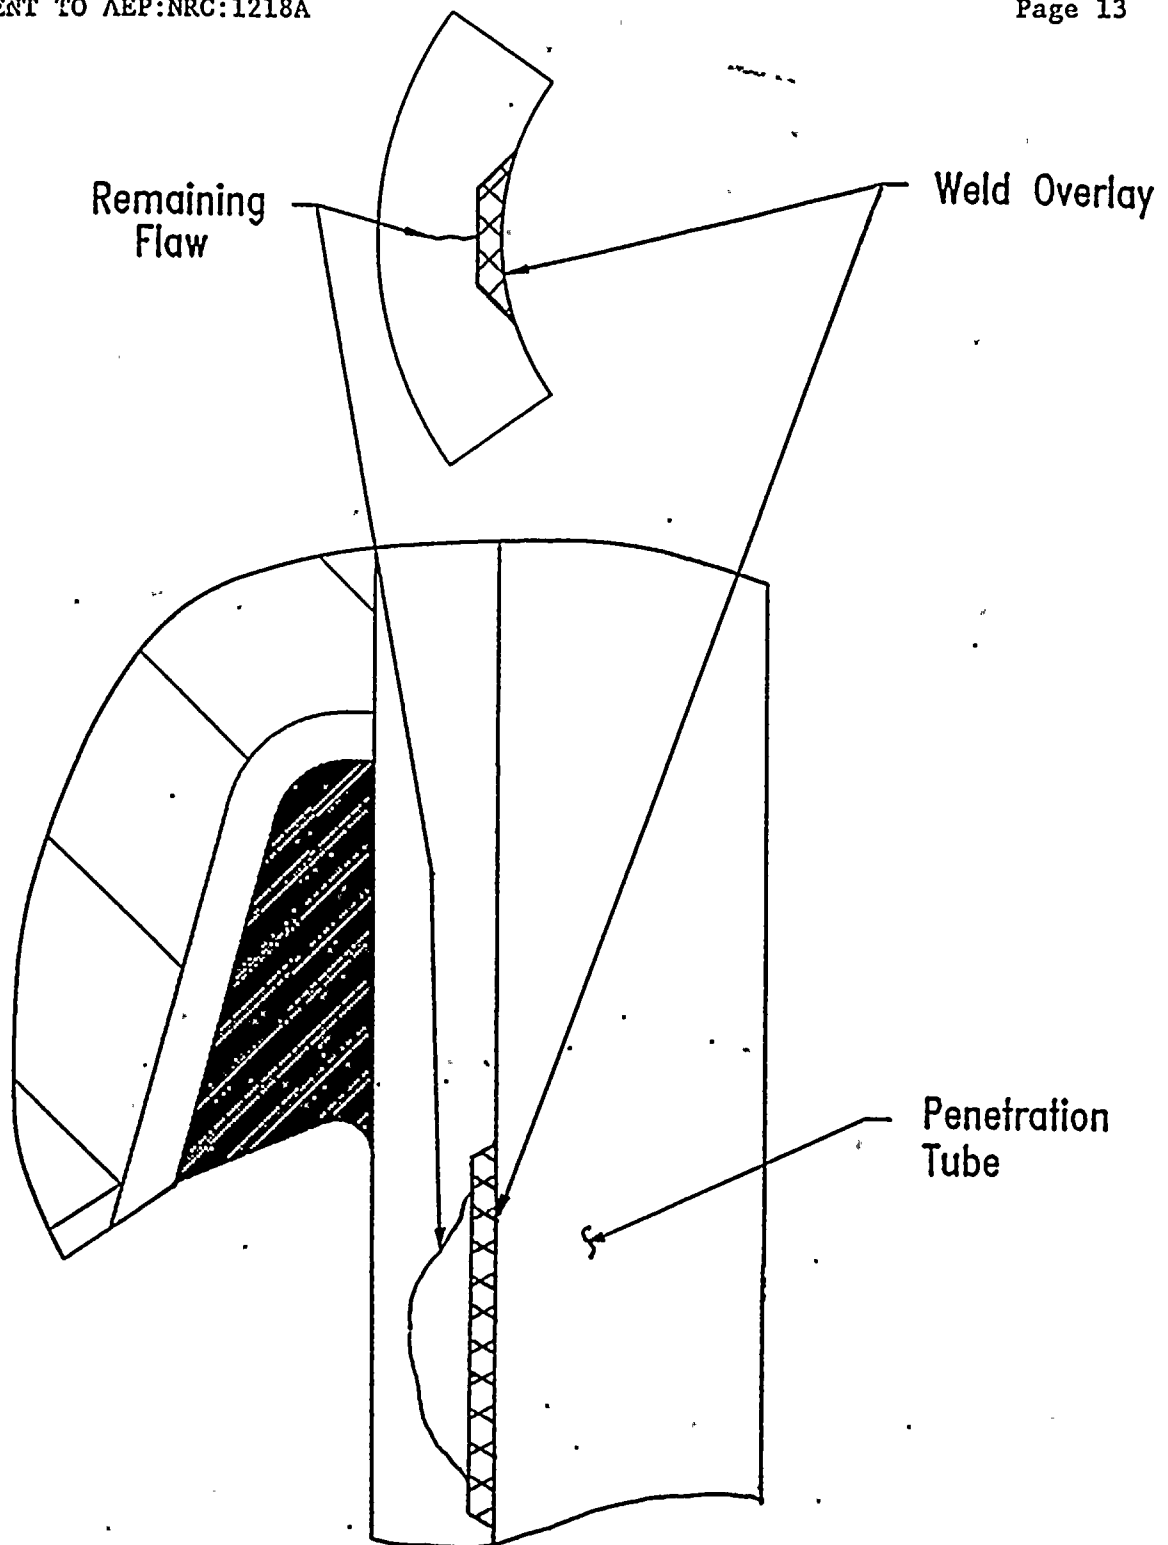
HEAD PENETRATION EMBEDDED FLAW REPAIR

The embedded flaw repair technique involves an excavation at the inside surface of the penetration. This excavation would be sufficient to remove the portion of the crack which is exposed to the reactor coolant at the inside surface of the penetration. The depth of the excavation, 0.125 inch or smaller, is established such that, following application of a weld overlay, the remaining portion of the flaw qualifies as an embedded flaw according to the rules of ASME Section XI paragraph IWA 3310(b). The depth of the excavation is controlled by utilizing

"hard stops" which are incorporated into the tooling to limit travel of the EDM electrode. The extremities of the flaw relative to the boundaries of the excavated area must be examined by appropriate NDE methods or otherwise evaluated to ensure that the excavation has covered the full length of the flaw. The weld is applied and examined with dye penetrant and either eddy current or ultrasonics to verify an acceptable weld. This approach eliminates exposure of the flaw to the reactor coolant environment, and stops further flaw growth due to PWSCC. See attached figure entitled "Head Penetration Embedded Flaw Repair" for a schematic of the proposed repair configuration.

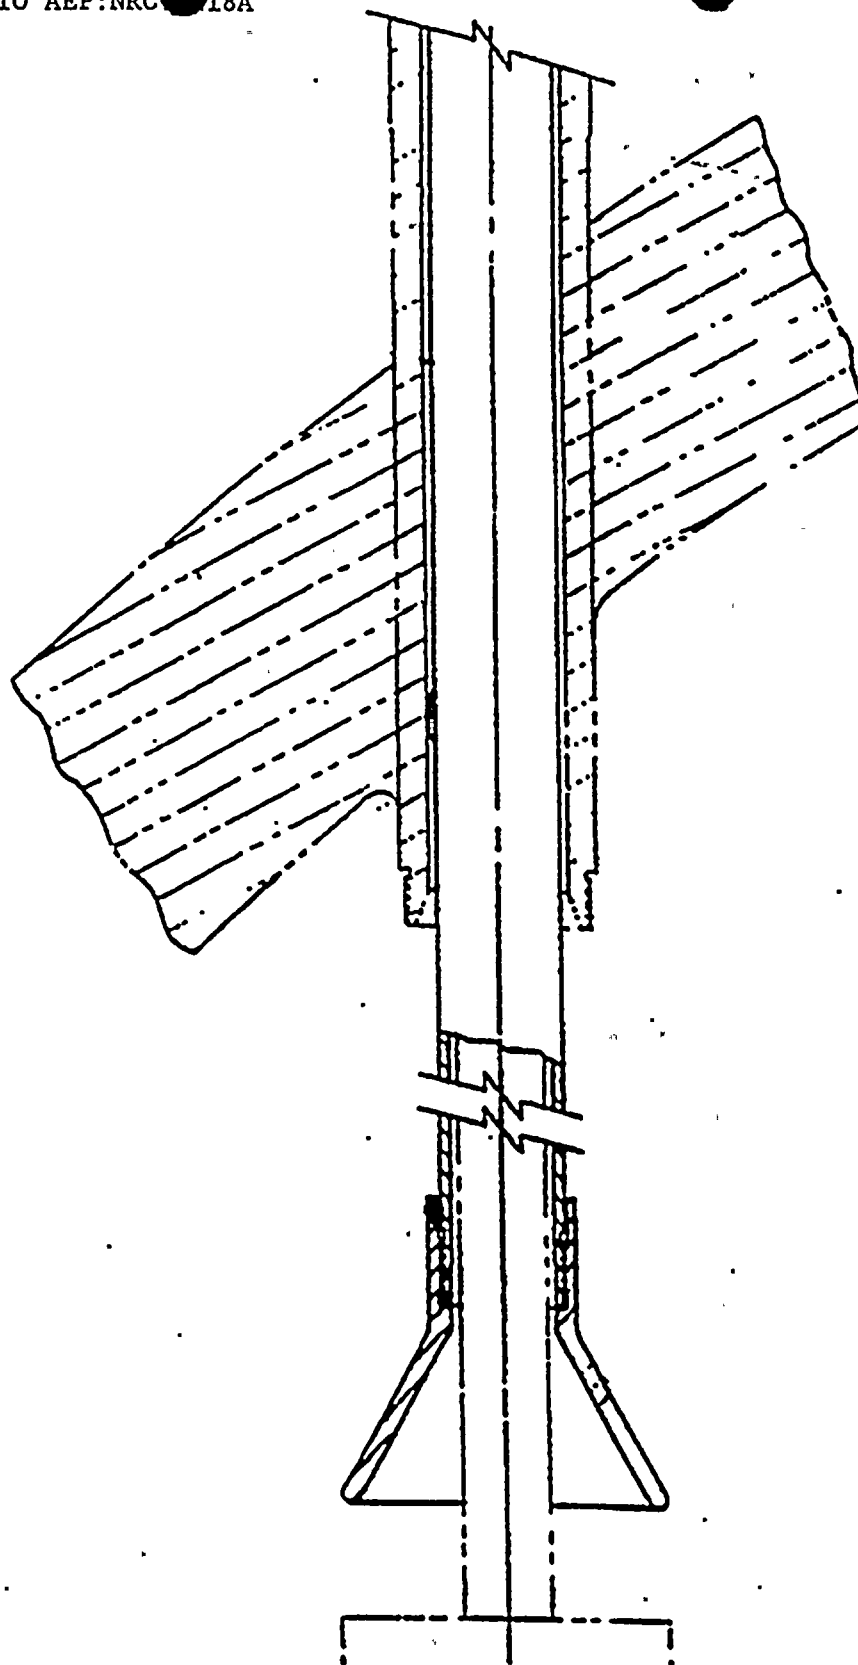
THERMAL SLEEVE GUIDES

Due to the spatial constraints associated with the design of the vessel penetration and thermal sleeve (refer to attached figure entitled "Thermal Sleeve Guides"), thermal sleeve removal is necessary to completely eliminate a flaw that is deeper than 0.25 inch for those penetrations which contain thermal sleeves. Removal of the thermal sleeve can be achieved by two methods.
