SUBJECT: LER 88-001-00: on 871230, incorrect sample valve lineup for
 VRS-2500 auxiliary bldg vent radiation monitor discovered
 resulting in failure to meet Tech Spec 3.3.3.10 criteria.
 Caused by personnel error. Procedure changed. W/880129 ltr.

| FACILITY NAME (1) DONALD C. COOK NUCLEAR PLANT, UNIT 2 | | | | | | | | | | DOCKET NUMBER (2) 0 5 0 0 0 3 1 6 | | | | | PAGE (3) 1 OF 4 | | | | | | | | | | | |
| TITLE (4) MISSED TECHNICAL SPECIFICATION REQUIRED VENT STACK SAMPLING AS A RESULT OF INCORRECT SAMPLE VALVE ALIGNMENT DUE TO PERSONNEL ERROR | | | | | | | | | | | | | | | | | | | | | | | | | | |

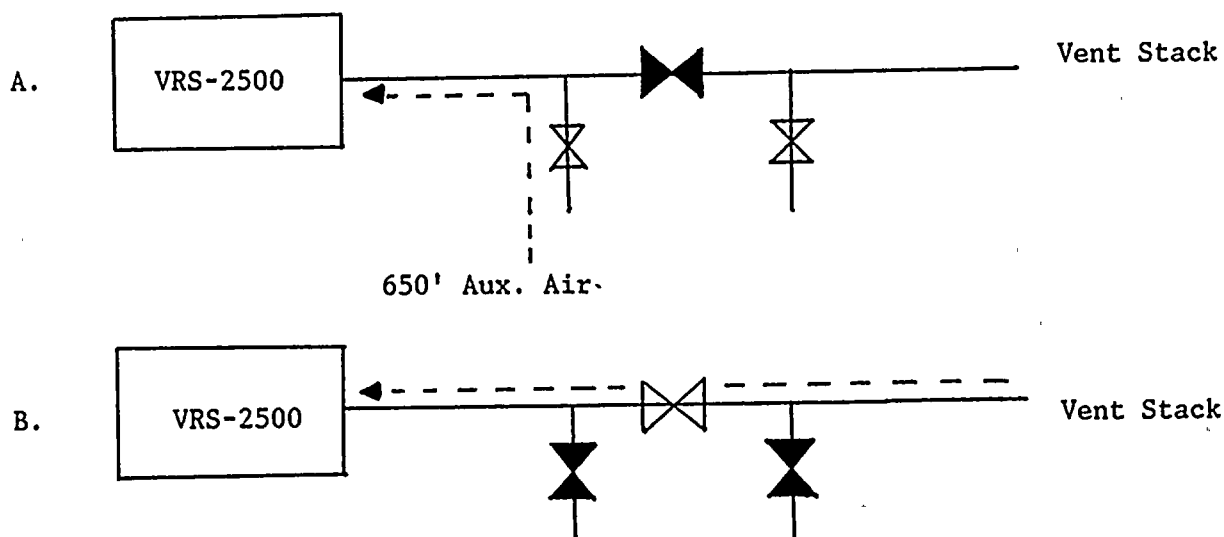
On January 6, 1988 at 1310 hours, while obtaining a weekly sample from VRS-2500, Unit 2 Auxiliary Building Vent Radiation Monitor (EIIS/IL-MON), it was discovered that the sample valve lineup (EIIS/IL-SMV), to allow continuous monitoring of the Unit 2 Auxiliary Building Vent, was incorrect. The lineup, as found, was drawing air from the 650' auxiliary building elevation not the vent stack as required. (See attached sketch). Review of data from VRS-2500 indicates this condition had existed in all likelihood, since the last time VRS-2500 was sampled on December 30, 1987. At that time, the chemistry technician involved in sampling VRS-2500 did not restore the valving to its normal alignment as required by 2 THP 6020 LAB.135. During the time period (12/30/87 through 1/6/88), when the sample lineup was incorrect for VRS-2500, continuous noble gas monitoring or 8 hour grab samples as required by Technical Specification 3.3.3.10 Table 3.3-13 Section 3.a was not met. Other than the Auxiliary Building Vent Radiation Monitor, there were no inoperable structures, components, or systems that contributed to this event.

The cause is cognitive personnel error. The valves were not restored to normal alignment after sampling VRS-2500 on December 30, 1987.

Configuration A reflects the as found condition. Configuration B is the correct by procedure flow path.

After discovery of incorrect valve lineup on January 6, 1988, proper flow was restored to VRS-2500 and the valve lineup was verified correct (completed at 1320 hours). The technician involved was counselled as to the importance of insuring quality and procedure compliance. As preventive action a change to both 2 THP 6020 LAB.135 and 1 THP 6020 LAB.135 was written to require local independent verification of the proper valve alignment in addition to requesting Control Room personnel to verify the monitor has been returned to proper operational state.
