SUBJECT: Summarizes 901004 meeting w/NRC in Rockville,MD,to discuss SSFI rept.

Donald C. Cook Nuclear Plant Units 1 and 2
License Nos. 50-315 and 50-316
Docket Nos. DPR-58 and DPR-74
SUMMARY OF OCTOBER 4, 1990, MEETING TO DISCUSS SSFI REPORT

SUMMARY OF DESIGN VERIFICATION ISSUES
DISCUSSED DURING OCTOBER 4, 1990 MEETING

SUMMARY OF TECHNICAL ISSUES DISCUSSED
DURING OCTOBER 4, 1990 MEETING

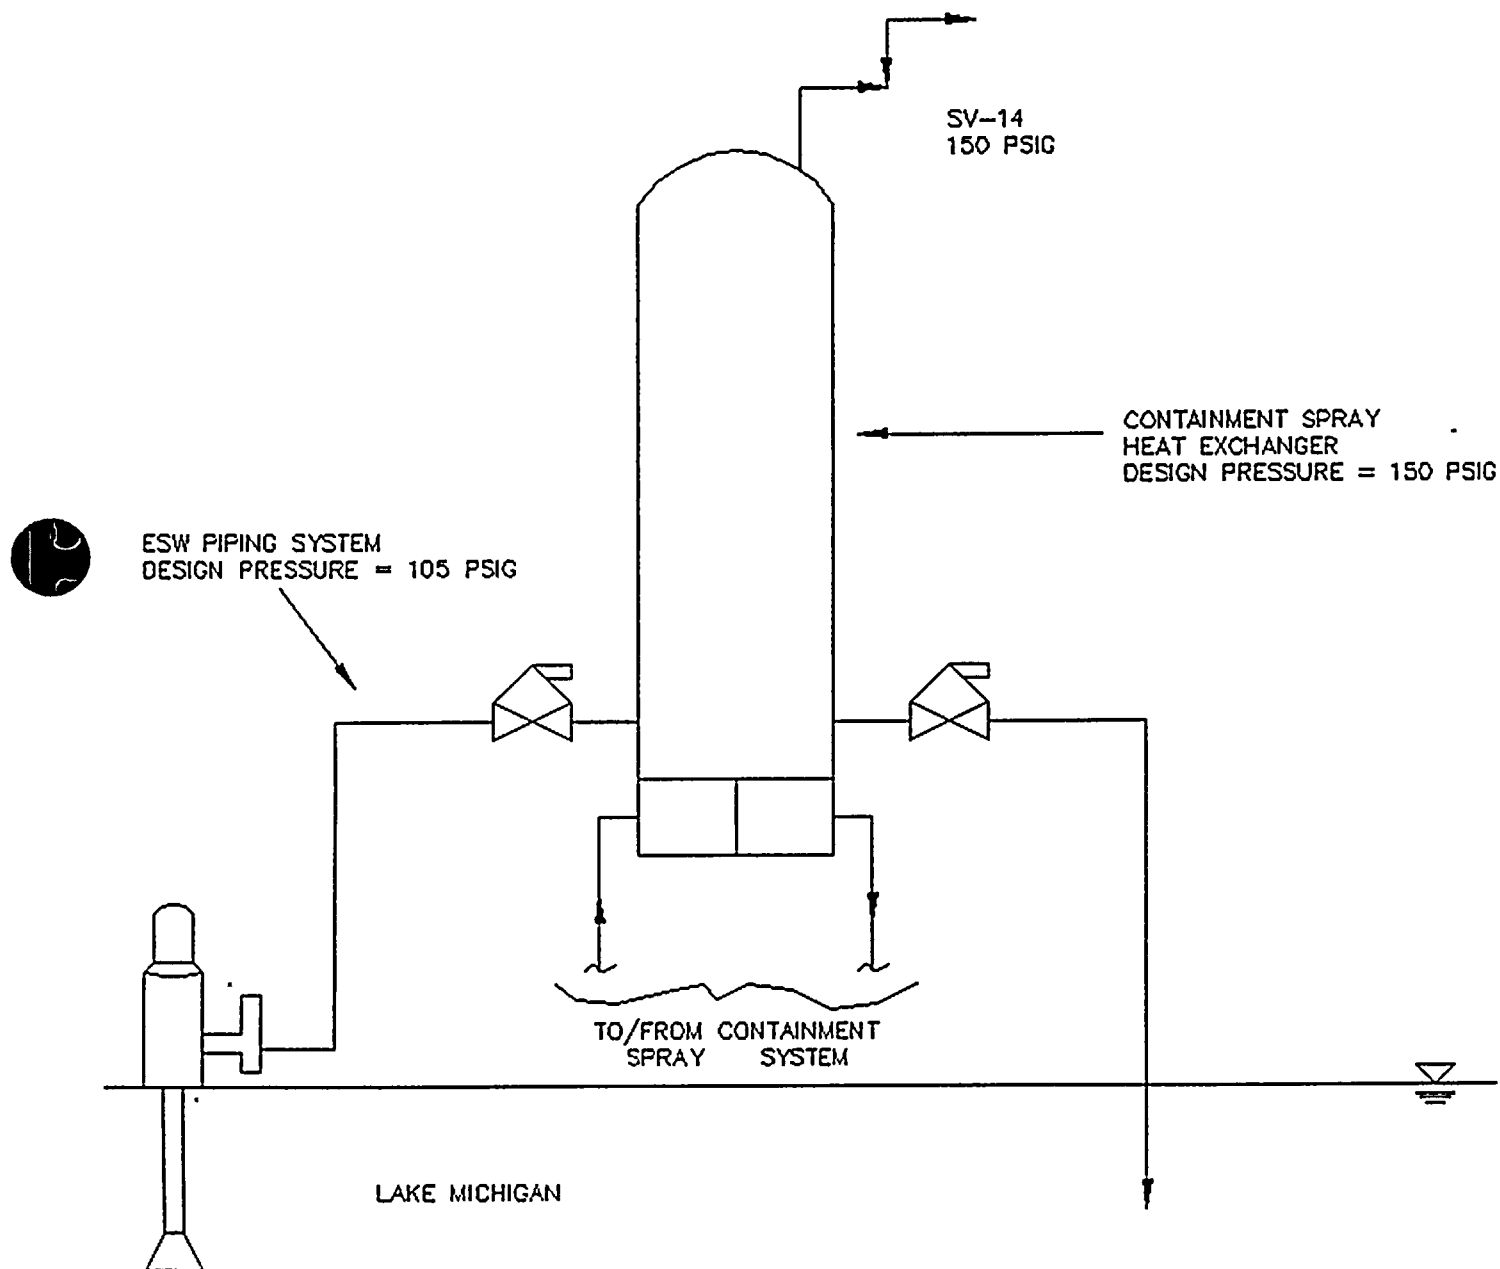
CONTAINMENT SPRAY HEAT EXCHANGER THERMAL RELIEF VALVE

The configuration traces back to the original ESW system design, which has a 105 psig design pressure, corresponding to the shutoff pressure of the ESW pumps. When the system equipment was specified, it was common practice to specify components with design pressures higher than the system design pressure, which is conservative. Typically a 150 psig component design pressure was used.

The code of construction for the service water side of the ESW system heat exchangers, ASME Section VIII - 1968, requires that a pressure relieving device be provided which prevents the pressure from rising more than 10 percent above the maximum allowable working pressure (assumed to be the same as the design pressure, as allowed by the code). Since the only source of potential overpressure above pump shutoff head is thermal expansion when the heat exchanger is isolated, 150 psig relief (or sentinel) valves were provided, corresponding to the component design pressure.

- ESW PIPING SYSTEM DESIGN PRESSURE IS 105 PSIG (PUMP SHUTOFF HEAD)
- COMPONENTS SPECIFIED AT 150 PSIG, WHICH IS CONSERVATIVE
- THERMAL RELIEF VALVE SET PRESSURE SET AT 150 PSIG CONSISTENT WITH COMPONENT DESIGN PRESSURE
- WORDING CHANGES IN SECTION XI REQUIREMENTS POINTED TO HYDRO TESTS BASED ON RELIEF VALVE PRESSURE RATHER THAN DESIGN PRESSURE
- SELF-IDENTIFIED RESOLUTION TO LOWER VALVE SET PRESSURE TO SYSTEM PRESSURE FOR TESTING CONVENIENCE
- CHARACTERIZED AS EXAMPLE OF INADEQUATE DESIGN VERIFICATION CONTRIBUTING TO DESIGN DEFICIENCIES

requirements for the erosion/corrosion program and would also have required hydrostatically testing the system at two pressures. Therefore, as a matter of convenience, it was decided to lower the set pressure of the sentinel valves to the piping system design pressure of 105 psig to provide literal compliance with the 1983 version of ASME Section XI. A problem report was written to ensure a thorough review of this issue. The investigation of this problem report resulted in a planned design change to lower the safety valve settings for ESW system components to 105 psig.

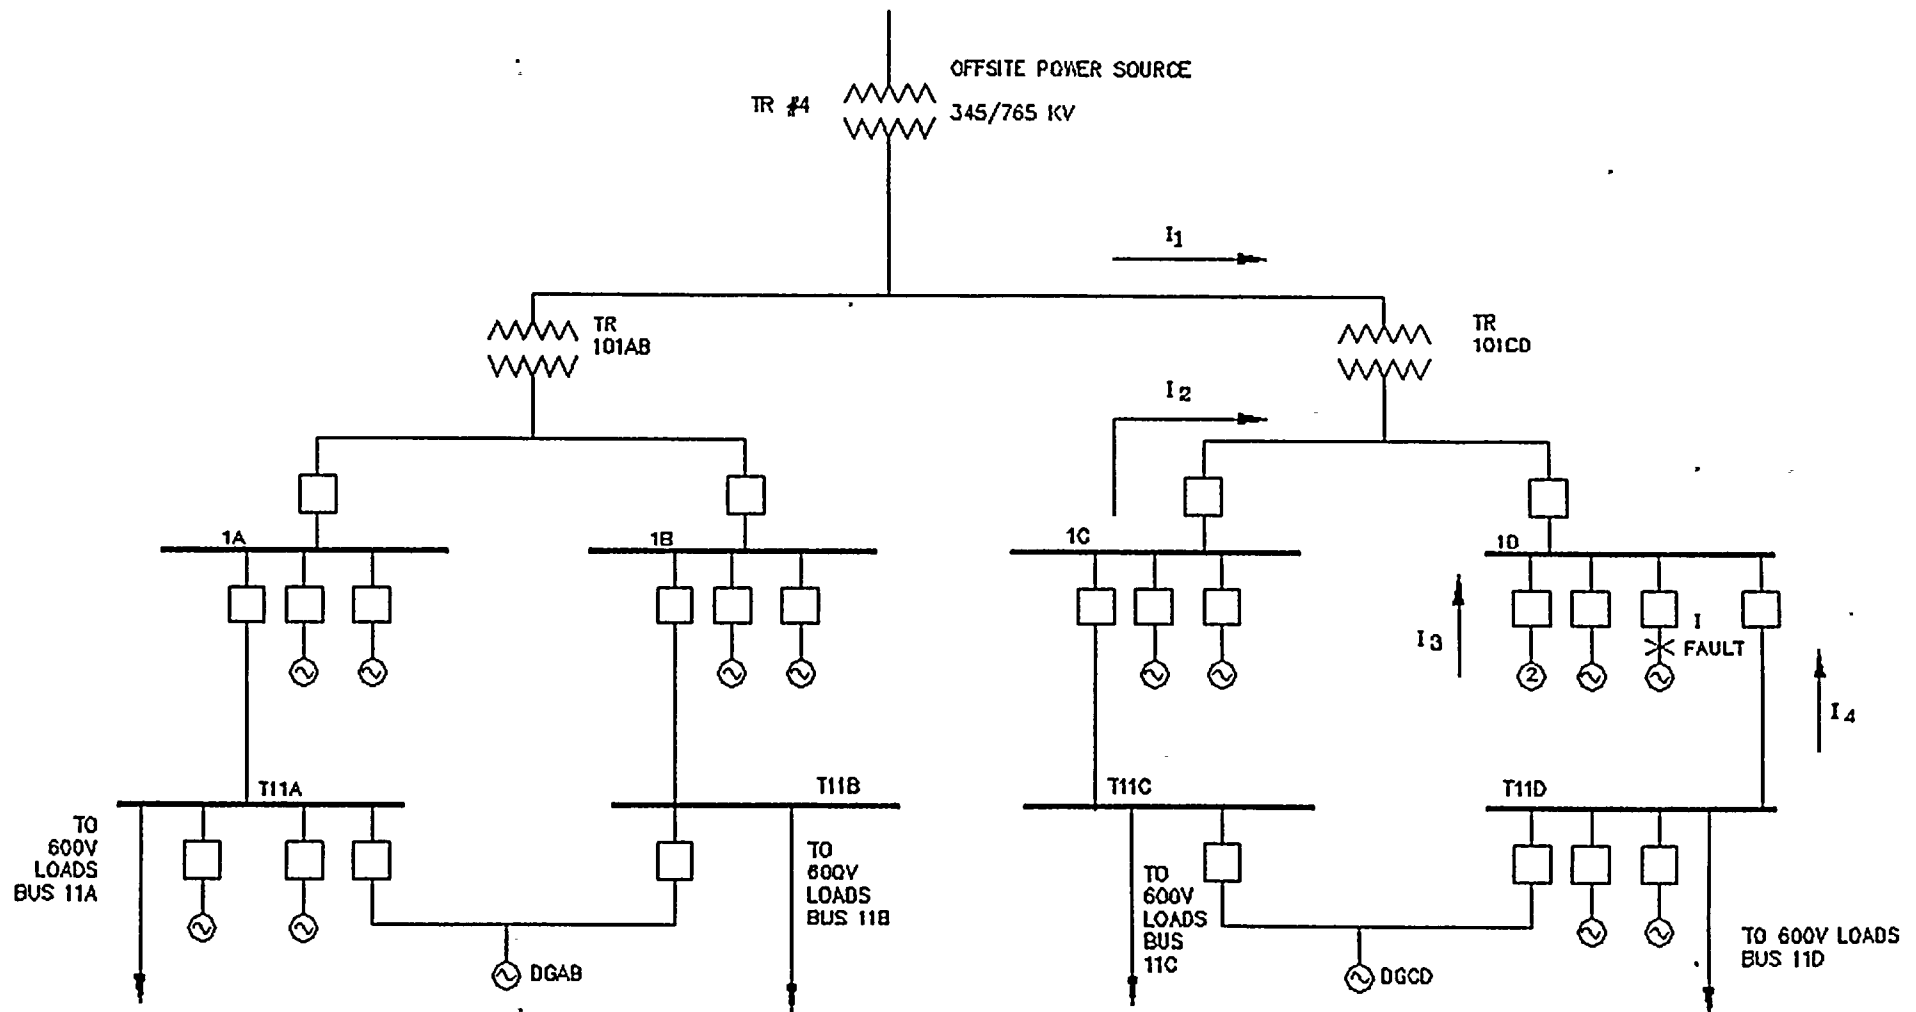
4KV BREAKER FAULT CURRENT

The technical review determined that this was a very low probability concern. In order for the fault current to exceed the breaker rating, a bolted three-phase fault must occur at or near the breaker in conjunction with maximum DC offset and the system in an atypical configuration. (By atypical, it is meant that the fault would have to occur while the unit is powered by the reserve (offsite) source, rather than the generator auxiliary transformers.) A bolted three-phase fault at or near the breaker is considered highly unlikely. The switchgear is enclosed in metal cabinets which are not accessed with the equipment energized. The power cables are individually shielded, grounded, phase cables, making the likely failure a phase-to-ground fault. The Cook Nuclear Plant electrical distribution system is a resistance ground system which limits the phase-to-ground fault current to approximately 2,000 amps.

The safety-related electrical buses are designed such that no single fault can affect redundant trains of safety equipment. Besides being separated electrically, the electrical equipment trains are physically separated such that if a breaker were to be physically damaged, the other train would not be impacted by the damage.

ASSUME FAULT ON BUS 1D BREAKER LOAD SIDE TERMINALS SINCE THIS IS THE WORST CASE BUS MOTOR CONTRIBUTION.

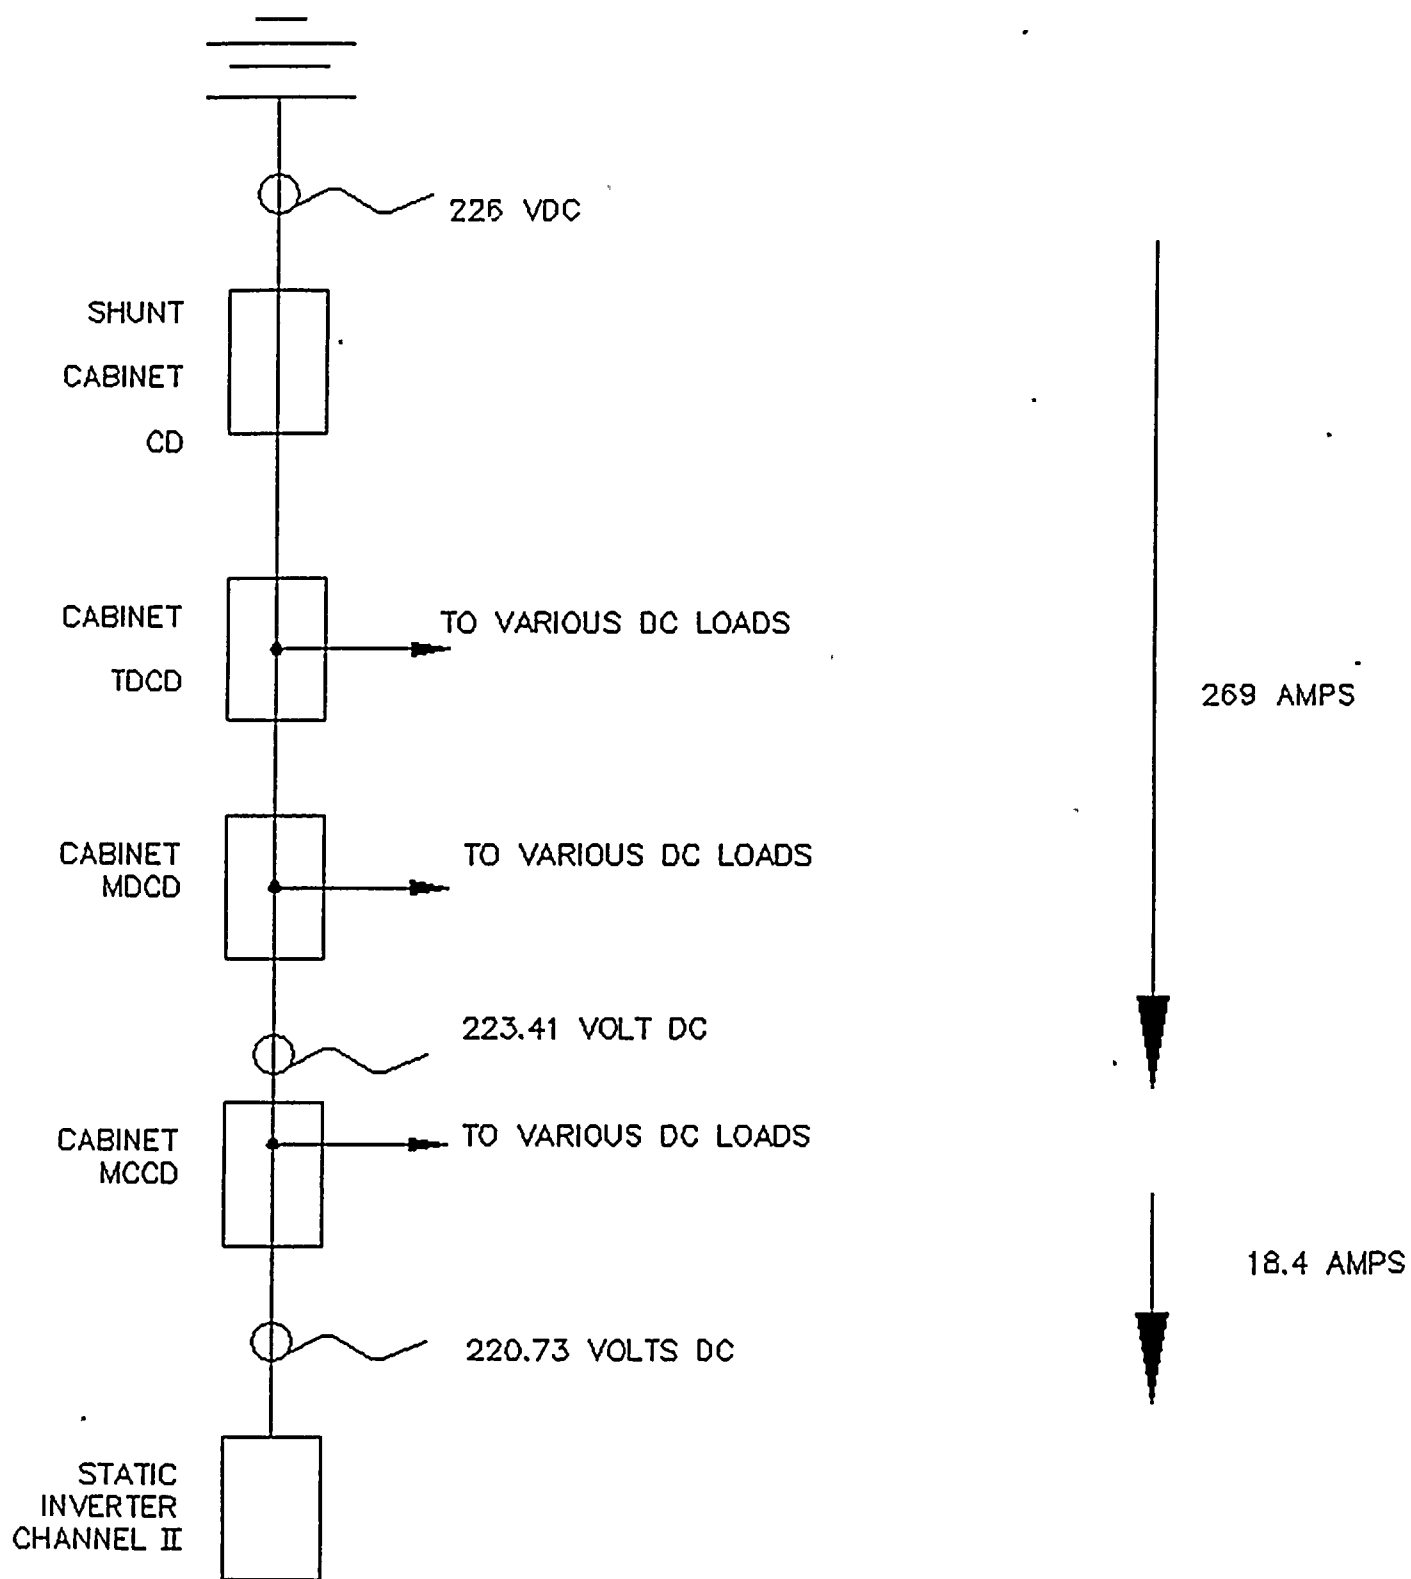
STATIC INVERTER VOLTAGE PROFILE

Per Technical Specification Table 4.8-2, the inverters are only required to function for three hours in an emergency. Under the newer station blackout requirements, the inverters are only required for four hours. At the end of four hours, the battery terminal voltage is calculated to be 226 volts, with the corresponding voltage at the inverter being 220 volts, which is above the inverter's specified minimum rating of 210 volts. We believe this adequately addresses the NRC's concerns.

- ISSUE - END OF LIFE BATTERY VOLTAGE SAME AS MINIMUM INVERTER VOLTAGE RATING 210 V D.C.
- DESIGN BASIS ACHIEVED
 - INVERTERS REQUIRED - 4 HOURS
 - BATTERY VOLTAGE - 226 V, INVERTER VOLTAGE - 220V
- ENGINEERING REVIEW
 - BATTERY vs INVERTER DUTY
 - VOLTAGE DROP REDUCED AT END OF PROFILE
 - INVERTER MANUFACTURER - 200 VOLT FUNCTIONAL STATEMENT
- CONCLUSION
 - INVERTER APPLIED WITHIN RATINGS
 - NOT A DESIGN VERIFICATION PROBLEM
