Subject Cook Nuclear Plant  
NFPA Code Compliance  
Impell Contract C-6945

May 18, 1988  
0120-108-021

SUBJECT: D. C. Cook Plant NFPA Code Compliance Evaluation  
Impell Report #09-0120-0123 Rev. 0  
"NFPA Code Compliance Evaluation"  
Indiana Michigan Electric Company - Contract C-6945  
Impell Job No. 0120-108

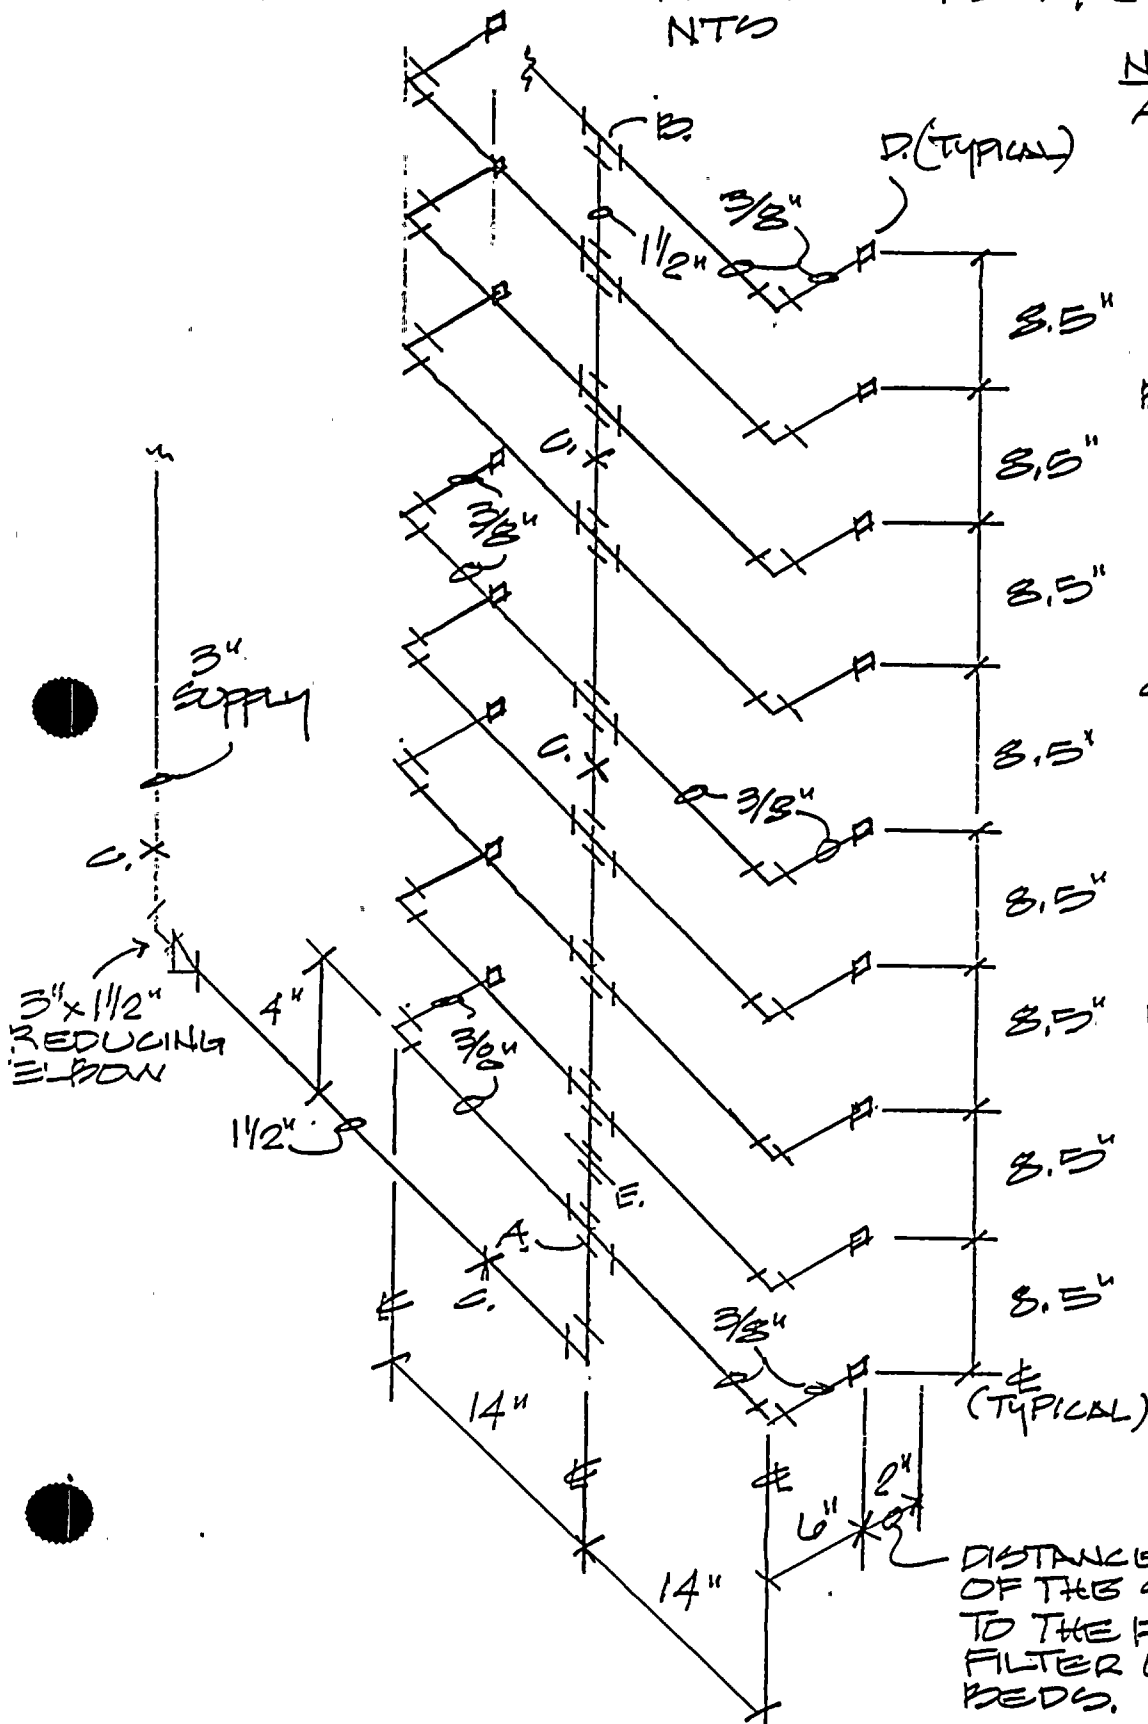
SUBJECT SKETCH OF FILTER UNIT SPRAY SYSTEM (CONT'D)

DISTANCE FROM THE END  
OF THE SPRAY NOZZLE  
TO THE FACE OF THE  
FILTER UNIT CHARCOAL  
BEDS.
