Docket No. 05200046

Supplemental Reply to NOV 05200046/2016-202

December 2017

## **Supplemental Reply to a Notice of Violation (NOV): NRC Inspection Report No.05200046/2016-202**

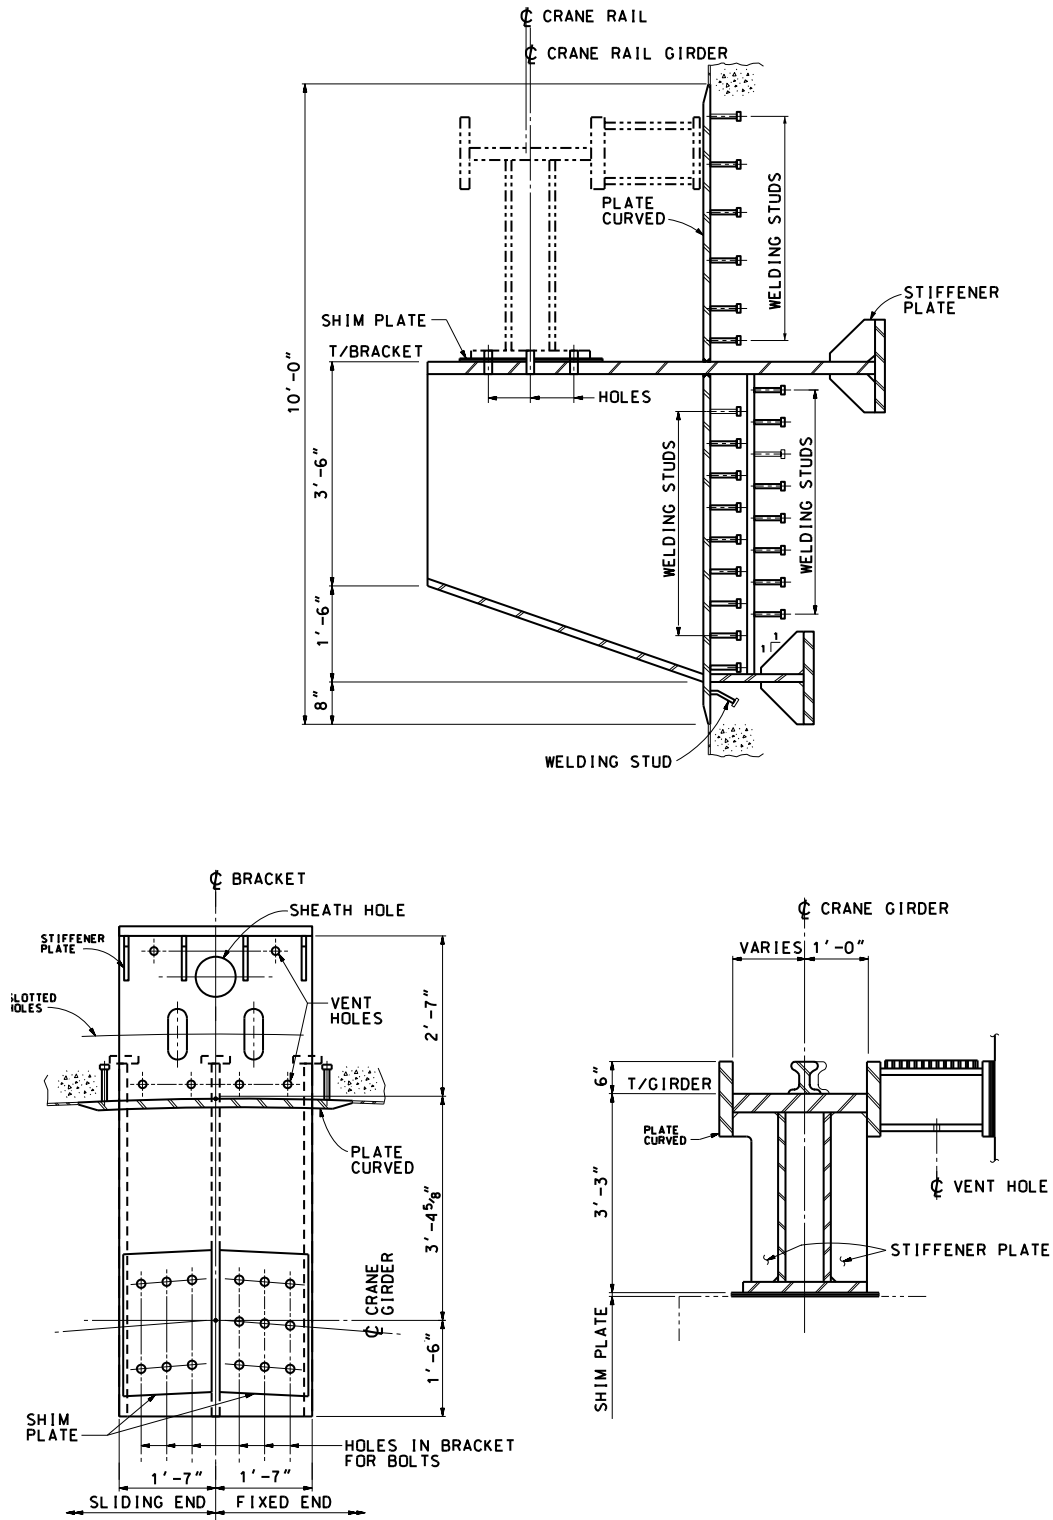
Figure 19.5-11 Polar Crane Bracket

The polar crane bracket and rail girder shown in Figure 19.5-11, are key design features to protect the safety system located inside containment from the drop of polar crane due to the impact of a large commercial aircraft. The polar crane brackets and girders shall be ASTM A588 Grade A or B and the bolts for the connection between polar crane bracket and rail girder shall be minimum 1.5" diameter ASTM A490X. The design of polar crane bracket and rail girder is performed to maintain adequate design margins. The summary of design results and material properties are shown in Table 19.5-1.
