SUBJECT: FORWARDS RESULTS OF STEAM GENERATOR INSP CONDUCTED DURING
 CURRENT OUTAGE:NO NEWE OR UNEXPECTED PHENOMENA FOUND.GENERAL
 PATTERN OF DENTING FOUND TO BE WITHIN PREDICTABLE LIMITS.
 REQUESTS PERMISSION TO RETURN UNIT TO POWER OPERATION.

Re: Turkey Point Unit 3
Docket No. 50-250
Steam Generator Inspections

TURKEY POINT 3 STEAM GENERATOR

INSPECTION PROGRAM

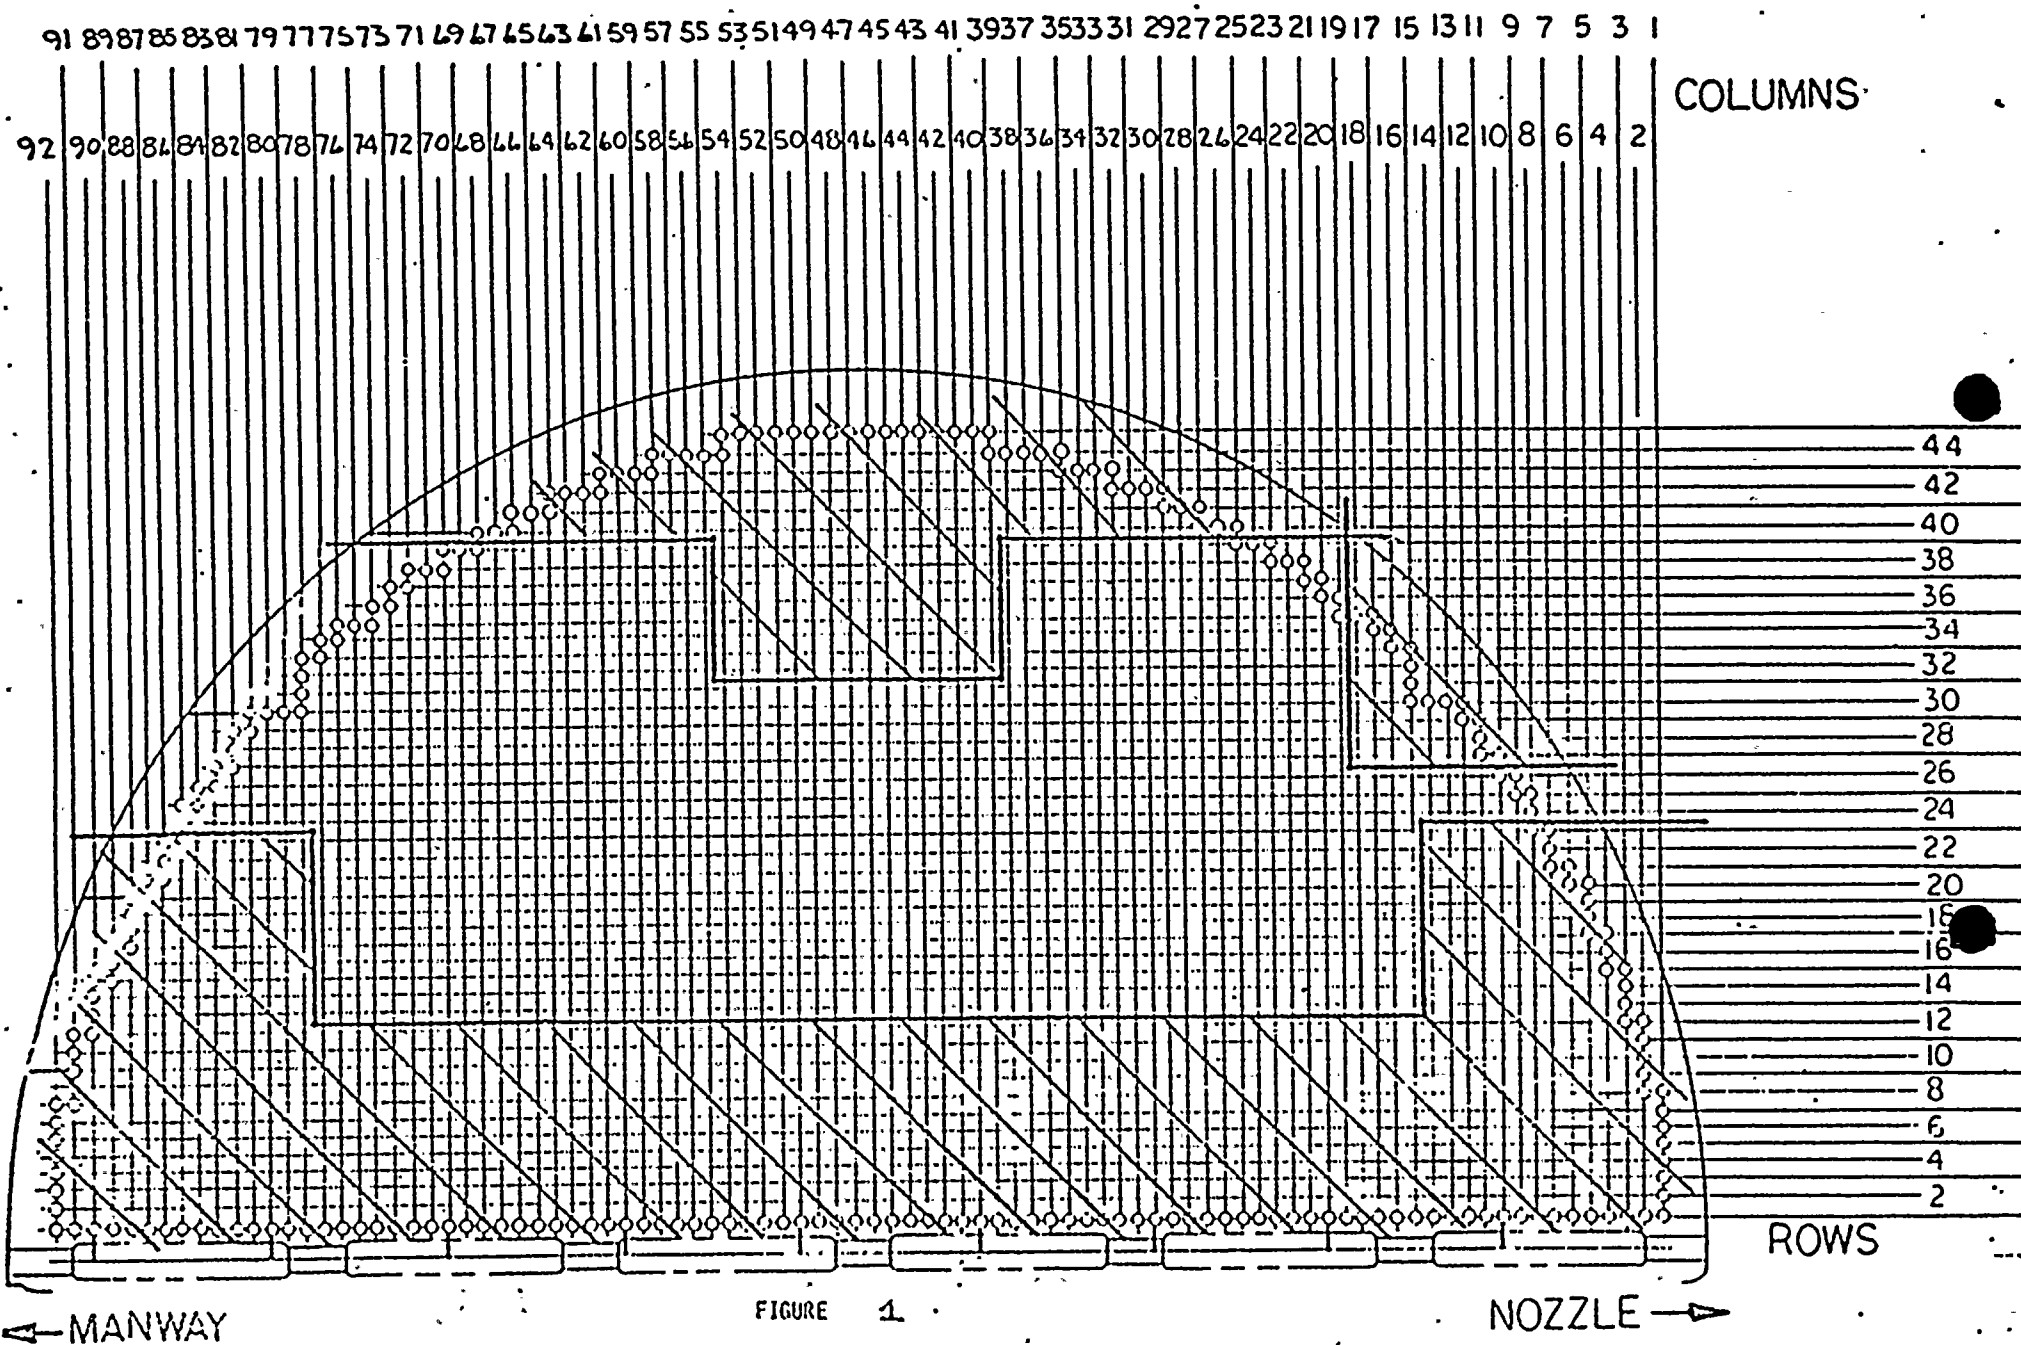
FIGURE 1

The inspection boundary for the December 1977 inspection (Figure 1) is included for reference. The gauging inspection boundaries for the January 1979 inspection are indicated in Figure 2 (typical hot leg) and Figure 3 (typical cold leg).

TURKEY POINT UNIT 3 GAUGING PROGRAM - DEC 77
(HOT LEG)

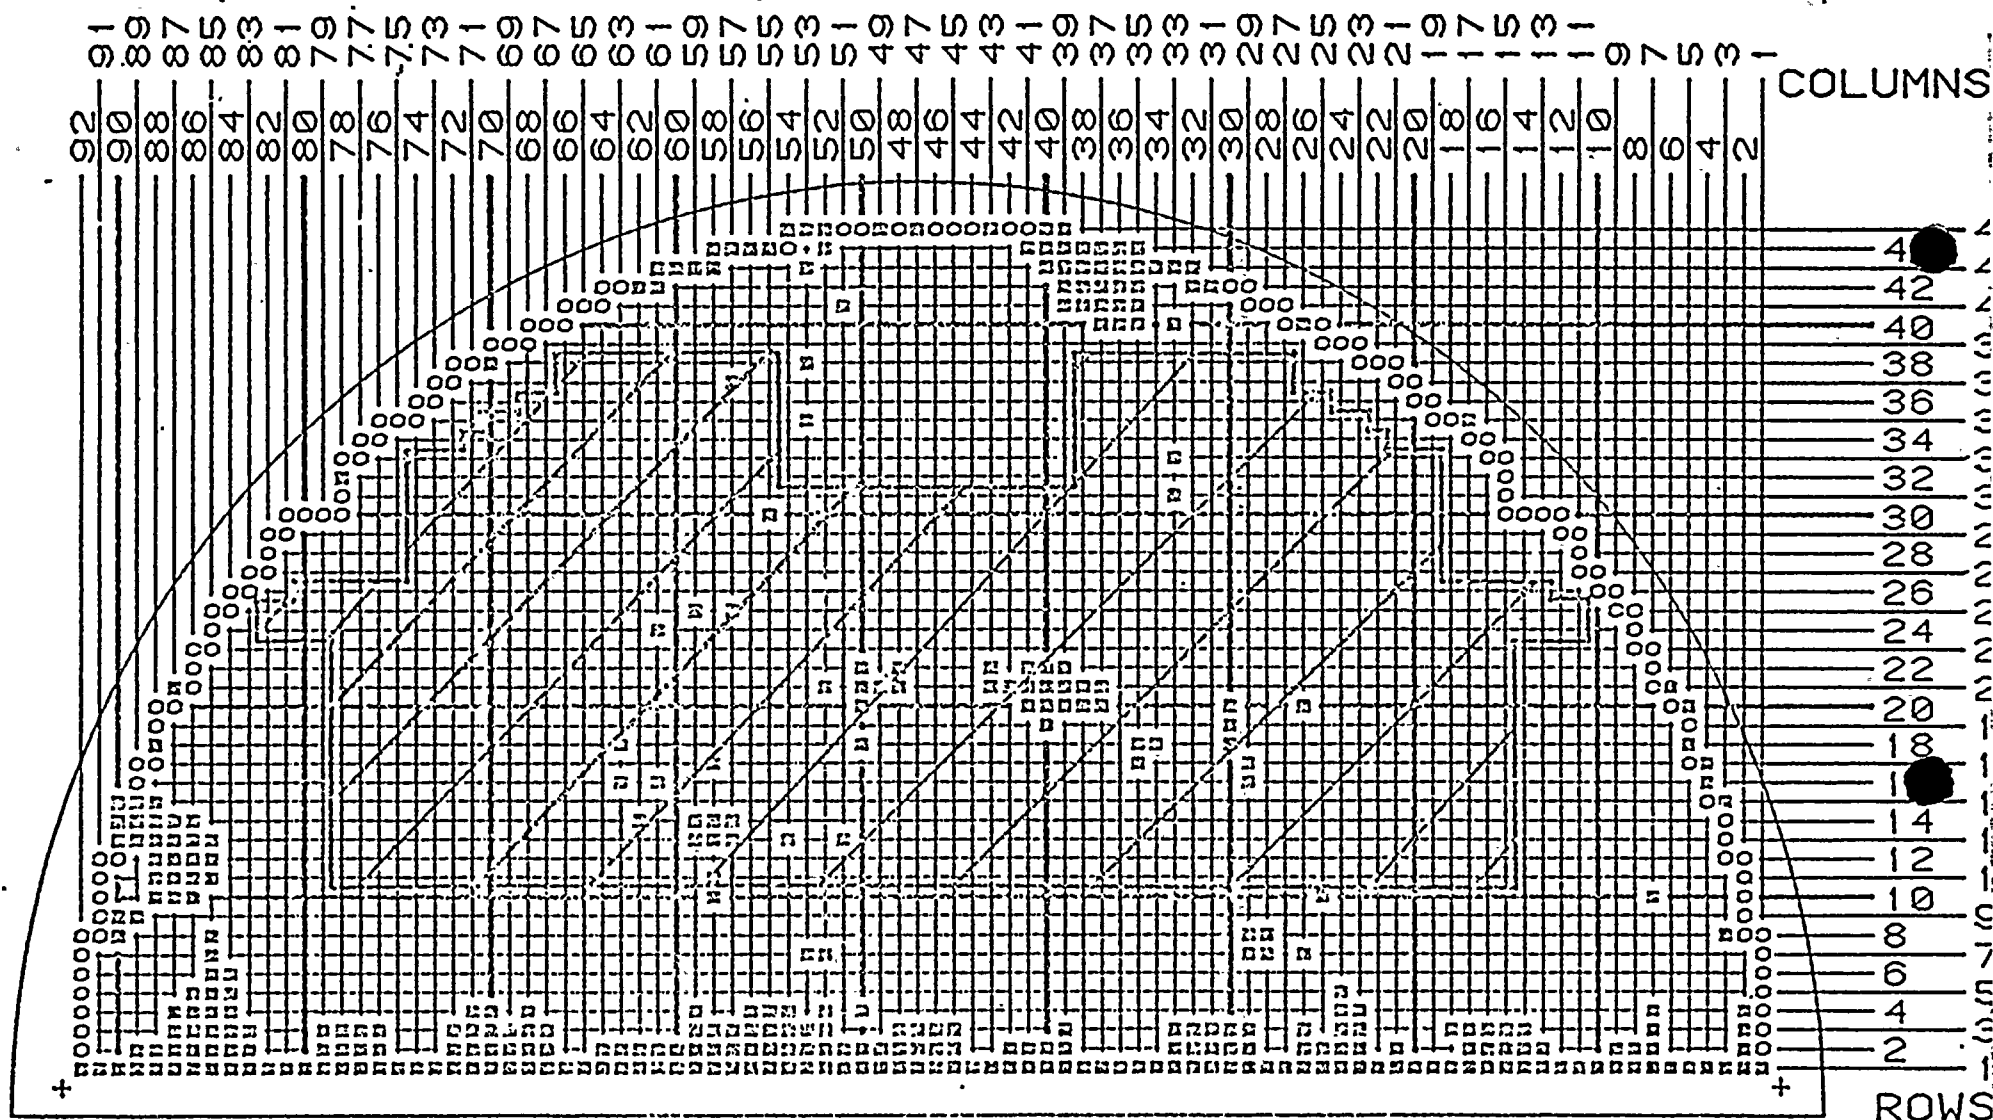
FIGURE 3

It should be noted that the cold legs and certain peripheral wedge areas in the hot legs were inspected for the first time in January 1979.

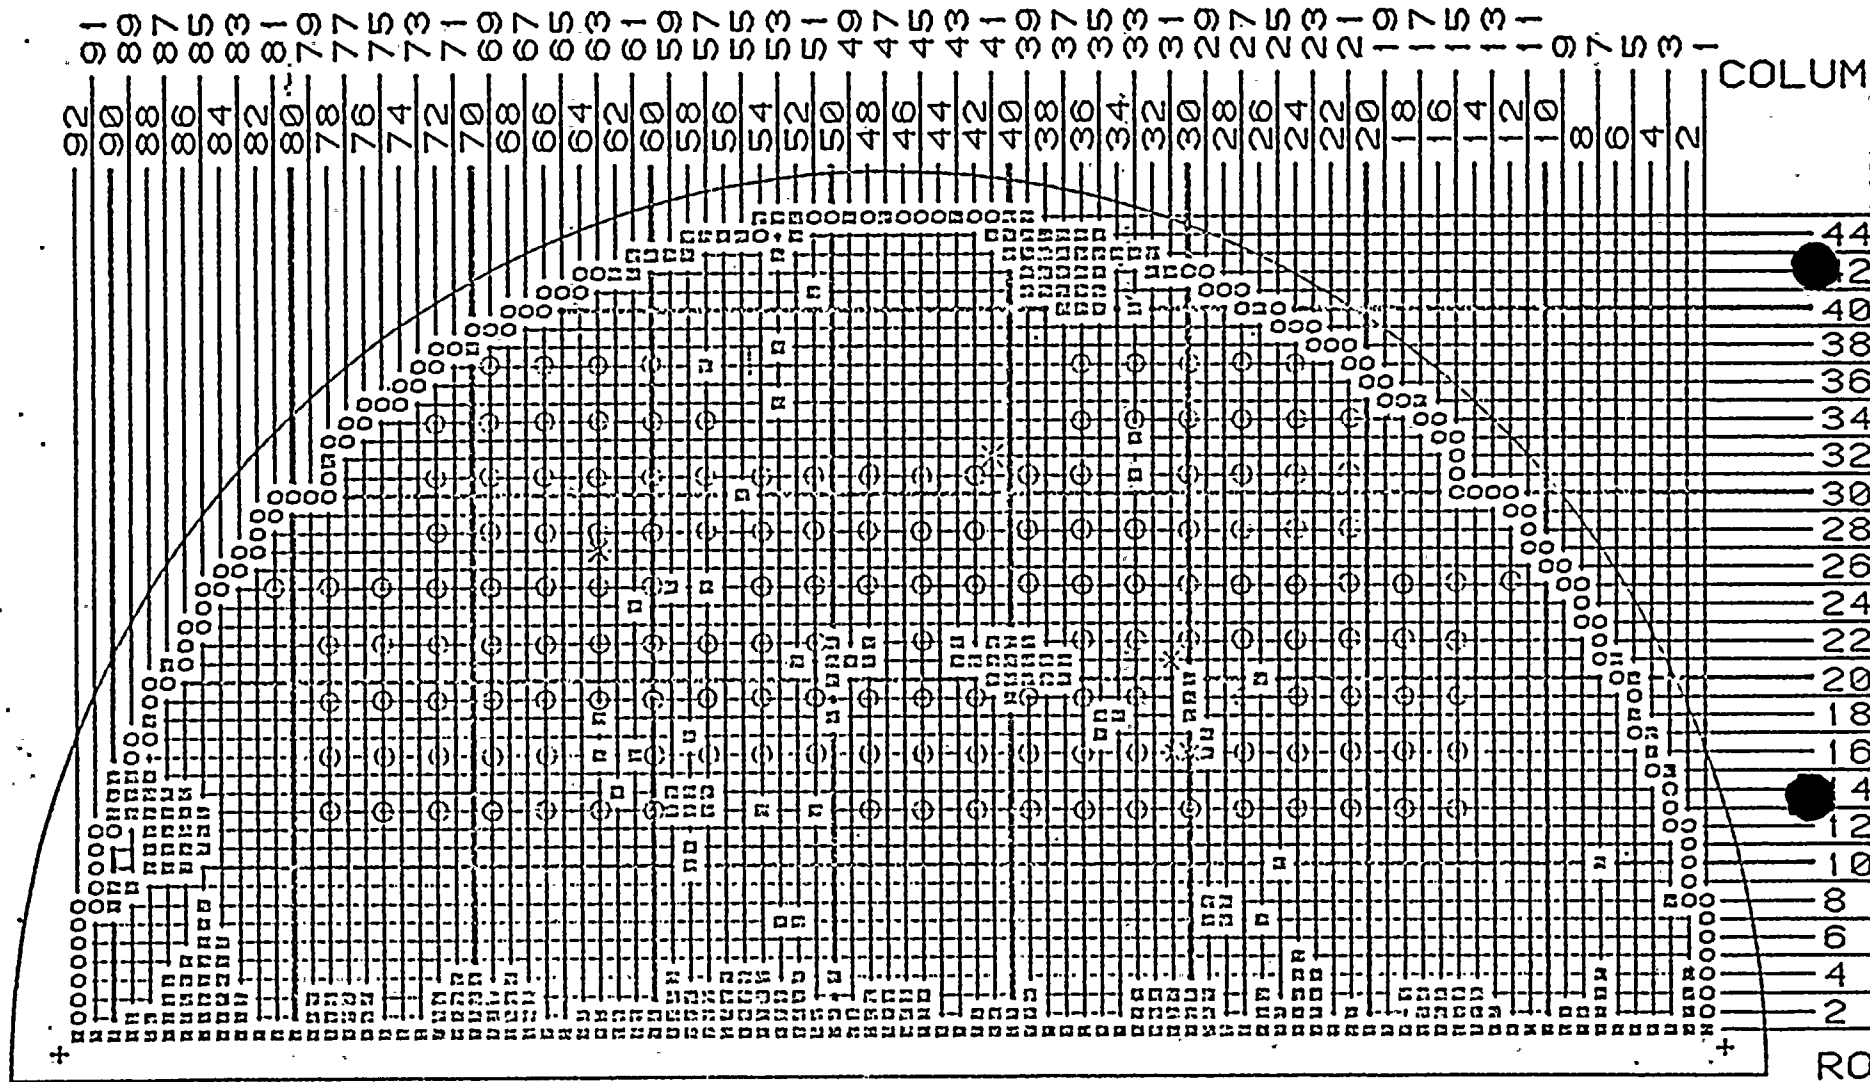
FIGURE 4

The types and extent of inspections required in this area are specified in R.G. 1.83. Typical inspection plans are included (Figures 4 and 5). During the inspections, expansions of the programs in steam generators A and C were accomplished as per R.G. 1.83. Results of the inspection are discussed later in this report.

○ INDICATES TUBES TO BE INSPECTED AT 400KHZ WITH .700 PROBE THROUGH THE U BENDS - Tech. Sup 1; 158 TUBES

X- INDICATES PREVIOUS > 20% INDICATIONS TO BE INSPECTED AT 400KHZ WITH .700 PROBE THROUGH THE U BENDS - Tech Sup 1; 3 TUBES

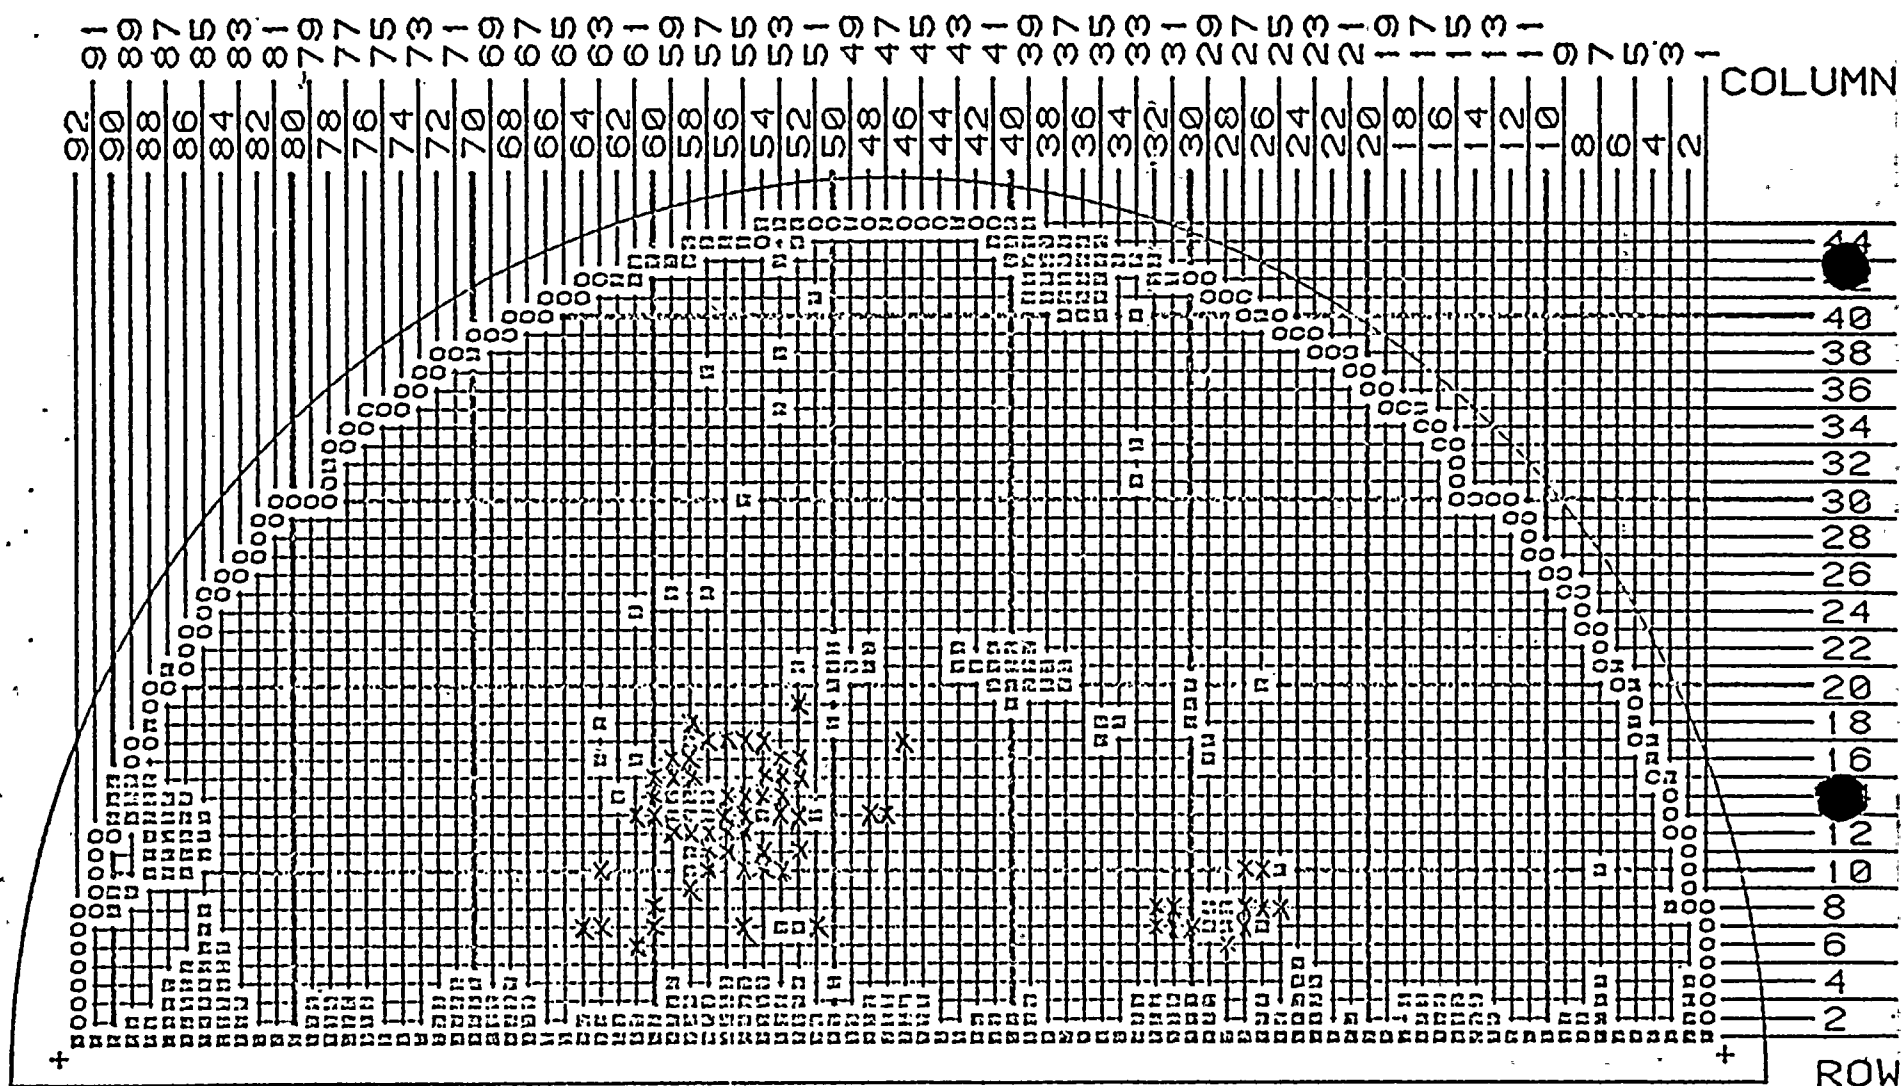
FIGURE 5

X- INDICATES PREVIOUS >20% INDICATIONS TO BE INSPECTED AT 400KHZ WITH .720 PROBE TO 1ST SUPPORT-TECH SUP I.; 66 TUBES.

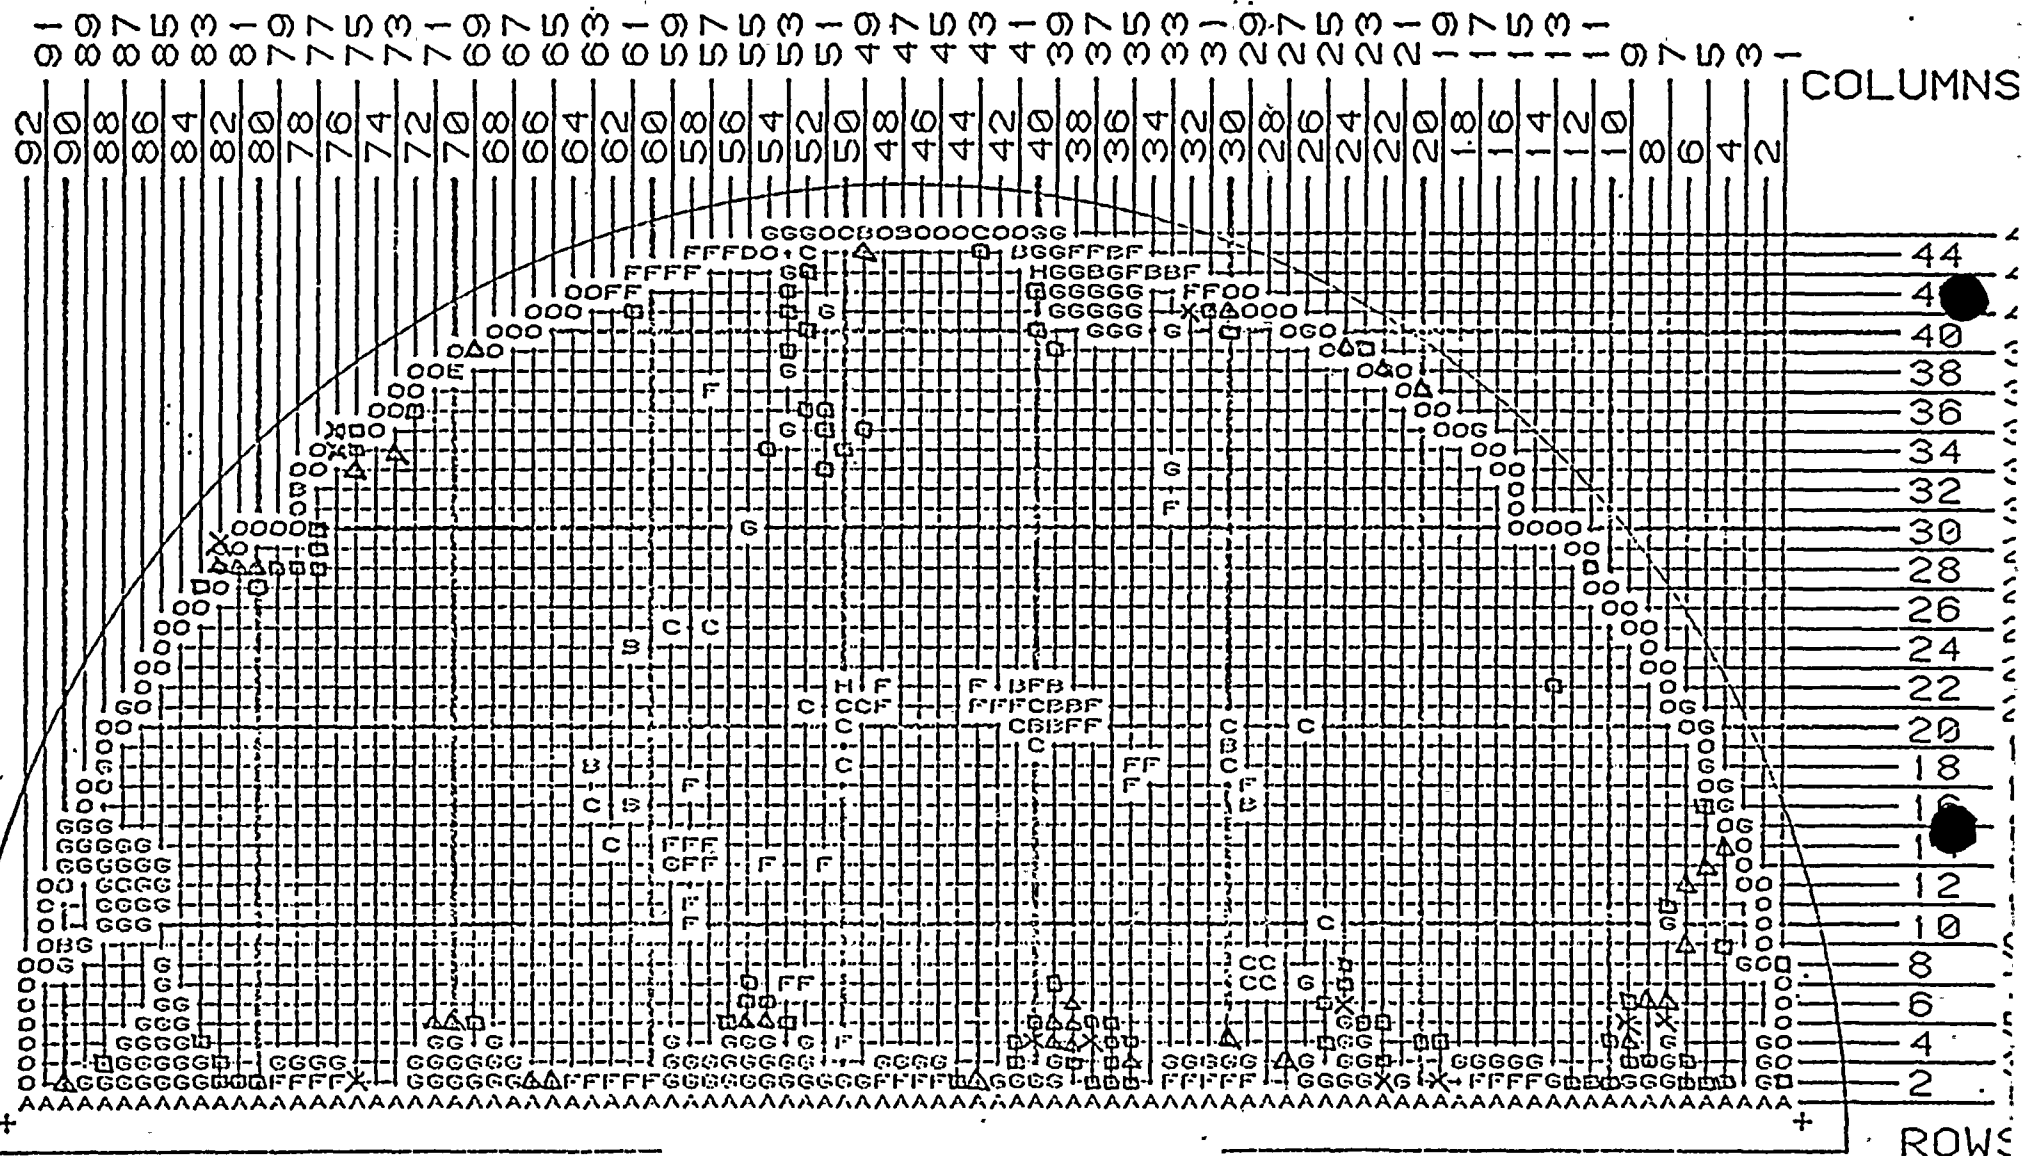
Results of the gauging inspections are indicated in Figures 6, 7, 8, 9, 10, and 11 and are summarized in Table 2.

1. Tubes in the tubelane region that restrict the 0.650 inch probe or less lie within the 15% strain boundary.
2. Tubes in the tubelane region restricting 0.540" probe (hot leg and cold leg) fell into the following categories by location:
 - (a) Row 2 8 tubes
 - (b) Adjacent to hard spots 9 tubes (row 4 or below)
 - (c) Adjacent to center of flow slots 5 tubes (SG A only-row 6 or below)

3. In steam generators A, B, and C, restricted tubes developed adjacent to previous activity or clustered together with other new activity. This was particularly true of tubes that restricted the 0.610" and 0.540" probes. Areas of activity were consistent with past historical data for this and other plants. Areas of note were Columns 1-15 and 77-92 near the flow slots which finite element analysis predicts should progress much more rapidly than other flow slot areas. The wedge and tubelane interaction is apparently causing the finite element analysis to over predict this reaction since the activity in this area is consistent with the remainder of the tubelane flow slots. It is intended that in future inspections this area will be plugged under the same criteria as the rest of the tubelane area.

4. Tube restrictions were noted in the inspected wedge areas (hot leg and cold leg) of all steam generators and this activity appears consistent with previous experience at this and other units. It should be noted that the majority of restrictions were in areas not previously inspected (i.e. wedge areas - see Figure I) and hence are not indicative of the degree of restrictions formed over the last 9.5 effective full power months.

FIGURE 6
 Turkey Point 3A Steam Generator
 Gauging Results
 Hot Leg

1. All tubes which do not pass the 0.540 inch probe will be plugged.

2. Additionally; for in excess of ten (10) months operation, three (3) tubes beyond (i.e., higher row numbers) any tube in columns 14 to 79 which did not pass the 0.540 inch probe will be plugged; for such tubes in column 1 to 13 and 80 to 92 near the tubelane, a maximum of six (6) tubes and a minimum of three (3) tubes (at the edges of the flow slot) beyond any tube which would not pass a 0.540 inch probe will be plugged.

3. All tubes which do not pass the 0.610 inch probe will be plugged.
4. The tubes in any column for which plugging under criteria (1), (2) or (3) above is implemented in the tubelane region will also be plugged in the lower row numbered tubes back to the tubelane if not already plugged.

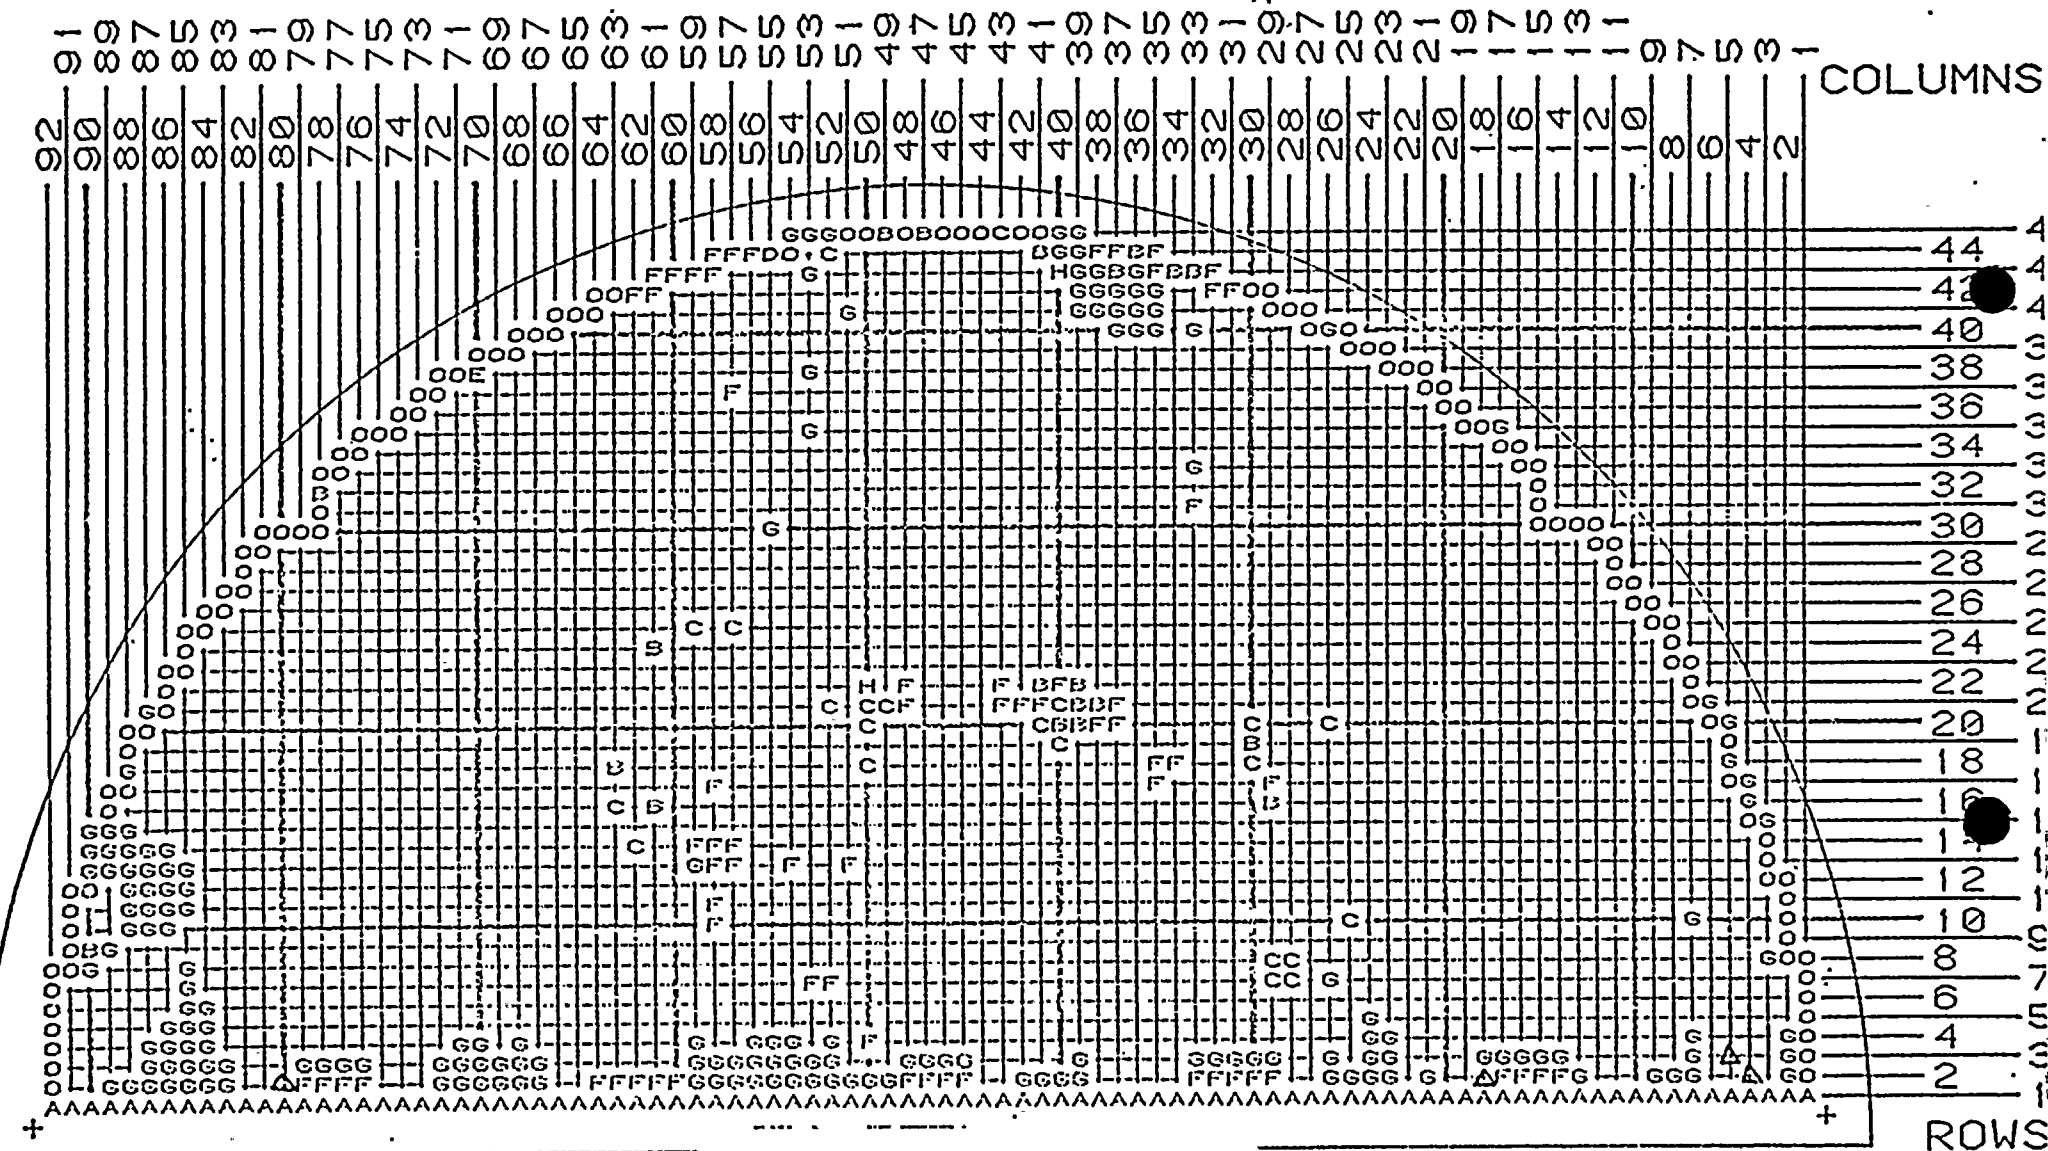
5. In this, the initial inspection of the cold leg areas, relatively few tube restrictions were noted in the tubelane region as compared to the hot leg. Activity was noted in the one cold leg wedge area inspected and

this activity was consistent with activity noted previously in the Turkey Point Unit #4 inspection. The overall level of activity indicates that the activity grows at a very slow rate as compared to the hot leg.

FIGURE 7
 Turkey Point 3A Steam Generator
 Gauging Results - Cold Leg

8. Application of the criteria specified in 7 above, will be made on the basis of engineering judgement for cold leg wedge locations.

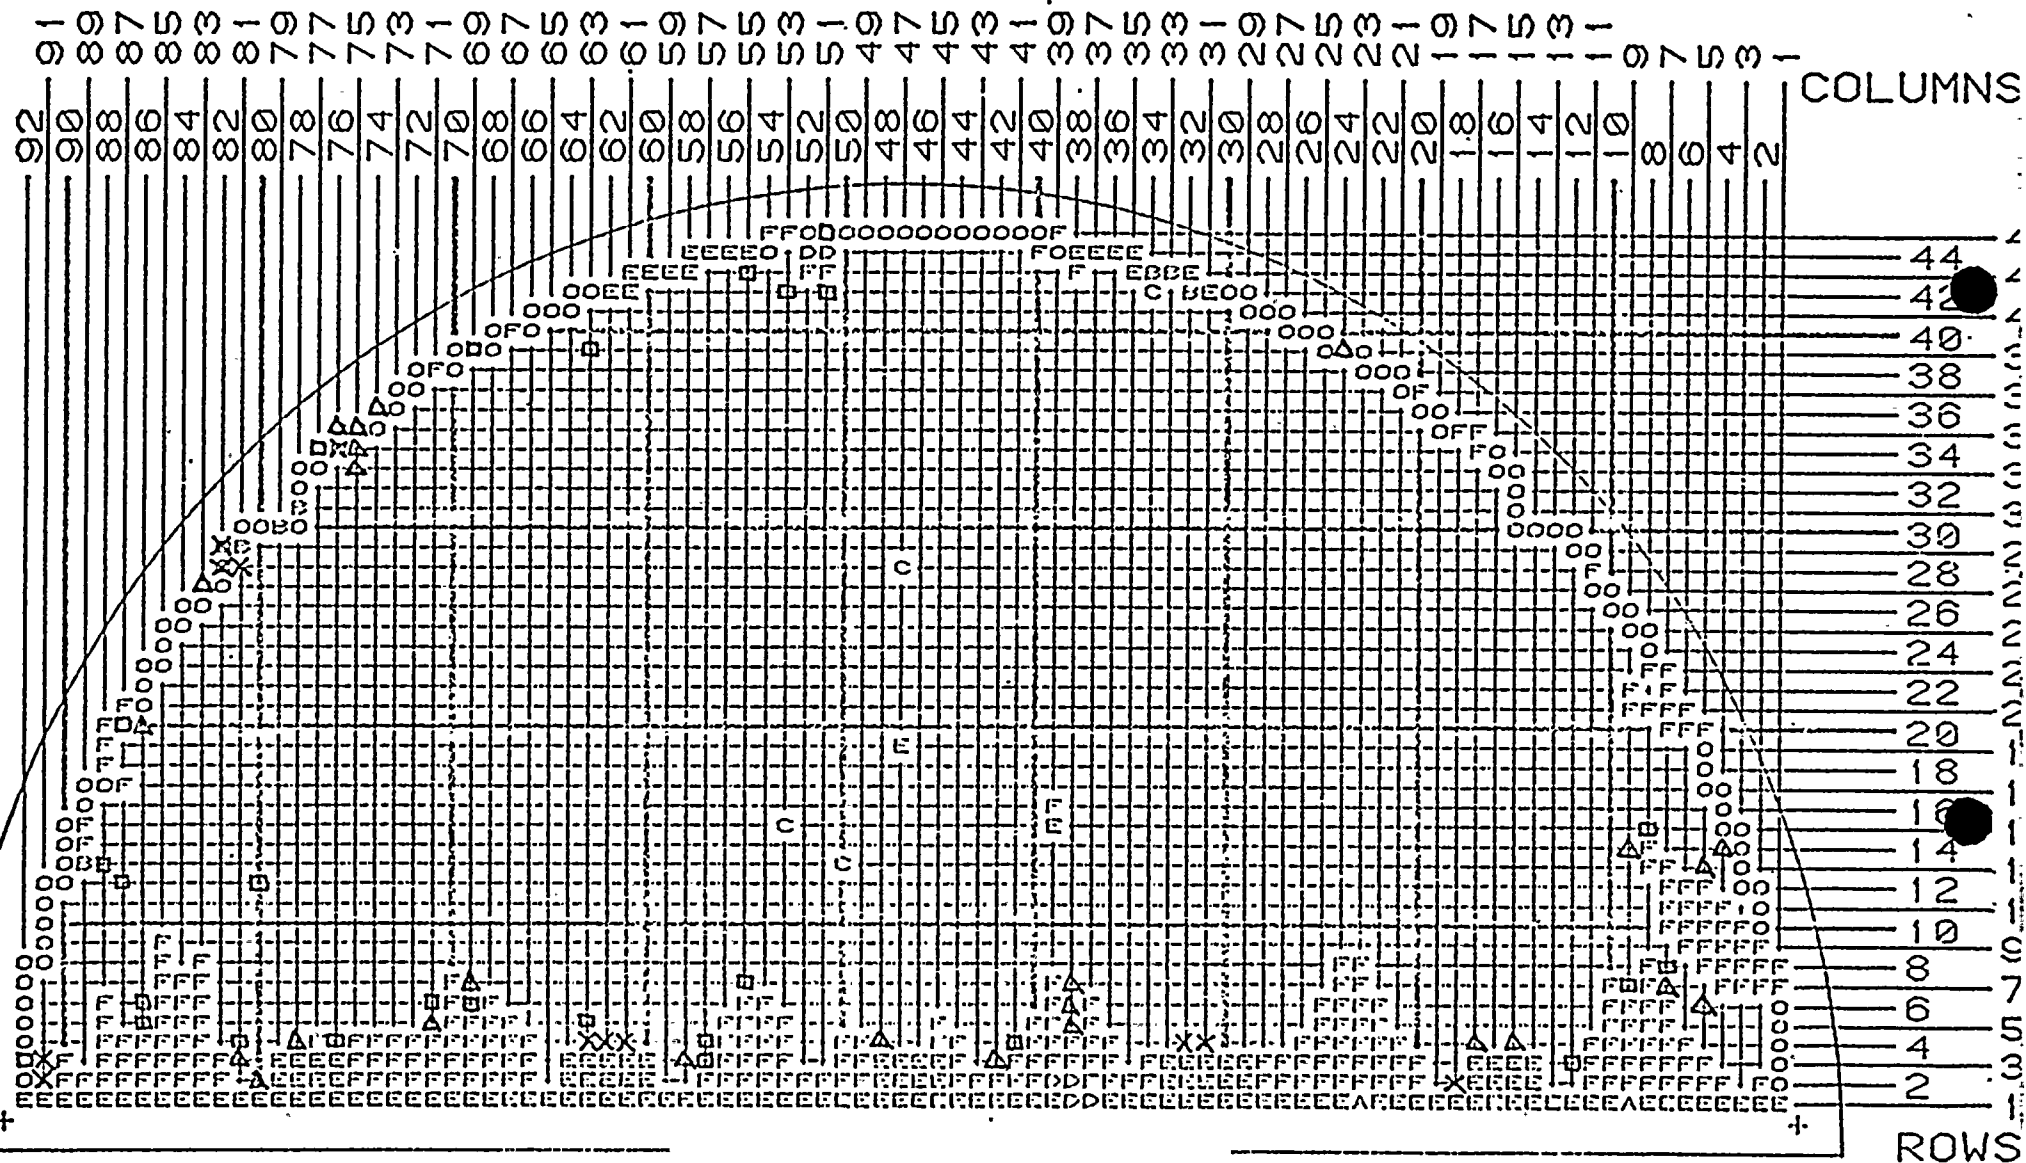
FIGURE 8
 Turkey Point 3B Steam Generator
 Gauging Results - Hot Leg

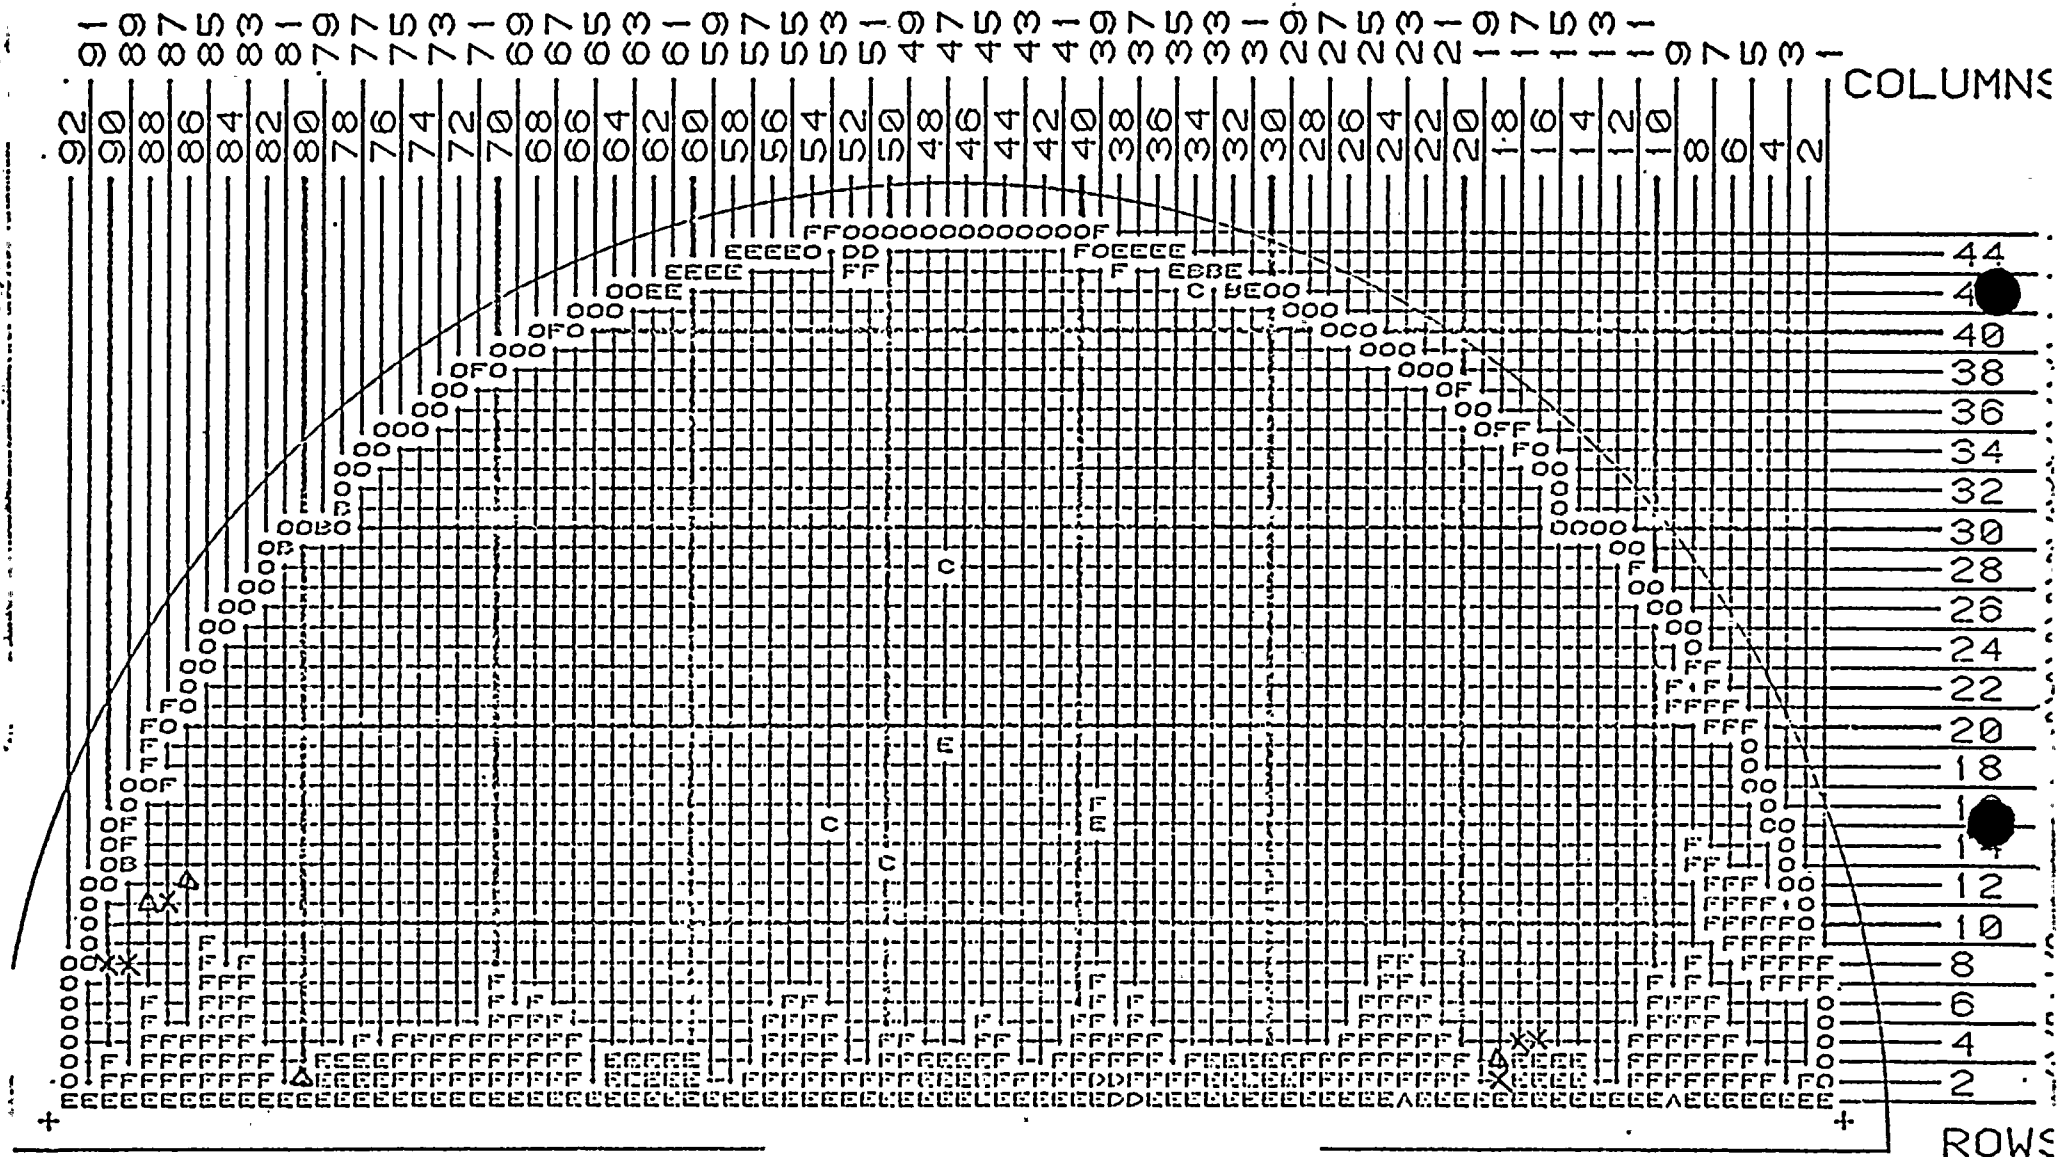
FIGURE 9

Turkey Point 3B Steam Generator
 Gauging Results - Cold Leg

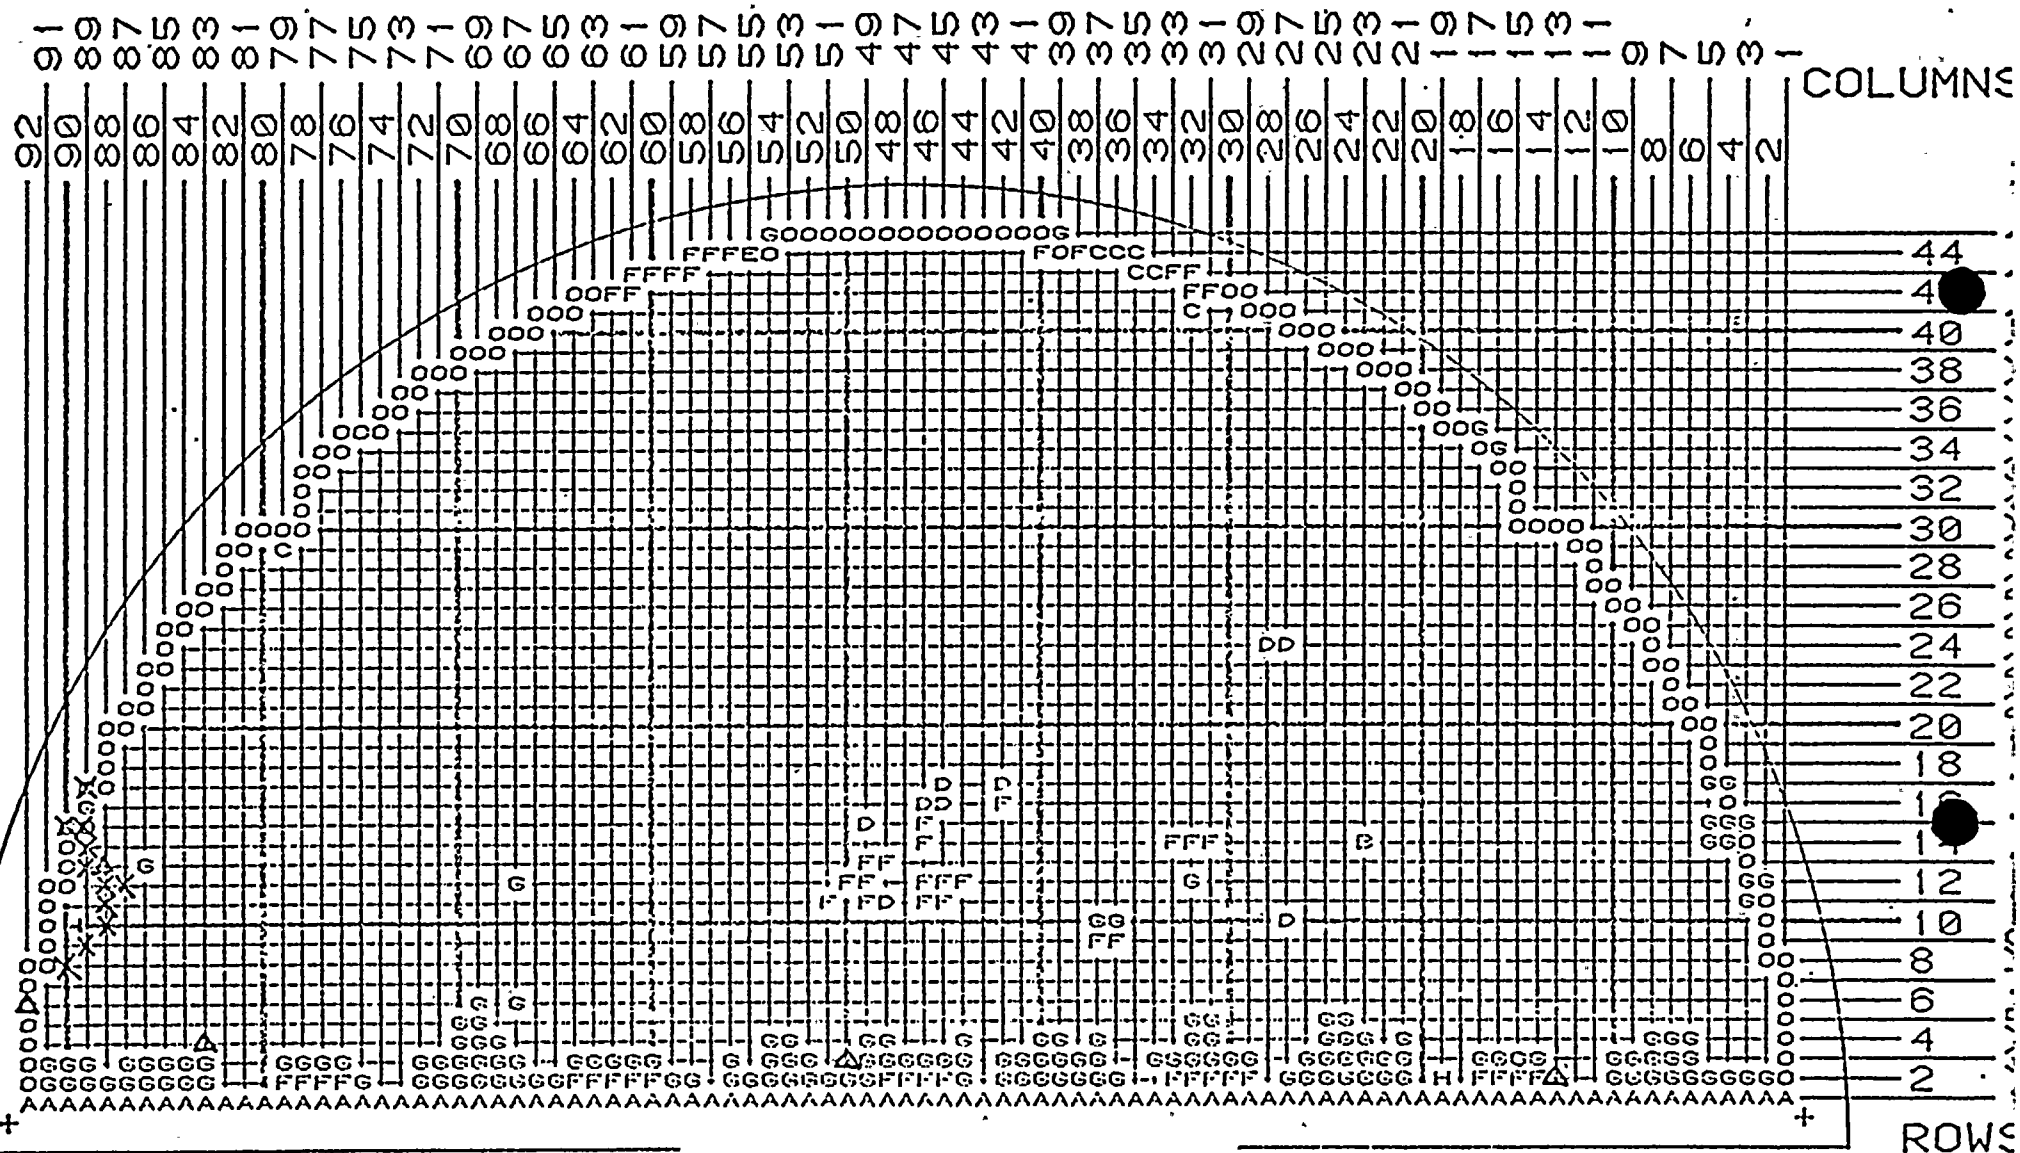
FIGURE 11
 Turkey Point 3C Steam Generator
 Gauging Results - Cold Leg
