SUBJECT: FORWARDS RESULTS OF STEAM GENERATOR INSP CONDUCTED DURING
 CURRENT OUTAGE:NO NEWE OR UNEXPECTED PHENOMENA FOUND.GENERAL
 PATTERN OF DENTING FOUND TO BE WITHIN PREDICTABLE LIMITS.
 REQUESTS PERMISSION TO RETURN UNIT TO POWER OPERATION.

Re: Turkey Point Unit 3
Docket No. 50-250
Steam Generator Inspections

TURKEY POINT 3 STEAM GENERATOR

INSPECTION PROGRAM

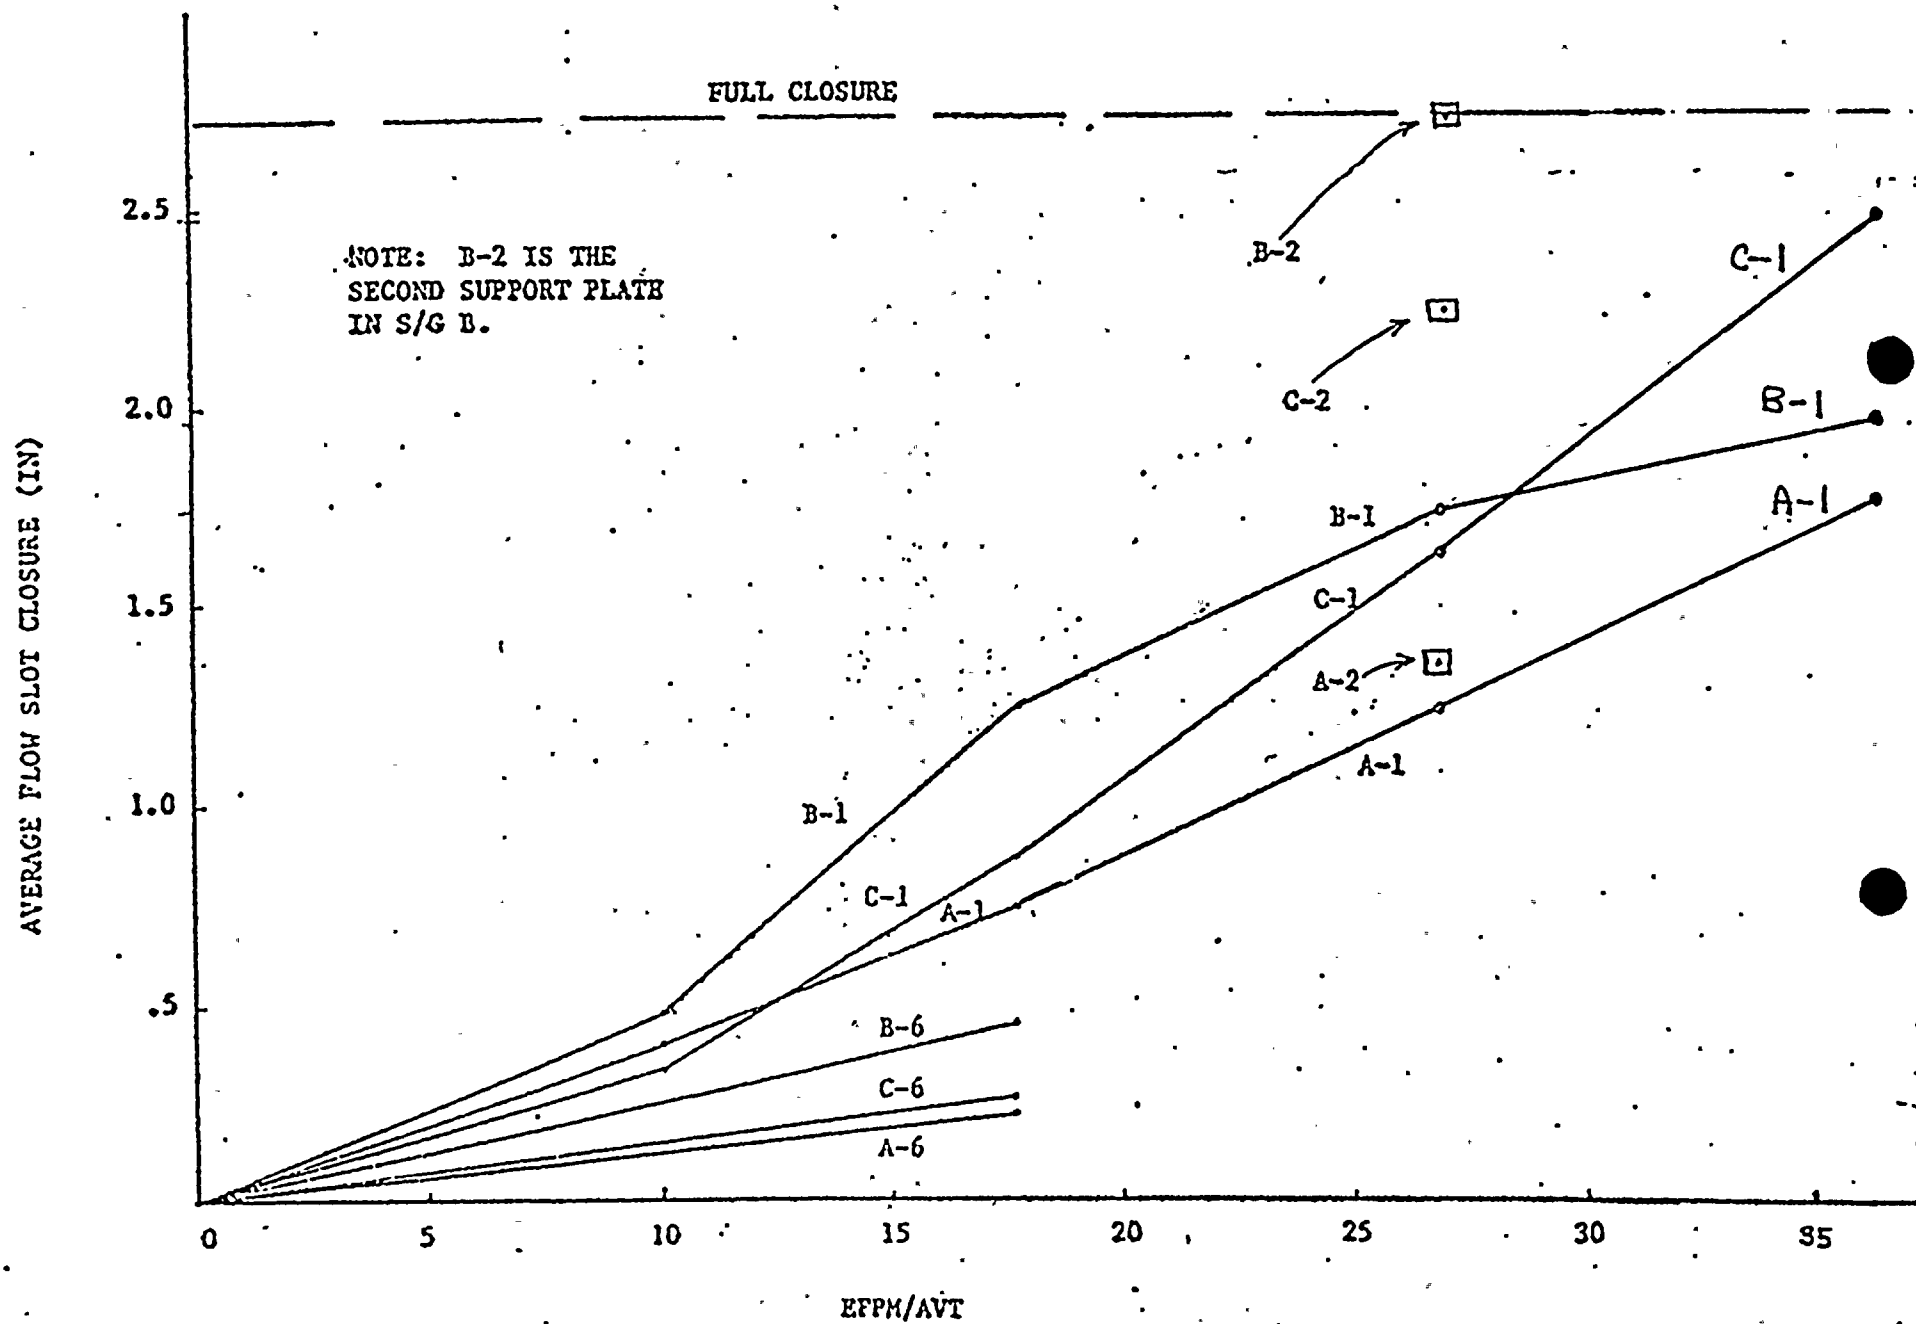
The results of the flow slot measurements are indicated in Figure 12. Only the first (lower) tube support plate was visible in each steam generator. The plots indicate that plate expansion is proceeding consistently with previous behavior.

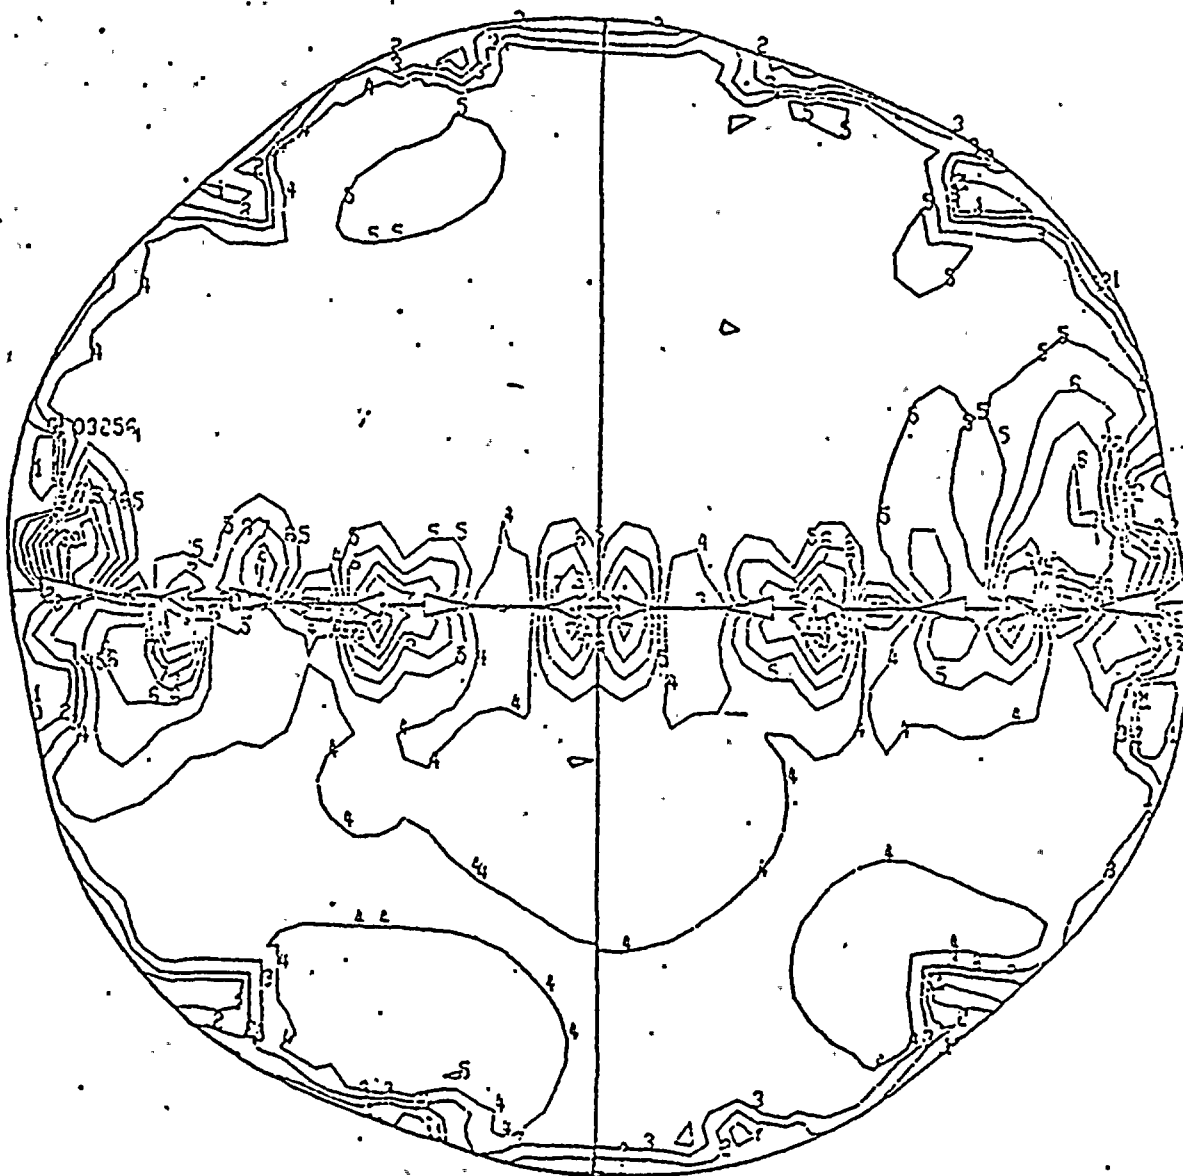
The ten month operating period was also evaluated relative to a postulated main steam line break accident (MSLB). In doing this, the finite element analysis plots for 11.5 and 21 EFPM beyond closure (Figures 13 and 14) were considered. These are considered to be representative of the anticipated advanced conditions of the Turkey Point Unit 3 steam generators over the next ten months operating period. It was assumed that the actual boundary of the 17.5% tube hoop strain contour in the most advanced steam generator (B) is indicated in the tubelane region by the previous plugging boundary and the present .540" restricted tubes. Using the finite element analysis results above, the advancement of the 17.5% tube hoop strain contour over the next ten months was estimated to be 1.8 rows. Using the fact that there are 92 tubes in a row, the total predicted tubes in the tubelane region lying within the 17.5% strain contour at the end of the next ten months is:

Figure 13. Tube Hoop Strain at 11.5 EFPM's
Beyond Full Closure

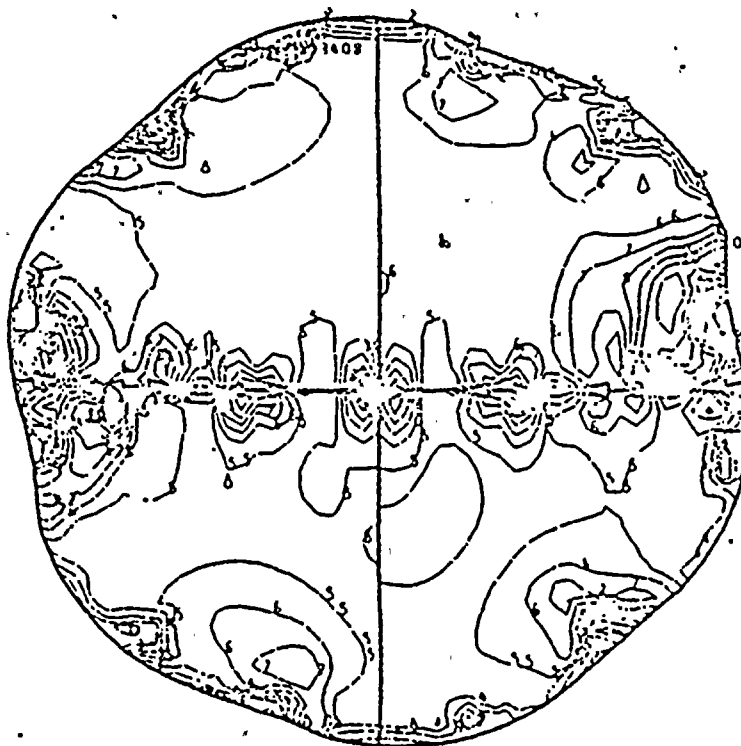
Subtracting out the tubes that were preventively plugged in this area in steam generator B, this outage (53), results in a total of 113 unplugged tubes within the 17.5% strain contour at the end of the ten month operating period. Assuming one intersection involvement per tube and assuming these tubes would leak during a postulated main steam line break, the total resulting leakage from these tubes would be:

This added to the 0.3 GPM leakage assumed to be present at the start of a postulated main steam line break (which would increase to approximately 0.7 GPM due to MSLB differential pressures) yield a total leakage less than 10 GPM, which has been determined in previous submittals to be an acceptable level of leakage during a postulated MSLB.

FIGURE 14. Tube Hoop Strain at 21 EFPM's
Beyond Full Closure

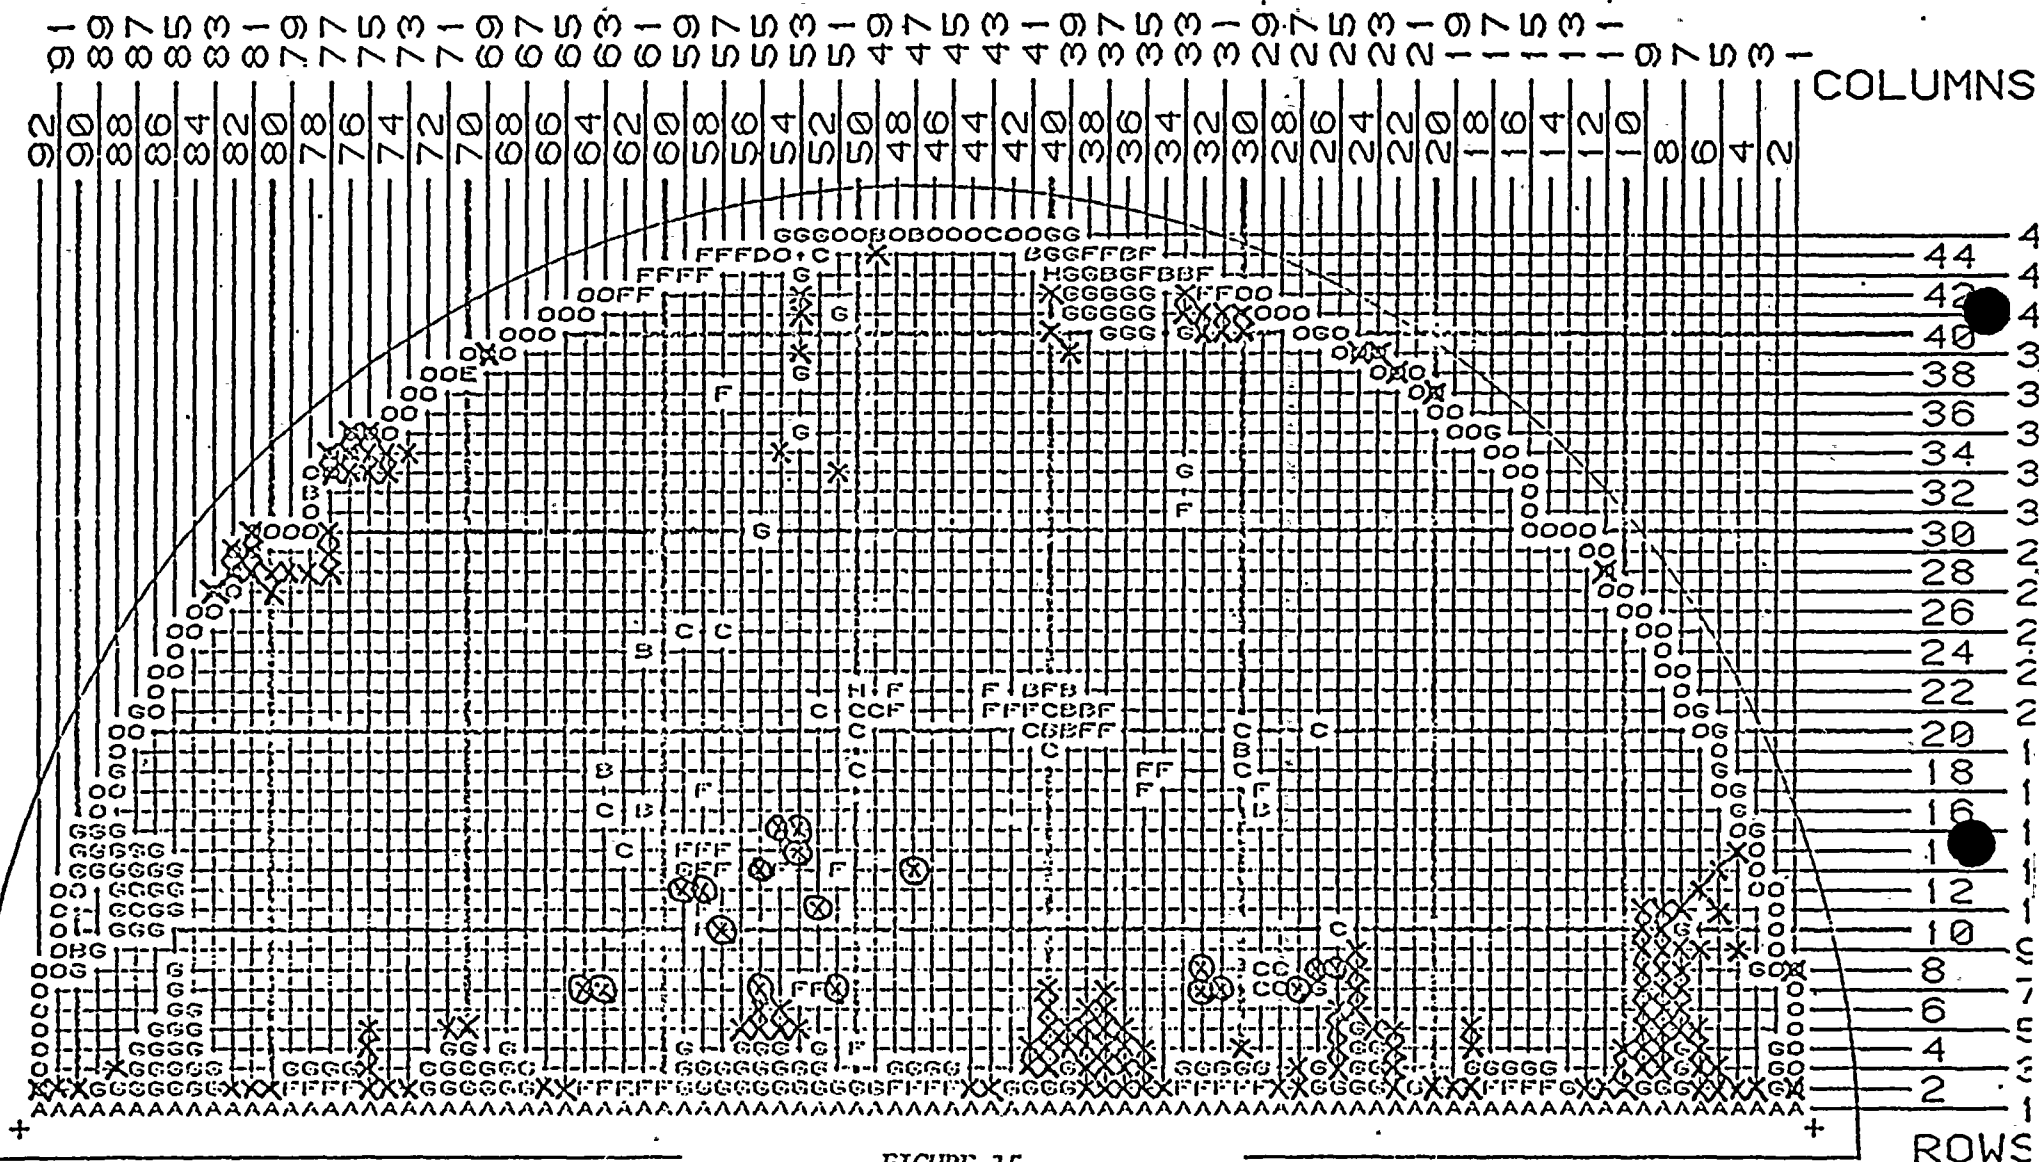
FIGURE 15
 Turkey Point 3A Steam Generator
 Preventive Plugging Pattern

The preventive plugging programs that were implemented are indicated in Figures 15, 16, and 17. Both gauging and Regulatory Guide 1.83 program plugging are indicated. Table 3 summarizes this plugging.

<u>Gauging</u>	<u>R.G. 1.83</u>
SG A	167	19
SG B	151	5
SG C	209	9
TOTALS	527	33

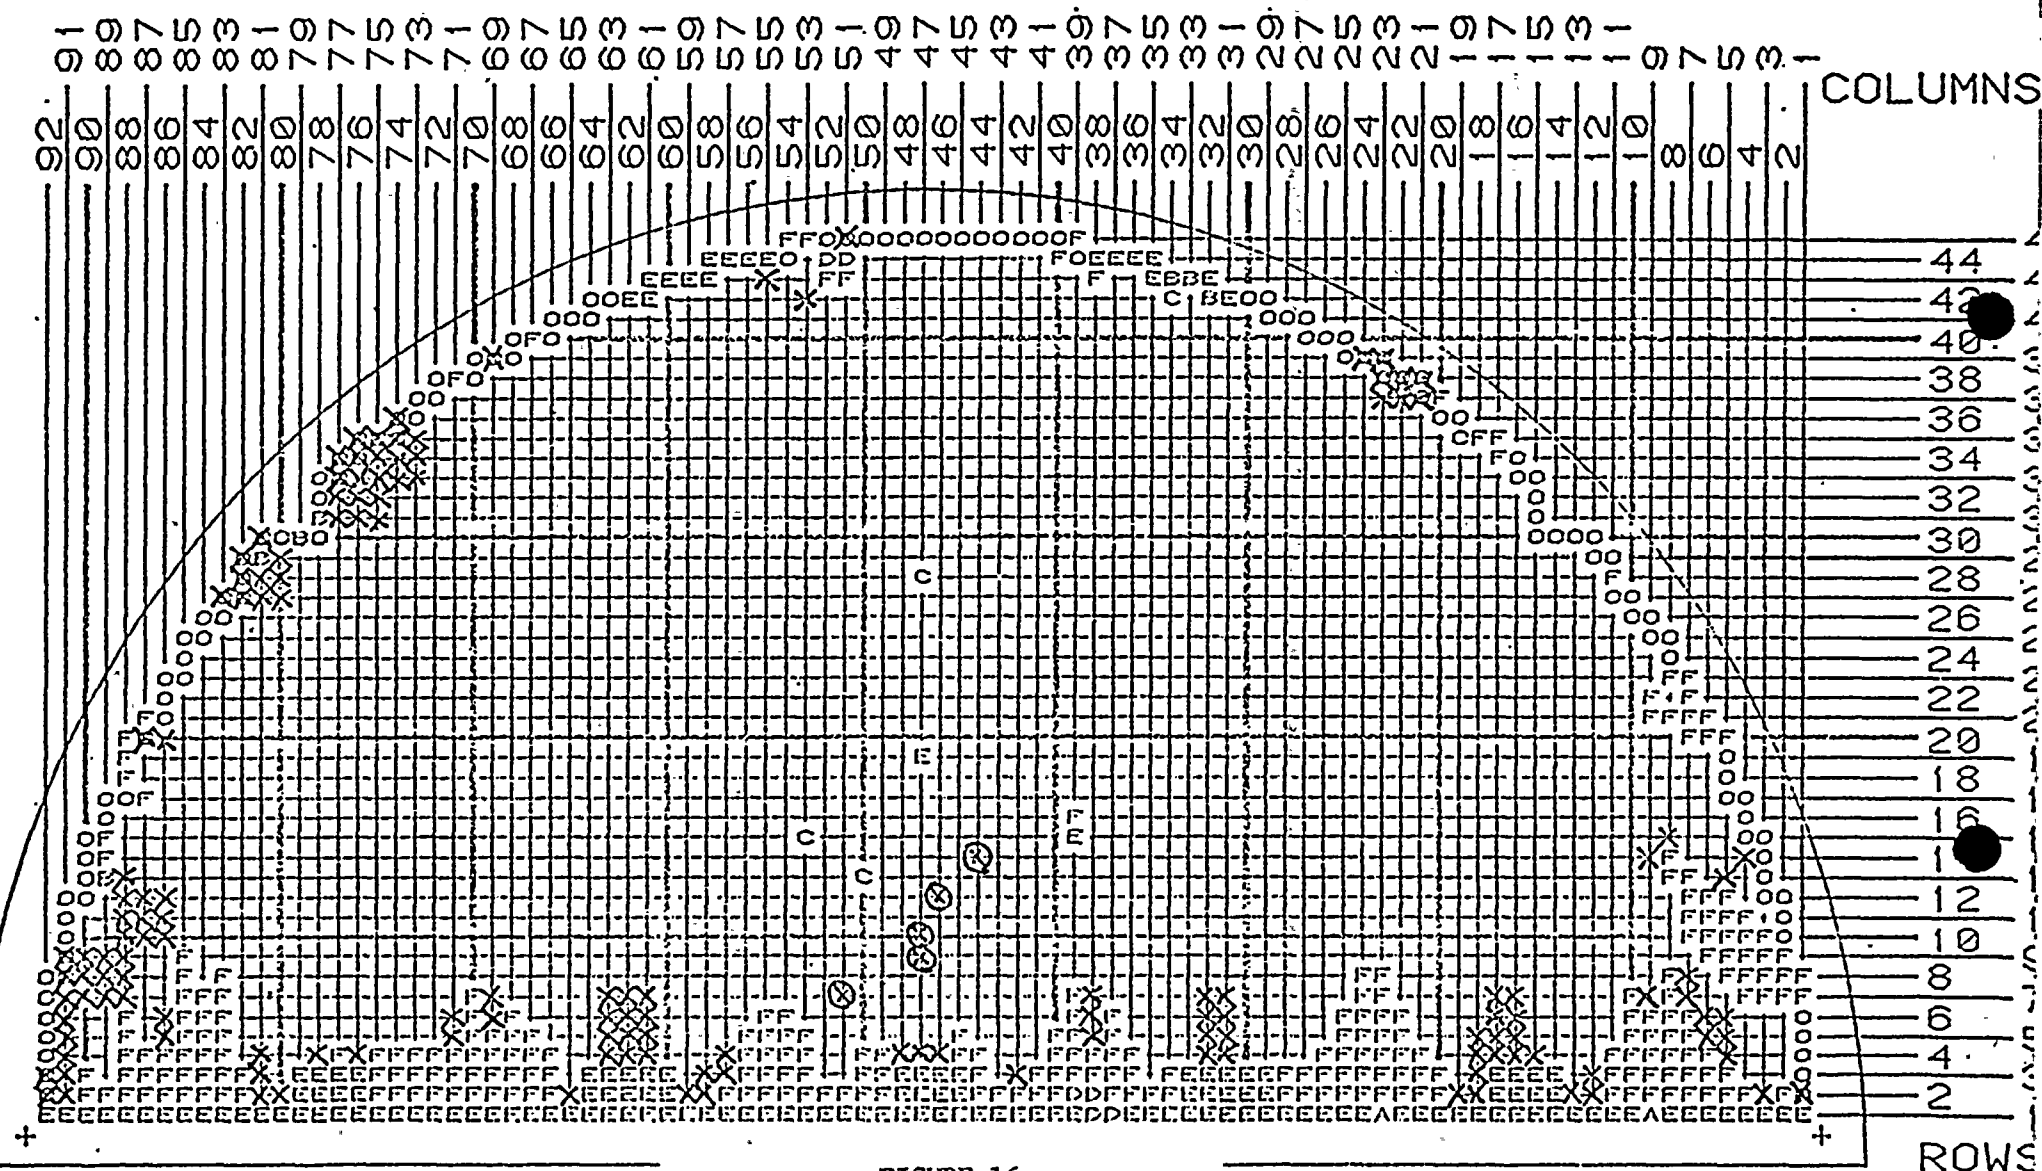
FIGURE 16
 Turkey Point 3B Steam Generator
 Preventive Plugging Pattern

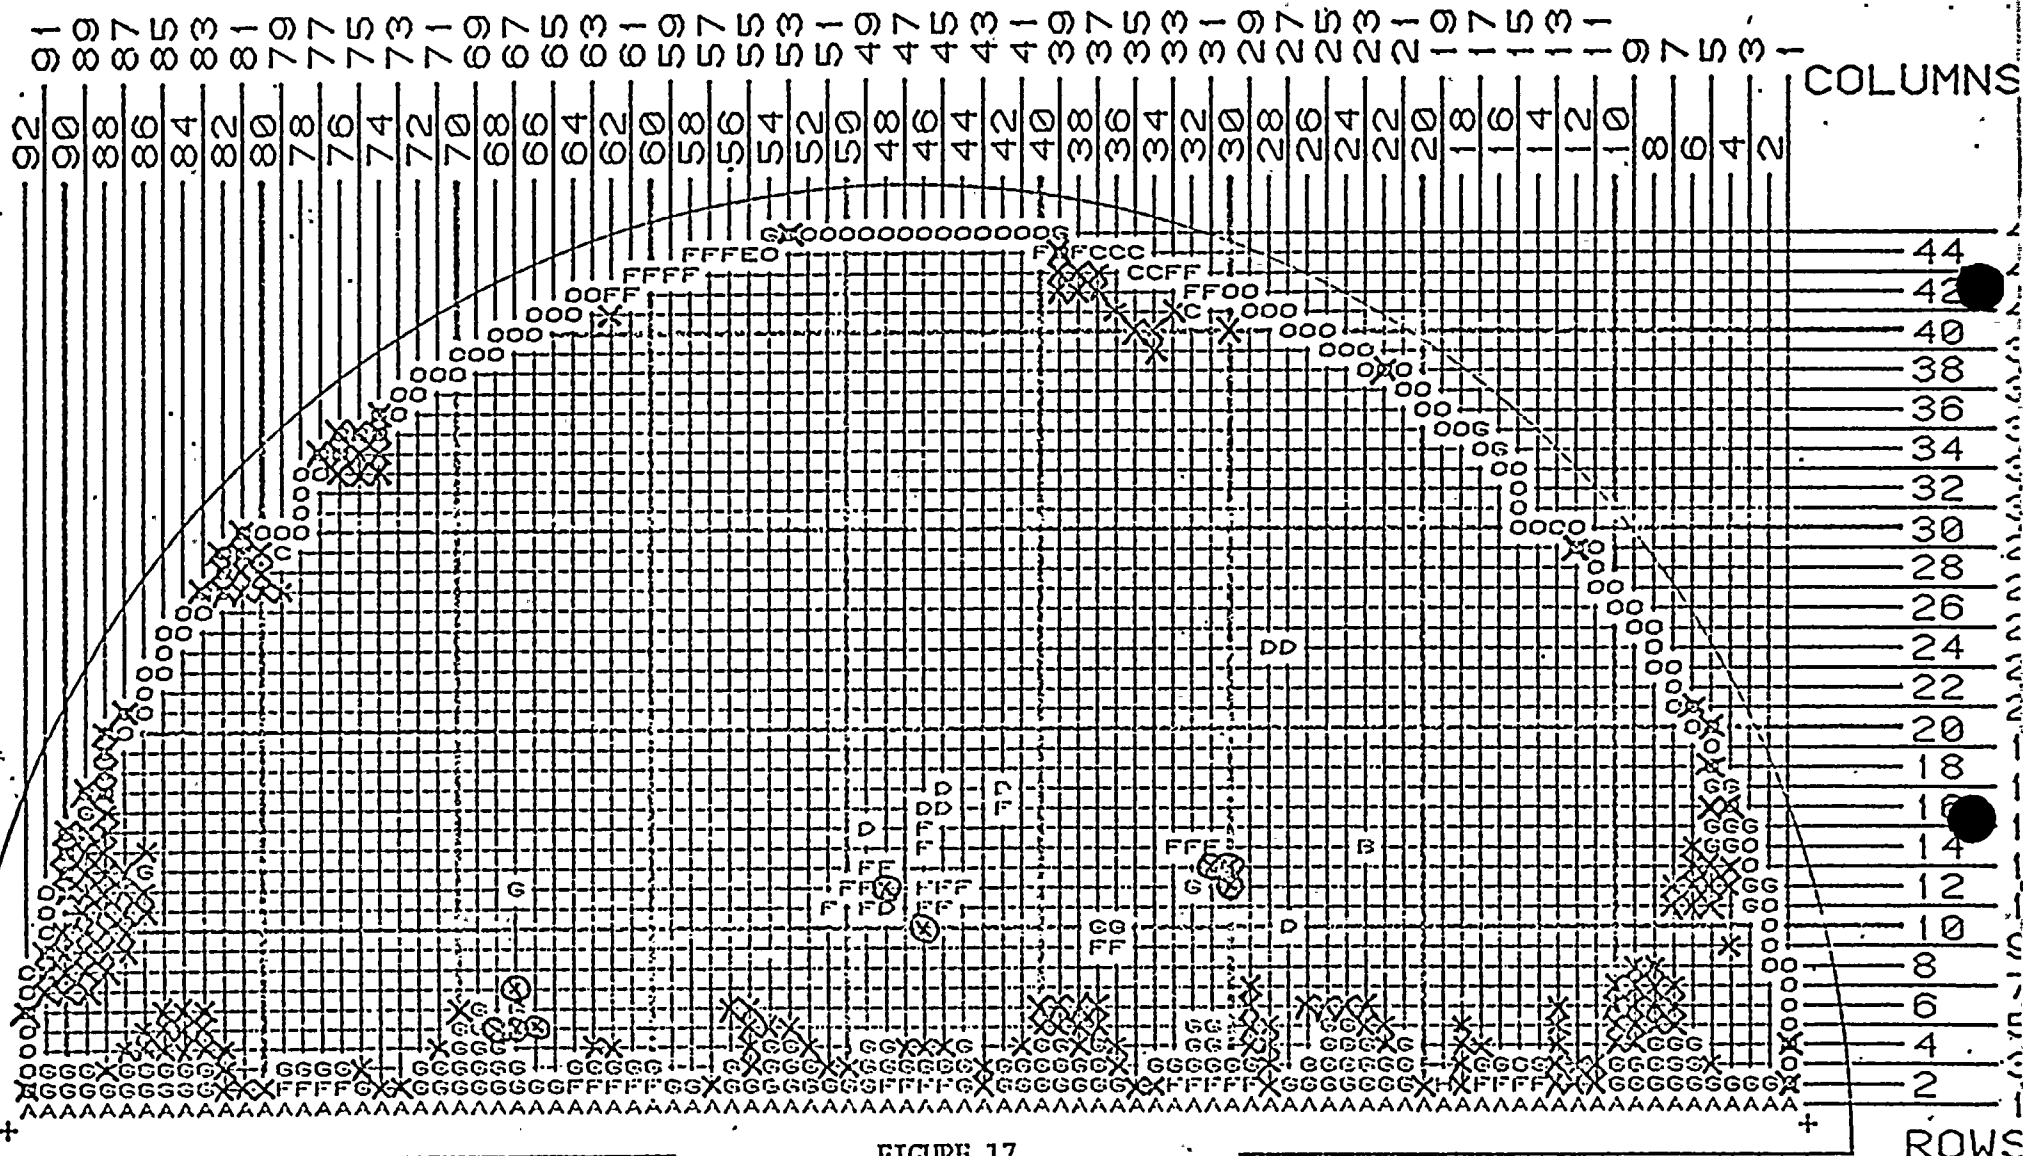
FIGURE 17
 Turkey Point 3C Steam Generator
 Preventive Plugging Pattern
