SUBJECT: Forwards analysis to support 800123 request for extension of two effective full power months operation prior to performing next steam generator insp. Analysis evaluates normal plant operation for 10 effective full power months.

Re: Turkey Point Unit 4
Docket No. 50-251
Steam Generator Inspection

TURKEY POINT UNIT 4

EXTENSION OF AUTHORIZED OPERATING INTERVAL

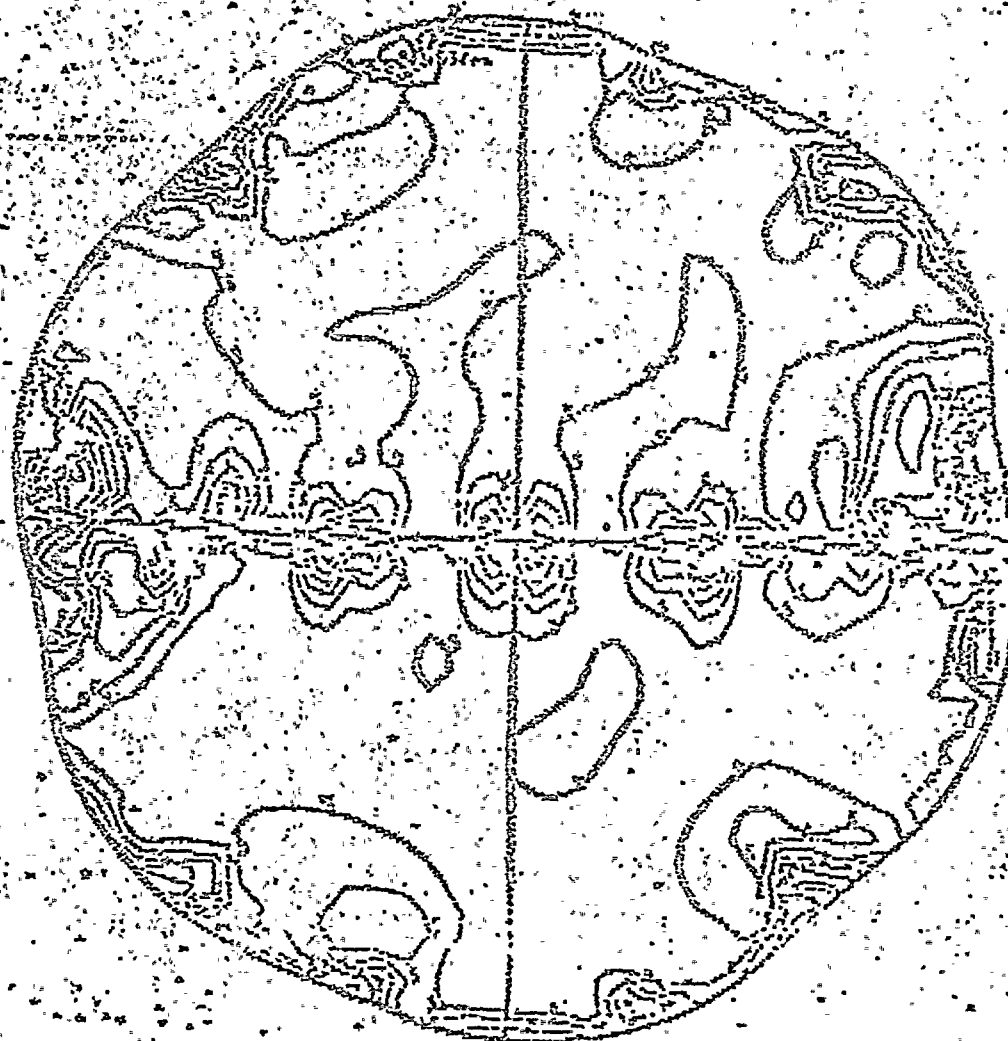
FIGURE 1 TUBE HOOP STRAIN
AT 18 EFPM'S BEYOND FULL
CLOSURE

The ten month operating period, which covers the authorized 8 EFPMs plus the requested additional 2 EFPMs, was also evaluated relative to a postulated main steam line break accident (MSLB). In doing this, the finite element analysis plots for 18 and 24 EFPM beyond closure (Figures 1 and 2) were considered. These were considered to be representative of the anticipated advanced conditions of the Turkey Point Unit 4 steam generators over the ten month operating period. It was assumed that the actual boundary of the 17.5% tube hoop strain contour in steam generator (B) is indicated in the tubelane region by the previous (prior to April, 1979) plugging boundary and the 0.540 inch restricted tubes found in April, 1979. Using the finite element analysis results above, the advancement of the 17.5% tube hoop strain contour over the next ten months' period was estimated to be 1.9 rows. Since there are 92 tubes in a row, the total predicted tubes in the tubelane region within the 17.5% strain contour at the end of the ten months' period is:

$$1.9 \text{ rows in ten months} \times 92 \text{ tubes per row} = 175 \text{ tubes}$$

Subtracting out the tubes that were preventively plugged (26) in this area in steam generator B in April, 1979, results in a total of 149 unplugged tubes within the 17.5% strain contour at the end of the ten month's operating period. Assuming one intersection involvement per tube and assuming those tubes would leak during a postulated main steam line break, the total resulting leakage from those tubes would be:

$$149 \text{ tubes} \times 0.05 \frac{\text{GPM}}{\text{tube}} = 7.45 \text{ GPM}$$

This added to the 0.3 GPM leakage assumed to be present at the start of a postulated main steam line break (which would increase to approximately 0.7 GPM due to MSLB differential pressure) yields a total leakage less than 10 GPM, which has been determined in previous submittals to be an acceptable level of leakage during a postulated MSLB.
