Re: Florida Power & Light Company (FPL)
Docket Nos. 50-250, 50-251, and 50-335
Request for Additional Information

Your letter of March 16, 1978 requested additional information regarding the FPL system disturbance which occurred on May 16, 1977. Our responses to your additional questions are attached.

SUBJECT: OFF-PEAK TRANSIENT STABILITY STUDY FOR 1977

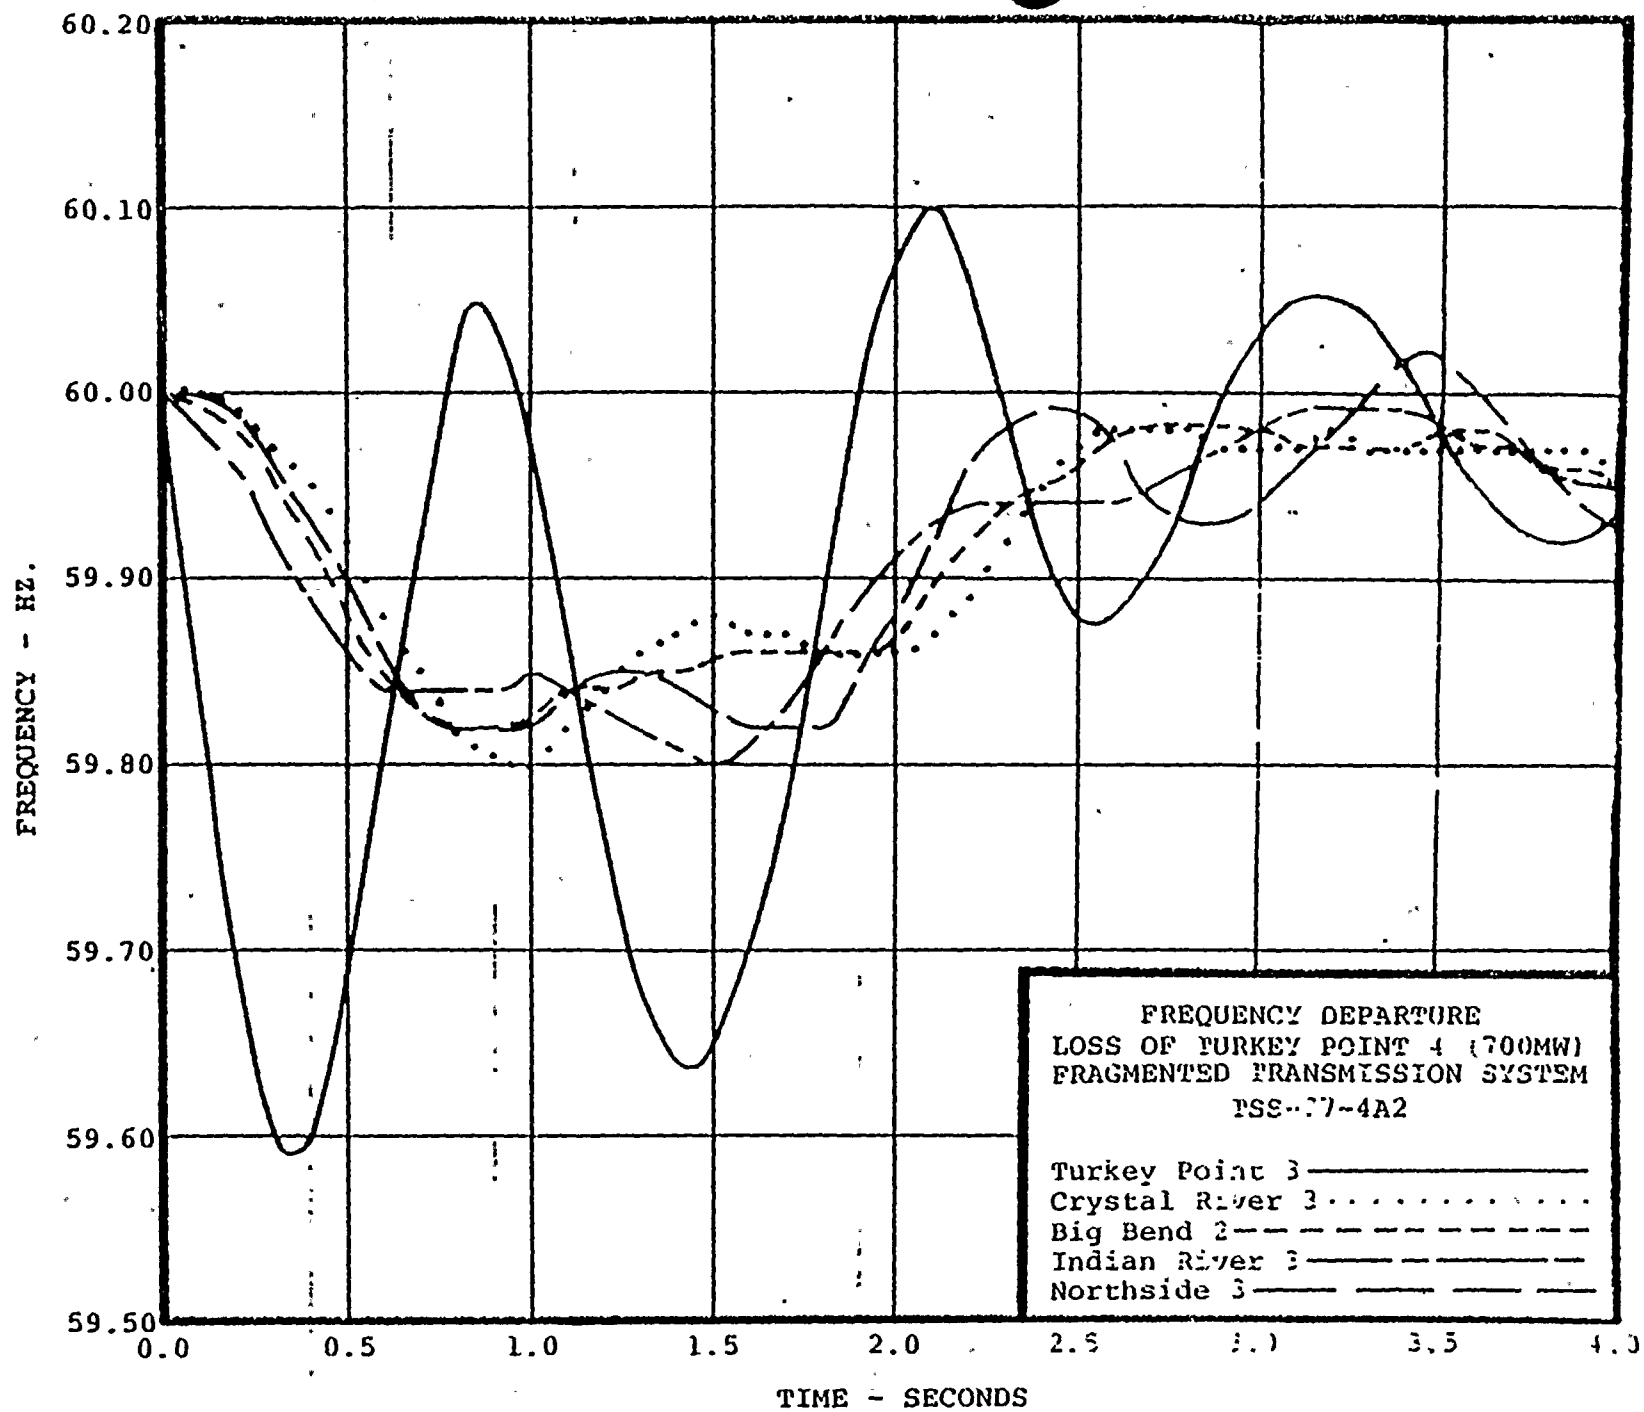
FIGURE 4A2-2

The loss of this unit resulted in the frequency decline of the other units in the state. Turkey Point Unit 3 reached a minimum frequency of 59.58 Hz at approximately $T = 0.35$ second. This frequency represented the lowest that occurred on any State of Florida generating unit. Frequency deviations from 60.00 Hz on those units progressively removed from Turkey Point were smaller and occurred later in simulation time (see Figure 4A2-2).

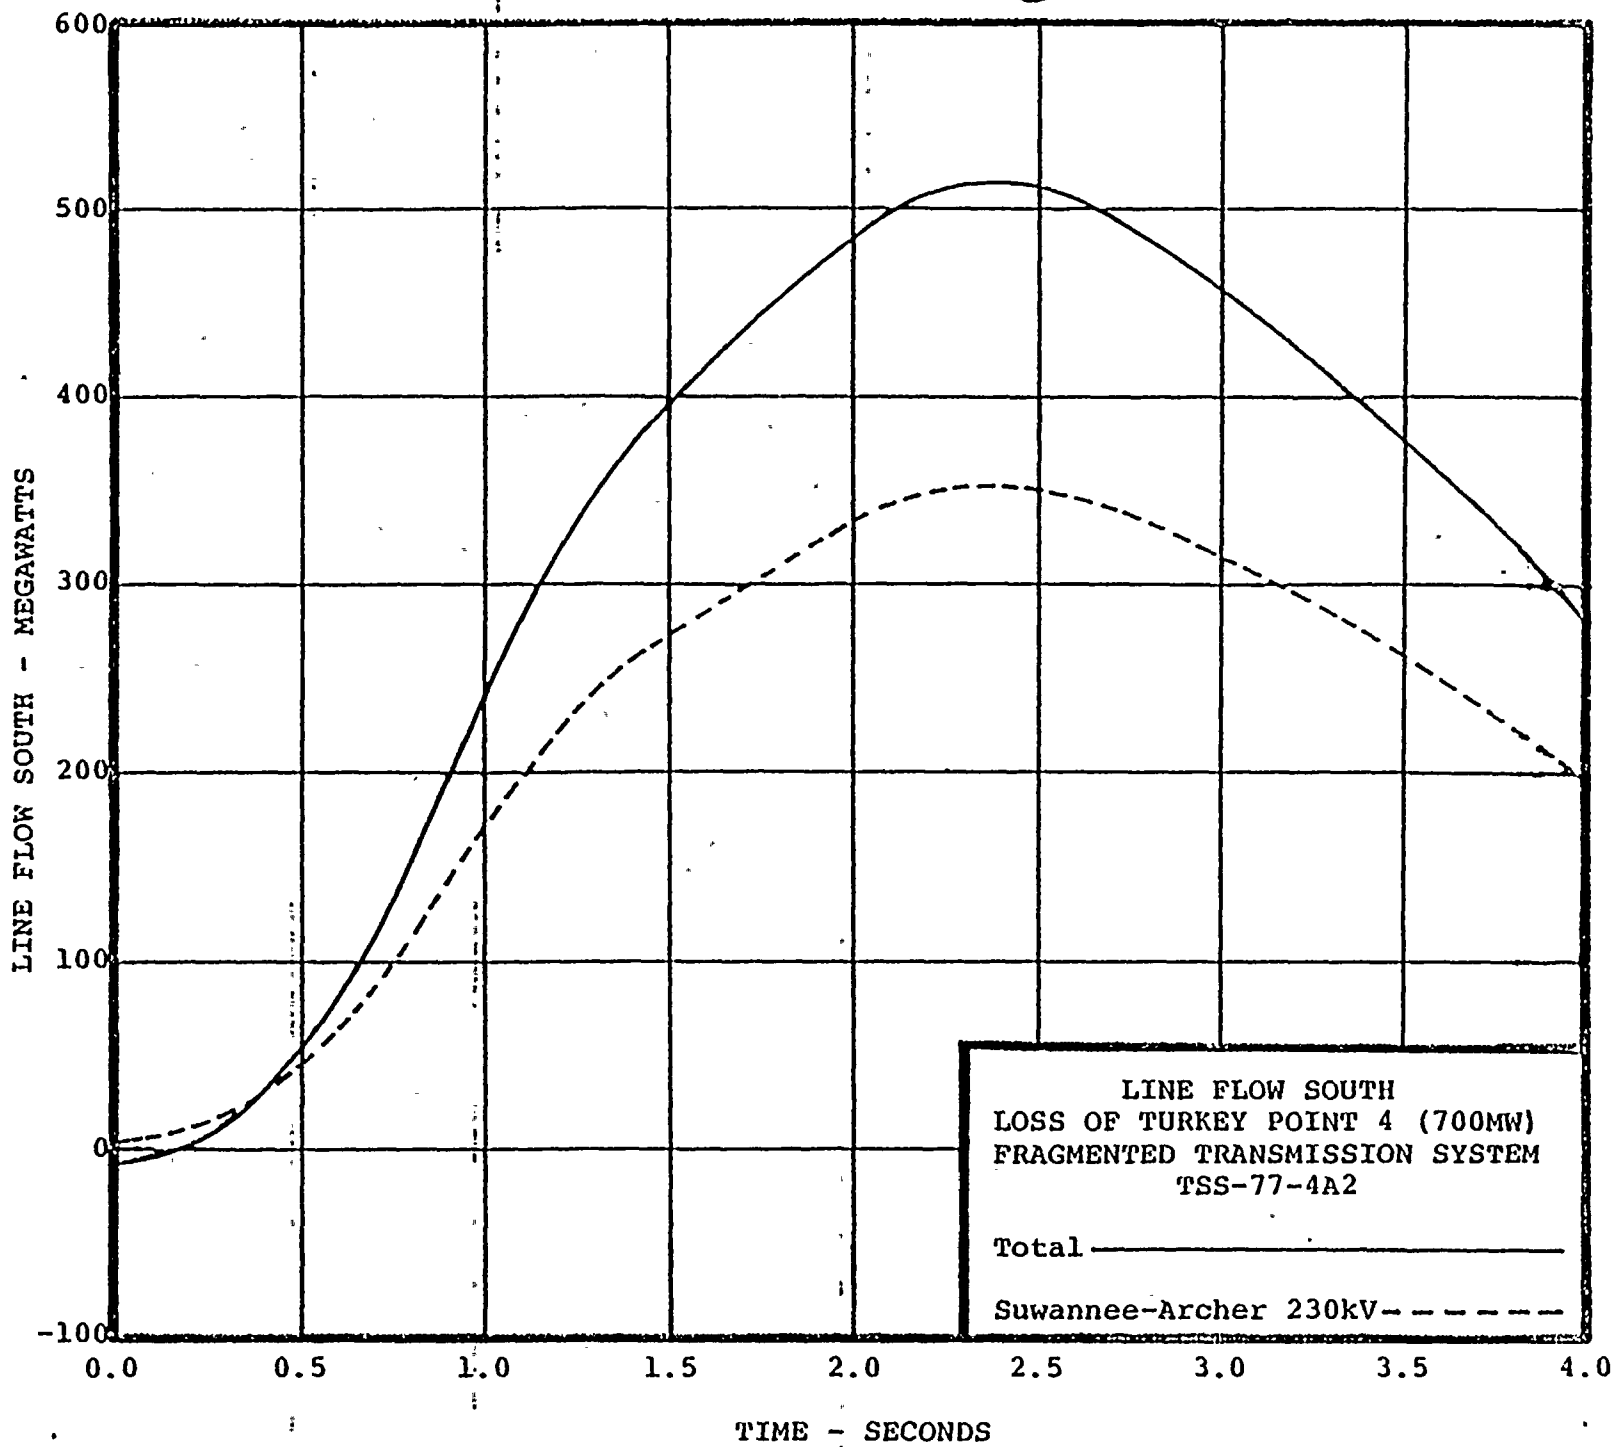
FIGURE 4A2-3

Tie lines were exporting approximately 3 MW of power when the unit outage occurred (see Figure 4A2-3). These tie lines were composed of the following circuits:

Net power flow over these tie lines reversed at $T = 0.2$ second, increasing to a peak of 515 MW at $T = 2.4$ seconds to the south. No transmission line relays operated during the course of the study.

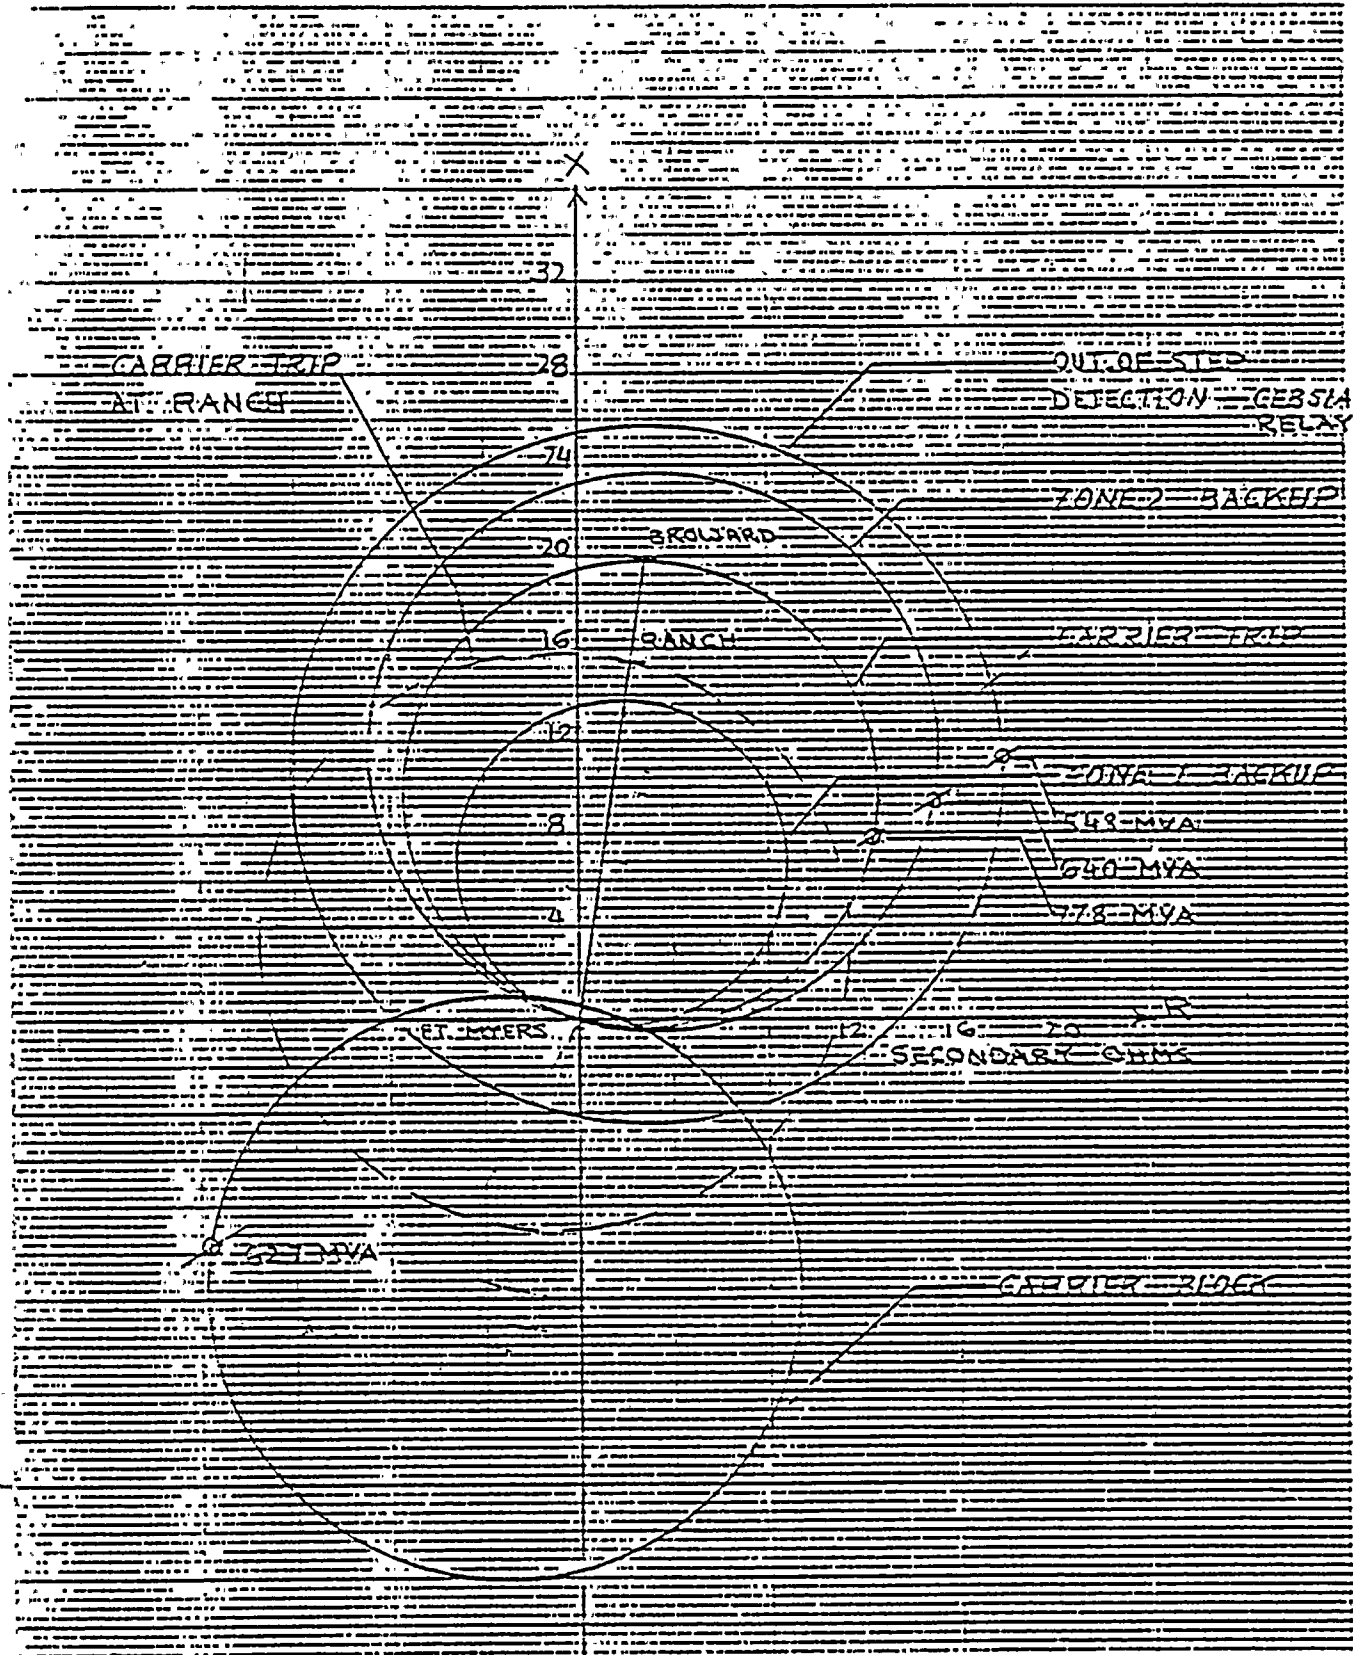
CHARACTERISTICS FOR PHASE RELAYS
 LINE FT MYERS - RANCH 240 KV
 TERMINAL - FT MYERS
 BASED ON SETTINGS DATED 12-10-76
 DRAWN BY A.S.

- 9) The line loading of the Fort Myers-Ranch line was well under the tripping value.

Setting sheets are attached (Appendix D) with a plot of the relay characteristic in terms of R & X and a plot in terms of watts and vars.
