**TURKEY POINT PLANT  
DOCKET NOS. 50-250 AND 50-251  
UNIT TRIPS - APRIL 25, 1974**

At the request of Mr. Austin Hardin of your staff, we are reporting the tripping of Units 3 and 4 at the Turkey Point Plant.

TURKEY POINT UNIT NOS. 3 & 4

UNIT TRIPS - APRIL 25, 1974

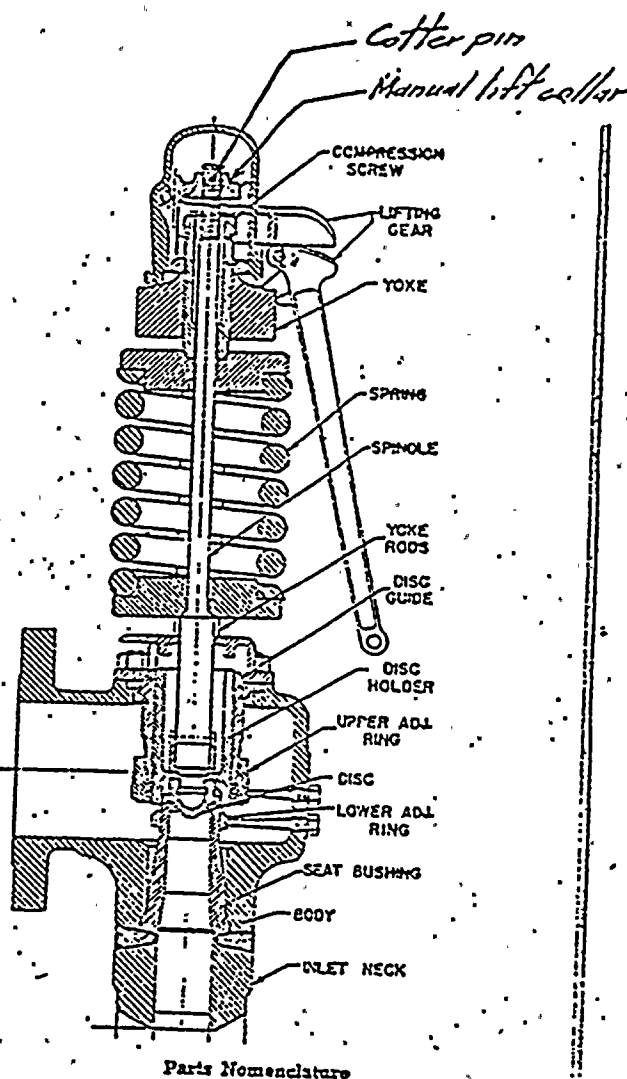
FIGURE 1

About five minutes after No. 4 reactor tripped, the 1085 psig safety valve on No. 4A Steam Generator main steam line header lifted and did not reseal. Immediate operator actions included additional boration of the reactor coolant system to ensure that adequate reactor shutdown margin was maintained. Feedwater flow to No. 4A Steam Generator was controlled to maintain adequate water level while efforts were made to close the safety valve. When the manual lifting device was removed from the safety valve, the safety valve reseated. (Refer to Figure 1 for details)

*TURKEY POINT PLANT - MAIN STEAM  
SAFETY VALVE*

The failure of the safety valve to reseal after opening was found to be caused by the loss of a cotter key in the safety valve topworks. This cotter key locks the manual lift collar in proper position on the safety valve spindle. When the cotter key vibrated out, the manual lift collar vibrated down and made contact with the manual lifting device. When the safety valve operated, the manual lift collar rotated further down the spindle. This physically prevented the safety valve from reseating as the steam pressure decreased.

The safety valve was reseated by removing the manual lifting arm.

The safety valve was repaired by returned the manual lift collar to its original position, installing a new cotter key, and replacing the manual lifting arm. The safety valve is now operable.
