REPORT
ON
SYSTEM DISTURBANCE
JUNE 28, 1974

FLORIDA POWER & LIGHT COMPANY

JULY 19, 1974

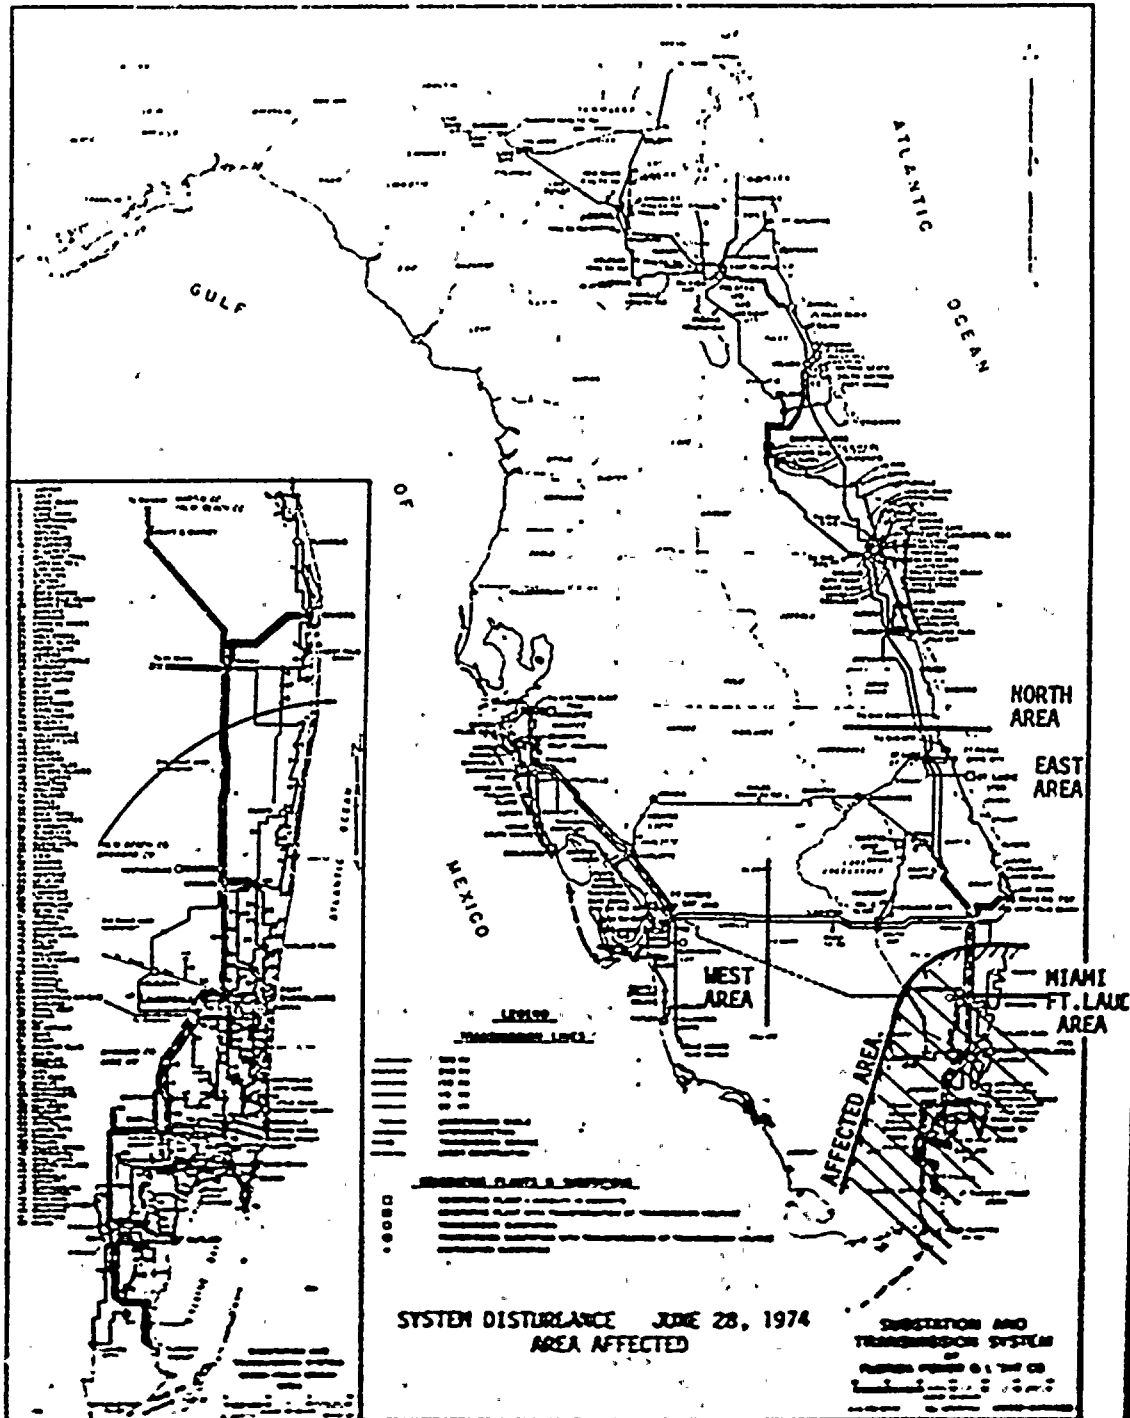
FIGURE 1

The delay in clearing the fault caused the system to become unstable. The fault and the consequent power swings resulted in low voltages over the southern part of the system. Protective relays operated to separate the portion of the system south of West Palm Beach from the rest of the system. (See Figure 1). Turkey Point No. 3 and No. 4 reactors were tripped by reactor protection. This 1425 MW loss of generation caused the frequency to drop rapidly. Underfrequency relays operated to shed approximately 70% of the load in the affected area. The frequency recovered and the system was tied back together in 11 minutes. Service restoration was complete in 56 minutes except for a few isolated cases.

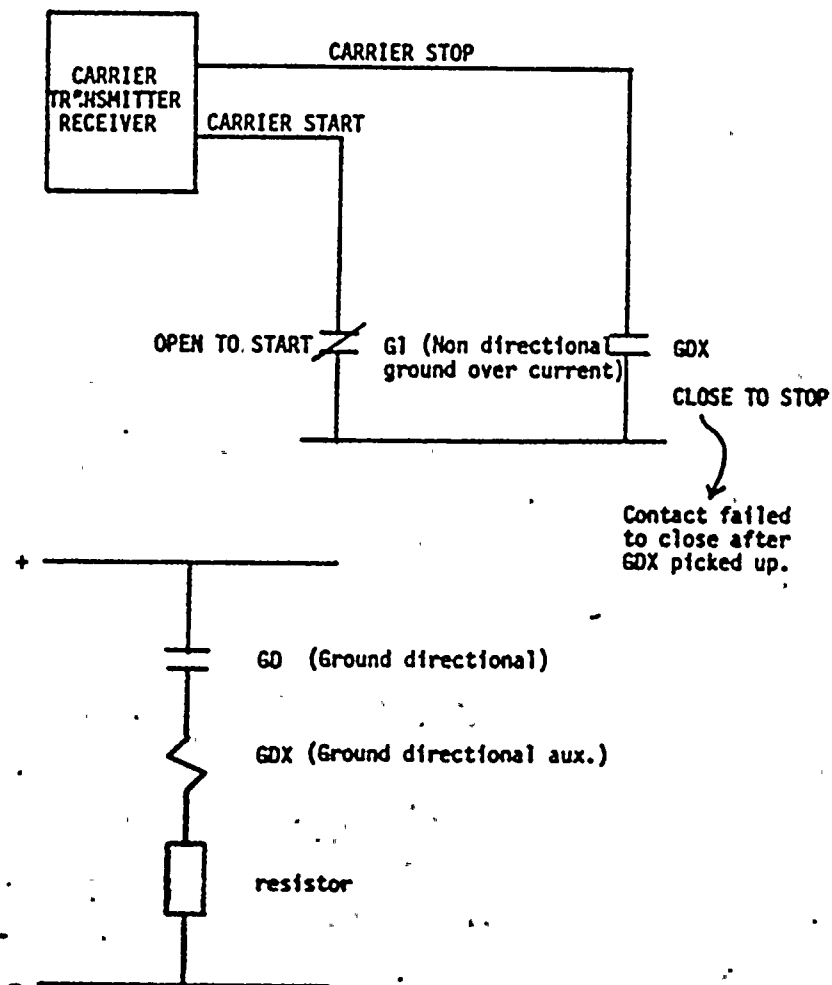
FIGURE 2
SIMPLIFIED
CARRIER CIRCUIT

The fault persisted for 41 cycles because the contact of the carrier stop relay (GDX) in the primary directional ground relay (CLPG) scheme did not close to stop the carrier signal from Port Everglades. A simplified diagram of the carrier circuit is given in Figure 2.

1. The contact of the carrier stop relay in the primary directional ground relay scheme of the Port Everglades-Laudania 240 kV line at Port Everglades Plant was adjusted. The line was returned to service on June 29.

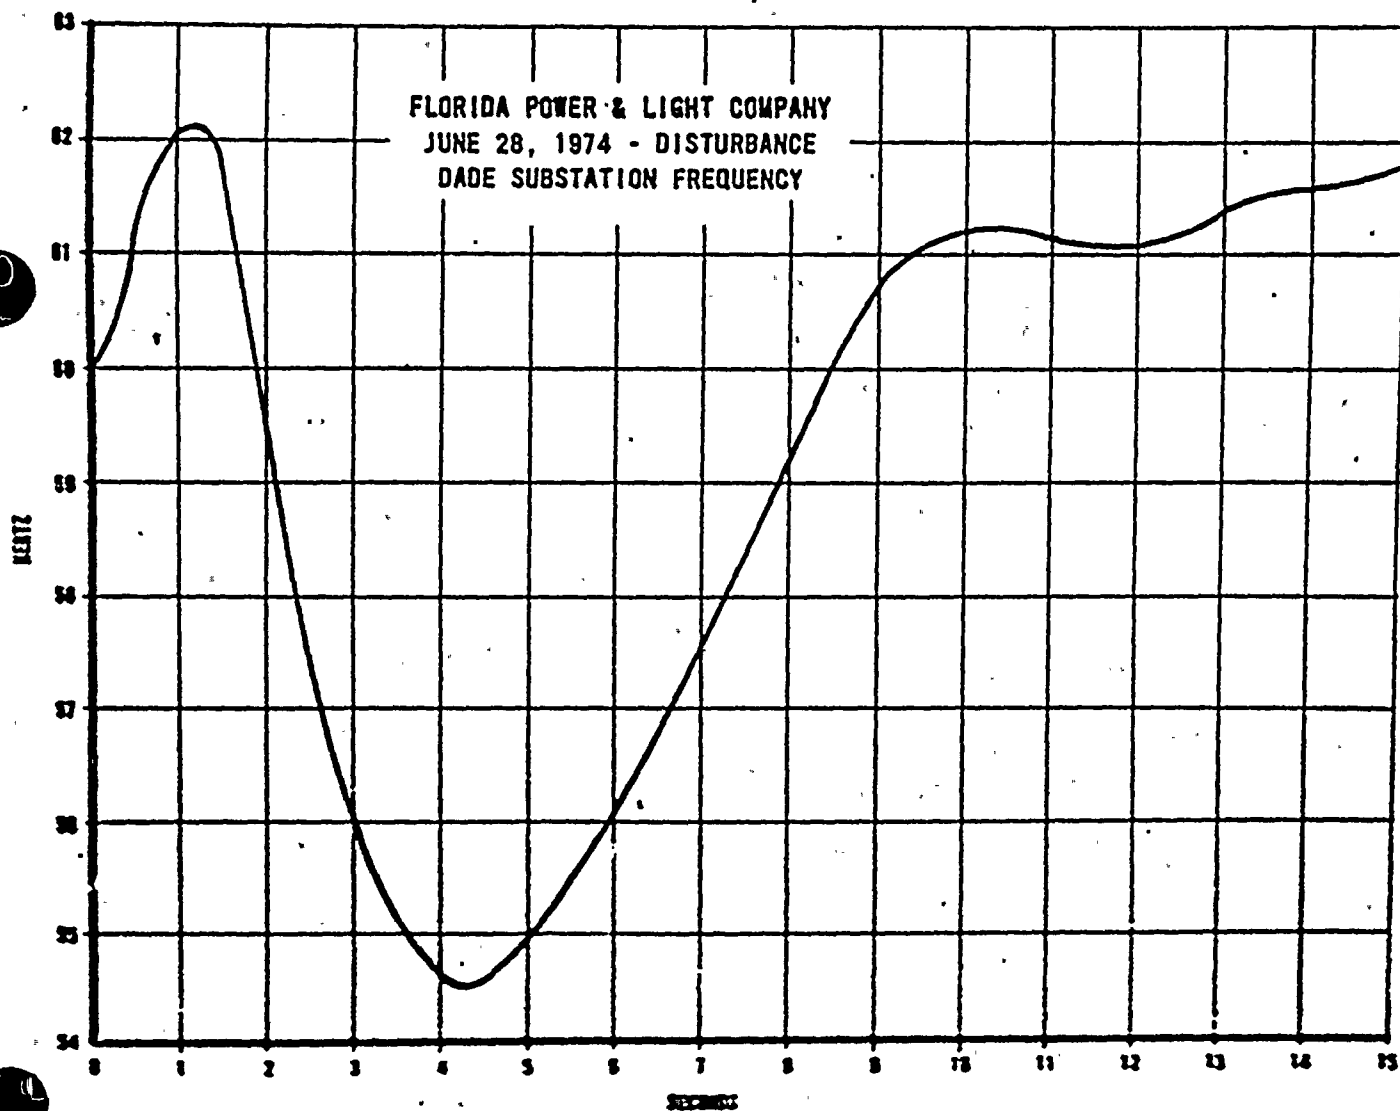
The generation lost at Turkey Point was 1425 MW. The loss of generation caused the frequency to decline to about 54.5 hZ at a rate of 5 Hz/second. Area frequency as recorded on the Dade Substation oscillograph is shown in Figure 4.

The underfrequency relays in the affected area operated between 59.2 Hz and 58.5 Hz to shed load. A total of 2250 MW of load was lost by load shedding, low voltage and low frequency. Load data is given in Table 2. The frequency recovered at a rate of about 1.5 Hz/second. The frequency was back to 60 Hz at 8.5 seconds, overshooting to 61.3 Hz at 10 seconds.

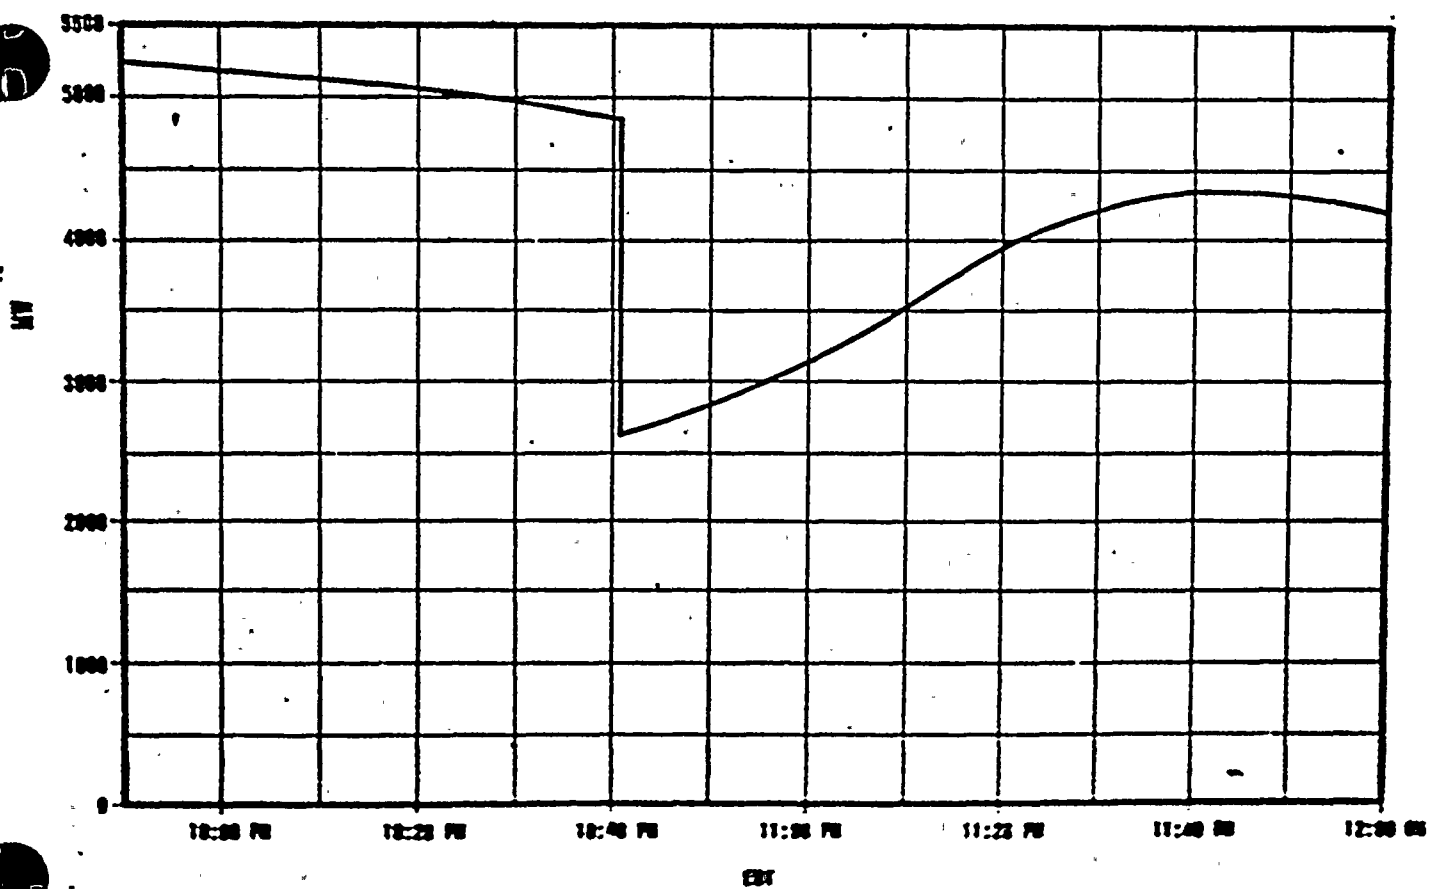
FIGURE 5
FLORIDA POWER & LIGHT COMPANY
JUNE 28, 1974 DISTURBANCE
SYSTEM LOAD

The Power Coordinators quickly identified the affected area and proceeded to reconnect the system. The isolated portion was resynchronized at 10:53 p.m. with the closure of the Broward-Ranch 240 kV line. Distribution circuit restoration was begun immediately by use of supervisory

control and progressed rapidly, as shown in Figure 5. Restoration was complete except for isolated cases in 56 minutes.

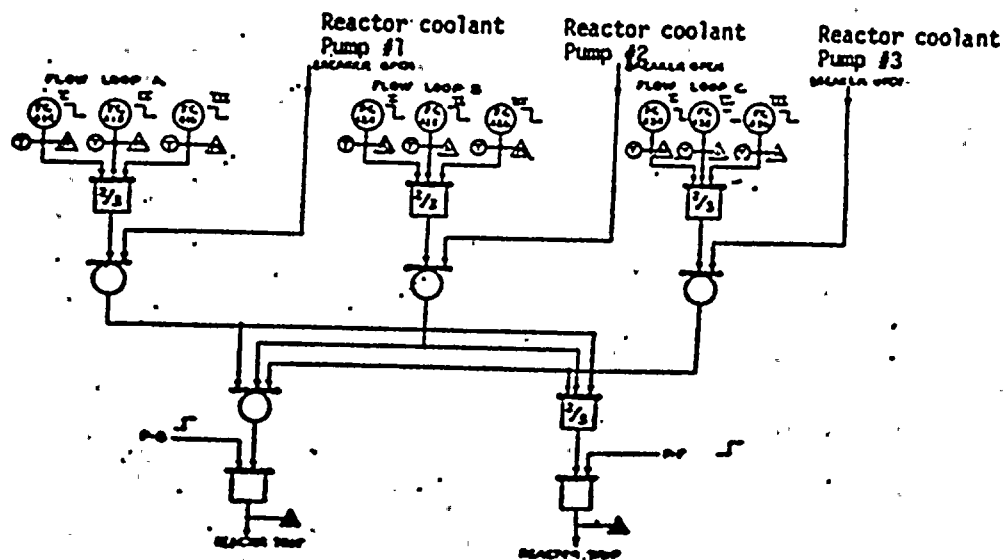
Tripping Logic Diagram
Figure 7

At approximately 60 cycles Turkey Point No. 3 and No. 4 reactors were tripped by reactor coolant flow protection devices. The most probable cause of the reactor trip was the operation of the undervoltage relays on the 4 kV auxiliary bus. These relays are set to trip at 70% of normal voltage with a 1 second time delay. A plot of the Turkey Point 200 kV bus voltages is shown on Figure 3. Low reactor coolant flow, resulting from the low voltage, could also have tripped the reactor. The low flow set point is 90% of full flow with no time delay. The protective devices

at Turkey Point functioned in the conservative manner intended to protect the nuclear reactors. A simplified diagram of the protective devices is shown in Figure 7.

- a-2. A continuous recording high-speed oscillograph is on order for the nuclear units to record events prior to, during, and after a disturbance.
 - a-3. The auxiliary bus undervoltage relay operation indication to the "first-out" annunciator system is to be reconnected to give indication after the time delay relays have timed out.

- b. To provide greater system reliability the nuclear safety committee will review the settings for the auxiliary bus under voltage reactor trips to determine if they can be reduced from 70% to 62% which is within the 60% setting allowed by the Technical specifications. The setting had been lowered in January 1974 from 75% to 70%, an adequate setting on the basis of analyses of system fault conditions. Subsequent faults on the transmission lines from Turkey Point had not caused reactor tripping.
