FLORIDA POWER & LIGHT COMPANY

SYSTEM DISTURBANCE

LOSS OF GENERATION AT TURKEY POINT

WEDNESDAY, APRIL 4, 1979

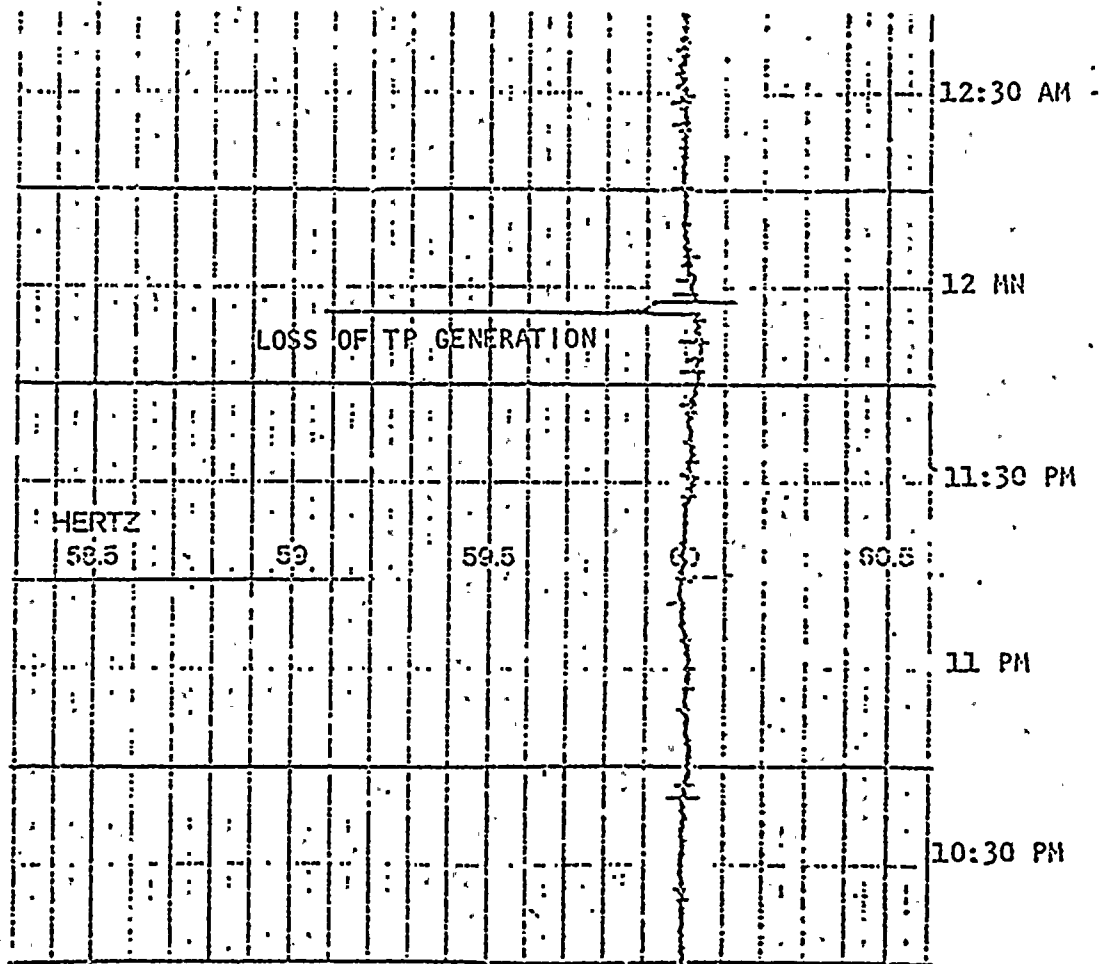
SYSTEM FREQUENCY
AT PORT EVERGLADES 138KV BUSS
APRIL 4, 1979

The resulting mismatch of load and generation caused the frequency to decline. Within FPL the system frequency declined to a low of 59.01 Hz, and initiated underfrequency relays which shed approximately 470 Mw of load in the areas shown below. Governor response and load shedding within Peninsular Florida stabilized the frequency at 59.85 Hertz within 10 seconds.

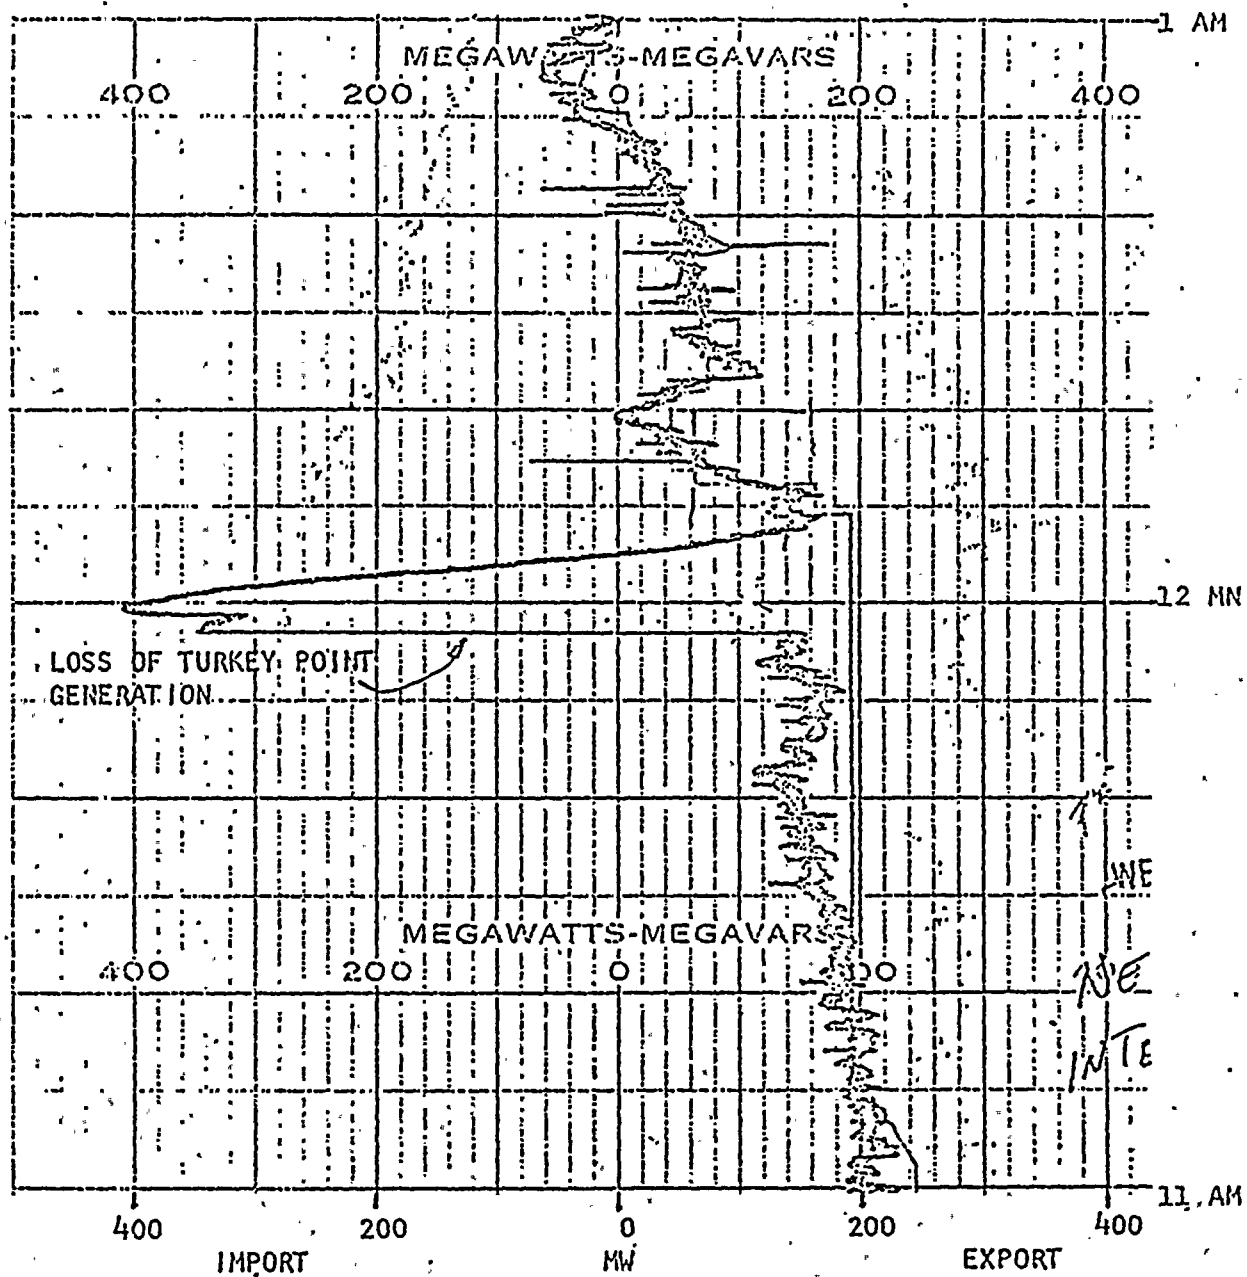
FLORIDA POWER & LIGHT
NET INTERCHANGE
APRIL 4/5, 1979

The FPL net interchange returned to its predisturbance level 11 minutes after the origination of the disturbance.
