REPORT
ON
SYSTEM DISTURBANCE

MAY 16, 1977

FLORIDA POWER & LIGHT COMPANY
JUNE 29, 1977

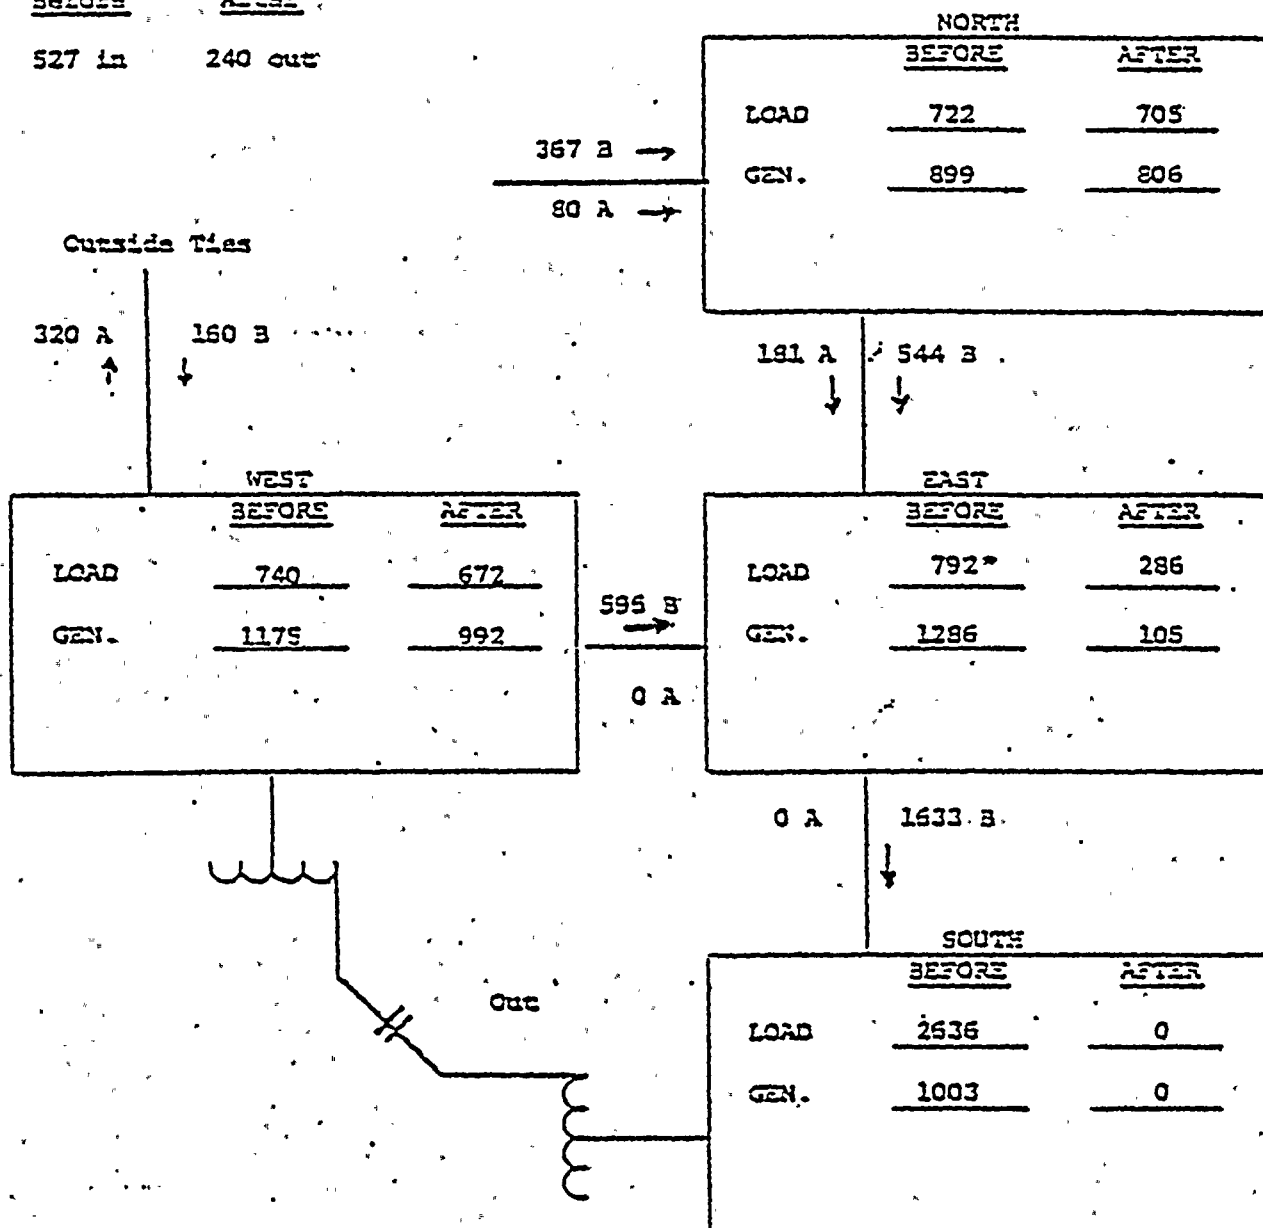
Figure 2

EVENT Loss of Ft. Myers - Ranch 240kV Line TIME 10:24 a.m.

Net Interchange
Before After
527 in 240 out

SYSTEM	BEFORE	AFTER
LOAD	4890	1663
GEN.	4363	1903

*321 MW isolated with South area after system split.

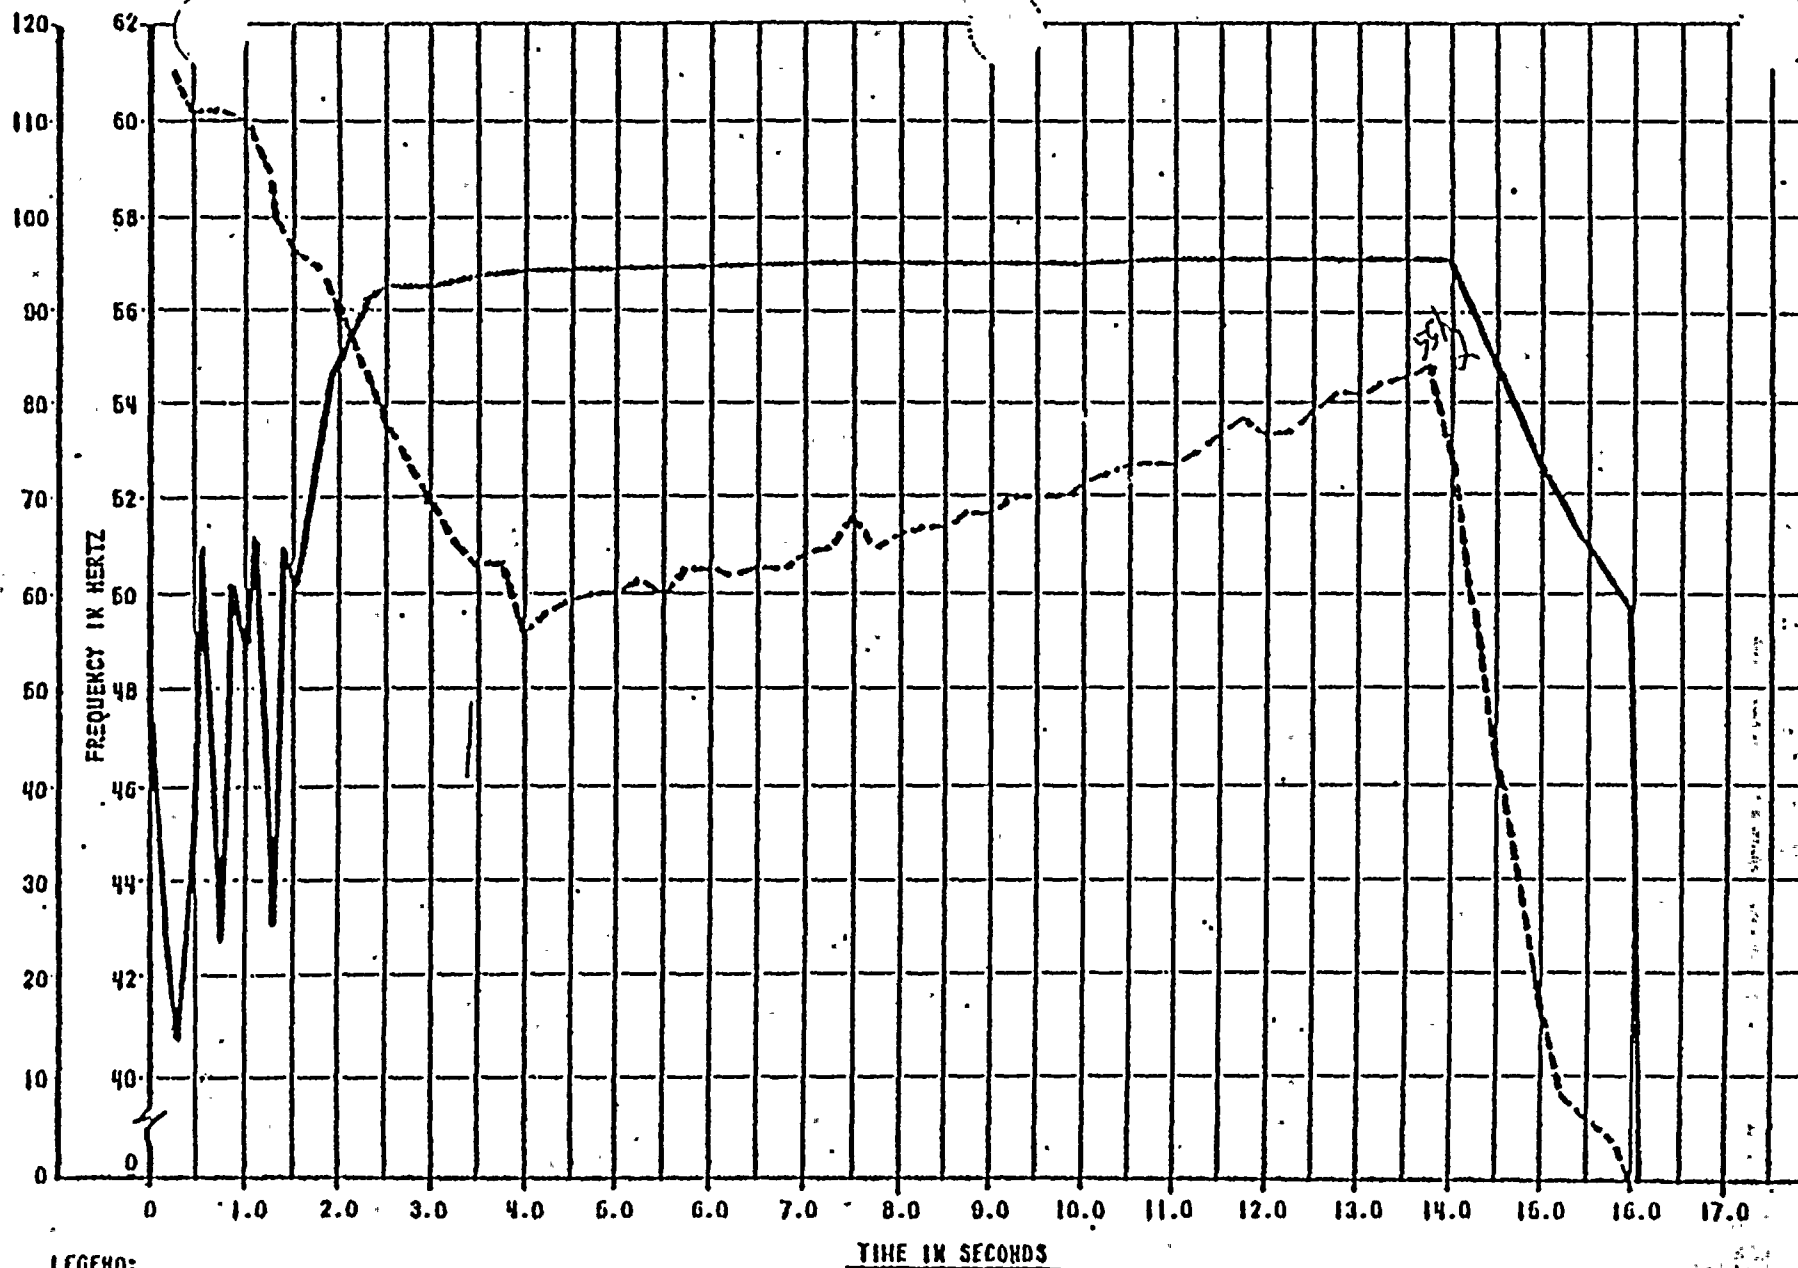
FREQUENCY & VOLTAGE vs TIME
 MEASURED ON THE RANCH LINE TERMINAL
 AFTER THE PRATT & WHITNEY-RANCH 240 kV LINE OPENED
 AT 10:24 AM FOR MAY 16 1977 DISTURBANCE

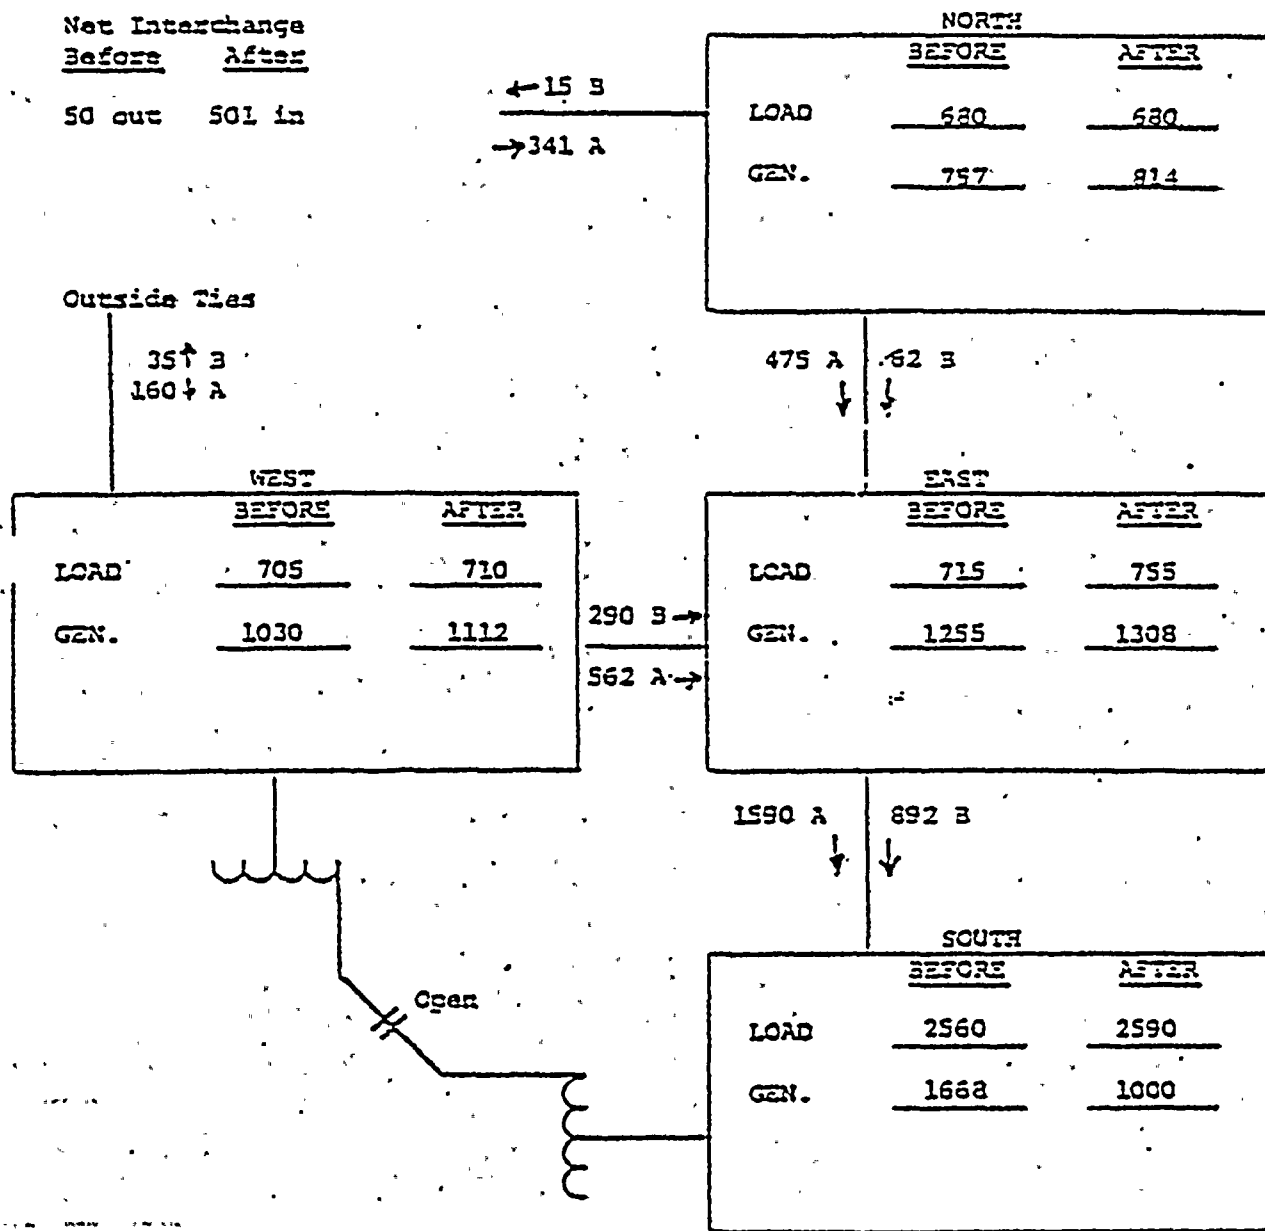
Figure 4

EVENT Loss of Turkey Point #3

TIME 10:08 a.m.

SYSTEM	BEFORE	AFTER
LOAD	4660	4735
GEN.	4710	4234

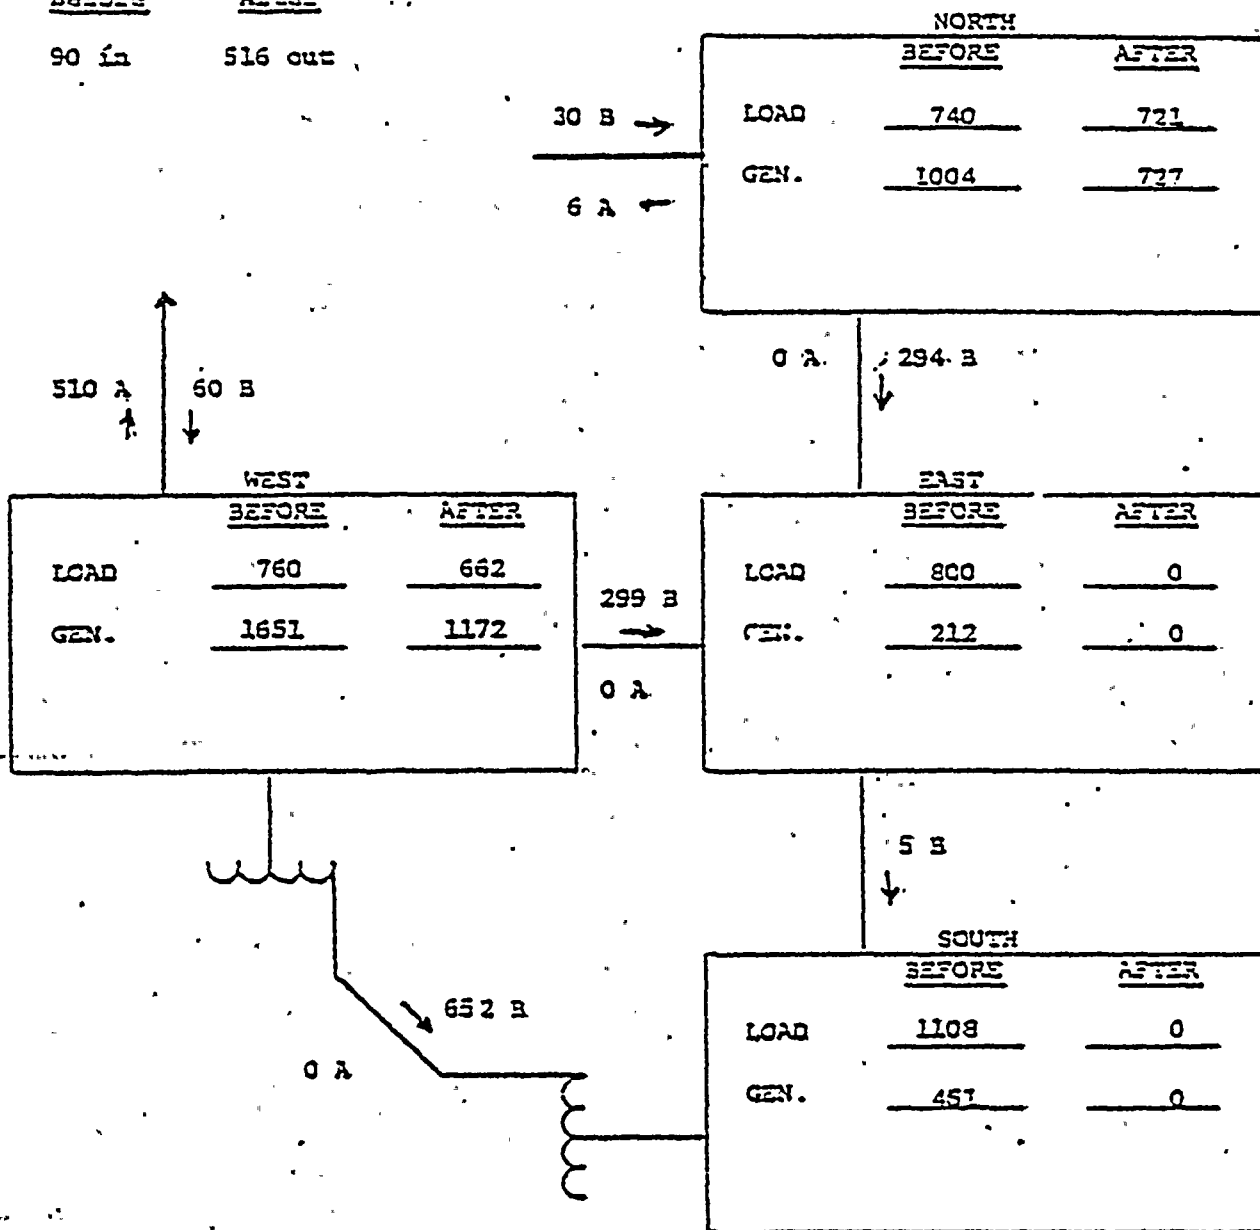
Net Interchange
Before After

90 in 516 out

SYSTEM	BEFORE	AFTER
LOAD	3408	1383
GEN.	3318	1899
