TURKEY POINT 4 STEAM GENERATOR  
INSPECTION PROGRAM

An extensive inspection program for the Turkey Point Unit 4 steam generators was conducted in May, 1980. The following items were accomplished:

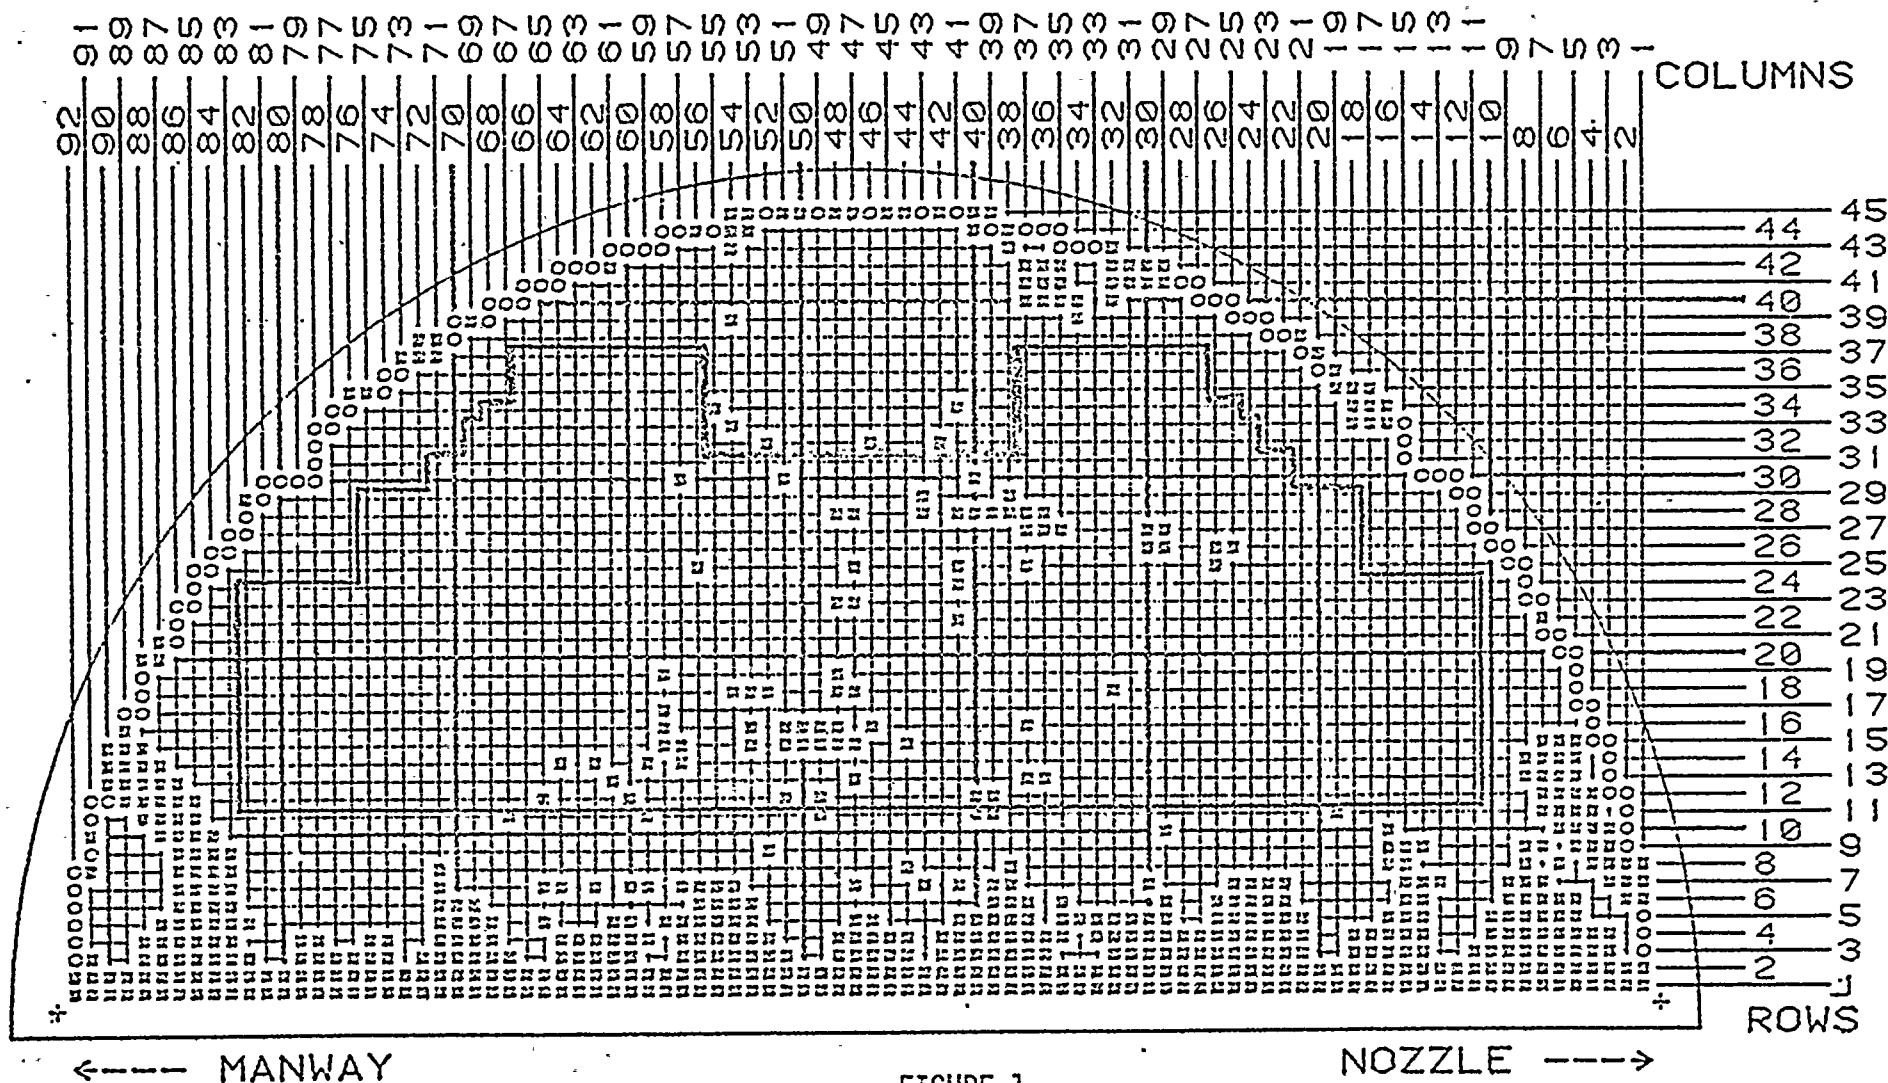
FIGURE 1

The gauging inspection boundaries for the May 1980 inspection are indicated in Figure 1 (typical hot leg) and Figure 2 (typical cold leg). Tubes restricted to a .650 mil probe in previous inspections were retested. If a restricted tube was found close to the inspection boundary, the inspection was expanded in that area.

GAUGING PROGRAM (TYPICAL) INLET  
ALL TUBES OUTSIDE LINED AREA

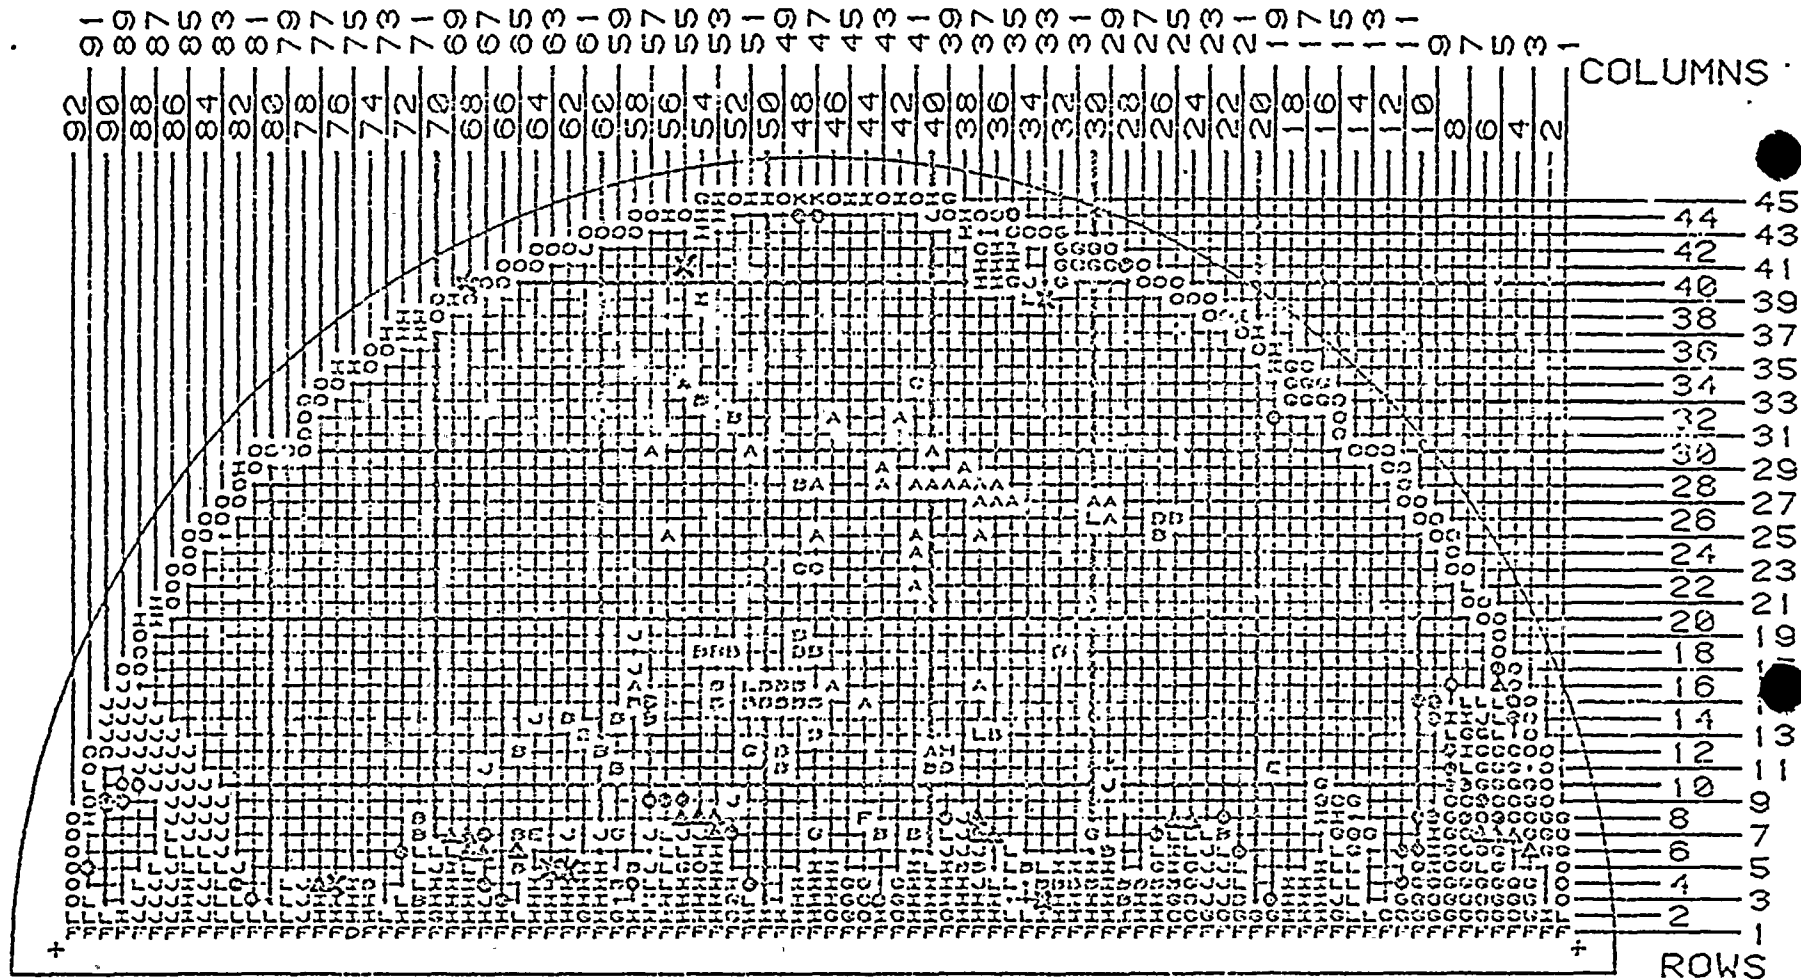
FIGURE 9

1. Tubes in the tubelane region that restrict the 0.650 inch probe lie adjacent to the areas in which such restrictions occurred in prior examinations.

STEAM GENERATOR A HOT LEG  
 GAUGING RESULTS - MAY, 1980

44  
 20  
 6

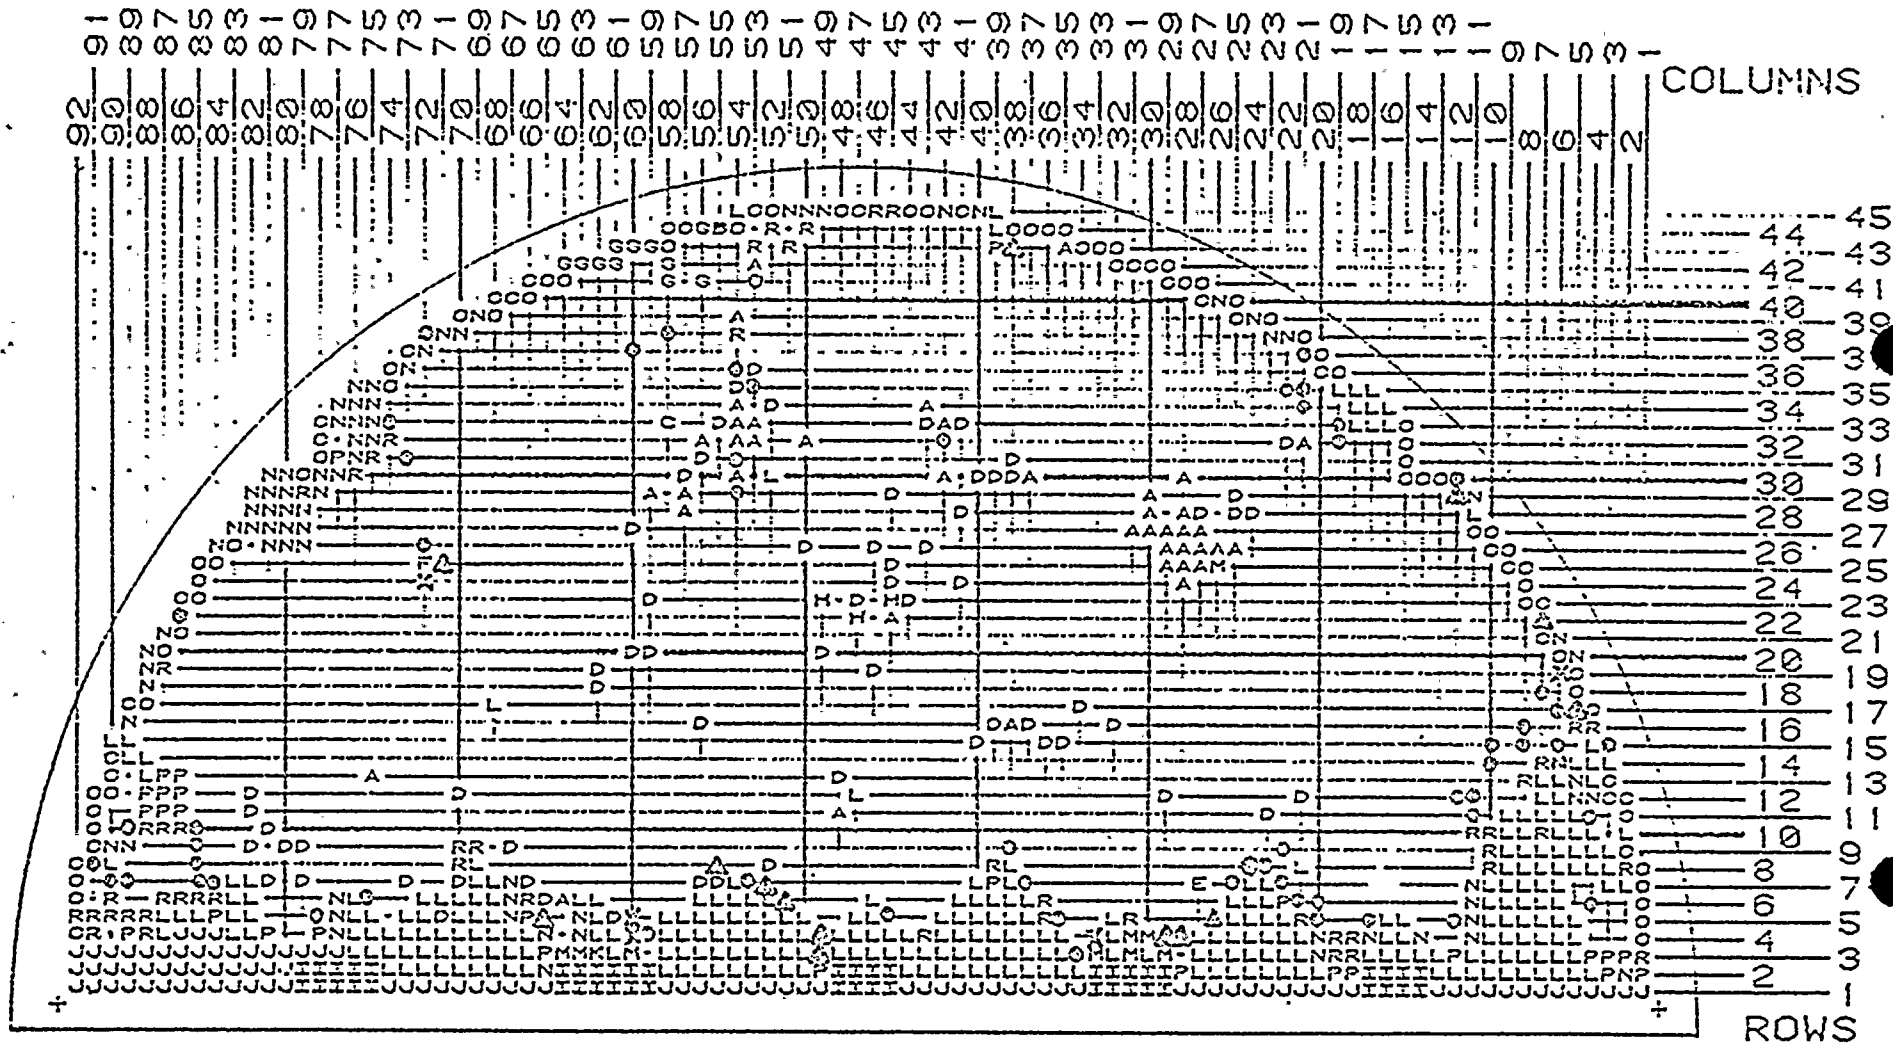
FIGURE 10

4. In steam generator B several tube restrictions appeared away from the pattern of prior results; these were located in the Reg. Guide 1.83 inspection program and appropriate expansions were performed. Three of the restrictions, four in all, were located adjacent to a tube which had been pulled in Sept. 1975, as part of the earliest field investigations of denting. The fourth tube lay adjacent to the patch plate inspection area.

TURKEY POINT UNIT #4  
GAUGING RESULTS, May, 1980  
STEAM GENERATOR B HOT LEG

RESTRICTED TUBES:	NO. OF TUBES
X = .540 Probe	5
Δ = .610 Probe	14
⊙ = .650 Probe	61

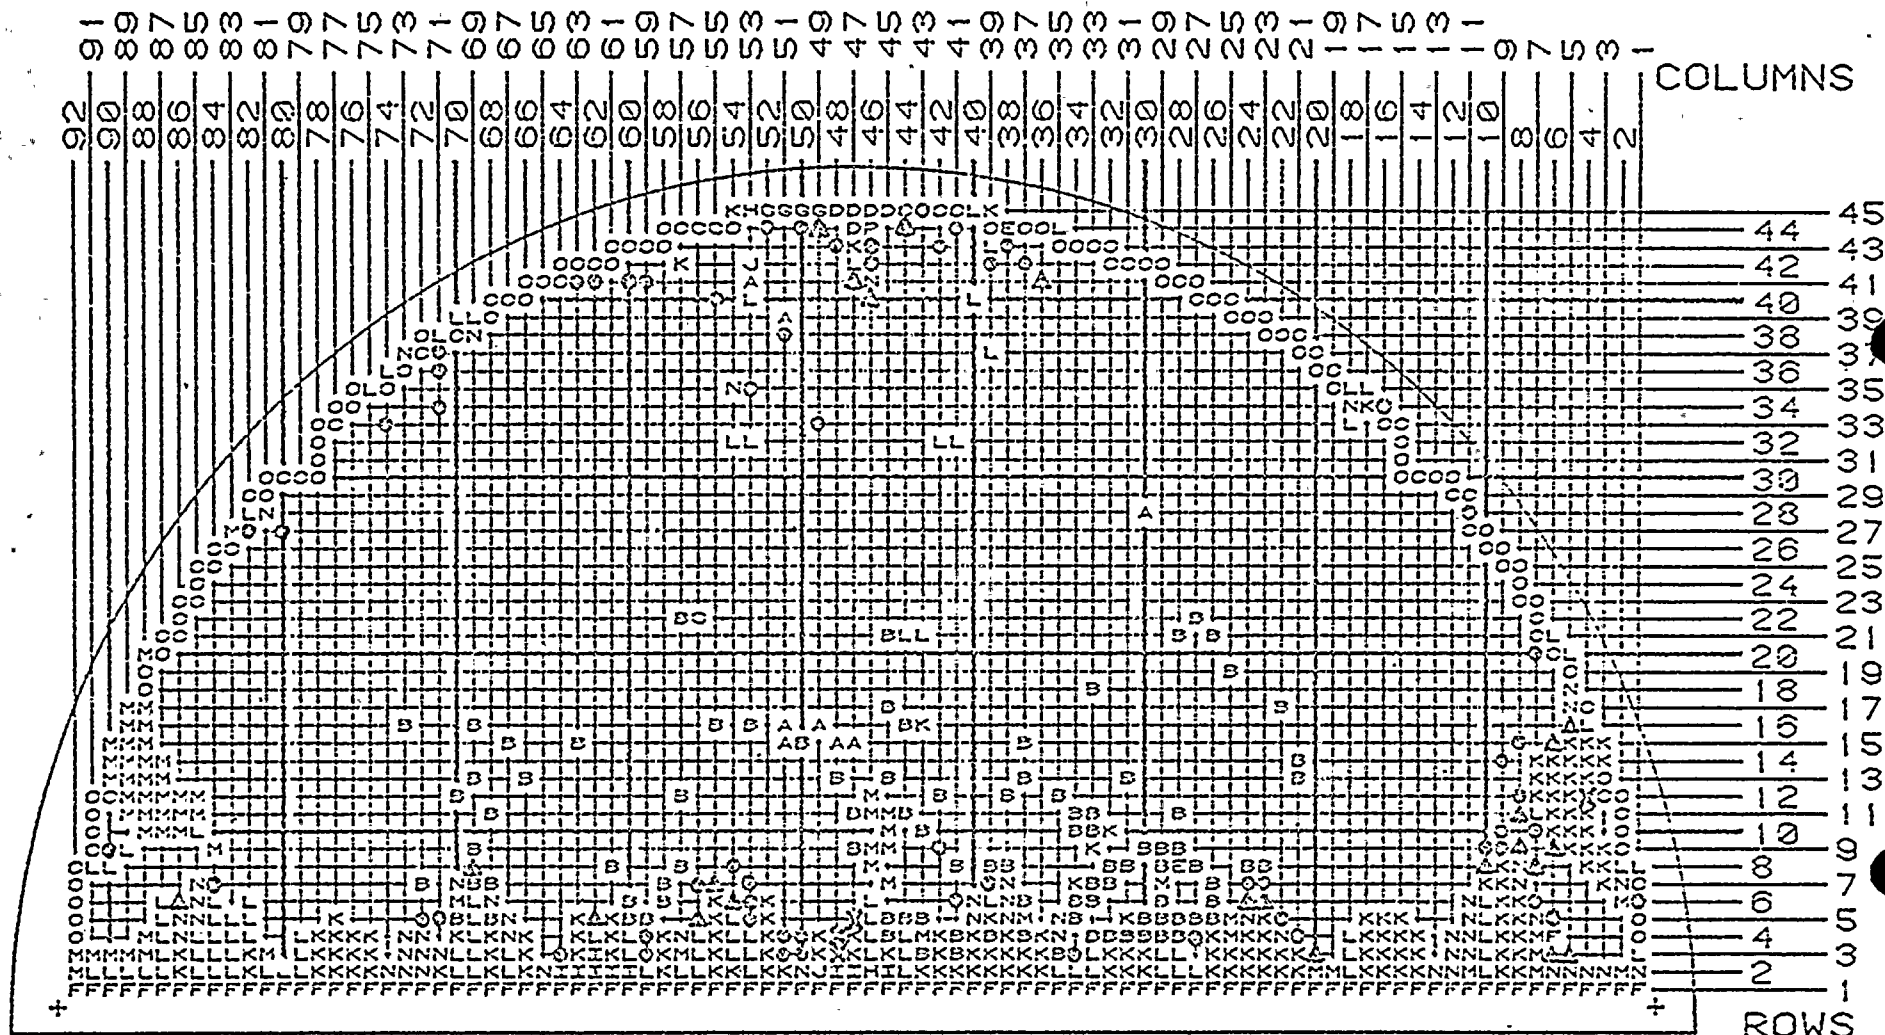
FIGURE 12

TURKEY POINT #4  
STEAM GENERATOR C HOT LEG  
GAUGING RESULTS, MAY, 1980

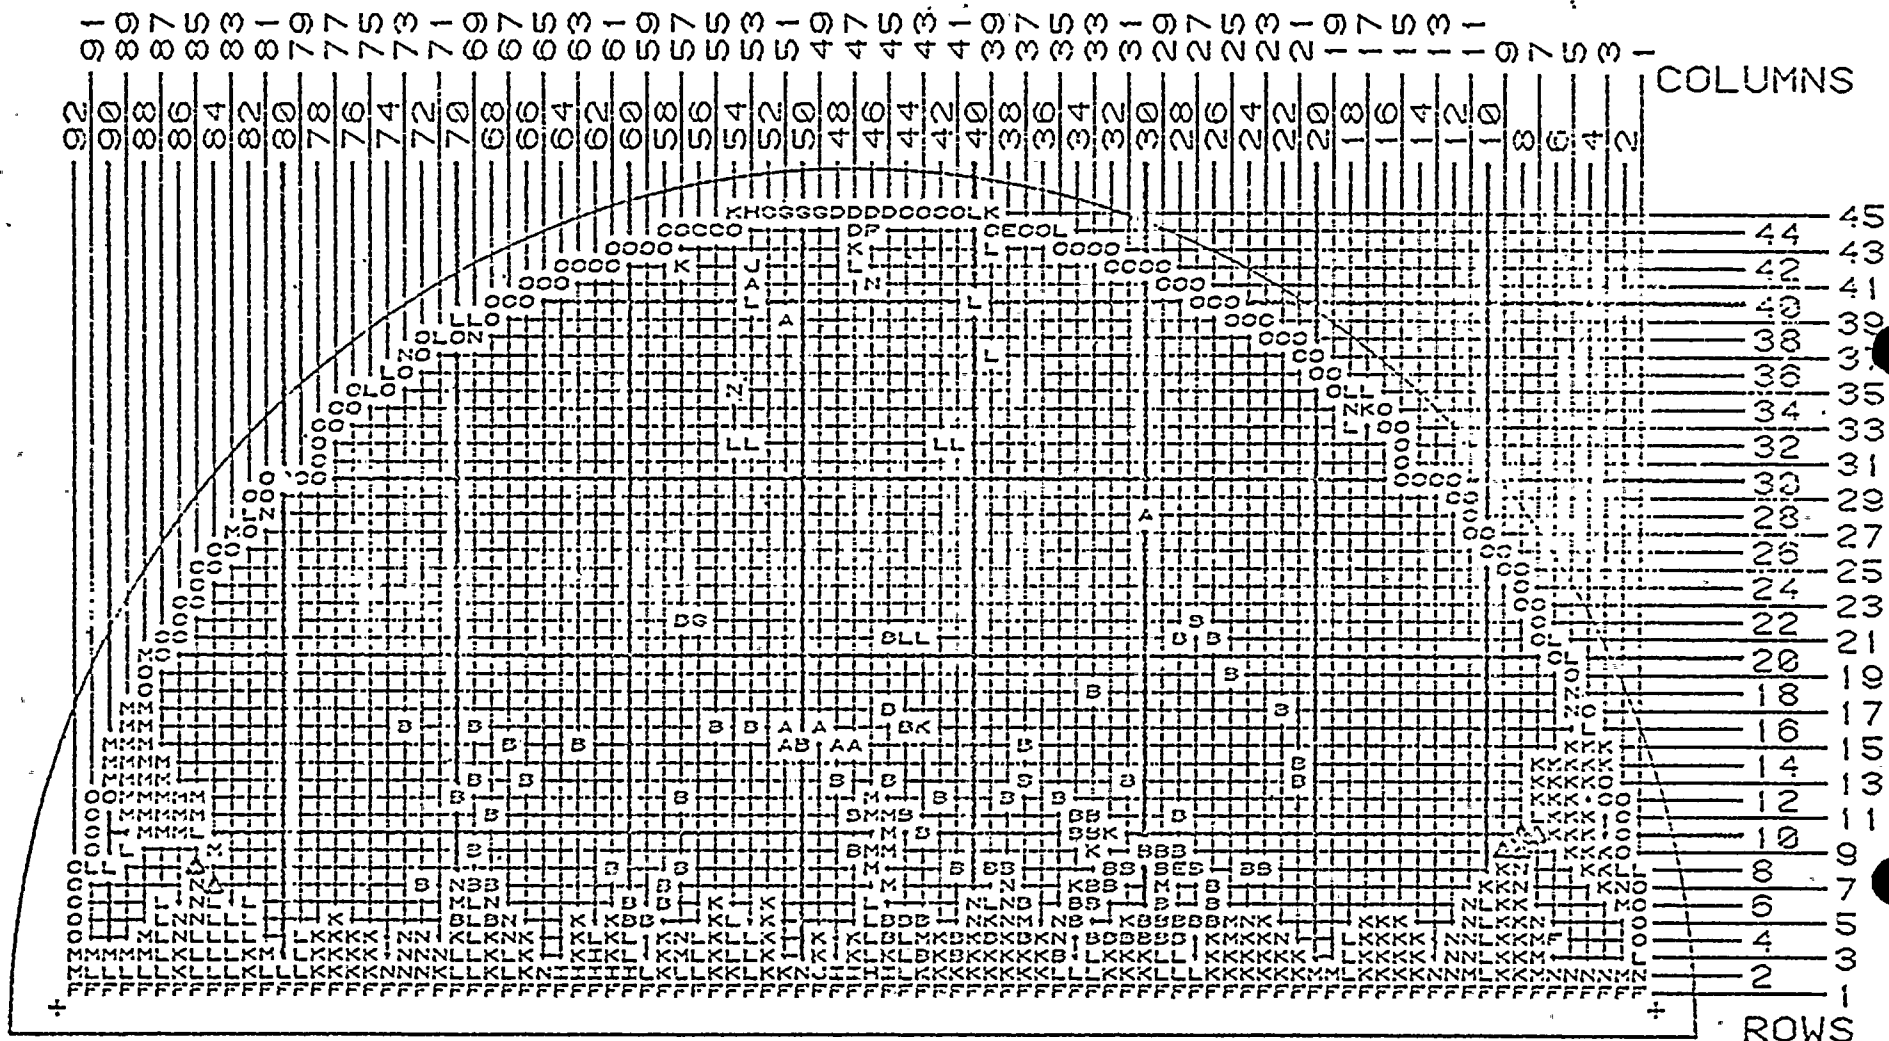
FIGURE 13

5. Only limited cold leg activity, i.e. restrictions less than 0.610 inches, was observed: No tubes in SG A, 2 in SG B, and 6 in SG C. The level of cold leg activity remains quite low compared to the hot leg experience.

TURKEY POINT UNIT #4  
STEAM GENERATOR C (COLD LEG)  
GAUGING RESULTS, MAY, 1980

6

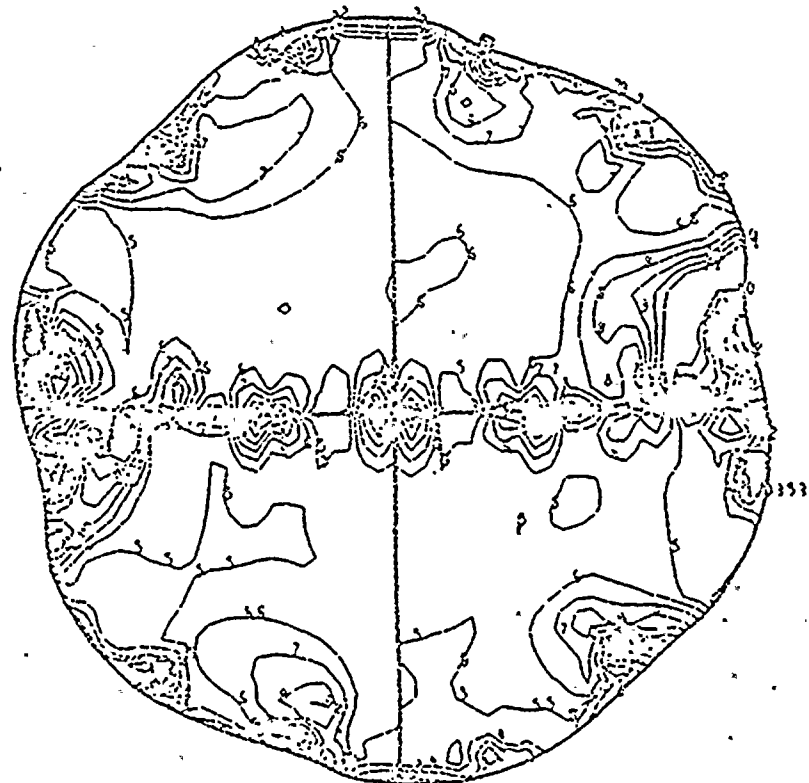
FIGURE 15 - TUBE HOOP STRAIN AT  
24 EFPM's BEYOND FULL CLOSURE

The six month operating period was also evaluated relative to a postulated main steam line break accident (MSLB). In doing this, the finite element analysis plot 24 EFPM beyond closure (Figure 15) was considered. This is considered to be representative of the conditions of the Turkey Point Unit 3 steam generators. It was assumed that the actual boundary of the 17.5% tube loop strain contour in the most advanced steam generator (B) is indicated in the tubelane region by

the previous plugging boundary and the present .540" restricted tubes. Using the finite element analysis results above, the advancement of the 17.5% tube loop strain contour over the next six months was conservatively assumed to be 2 rows. Assuming there are 92 tubes in a row, the total predicted tubes in the tubelane region lying within the 17.5% strain contour at the end of the next six months is:

This added to the 0.3 GPM leakage assumed to be present at the start of a postulated main steam line break (which would increase to approximately 0.7 GPM due to MSLB differential pressures) yield a total leakage less than 10 GPM, which has been determined in previous submittals to be an acceptable level of leakage during a postulated MSLB.

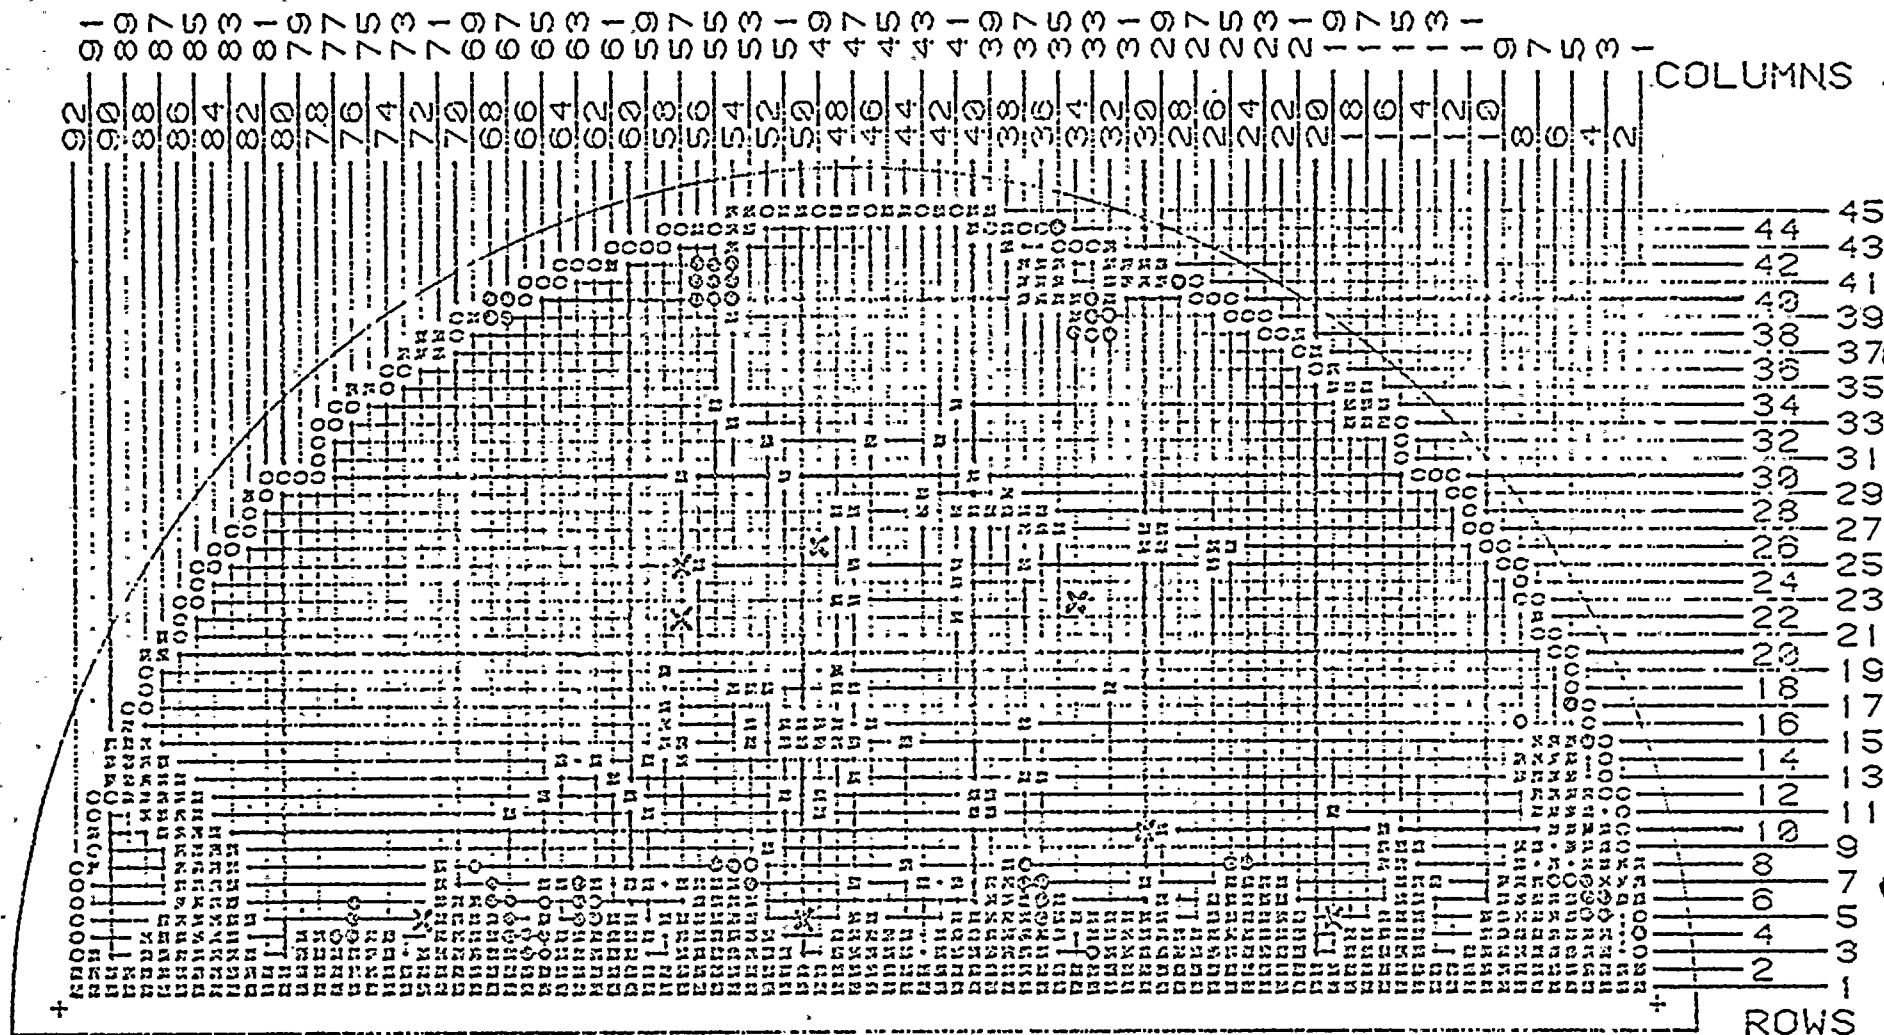
FIGURE 16

TURKEY POINT UNIT #4  
STEAM GENERATOR A  
MAY, 1980

The preventive plugging programs that were implemented are indicated in Figures 16, 17 and 18. Both gauging and Regulatory Guide 1.83 program plugging are indicated. Table 3 summarizes this plugging.

- O GAUGING RESULTS
- X REG. GUIDE 1.83
- E PREVIOUS PLUGGING

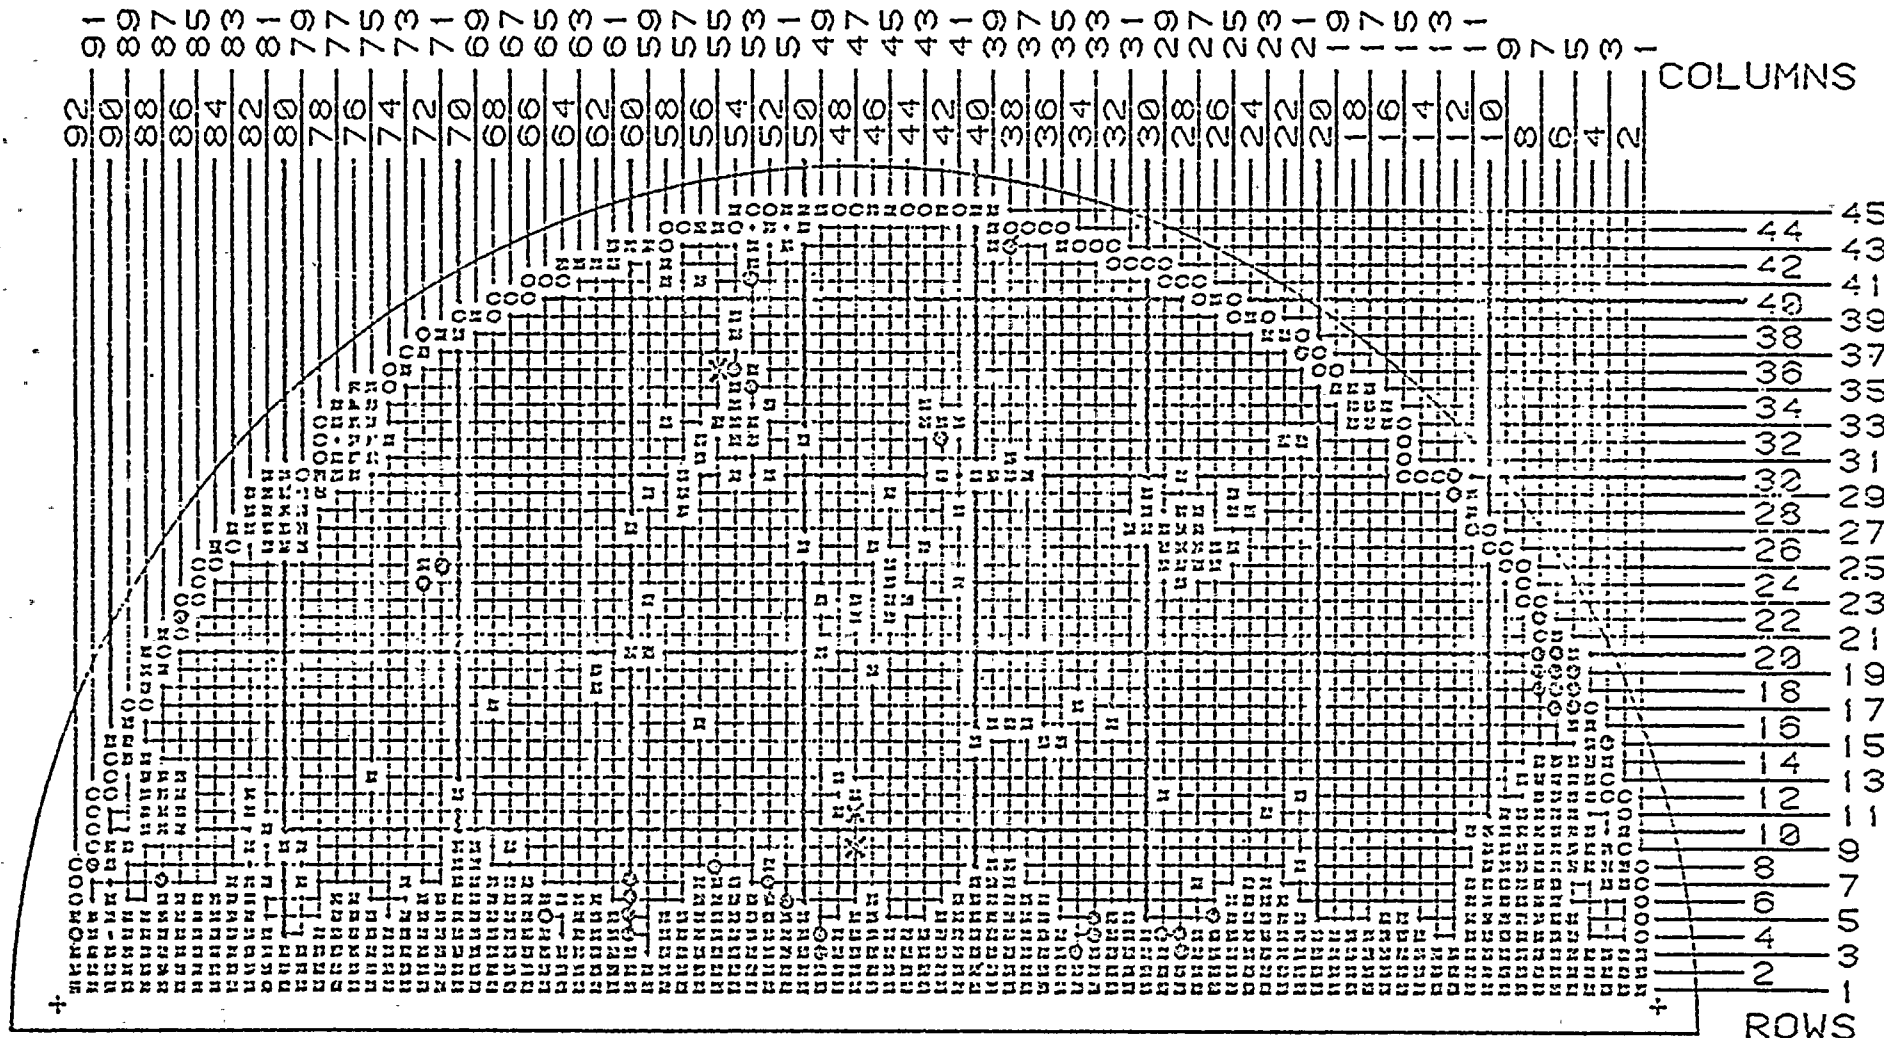
FIGURE 17

TURKEY POINT UNIT #4  
STEAM GENERATOR B  
MAY, 1980

- ⊙ = GAUGING RESULTS
- ⊗ = REG. GUIDE 1.83
- ⊠ = PREVIOUS PLUGGING

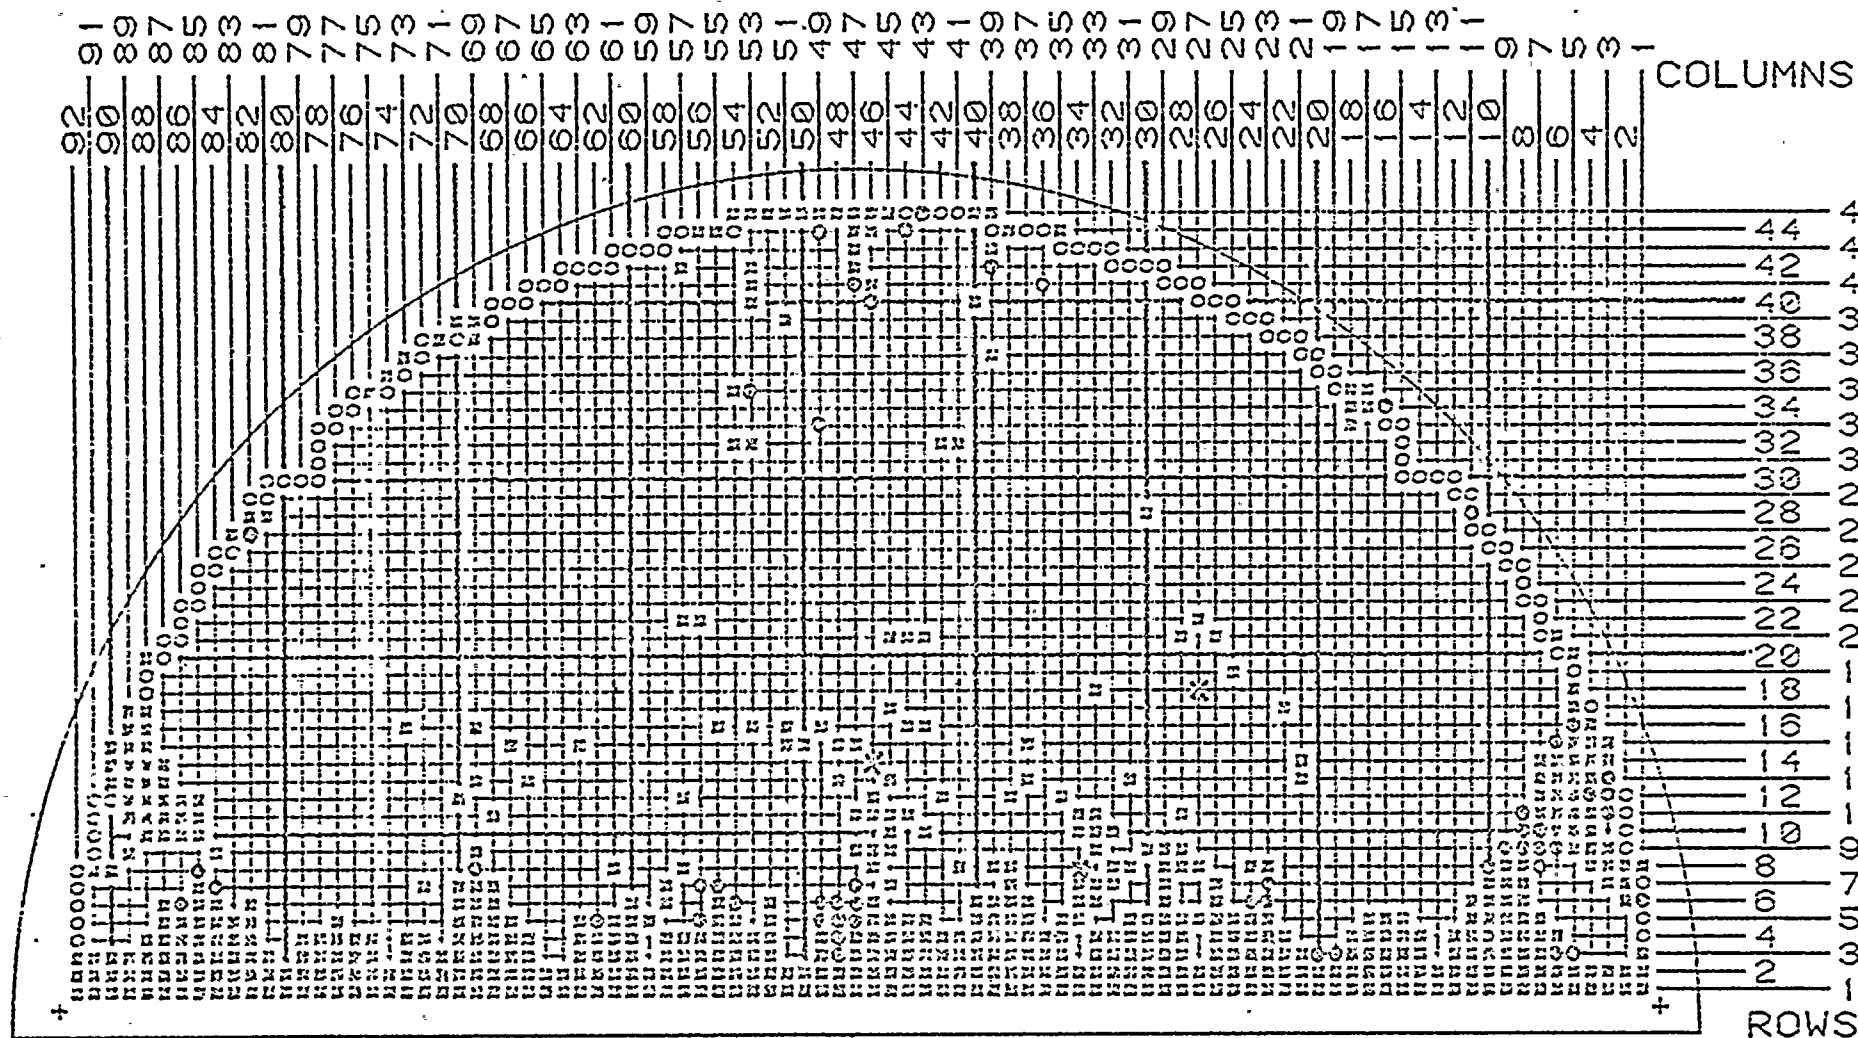
FIGURE 18

TURKEY POINT UNIT #4  
STEAM GENERATOR C  
MAY, 1980

- = GAUGING RESULTS
- X = REG. GUIDE 1.83
- = PREVIOUS PLUGGING
