TURKEY POINT 3 STEAM GENERATOR
INSPECTION PROGRAM

I. Introduction

An extensive inspection program for the Turkey Point Unit 3 steam generators was conducted in October, 1980. The following items were accomplished:

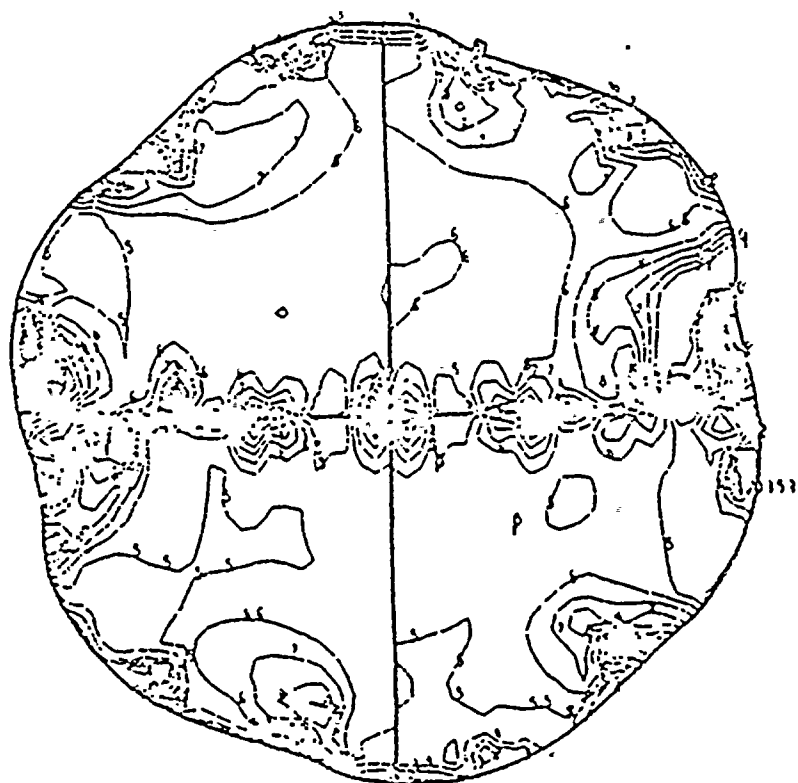
FIGURE 1 - TUBE HOOP STRAIN AT
24 EFPM's BEYOND FULL CLOSURE

The tube gauging program in the tubelane area is based on previously defined regions where significant tube deformation has occurred. These regions were formerly determined using finite element analysis techniques which yield tube hoop strain contours as a function of plate deformation. The boundary in the peripheral tubelane areas near the three and nine o'clock wedge locations is modified to take into account the greater extent of deformation in this region of the plate determined by previous experience. After four reinspections since the first gauging inspection at Turkey Point 3, it became apparent that the finite element model no longer gave reasonable

expectations as to the position of a strain boundary which might be linked to location of the most severely restricted tubes. The 17.5% strain contour utilized in the 12/79 inspection would encompass most of the hot leg tube bundle at 24 effective full power months beyond closure of the support plate flow slots, which is regarded as having occurred as of the 12/77 inspection. (The tube hoop strain at 24 effective full power months beyond full closure is given for reference purposes in Figure 1). Therefore, the gauging program, based on the program used in 12/79, has been adjusted to reflect prior experience at the Surry and Turkey Point plants. Additional inspection programs were defined for the periphery, wedge, and patch plate regions. These programs were based on previous tube leakage histories at the Turkey Point and Surry plant sites, as well as previous gauging results at the Surry and Turkey Point sites, as deemed appropriate. Due to the current awareness of the potential for tube deformation on the cold leg side, inspections of all three steam generator cold legs were performed.

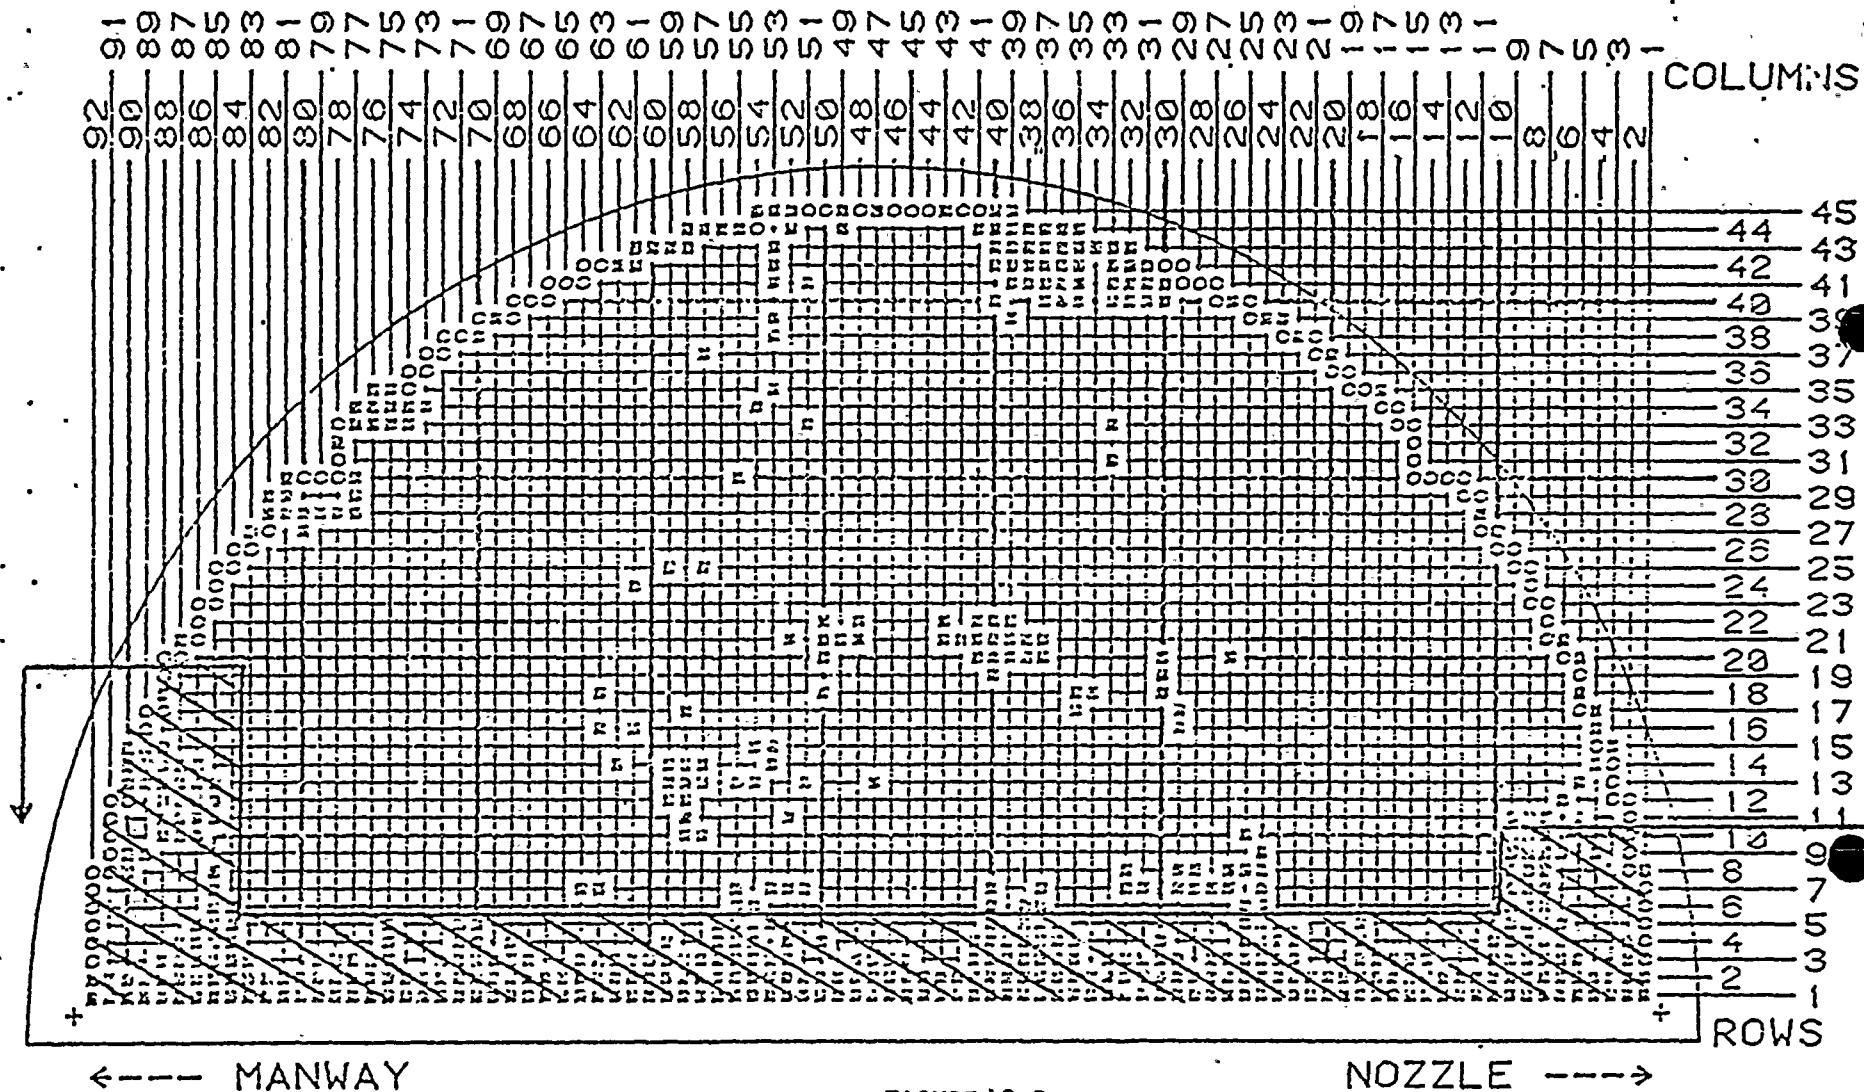
FIGURE 2 A

TYPICAL GAUGING INSPECTION
BOUNDARY - HOT LEG
DECEMBER 1979 INSPECTION

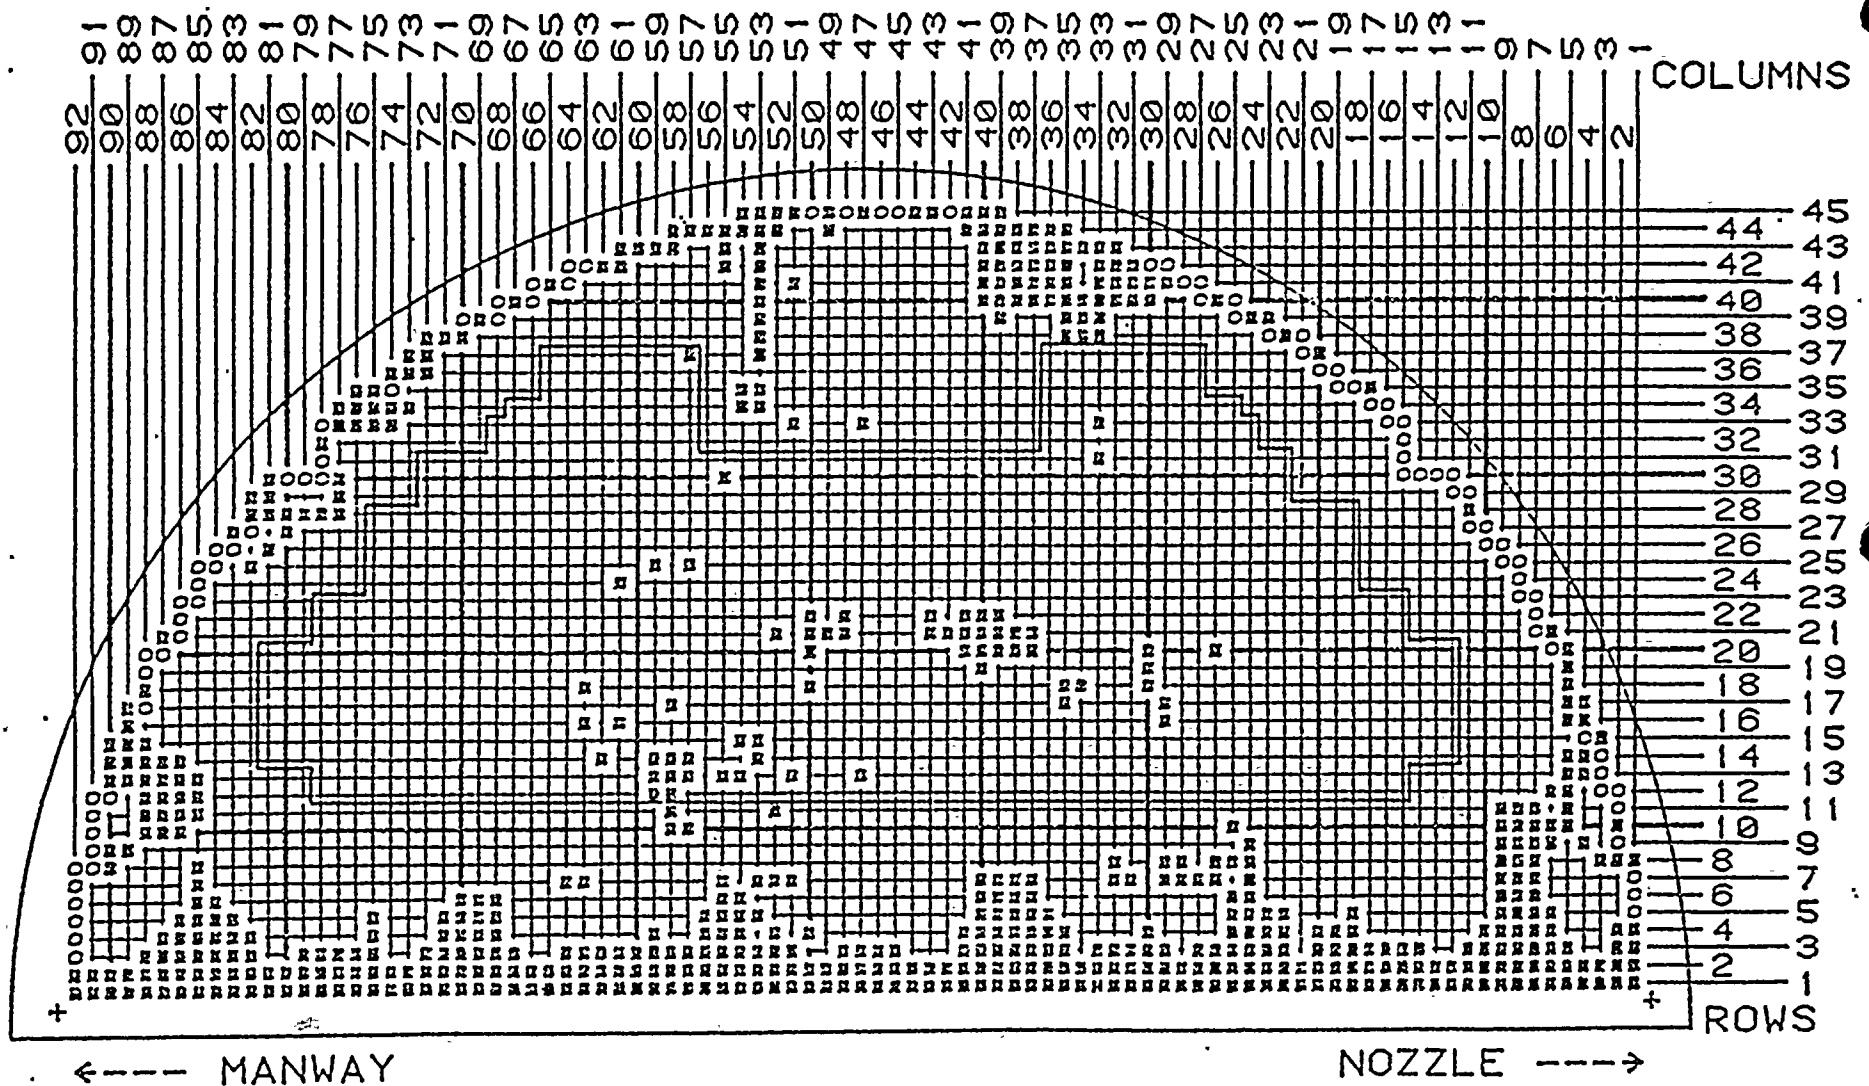
FIGURE 3

GAUGING PROGRAM (TYPICAL) INLET

GAUGE ALL TUBES OUTSIDE BOUNDED AREA, OCTOBER, 1980

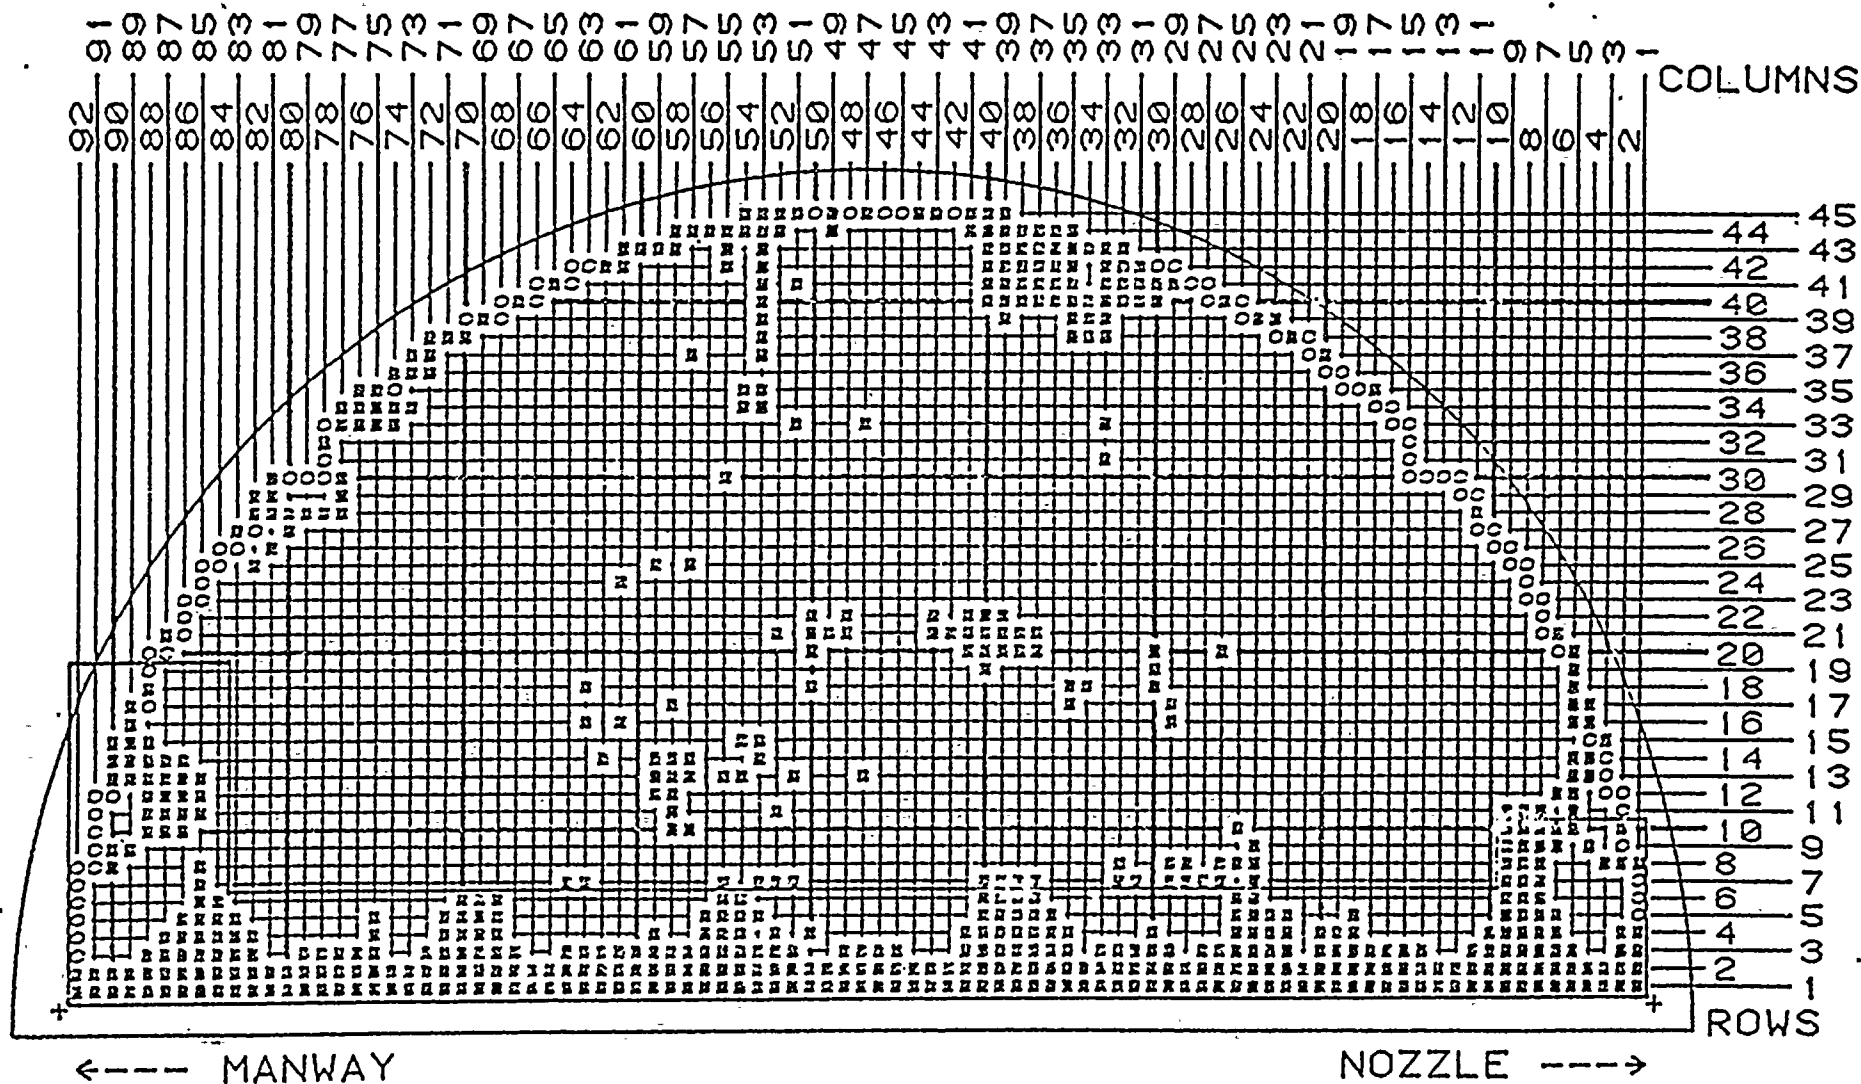
FIGURE 4

GAUGING PROGRAM (TYPICAL) OUTLET
GAUGE ALL TUBES WITHIN BOUNDED AREA
OCTOBER, 1980

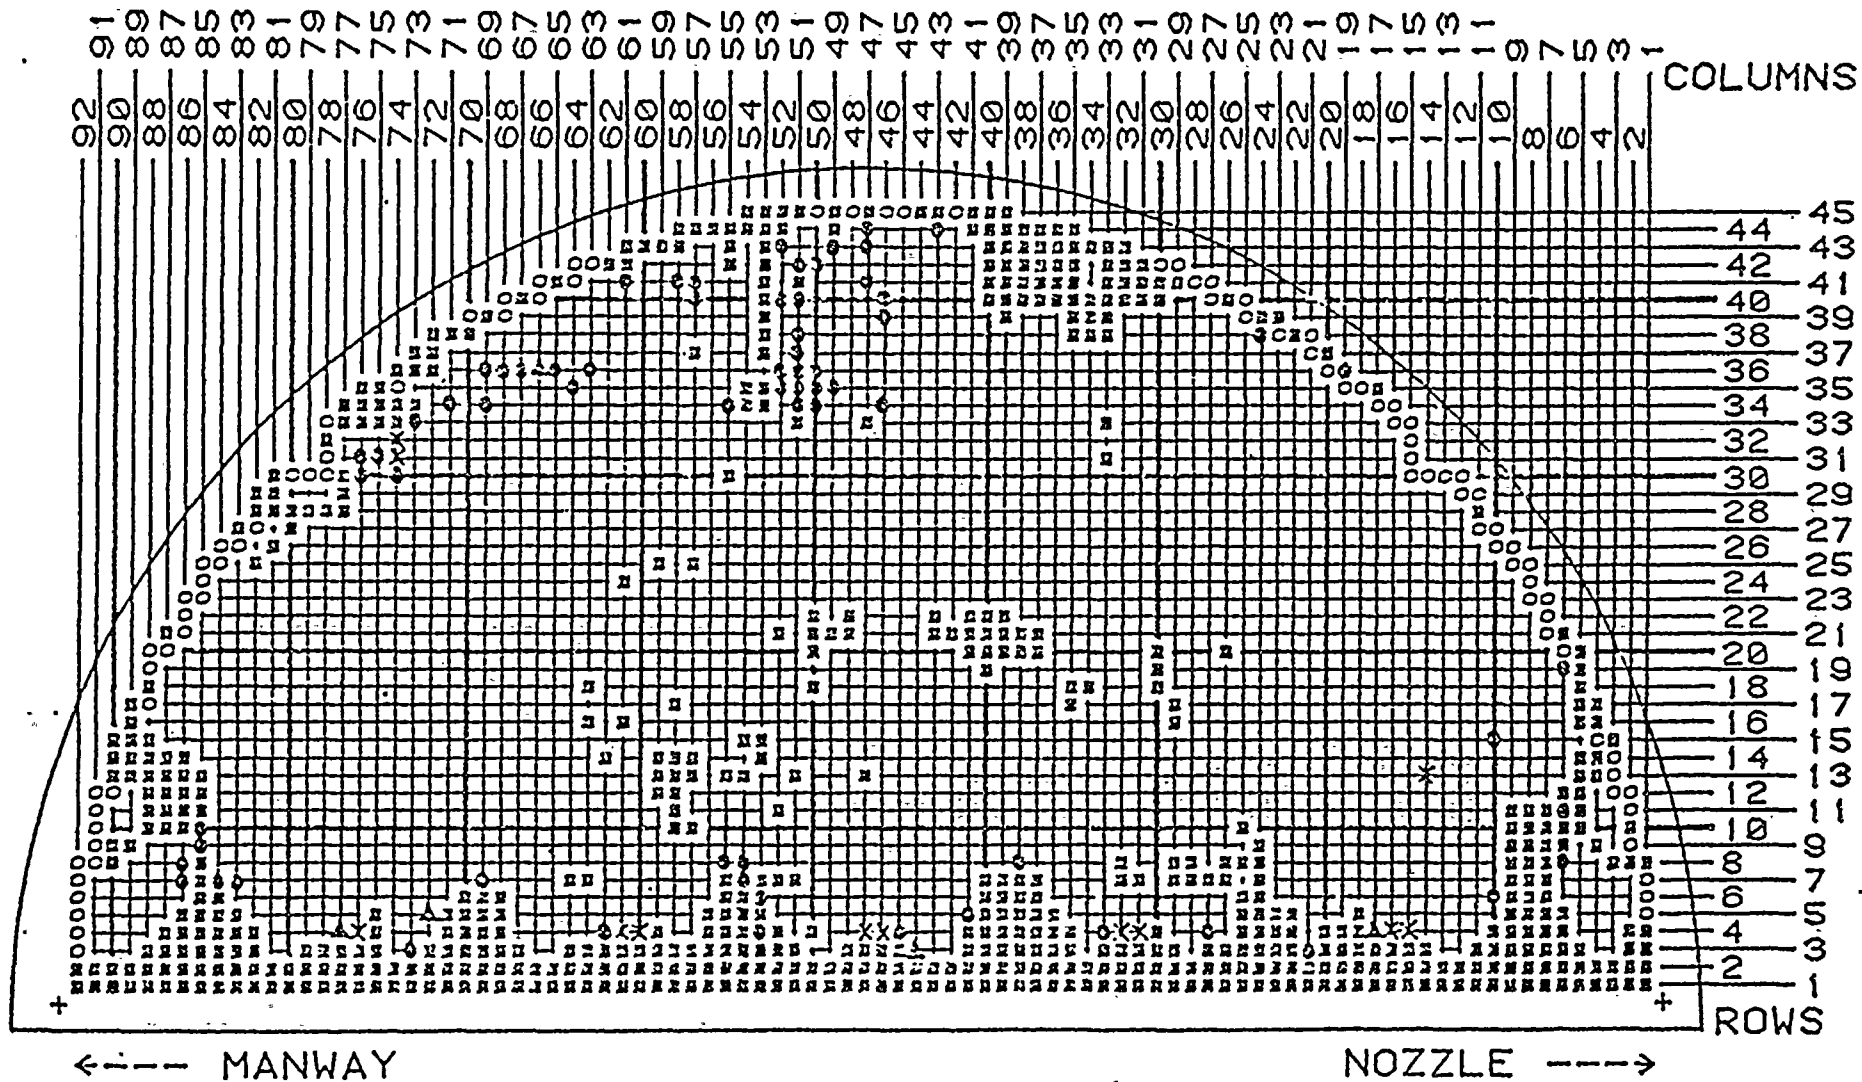
Turkey Point Unit 3
Steam Generator A - Inlet
Gauging Results - October, 1980

1. In steam generators A, B, and C, restricted tubes generally developed adjacent to previous activity or clustered together with other new activity. This was particularly true of tubes that restricted the 0.610" and 0.540" probes. Areas of activity were consistent with past historical data for this and other plants.

2. Tube restrictions were noted in some of the inspected wedge areas (in the hot legs) of all steam generators and this activity appears consistent with previous experience at this and other units.

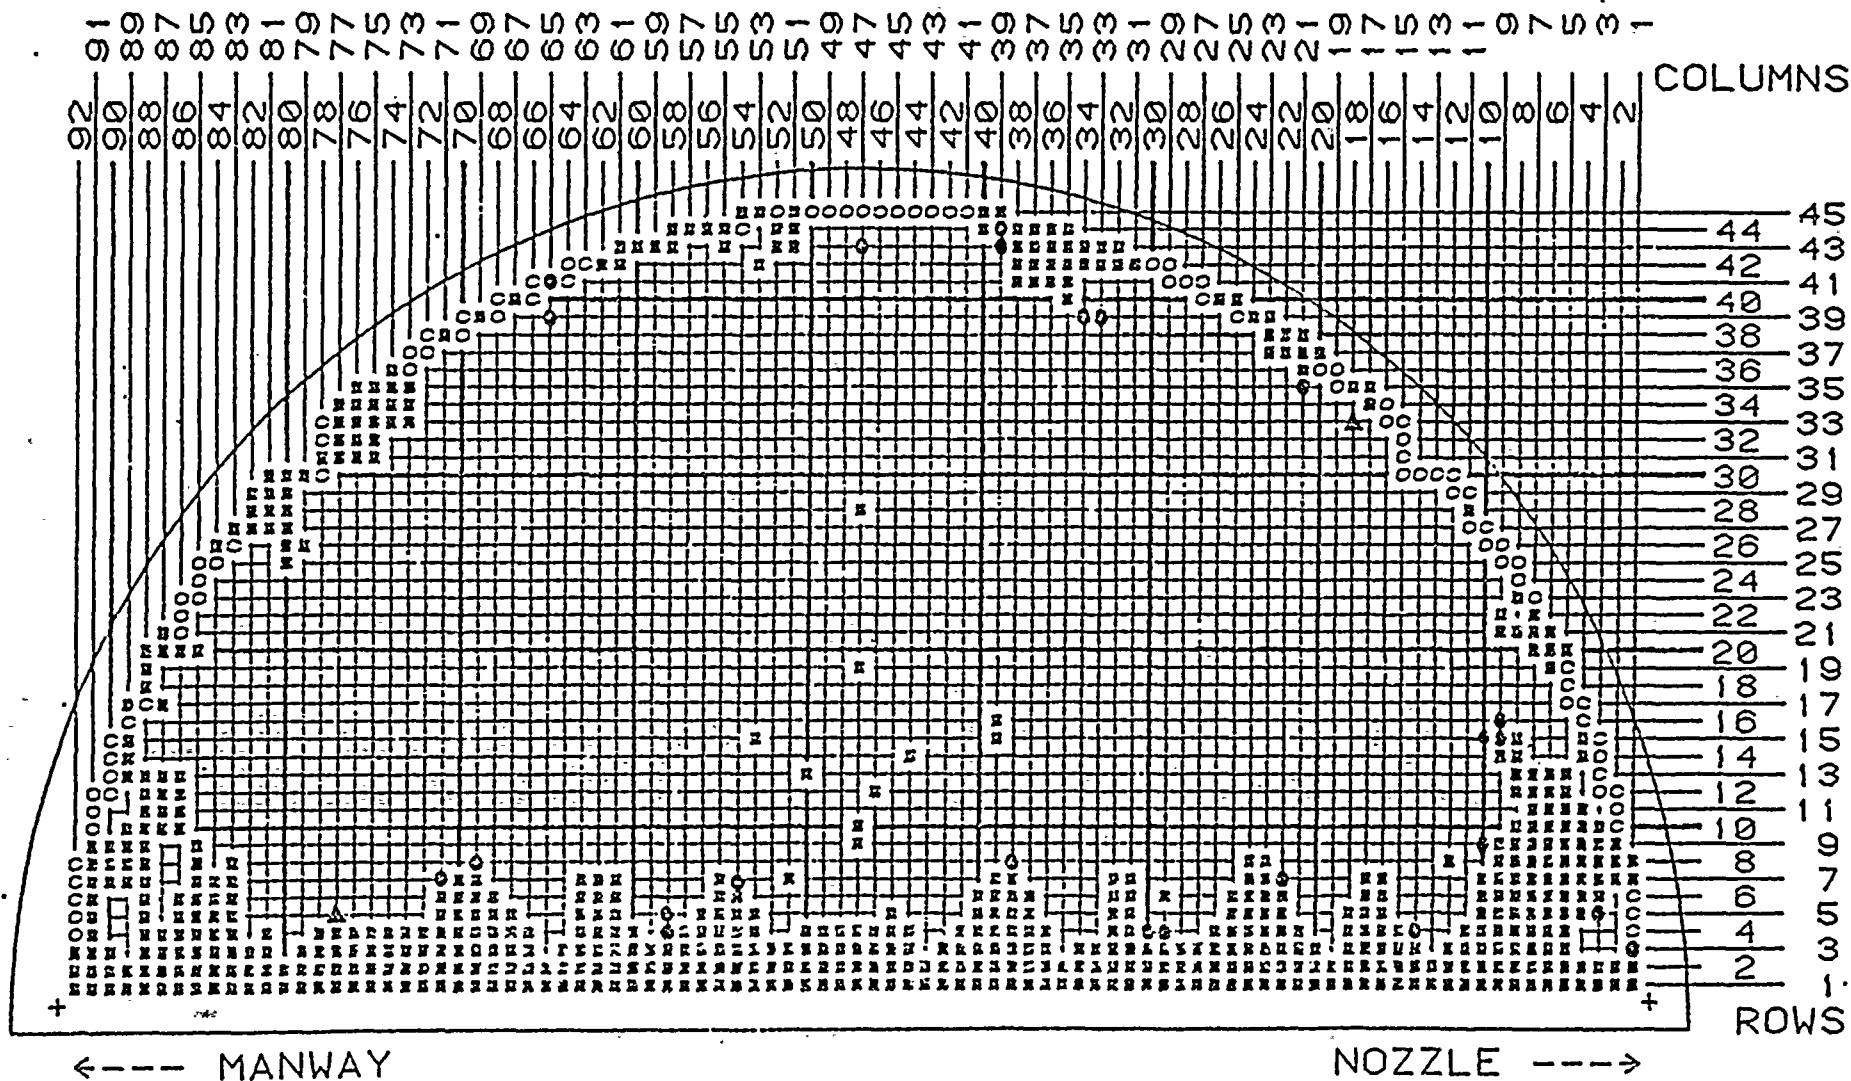
FIGURE 9

Turkey Point Unit 3
Steam Generator B - Inlet
Gauging Results - October, 1980

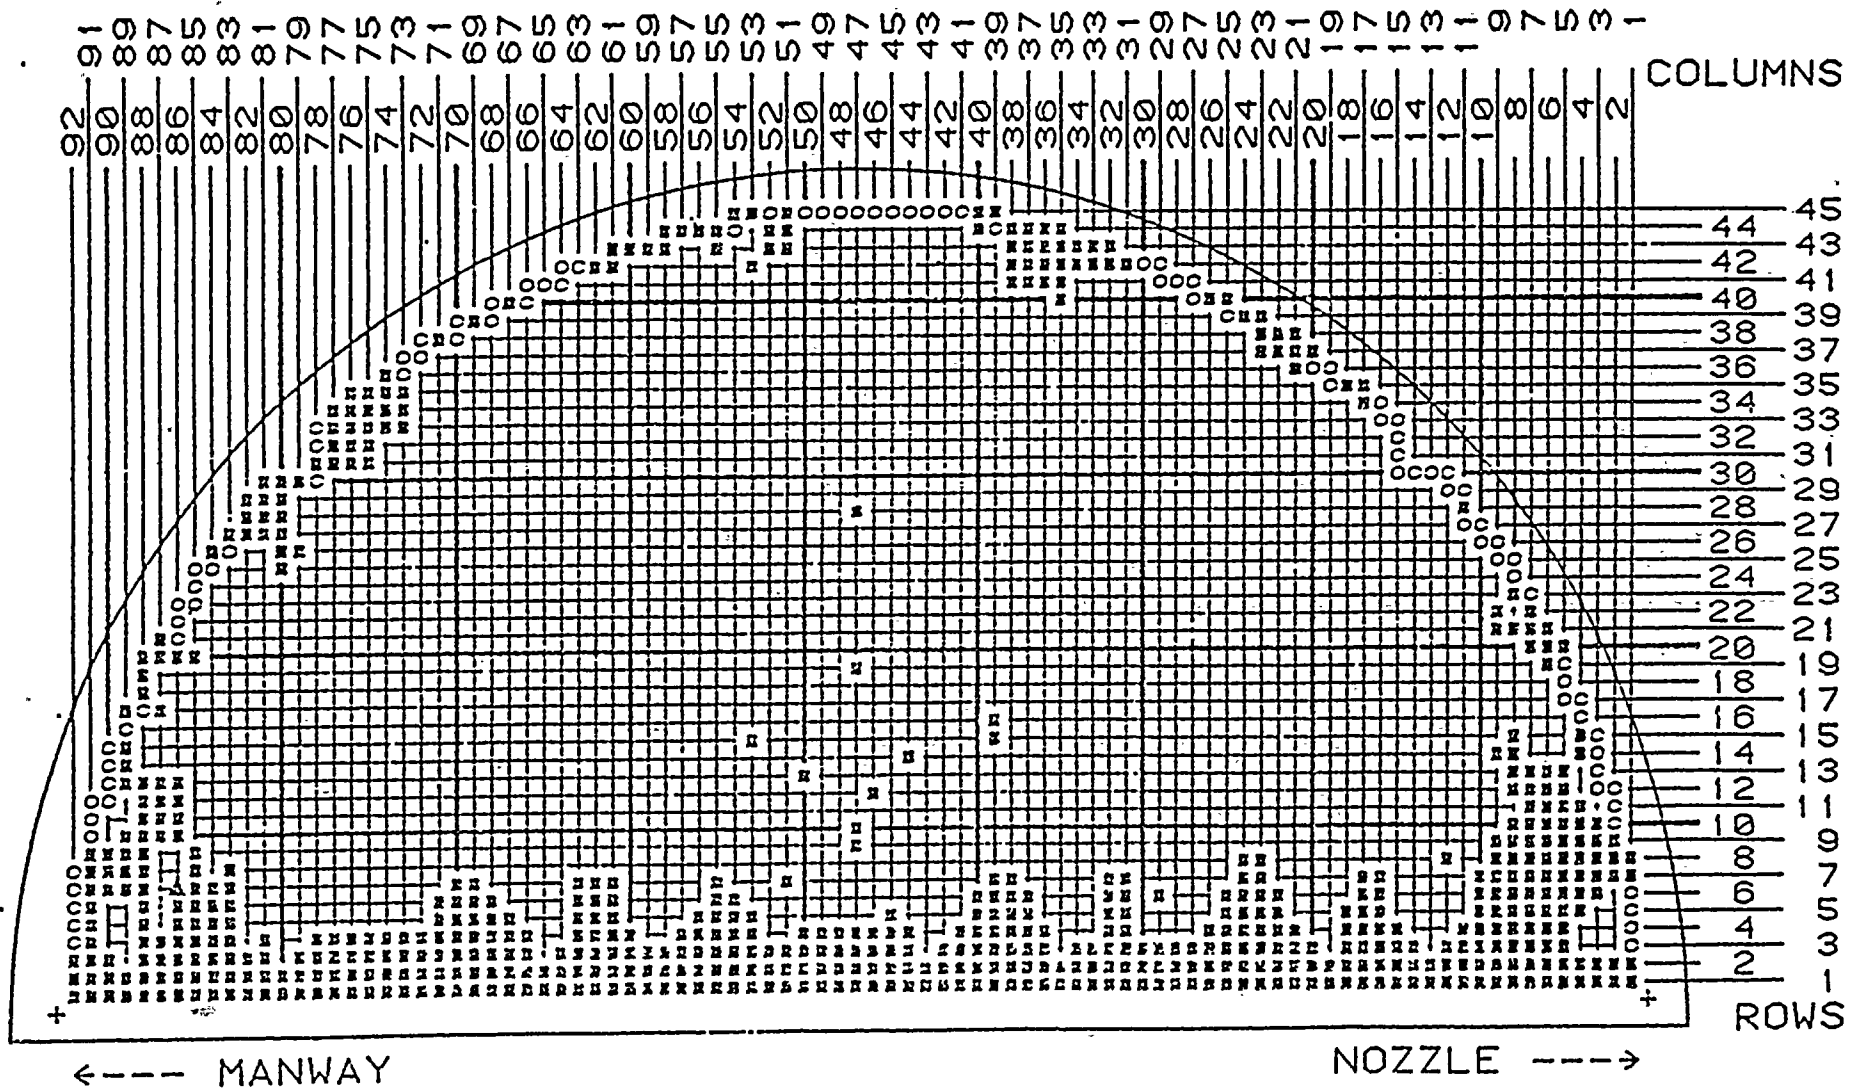
FIGURE 10

3. In this inspection of the cold leg areas, only one tube restriction was noted in the tubelane regions (SGB). No activity was noted in four of the six cold leg wedge areas inspected. Slight activity was noted adjacent to one of the inspected wedge areas in each of SG/A and SG/C. The level of activity is consistent with that noted in previous Turkey Point inspections. The overall level of activity continues to indicate a very low growth rate as compared to the hot leg.

Turkey Point Unit 3
Steam Generator B - Outlet
Gauging Results - October, 1980

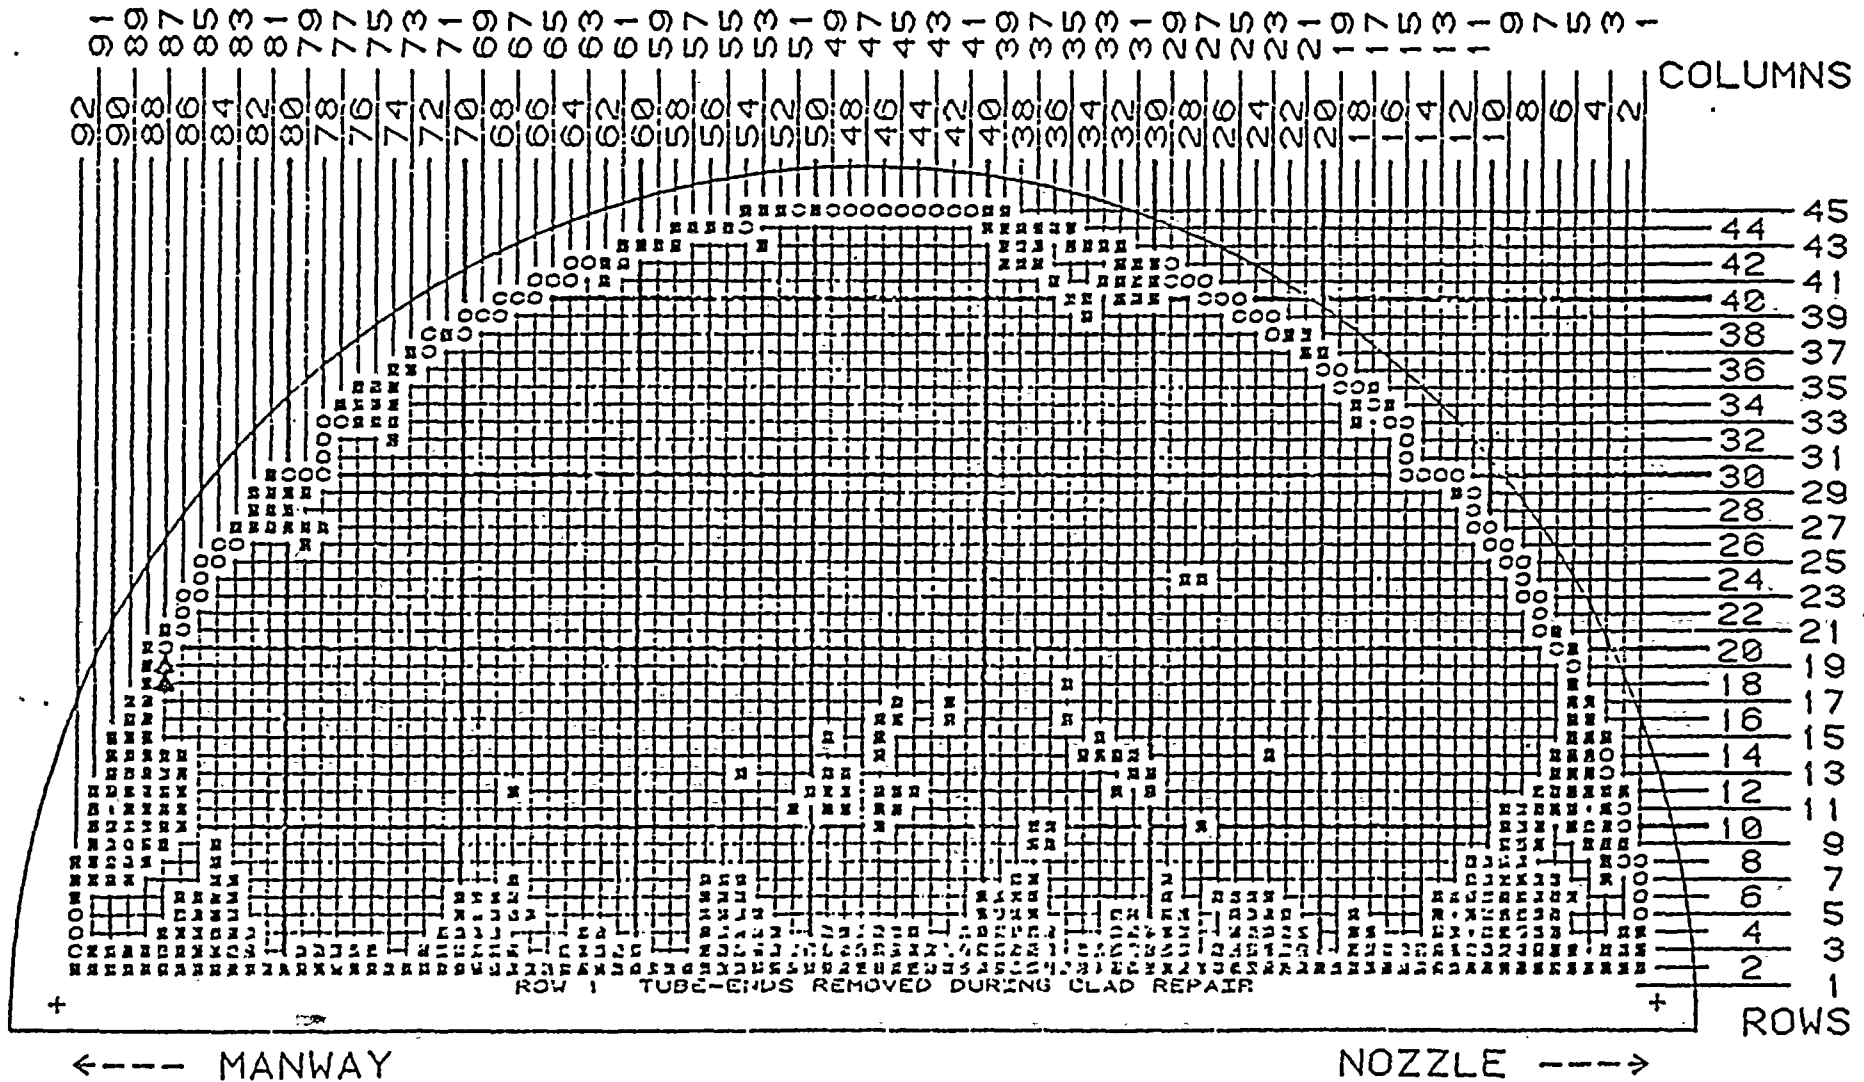
FIGURE 12

Turkey Point Unit 3
Steam Generator C - Outlet
Gauging Results - October, 1980

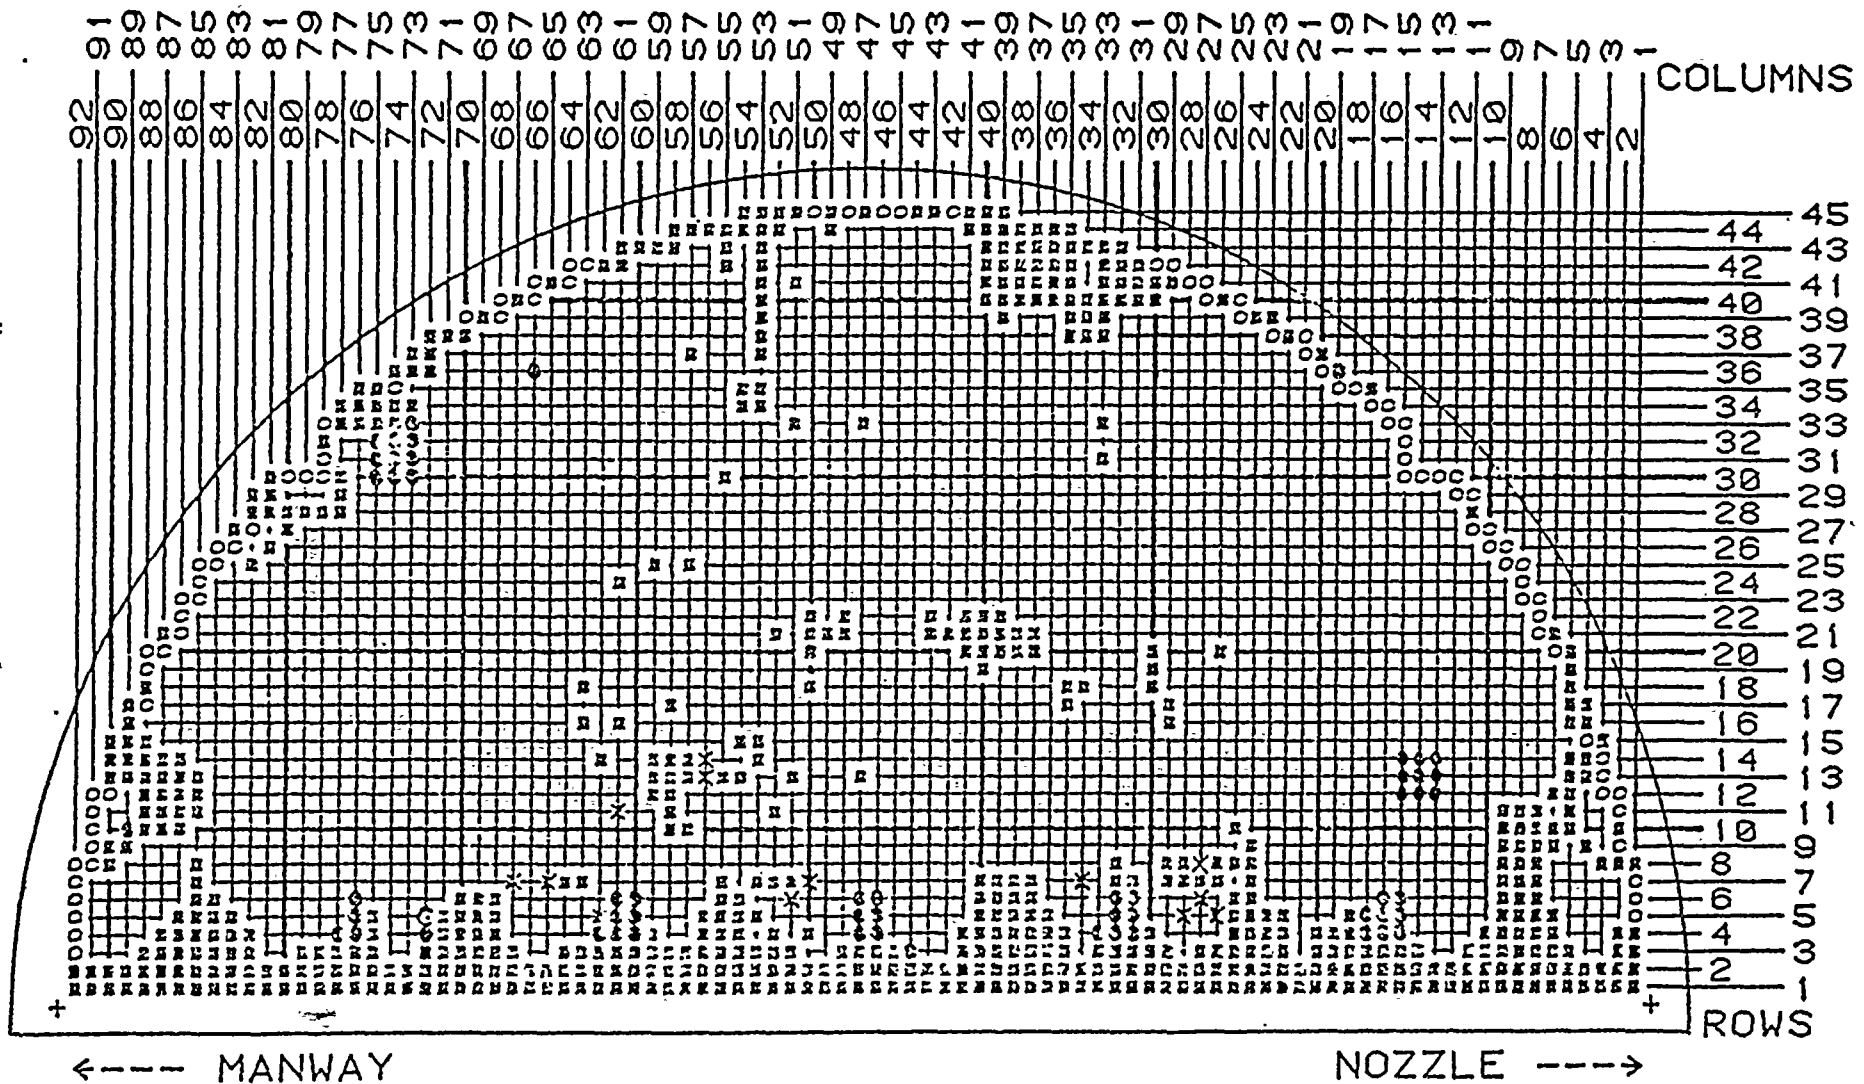
FIGURE 13

restriction. The pluggable tubes are generally located in rows 5 to 8, inclusive, with only a few in higher rows, as shown in Figures 13 and 15.

Evaluation of the results suggests probable thinning in the region of the sludge pile in the cold leg.

TURKEY POINT Unit #3
STEAM GENERATOR A
October, 1980

The preventive plugging programs that were implemented are indicated in Figures 13, 14 and 15. Both gauging and Regulatory Guide 1.83 program plugging are indicated. Table 4 summarizes this plugging.

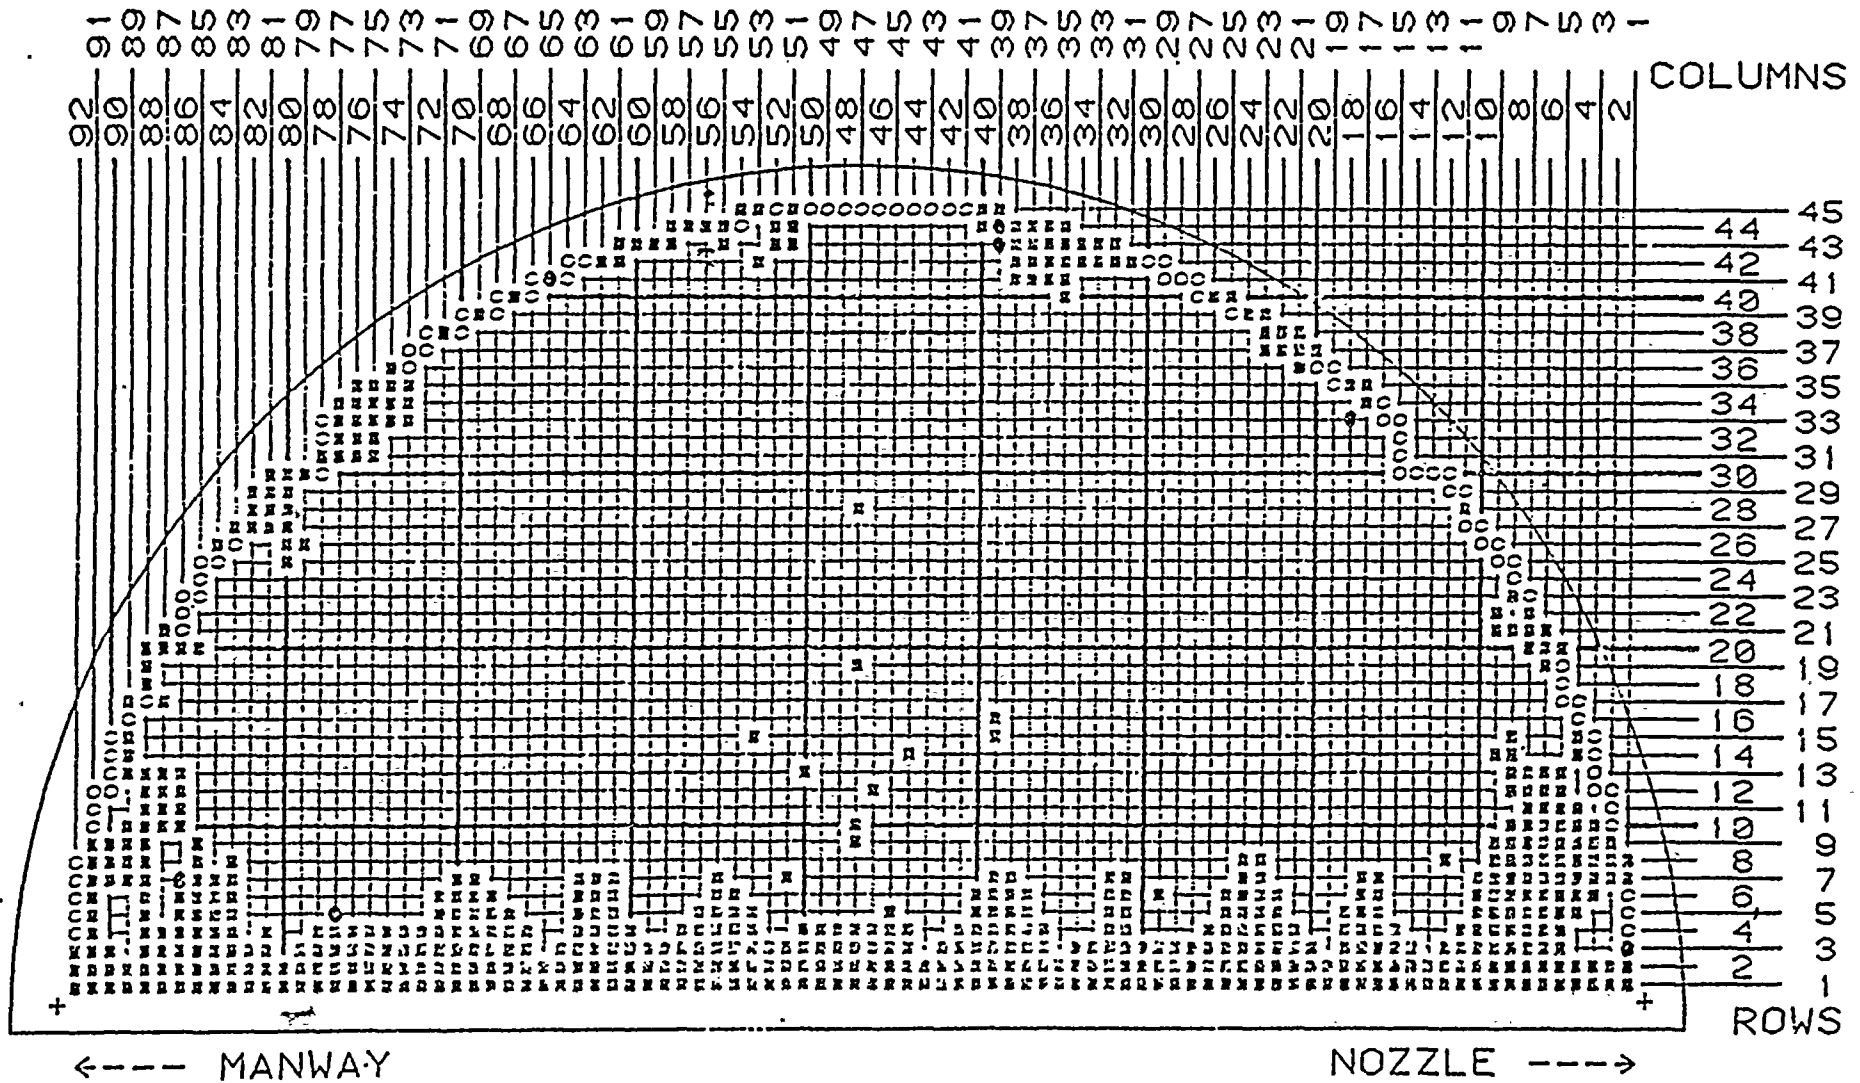
FIGURE 14

TURKEY POINT UNIT #3
STEAM GENERATOR B
October, 1980

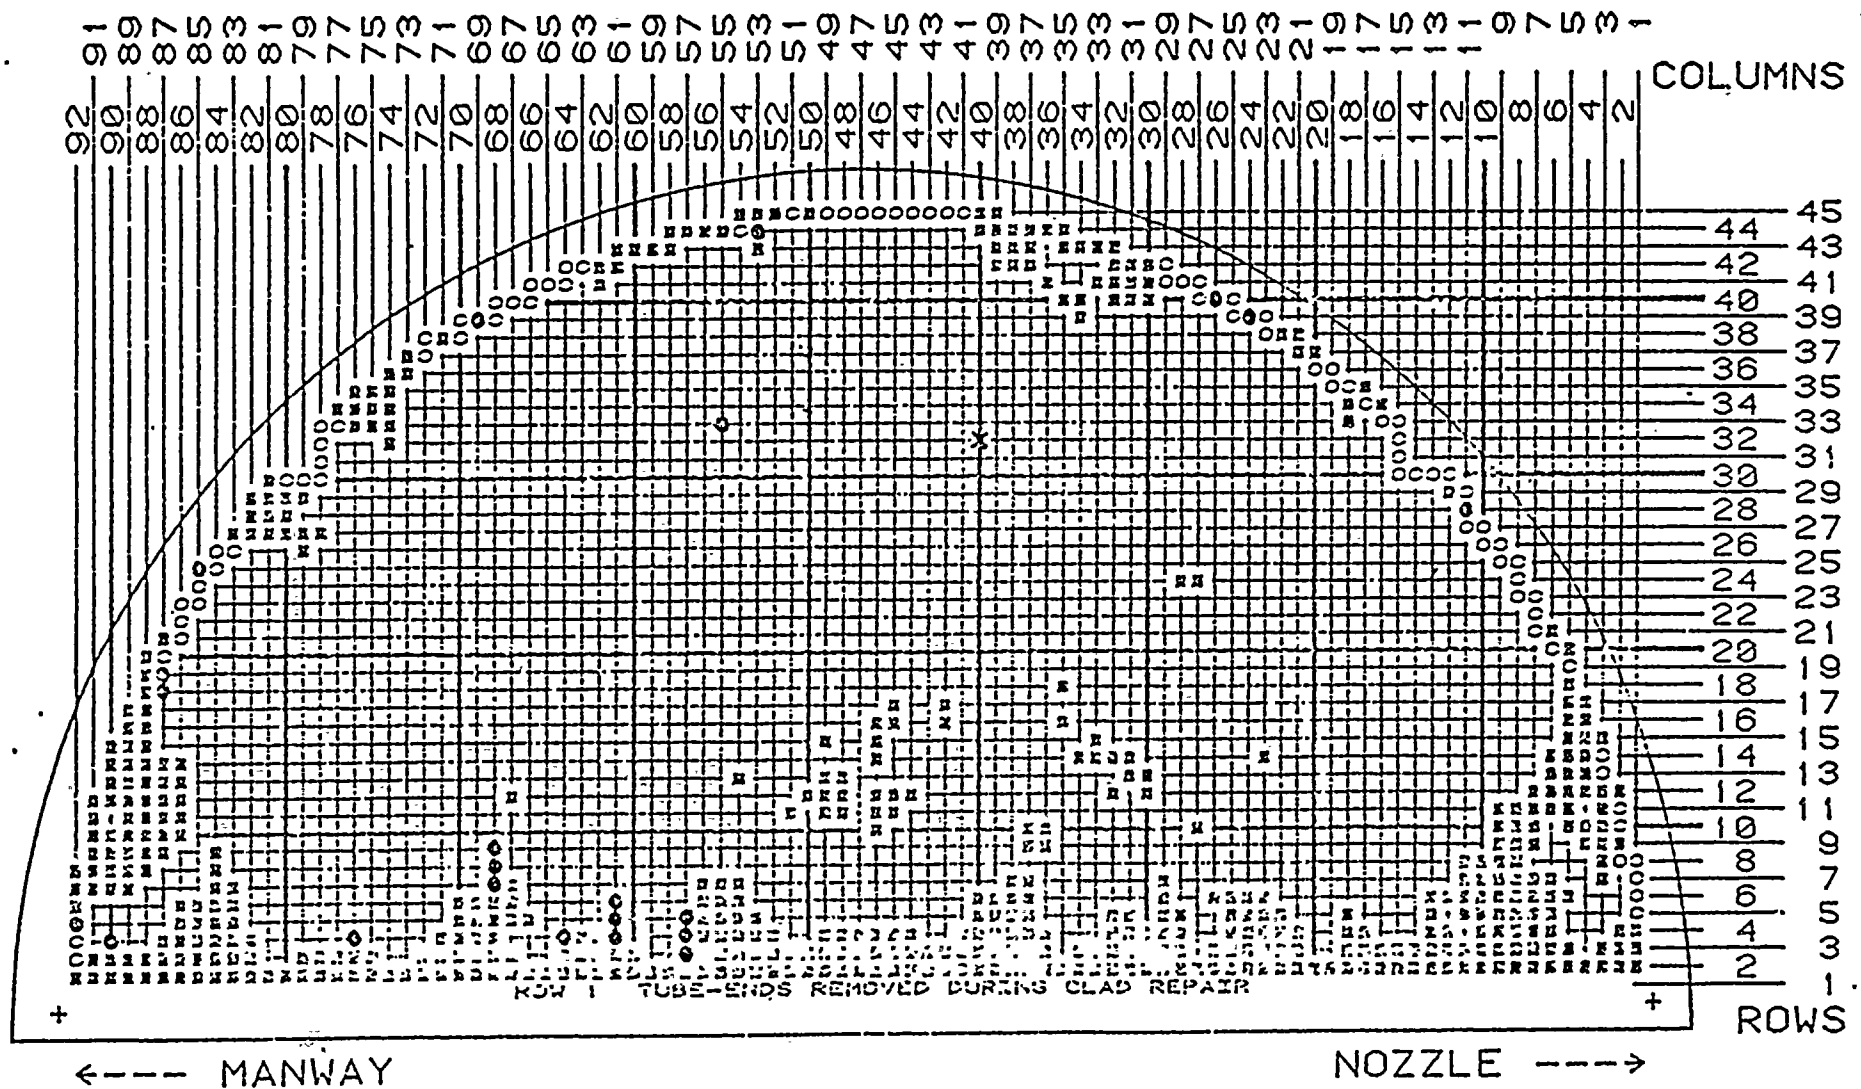
FIGURE 15

TURKEY POINT UNIT #3
STEAM GENERATOR B
October, 1980
