TURKEY POINT 3 STEAM GENERATOR
INSPECTION PROGRAM

I. Introduction

An extensive inspection program for the Turkey Point Unit 3 steam generators was conducted in October, 1980. The following items were accomplished:

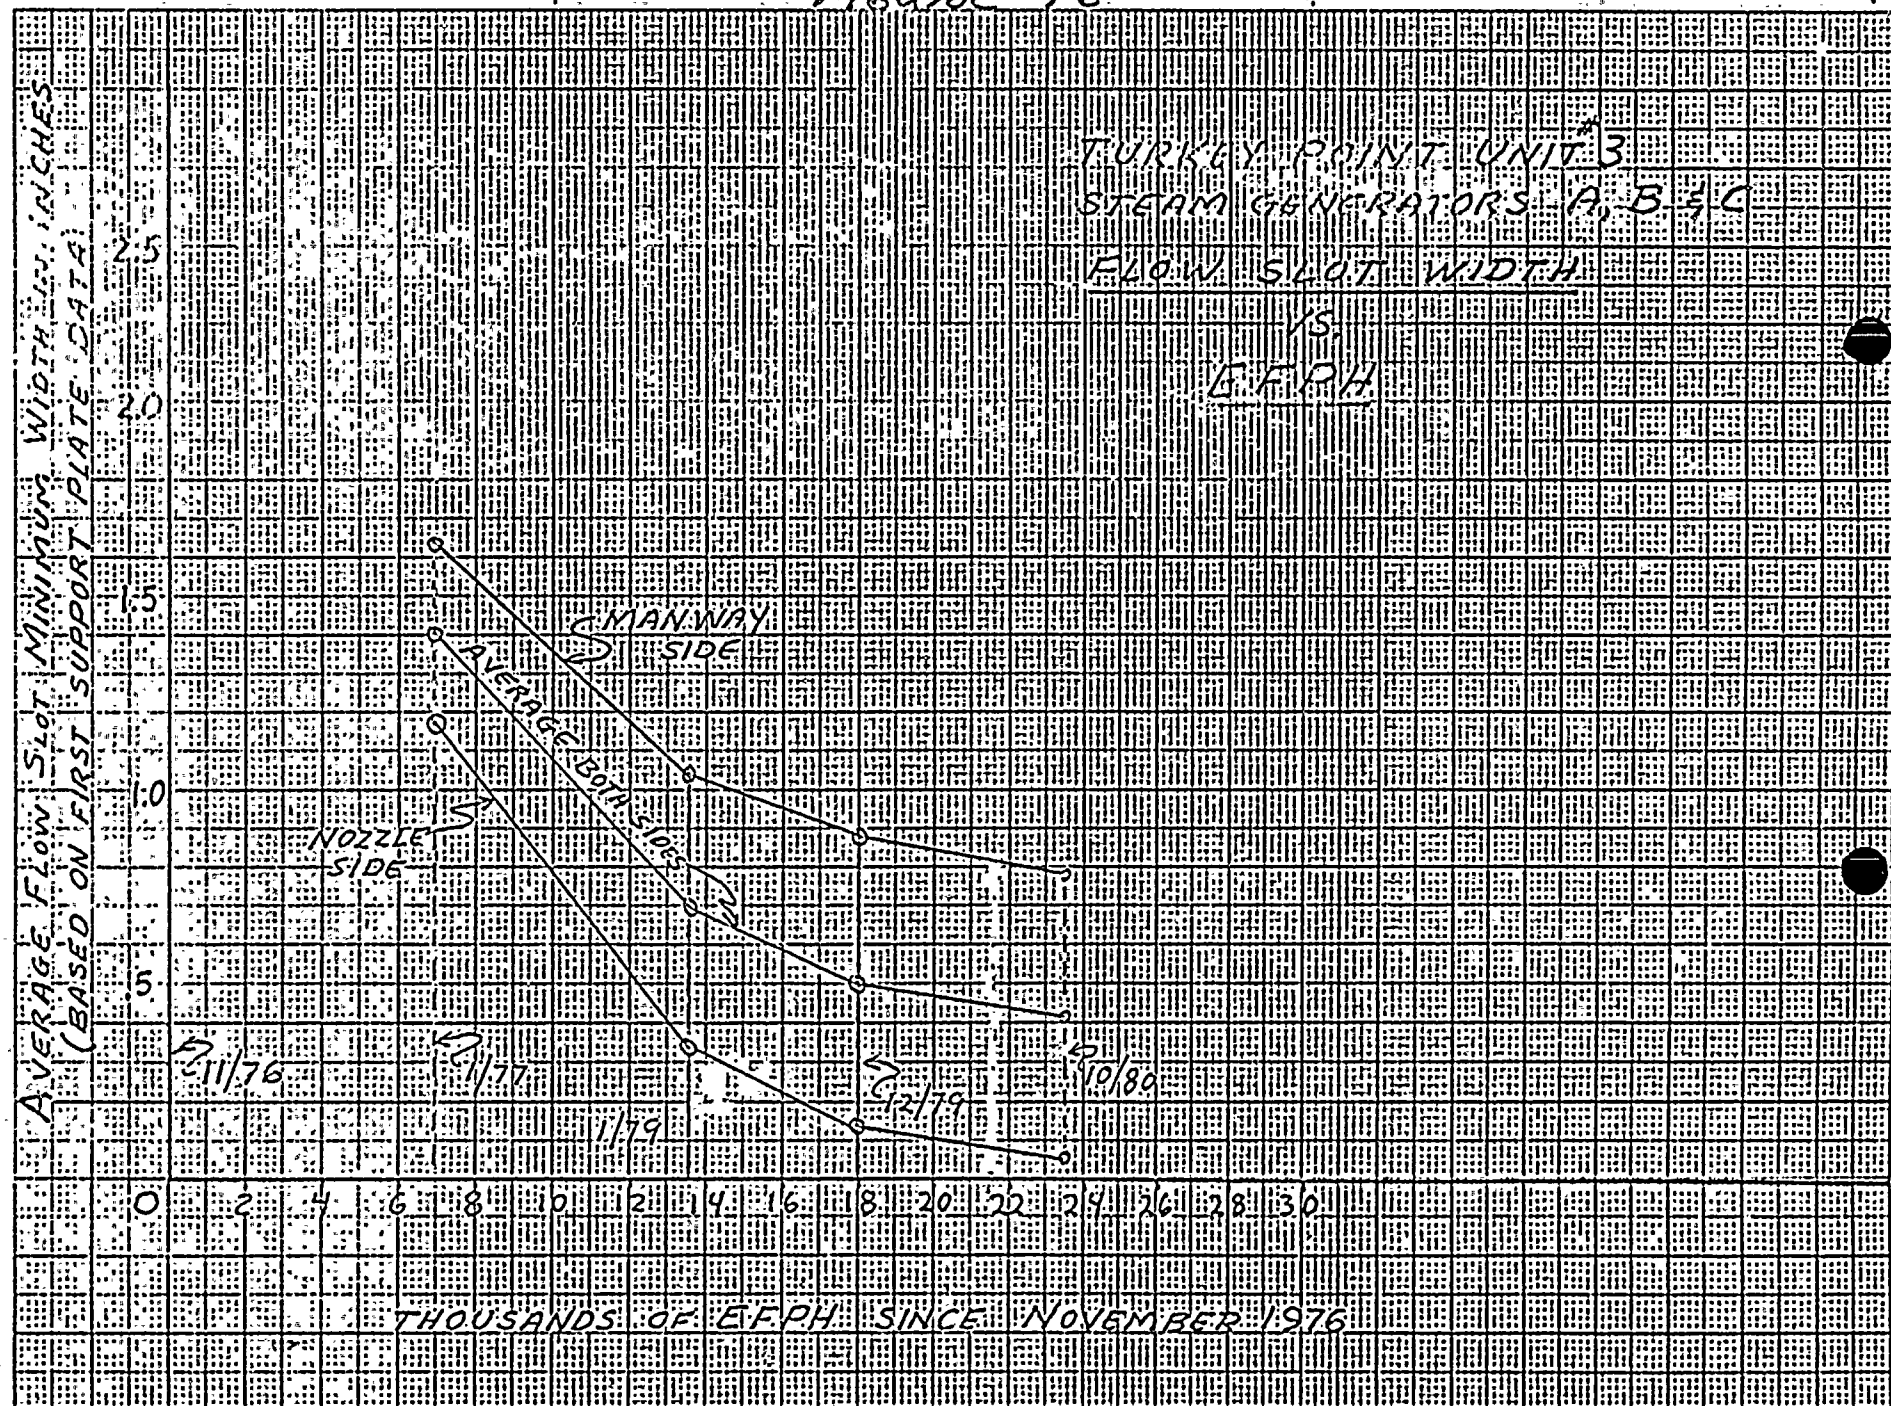
FIGURE 16

The results of the flow slot measurements are indicated in Figure 16. Only the lower support plates are clearly visible in each S/G. The results are consistent with previous behavior.
