TURKEY POINT 3 STEAM GENERATOR
INSPECTION PROGRAM

I. Introduction

An extensive inspection program for the Turkey Point Unit 3 steam generators was conducted in October, 1980. The following items were accomplished:

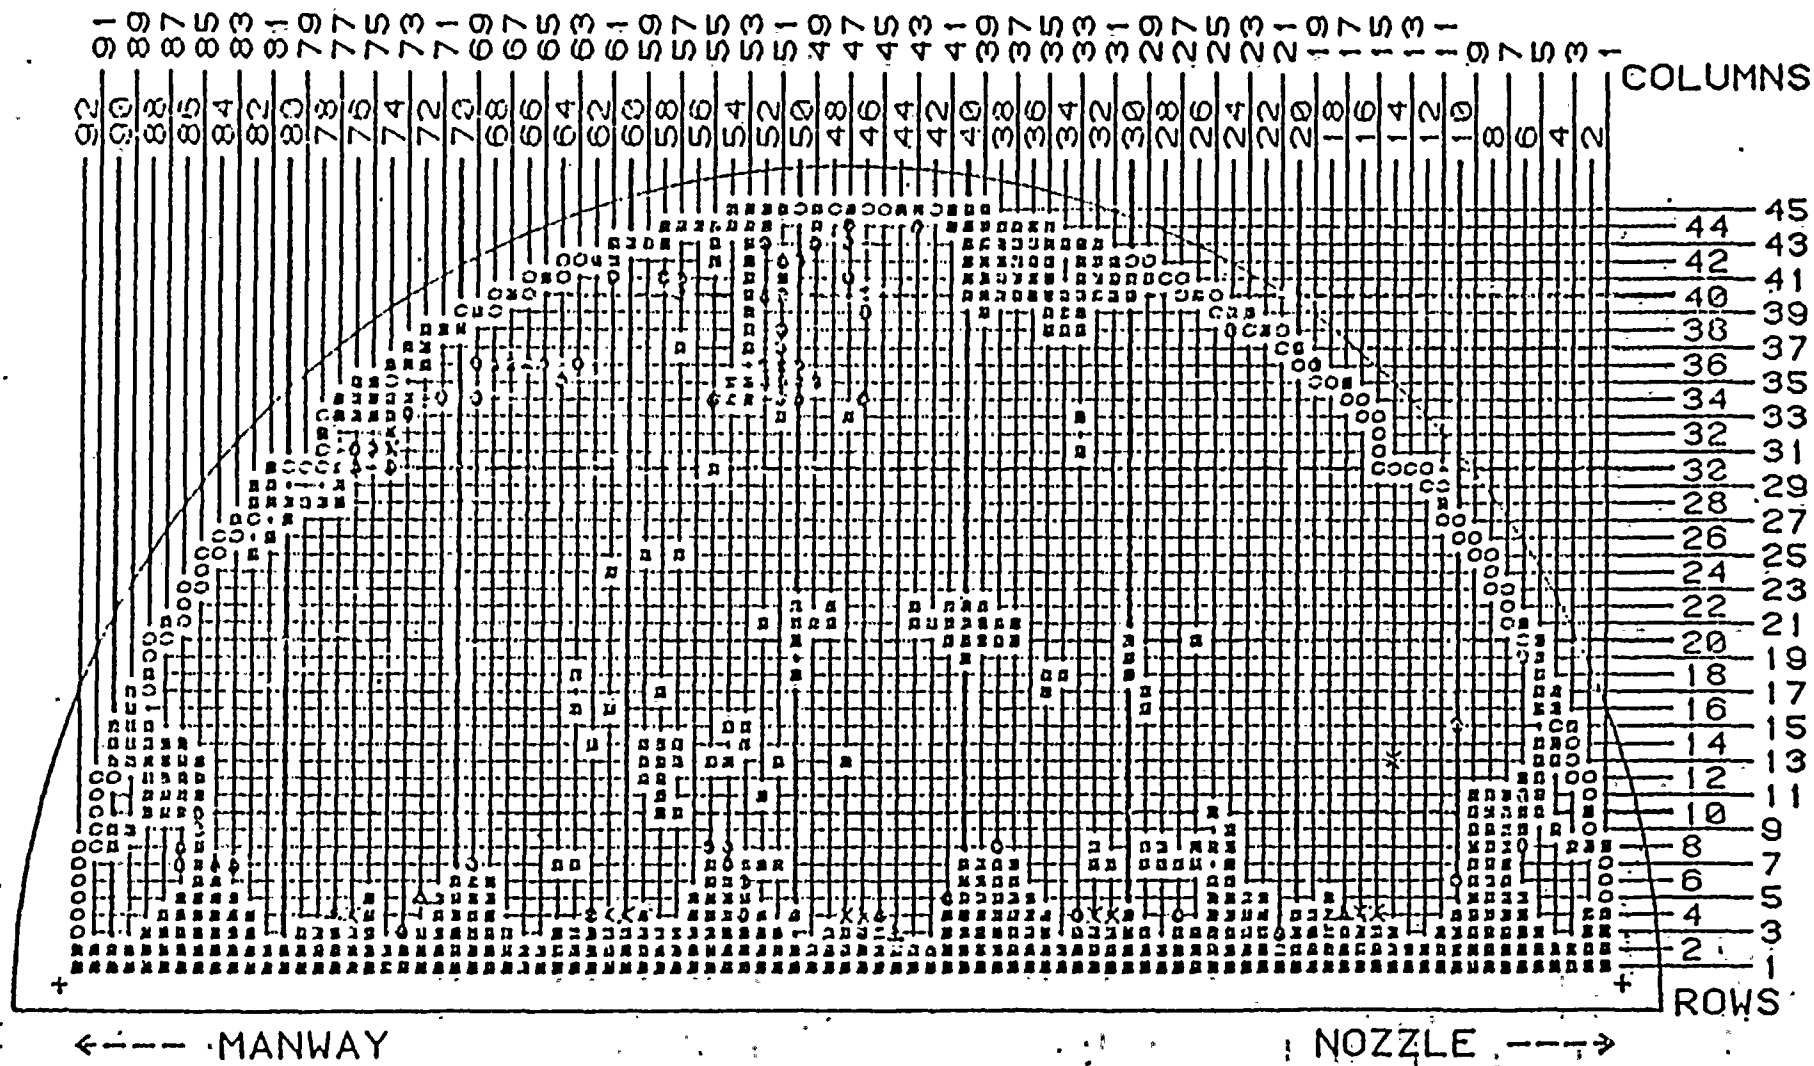
Turkey Point Unit 3
 Steam Generator A - Inlet
 Gauging Results - October, 1980

Results of the gauging inspections are indicated in Figures 7, 8, 9, 10, 11 and 12 and are summarized in Table 2. It should be noted that the tubes inspected included tubes R22 C13 (S/G3A) and R12 C80 (S/G3B). These tubes were previously reported to have been inadvertently omitted from the last inspection program and were committed to be inspected during this outage (letter L-80-26, January 18, 1980). The inspection results confirmed that neither tube required plugging nor were they located in areas of generalized denting.

1. In steam generators A, B, and C, restricted tubes generally developed adjacent to previous activity or clustered together with other new activity. This was particularly true of tubes that restricted the 0.610" and 0.540" probes. Areas of activity were consistent with past historical data for this and other plants.

2. Tube restrictions were noted in some of the inspected wedge areas (in the hot legs) of all steam generators and this activity appears consistent with previous experience at this and other units.

5. Review of the gauging results for this period shown that 82 tubes were reported restricted in the tubelane region, this compares with 75 observed in December, 1979 after 6 EFPM and 214 in 1/79 after 9.5 EFPM. A restricted tube is defined as a tube not passing a 650 mil probe. The apparent limitation in the number of restrictions reflects the fact that plugging in December, 1979 was performed for a 10 month period, but less than 3.5 months operation actually ensued.

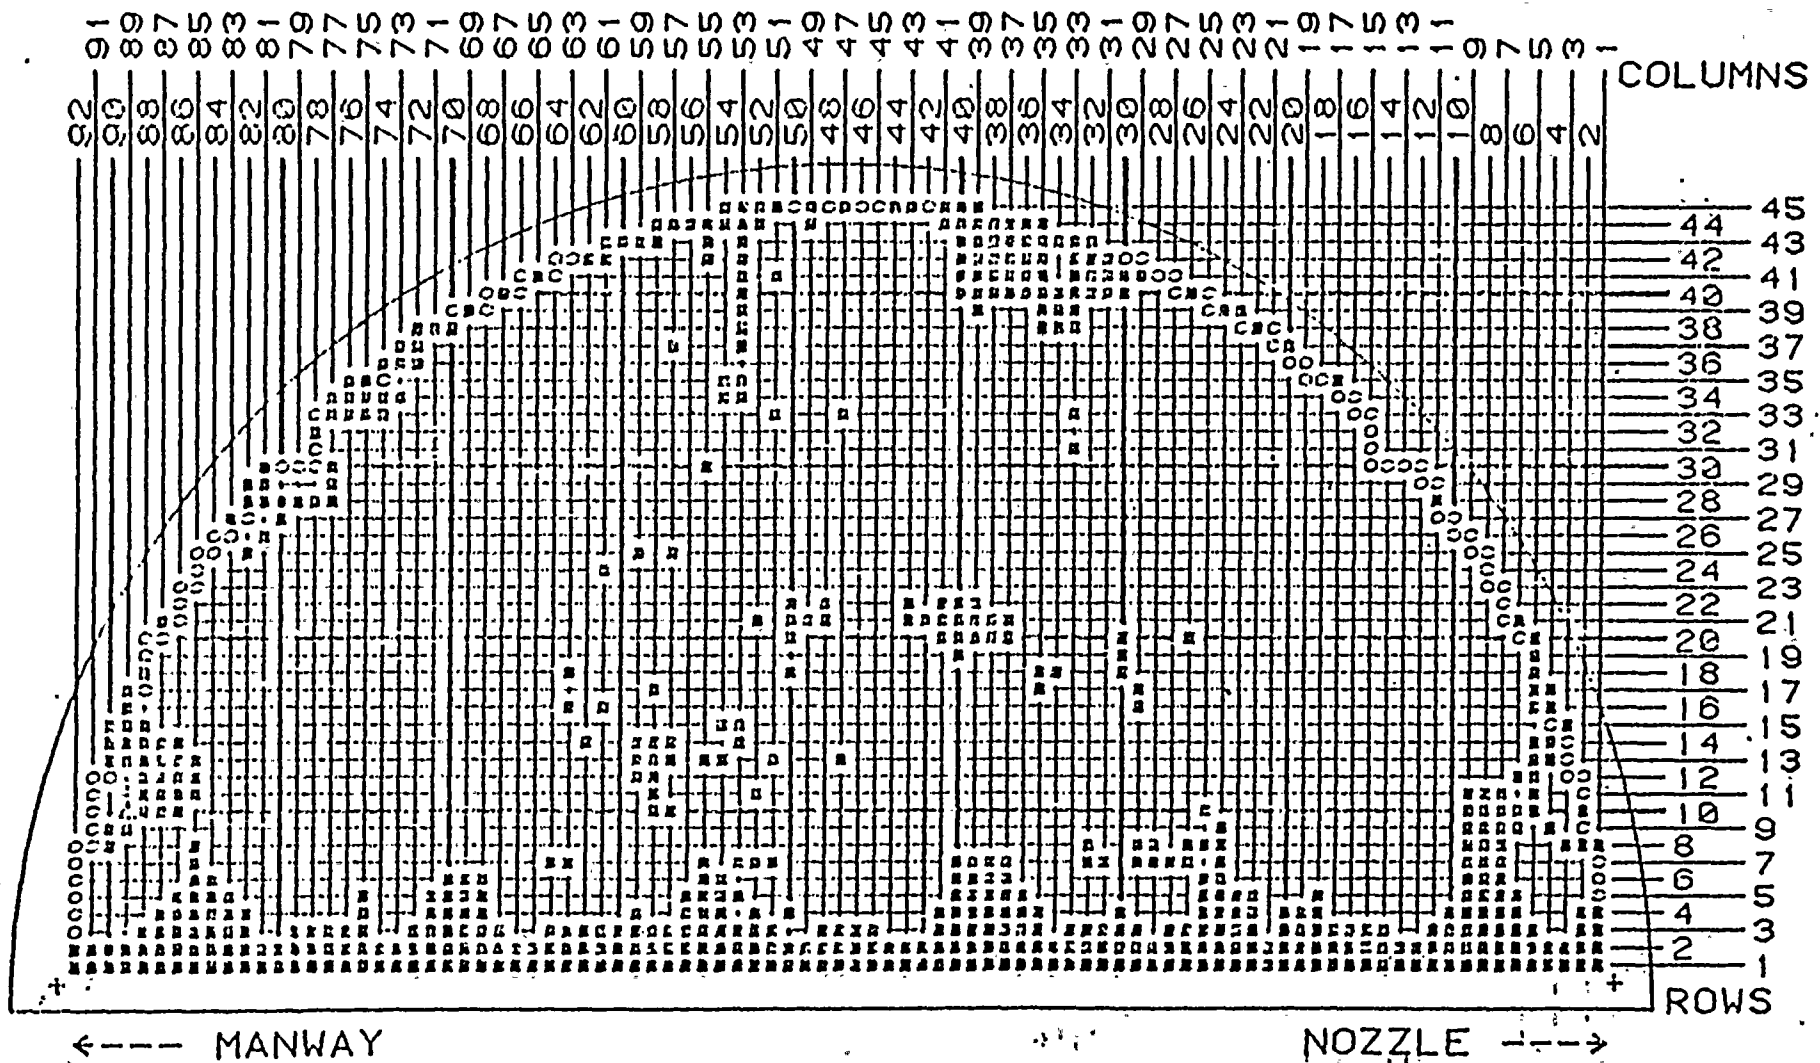
Turkey Point Unit 3
 Steam Generator A - Outlet
 Gauging Results - October, 1980

3. In this inspection of the cold leg areas, only one tube restriction was noted in the tubelane regions (SGB). No activity was noted in four of the six cold leg wedge areas inspected. Slight activity was noted adjacent to one of the inspected wedge areas in each of SG/A and SG/C. The level of activity is consistent with that noted in previous Turkey Point inspections. The overall level of activity continues to indicate a very low growth rate as compared to the hot leg.

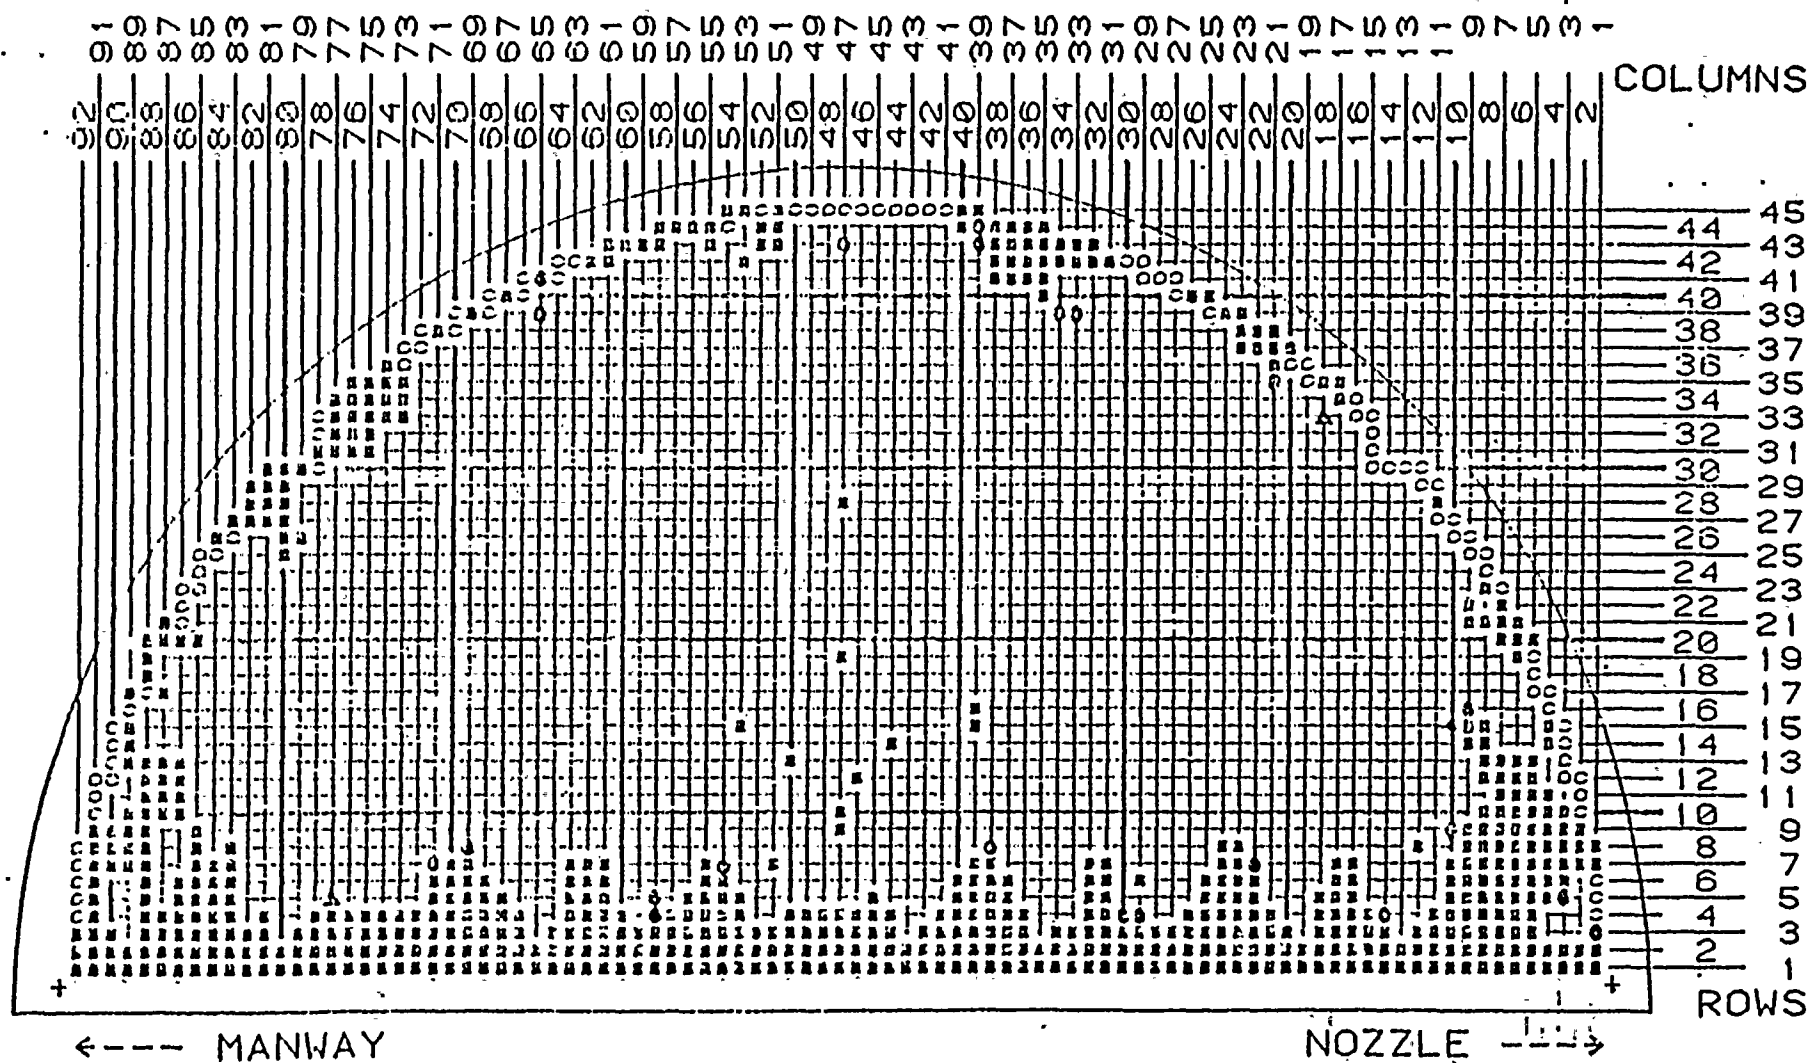
FIGURE 9

Turkey Point Unit 3
 Steam Generator B - Inlet
 Gauging Results - October, 1980

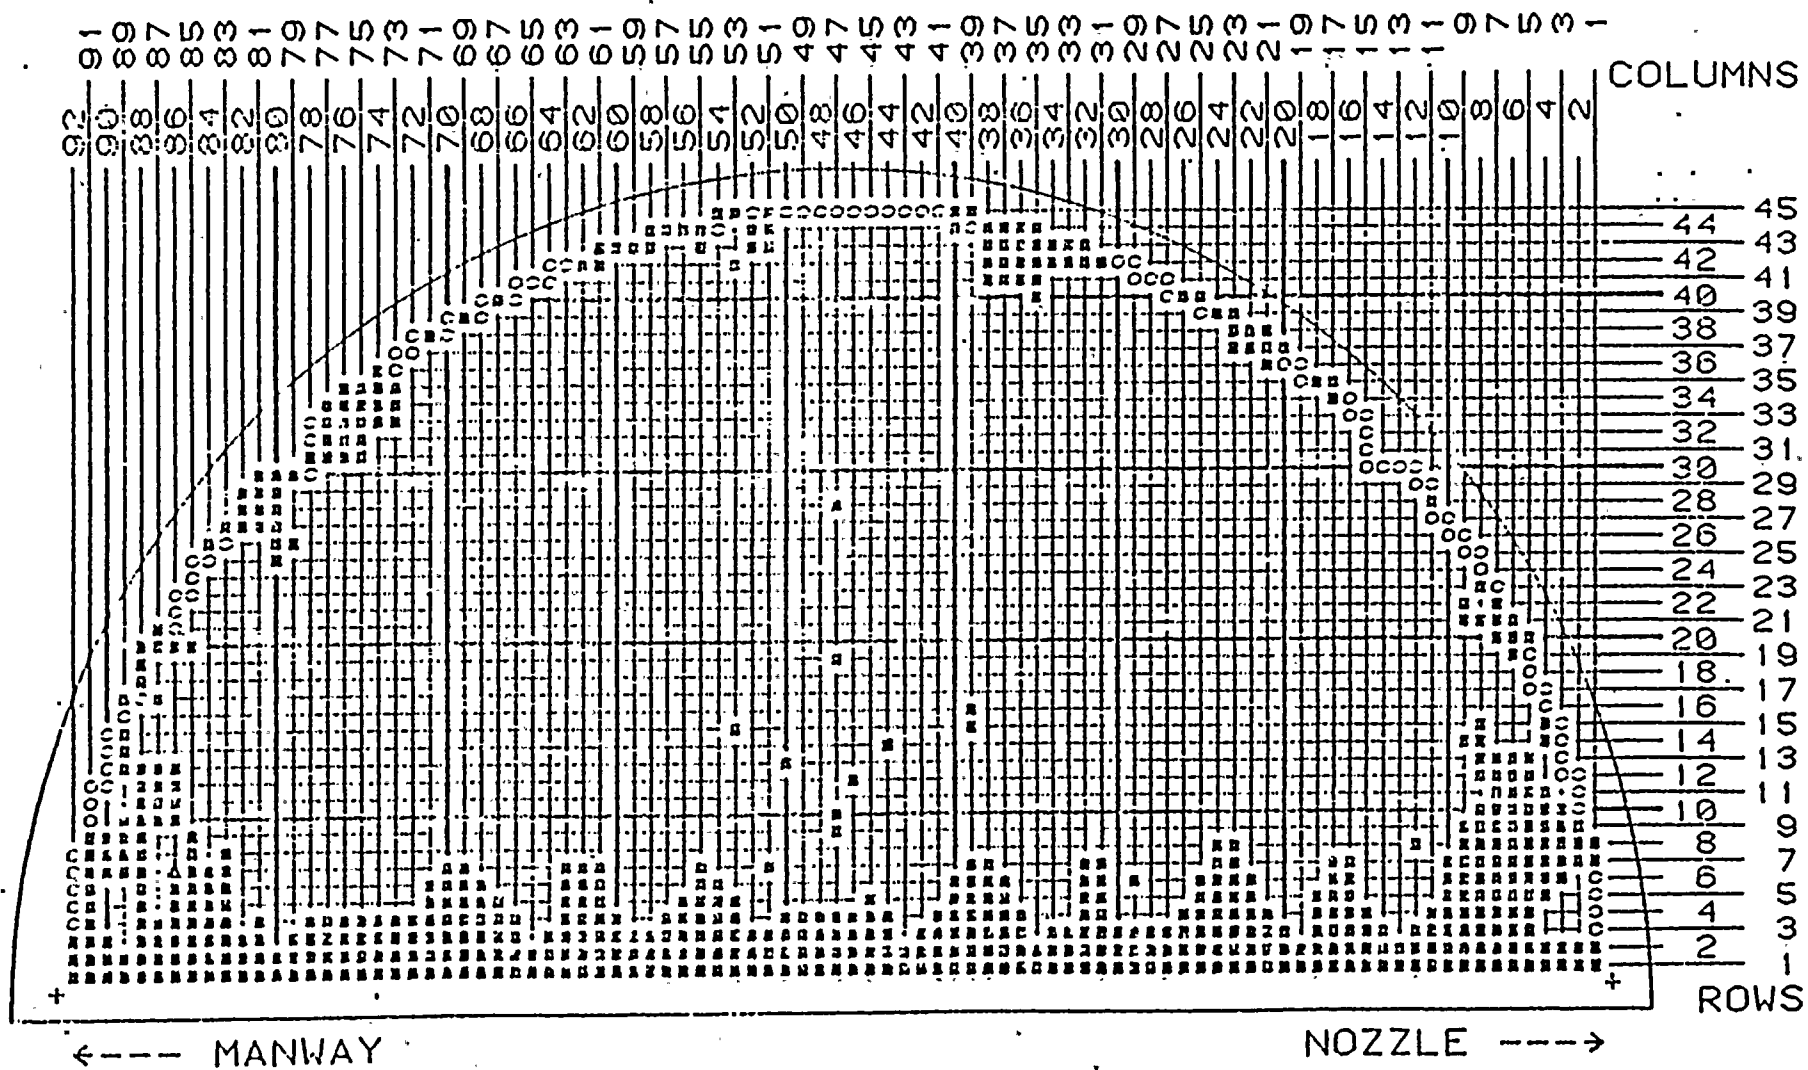
FIGURE 10

Turkey Point Unit 3
Steam Generator B - Outlet
Gauging Results - October, 1980

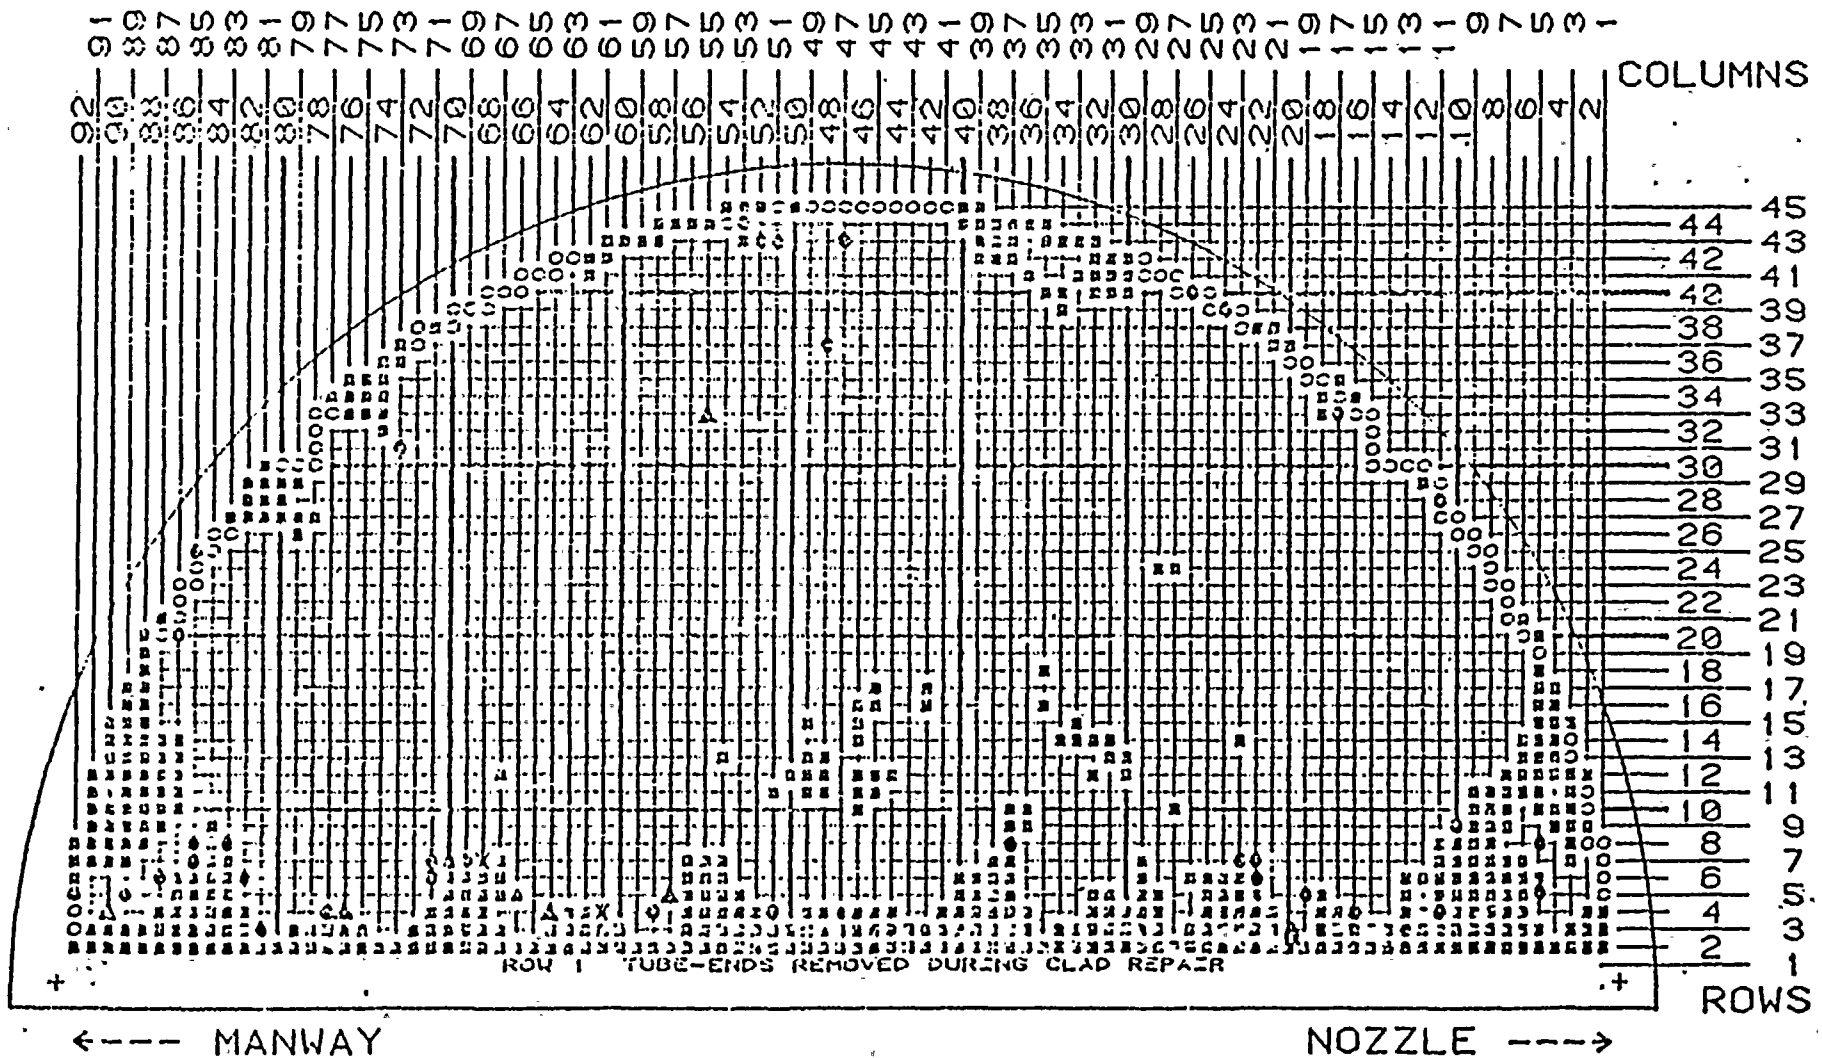
FIGURE 11

Turkey Point Unit B
Steam Generator C - Inlet
Gauging Results - October, 1980

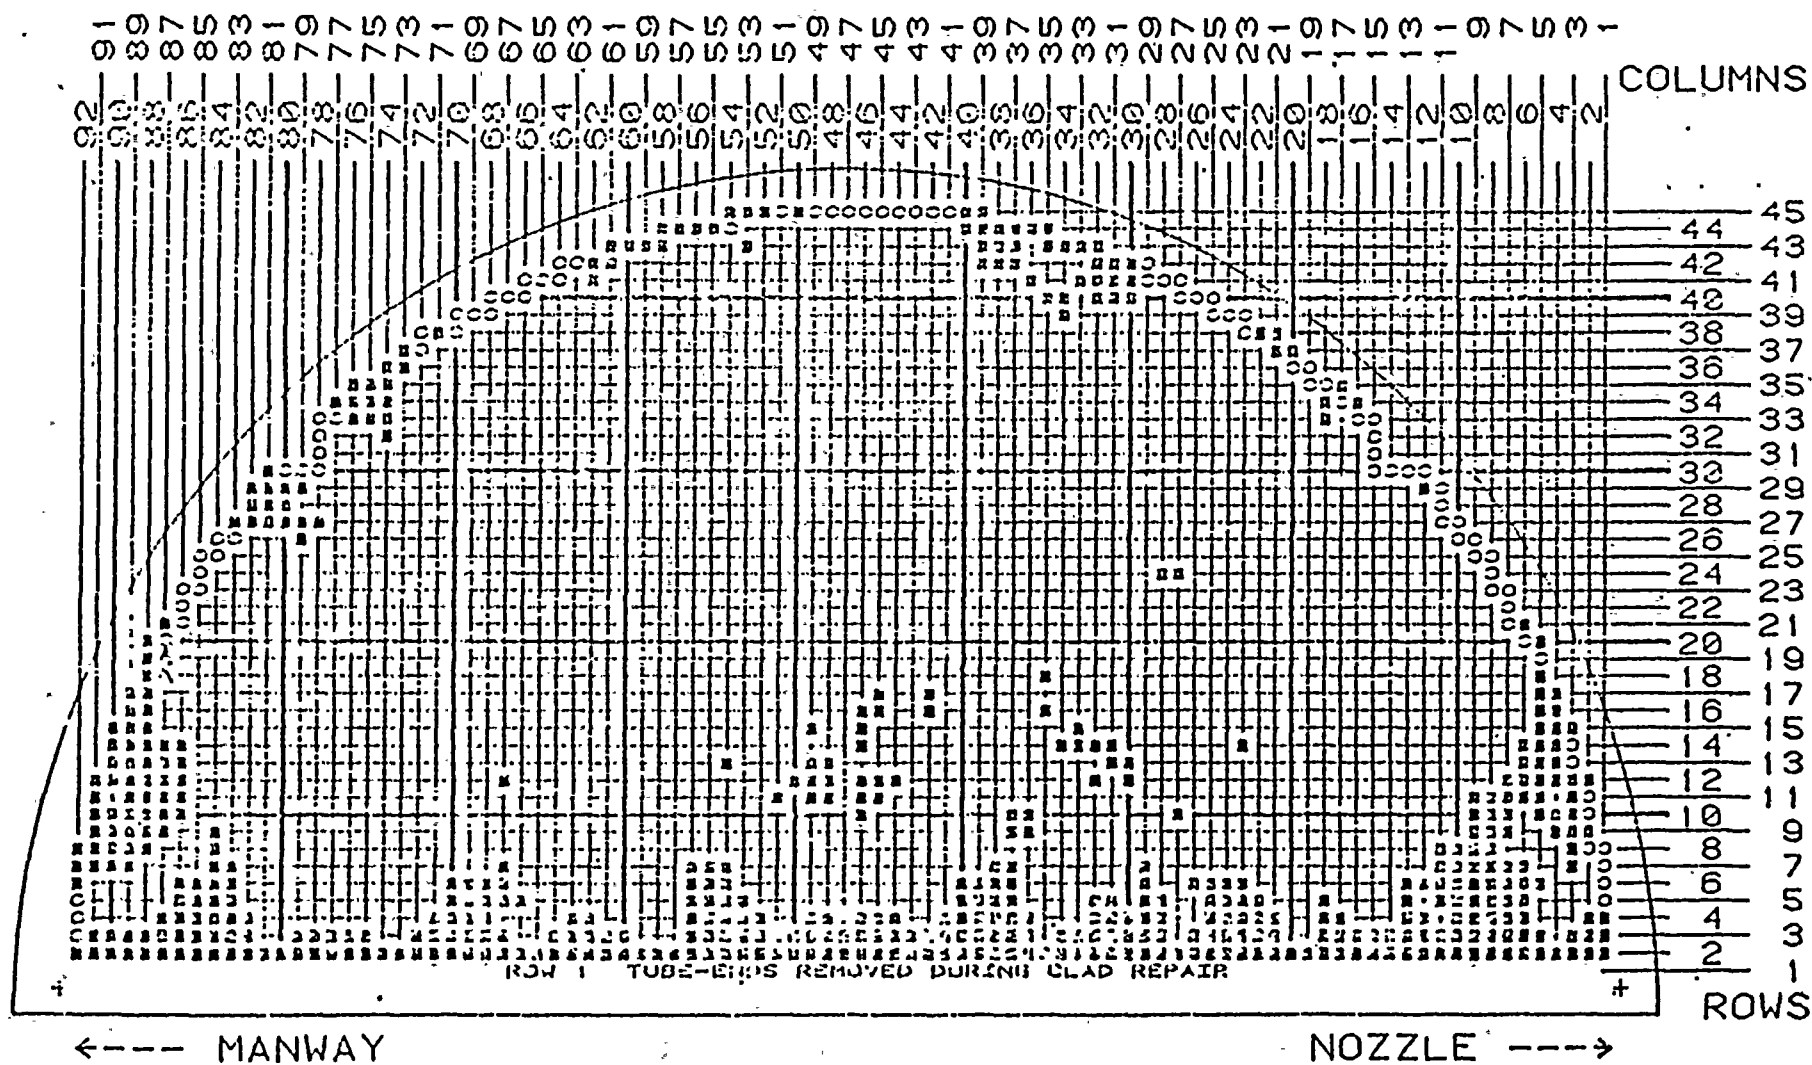
FIGURE 12

Turkey Point Unit 3
Steam Generator C - Outlet
Gauging Results - October, 1980

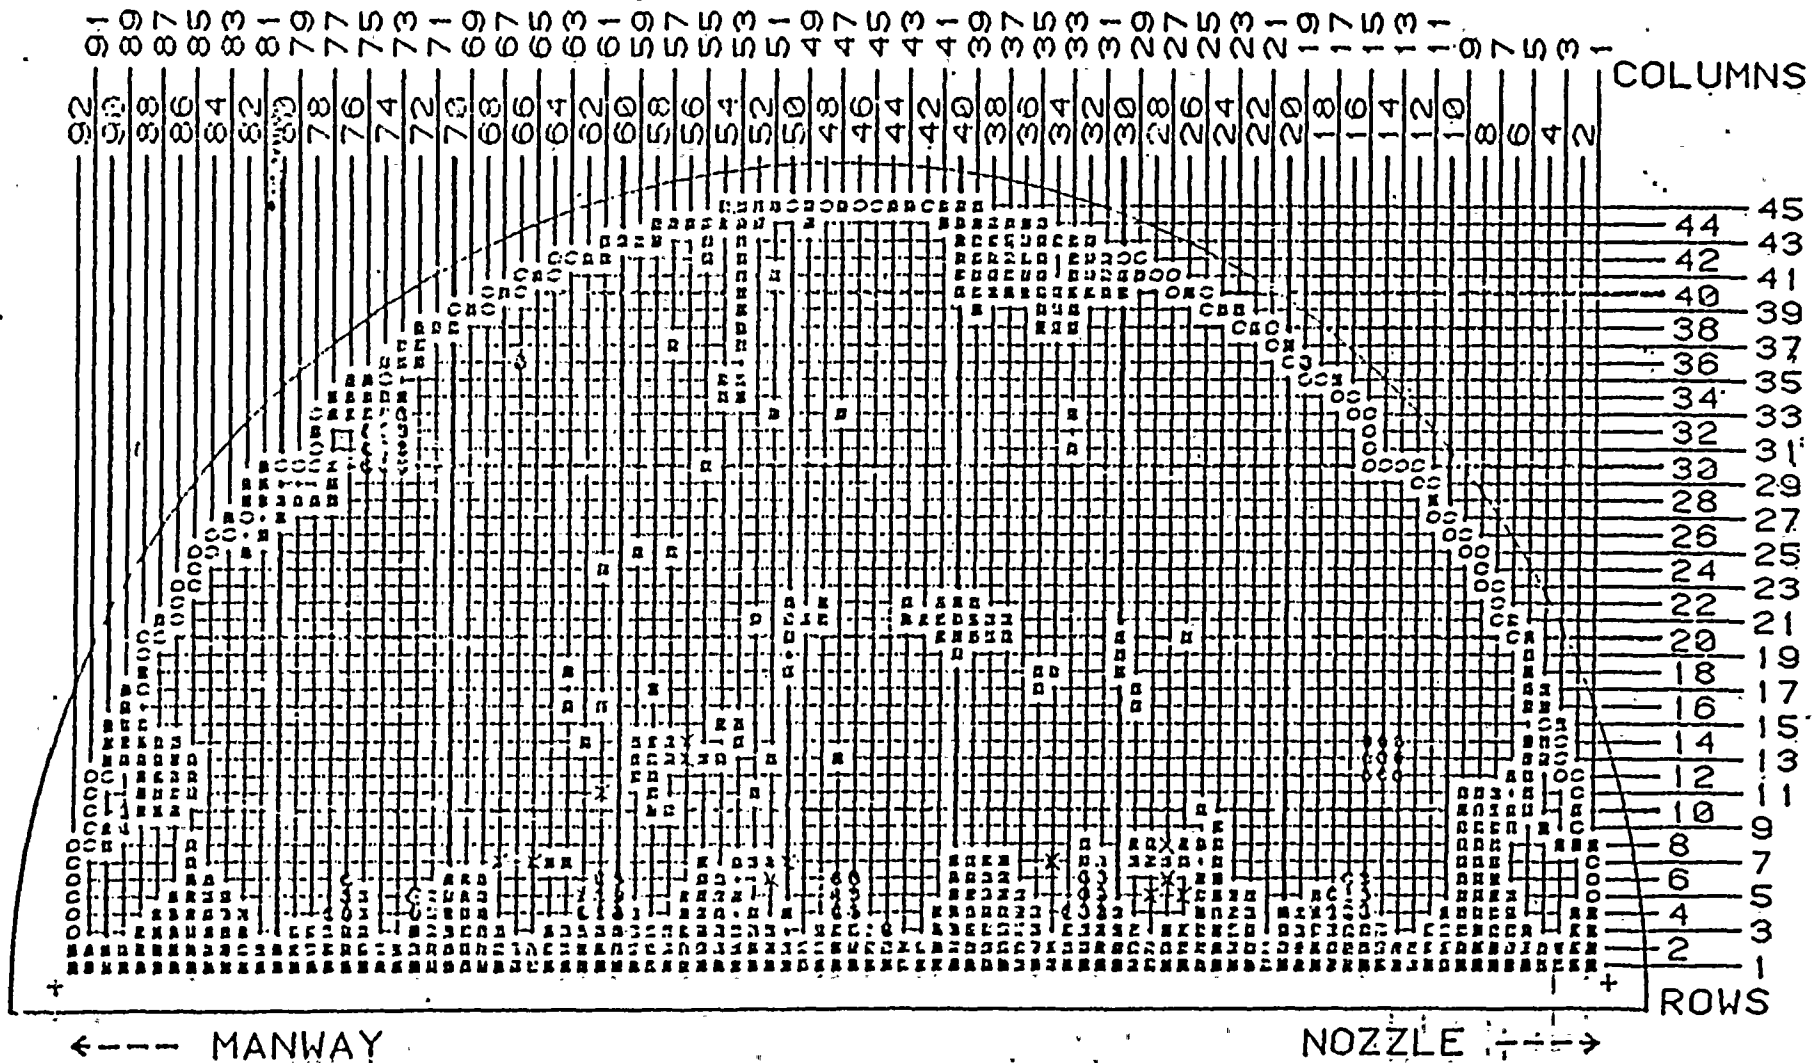
FIGURE 13

The results of the Regulatory Guide 1.83 Inspection are summarized in Table 3. As a result of this inspection, a total of fourteen tubes will be plugged for indications equal to or greater than 40% wall penetration. An additional tube (R4-C46) in steam generator A is pluggable on this basis, but is also pluggable due to a .540 inch

restriction. The pluggable tubes are generally located in rows 5 to 8, inclusive, with only a few in higher rows, as shown in Figures 13 and 15.

Evaluation of the results suggests probable thinning in the region of the sludge pile in the cold leg.

Comparison of the eddy current signals from the affected tubes with corresponding signals from previous inspections indicates that no major change in depth of penetration has occurred. Therefore, it is concluded that the rate of thinning has not increased substantially.

The preventive plugging programs that were implemented are indicated in Figures 13, 14 and 15. Both gauging and Regulatory Guide 1.83 program plugging are indicated. Table 4 summarizes this plugging.

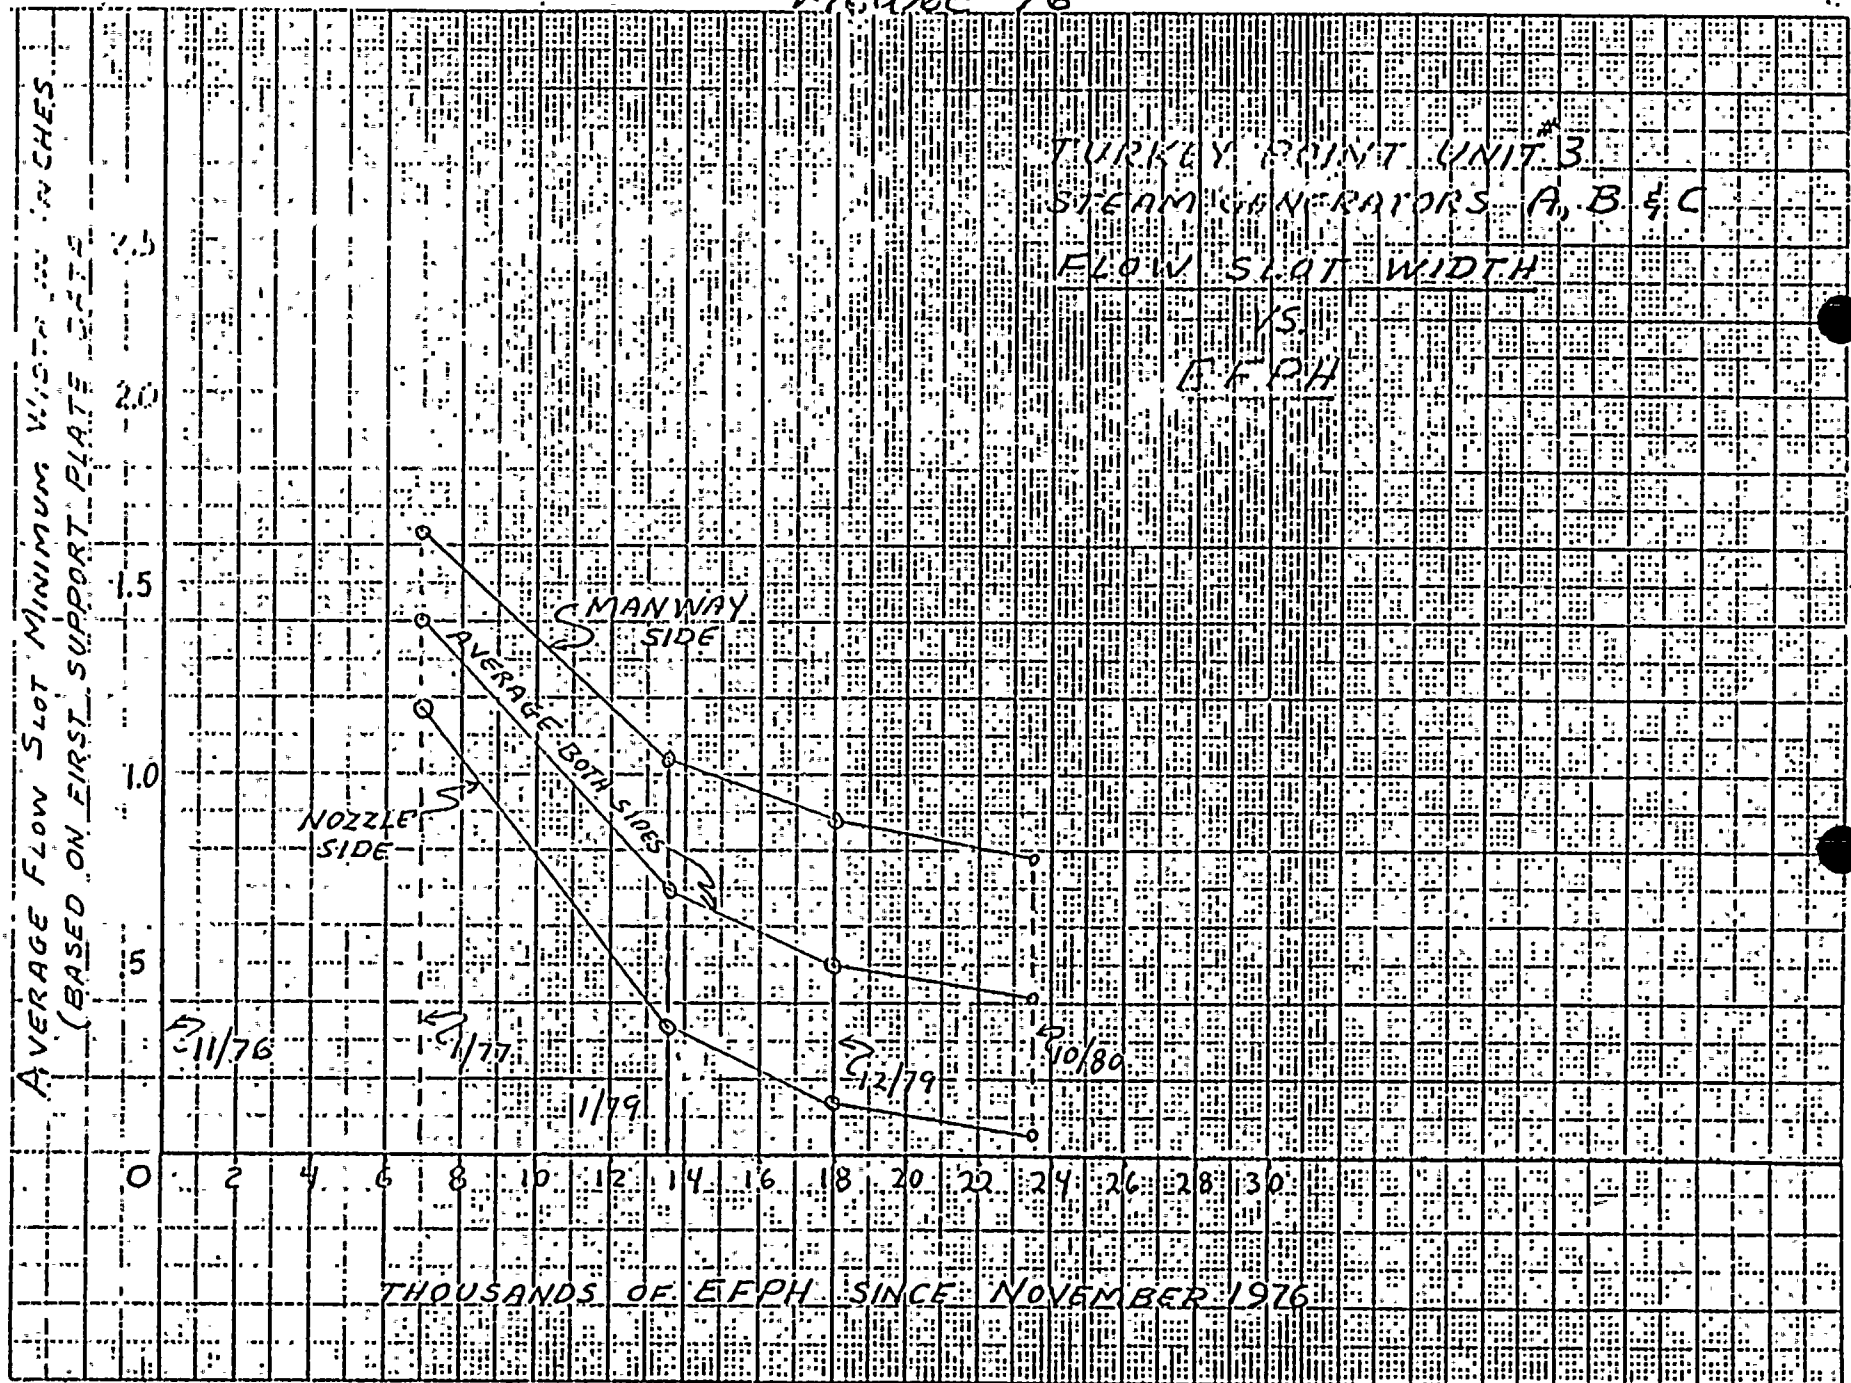
FIGURE 16

The results of the flow slot measurements are indicated in Figure 16. Only the lower support plates are clearly visible in each S/G. The results are consistent with previous behavior.
