TURKEY POINT 4 STEAM GENERATOR
INSPECTION PROGRAM

An extensive inspection program for the Turkey Point Unit 4 steam generators was conducted in November, 1980. The following items were accomplished:

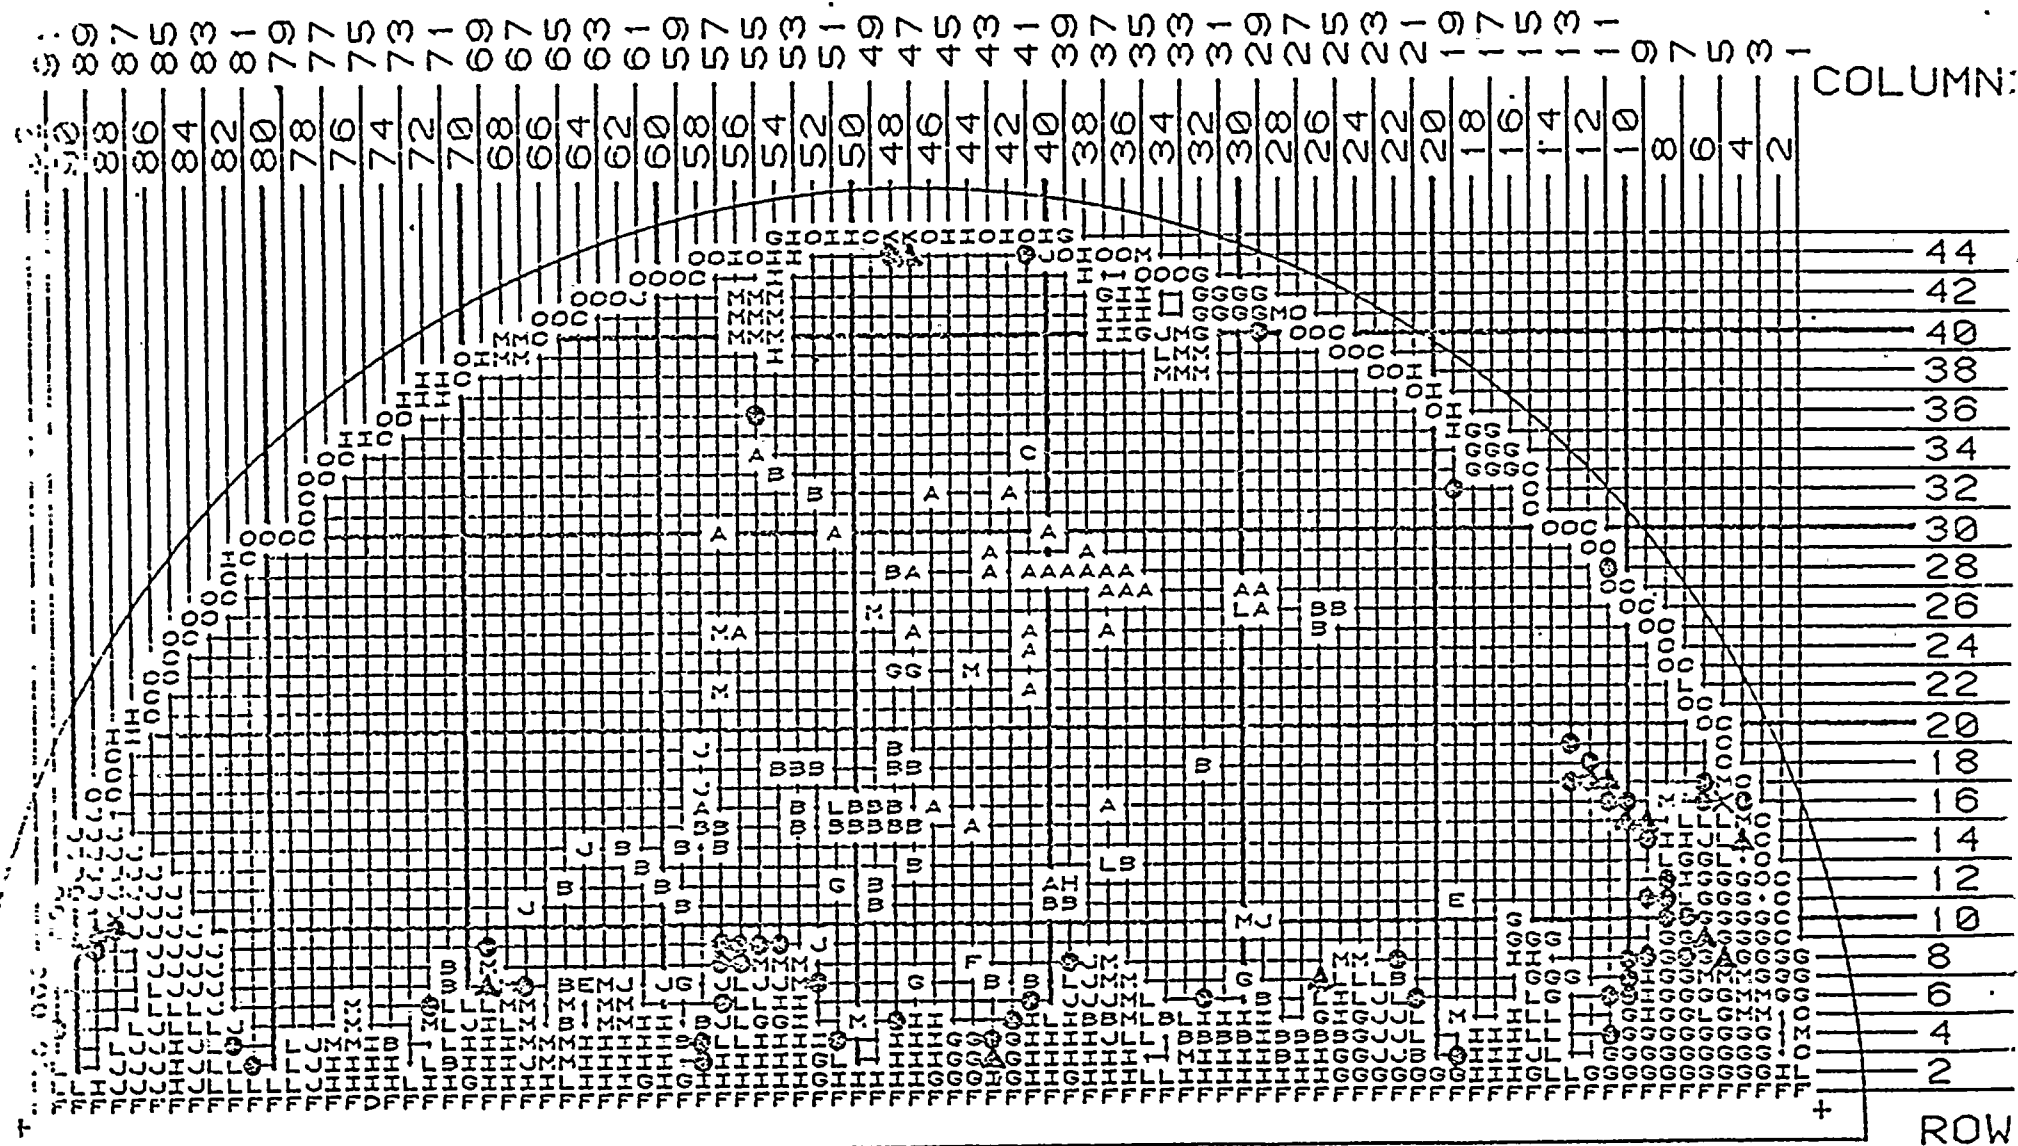
TURKEY POINT UNIT #4
GAUGING RESULTS, NOV., 1980
STEAM GENERATOR A INLET

1. Tubes in the tubelane region that restrict the 0.650 inch probe lie adjacent to the areas in which such restrictions occurred in prior examinations.

<u>RESTRICTED TUBES</u>	<u>NO.OF TUBES</u>	<u>NOZZLE</u> ---->
X = .540 PROBE	1	
A = .610 PROBE	11	
O = .650 PROBE	57

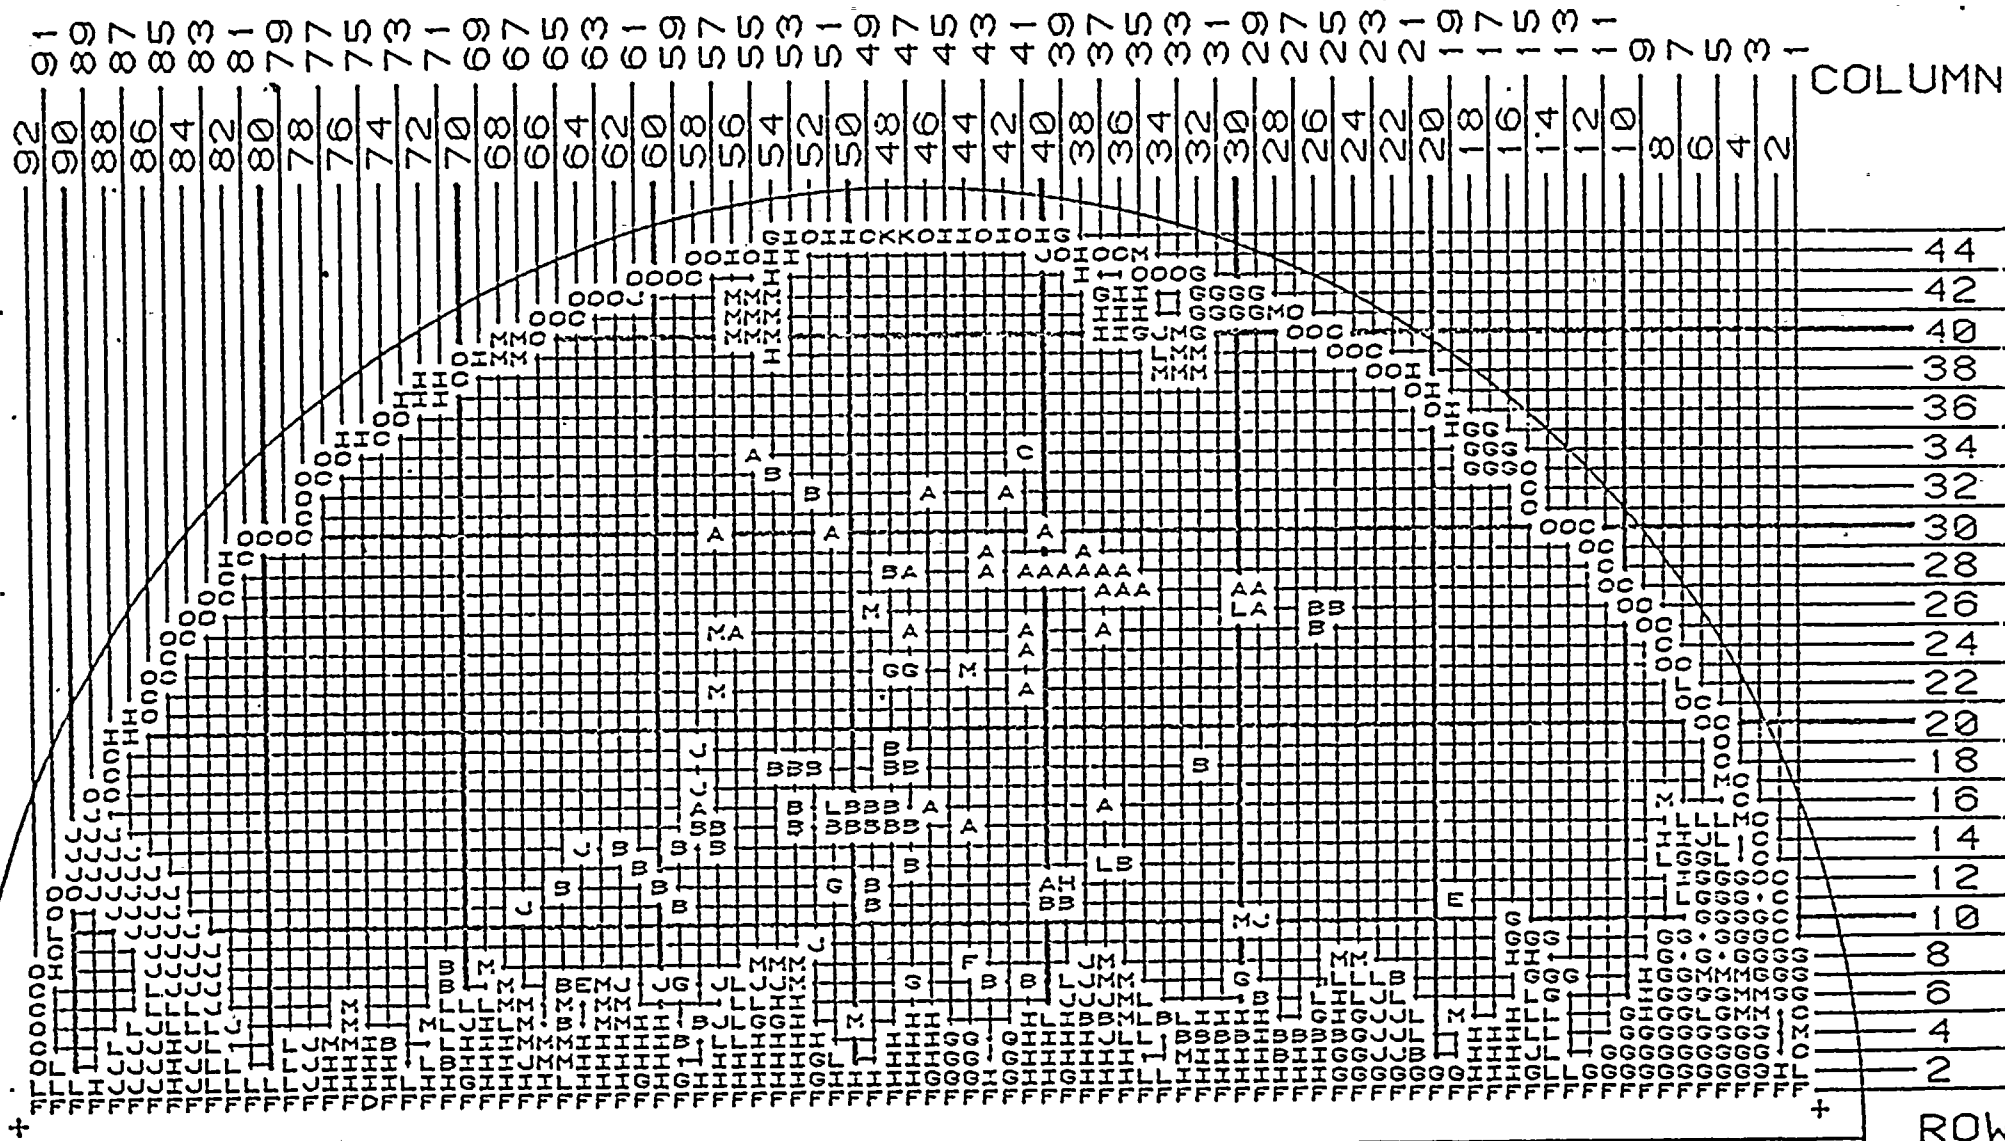
←--- MANWAY TURKEY POINT UNIT #4
GAUGING RESULTS NOV., 1980
STEAM GENERATOR A OUTLET

RESTRICTED TUBES
X= .540 PROBE
A= .610 PROBE
O= .650 PROBE

NO.OF TUBES NOZZLE --->
NONE
NONE
NOT TESTED

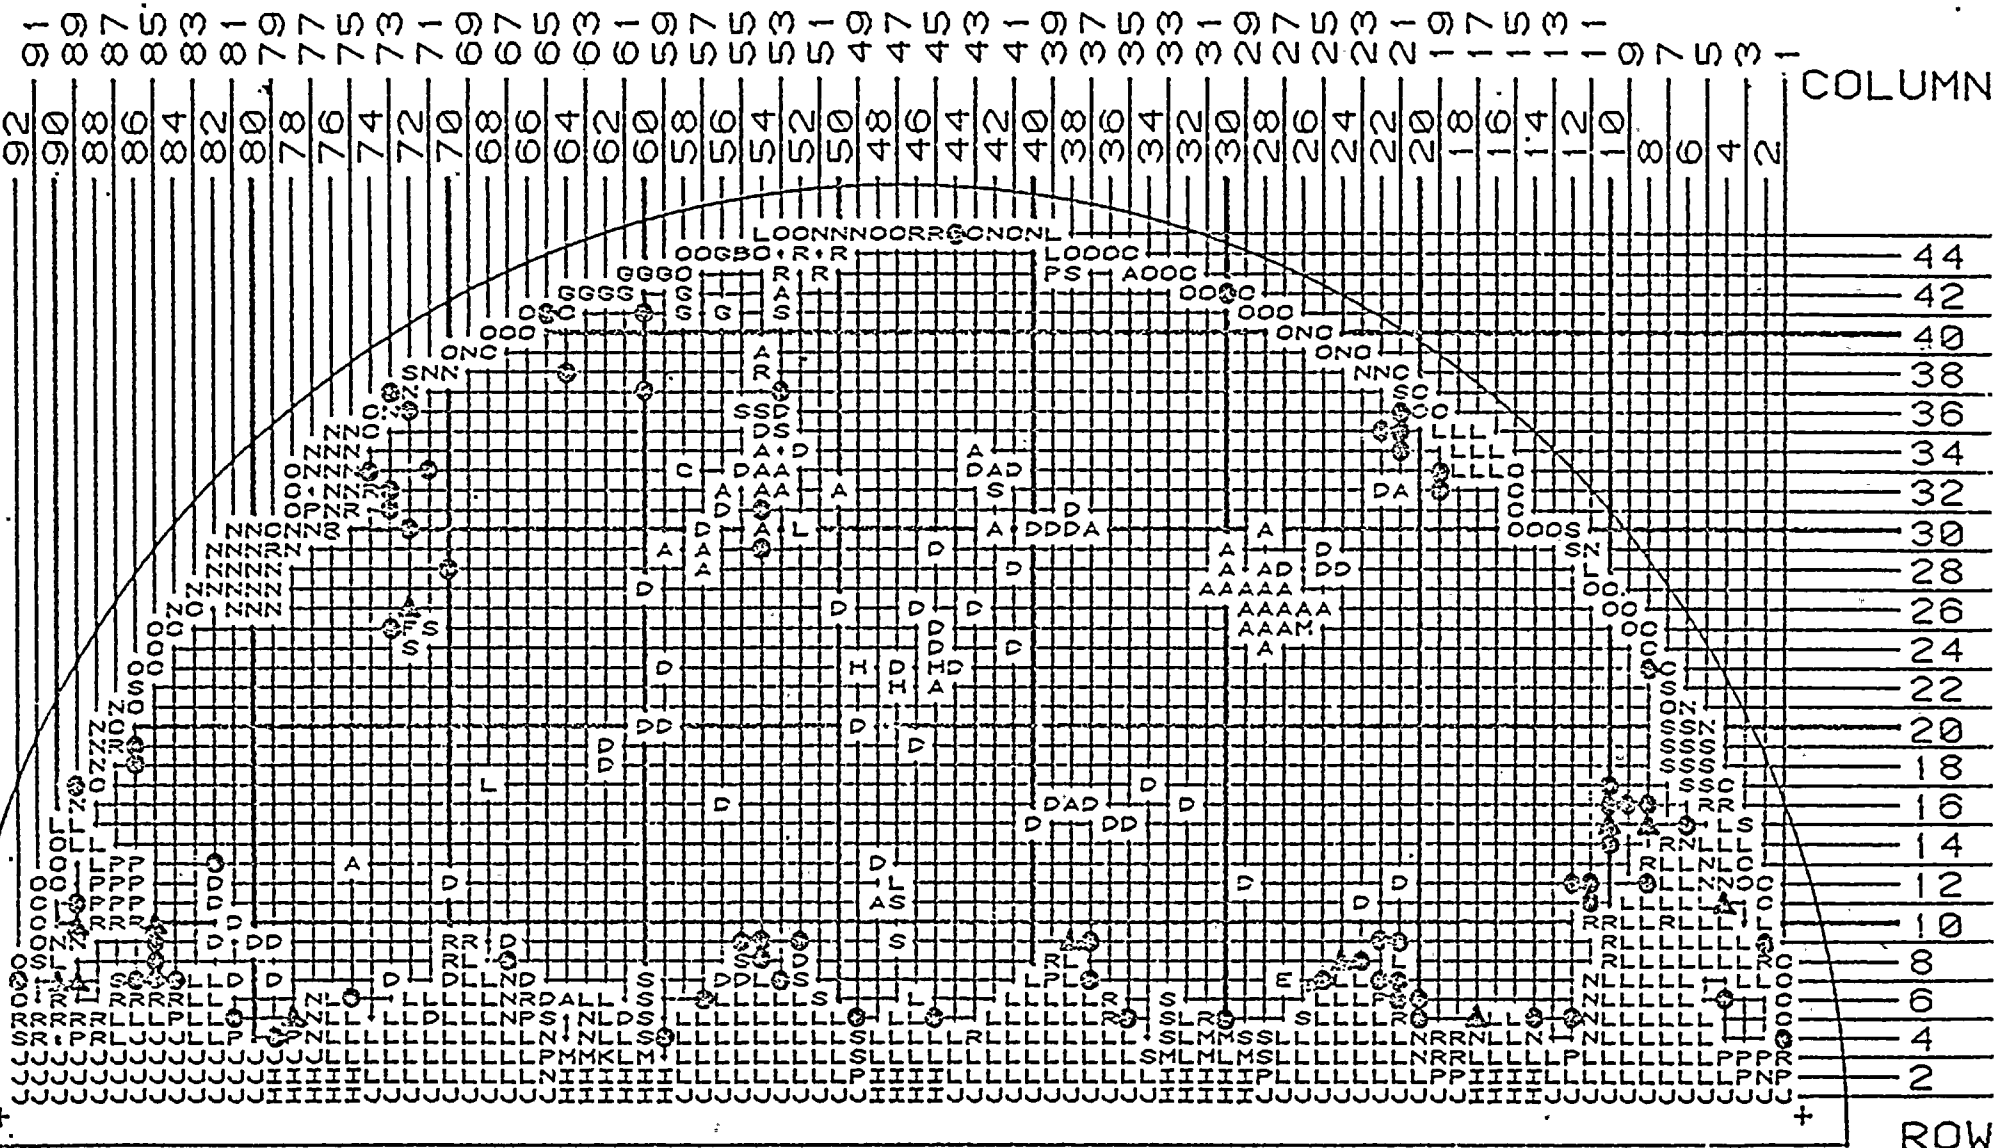
←--- MANWAY TURKEY POINT UNIT #4
 GAUGING RESULTS NOV., 1980
 STEAM GENERATOR B INLET

4. In steam generator B four tube restrictions appeared away from the pattern of prior results. Two of the restrictions were located adjacent to a tube which had been pulled in Sept. 1975, as part of the earliest field investigations of denting. The other two tube restrictions were located adjacent to the patch plate inspection area.

RESTRICTED TUBES
 X = .540 PROBE
 A = .610 PROBE
 O = .650 PROBE

NO. OF TUBES
 NONE
 12
 77

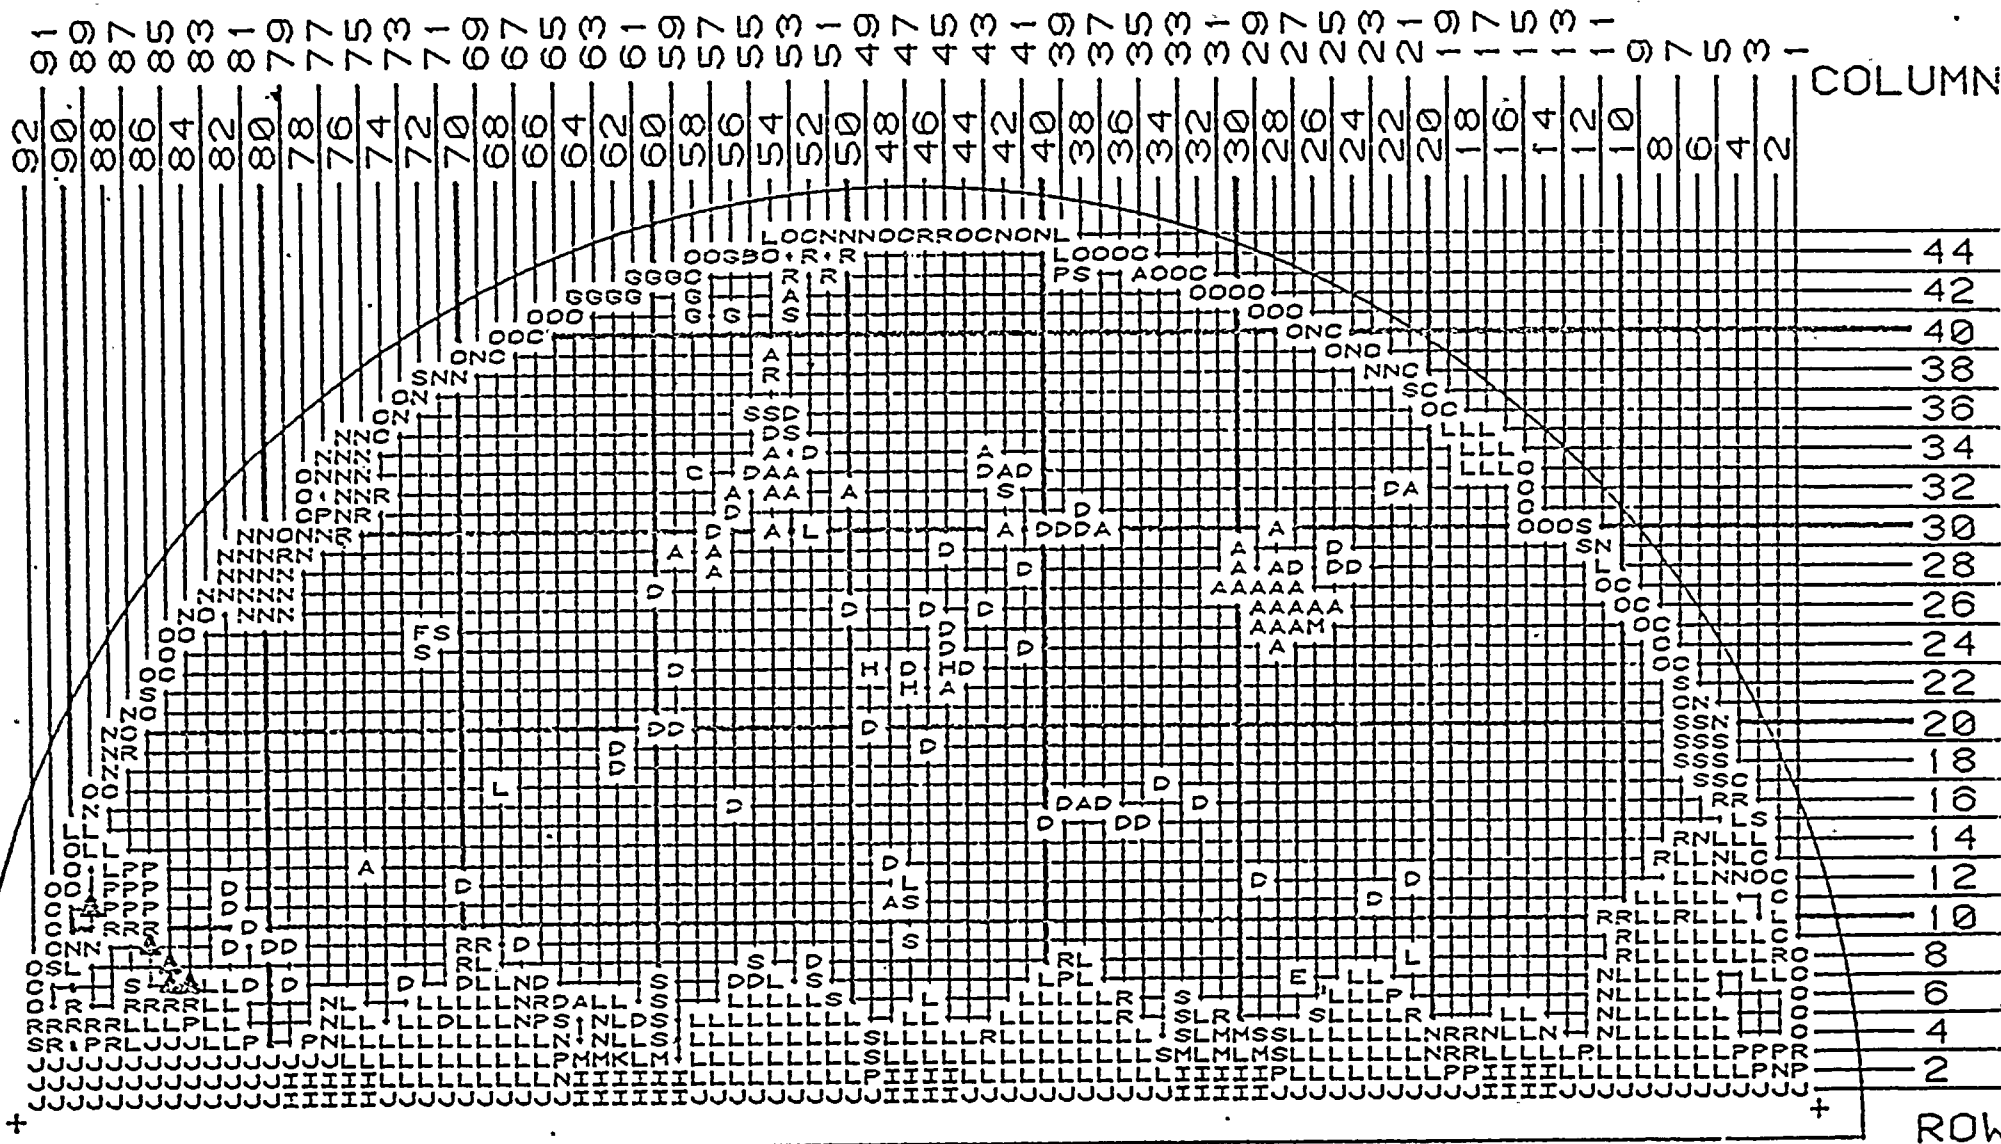
TURKEY POINT UNIT #4
GAUGING RESULTS NOV., 1980
STEAM GENERATOR B OUTLET

6. Only limited cold leg activity, i.e. restrictions to the 0.610 inch probe, was observed: No tubes in SG A, 5 in SG B, and 4 in SG C. The level of cold leg activity remains quite low compared to the hot leg experience.

<u>RESTRICTED TUBES:</u>	<u>NO. OF TUBES</u>
X= .540 PROBE	None
Δ= .610 PROBE	5
⊖= .650 PROBE	Not Tested

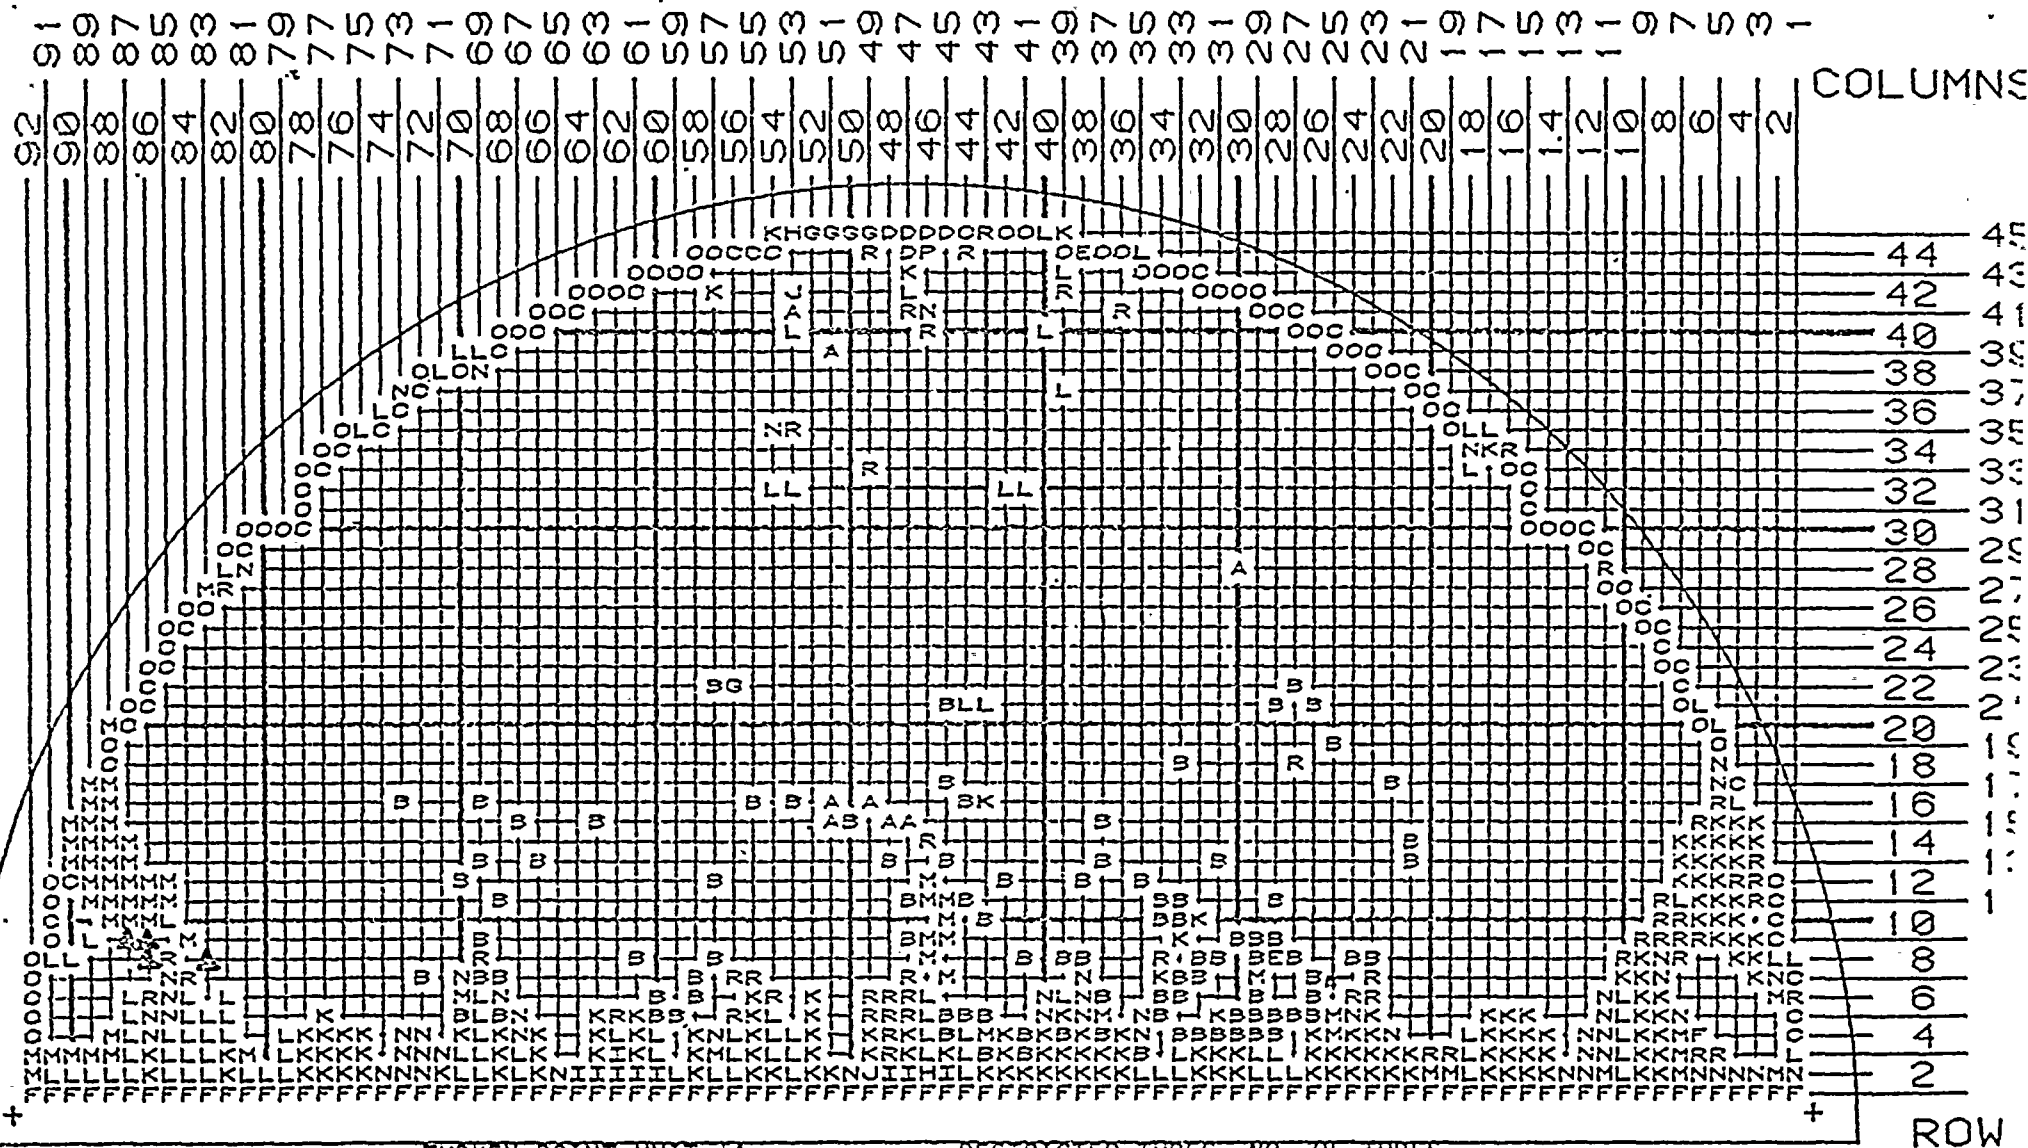
← --- MANWAY TURKEY POINT UNIT #4
GAUGING RESULTS NOV. 1980
STEAM GENERATOR C OUTLET

RESTRICTED TUBES NO. OF TUBES
X = .540 PROBE None
A = .610 PROBE 4
O = .650 PROBE Not Tested

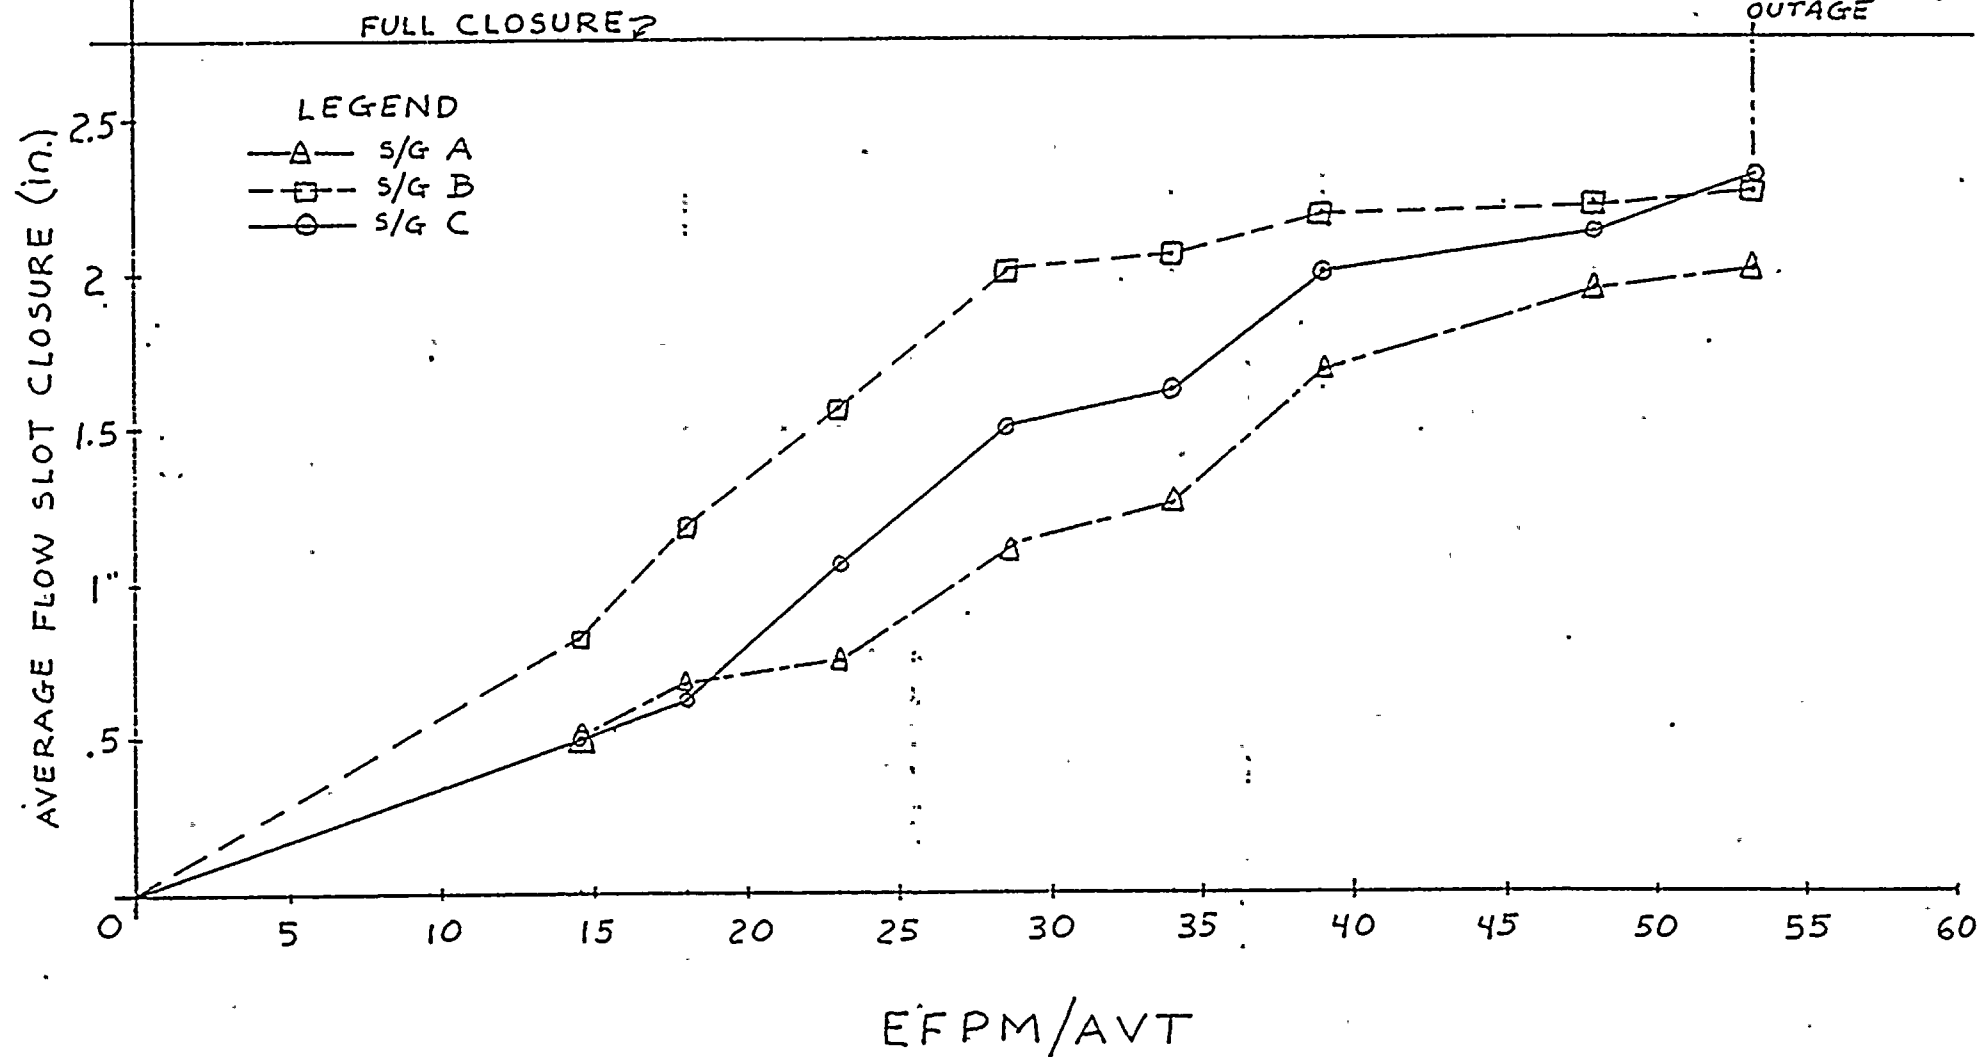
FLOW SLOT MEASUREMENT

The results of the #1 TSP flow slot measurements are indicated in Fig. 18. Results are consistent with previous behavior.
