Re: Turkey Point Unit 4  
Docket No. 50-251  
Steam Generator Tube Wastage Information

TURKEY POINT UNIT 4

SUPPLEMENTAL INFORMATION ON

S/G TUBE WALL THINNING

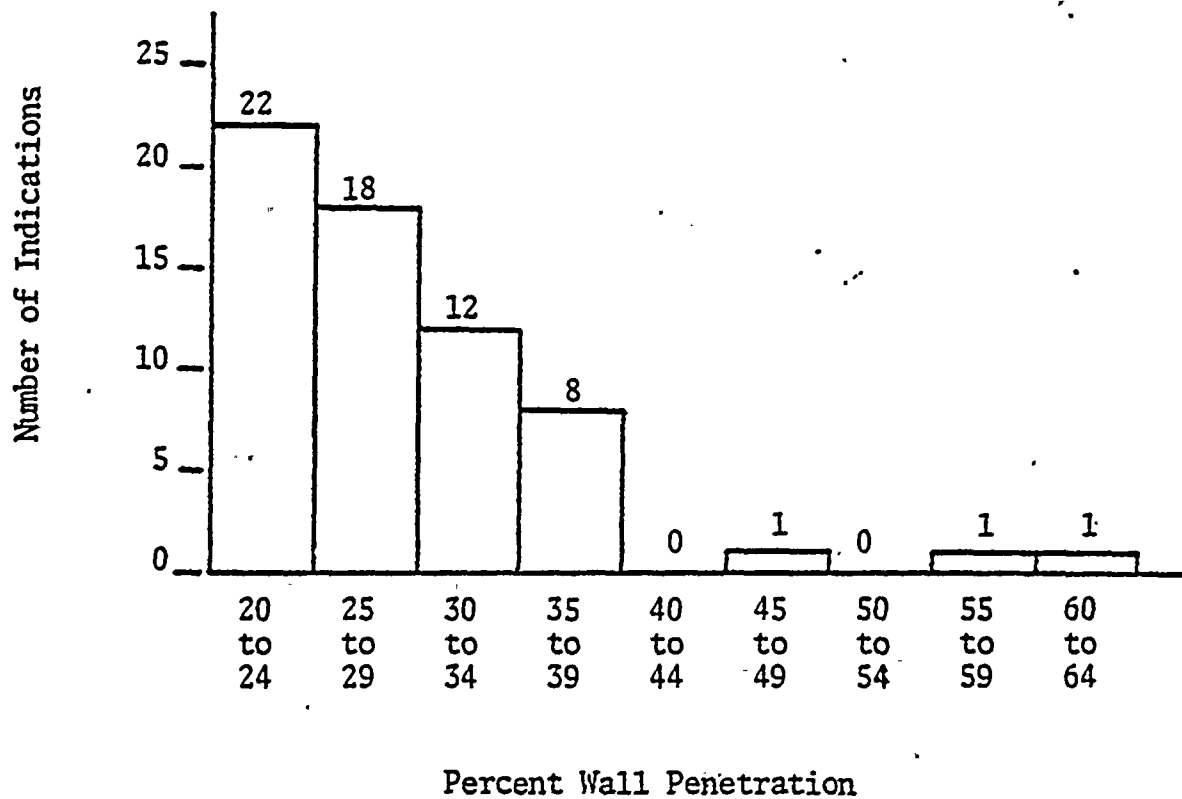
S/G A HOT LEG

- III. Figures A-1 to A-6 show the distribution of eddy current indication  $\geq 20\%$  for each leg of the three steam generators. The preponderance of indications at low percentages, i.e. less than 40%, strongly suggests thinning as the nature of the tube degradation since detection of cracking by eddy current techniques is insensitive below about 40% wall penetration.

DISTRIBUTION OF EDDY CURRENT INDICATIONS  $\geq 20\%$   
NOVEMBER 1980 INSPECTION

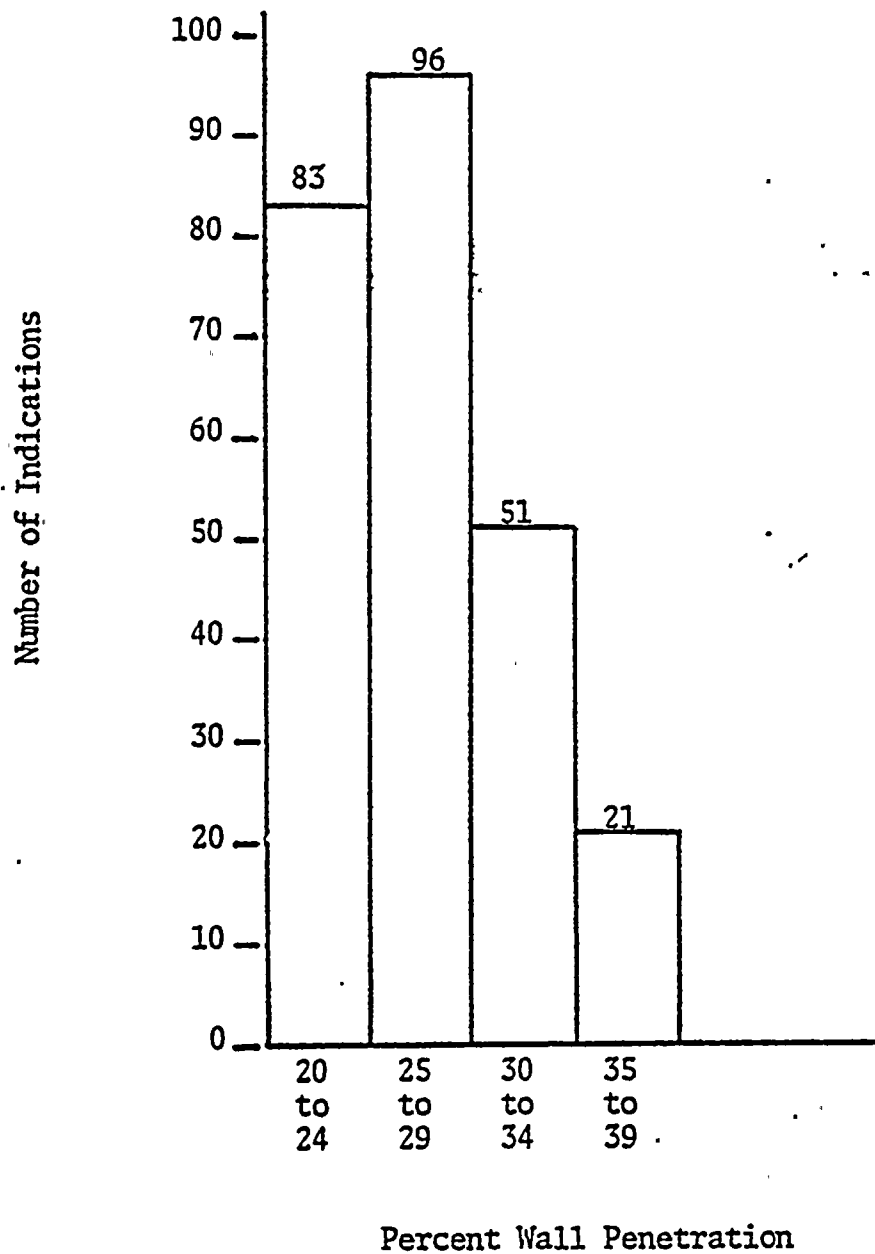
S/G A COLD LEG

DISTRIBUTION OF EDDY CURRENT INDICATIONS  $\geq 20\%$   
NOVEMBER 1980 INSPECTION

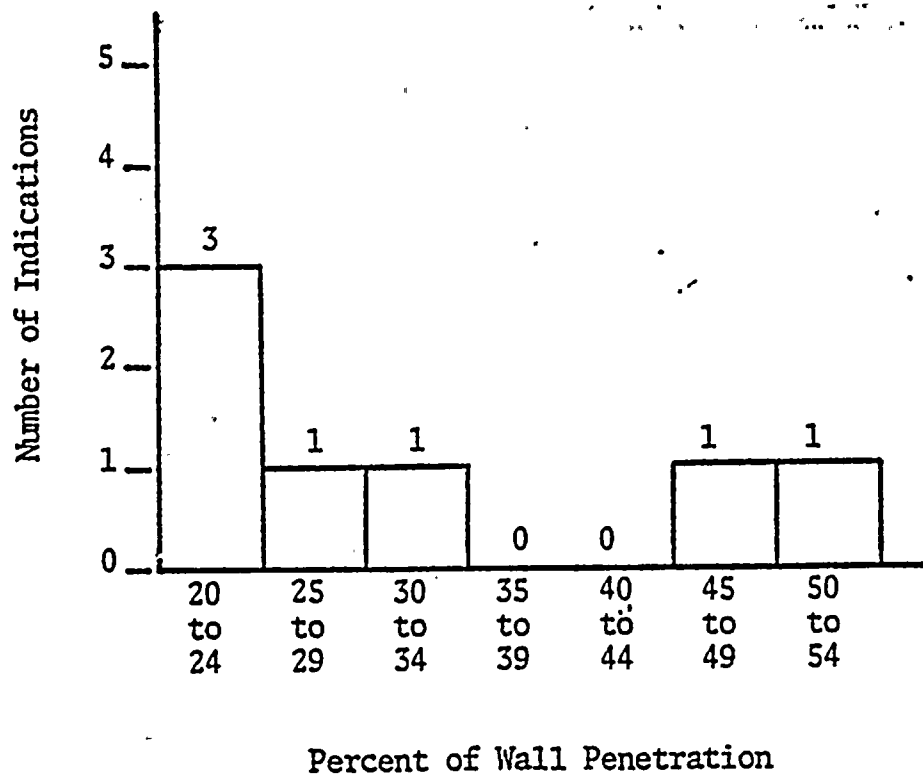
S/G C HOT LEG

In the case of Steam Generator C, hot leg, where only one indication could be compared between the two inspection periods, only seven indications  $\geq 20\%$  were observed, suggesting a low degree of thinning activity.

DISTRIBUTION OF EDDY CURRENT INDICATIONS  $\geq 20\%$   
NOVEMBER 1980 INSPECTION

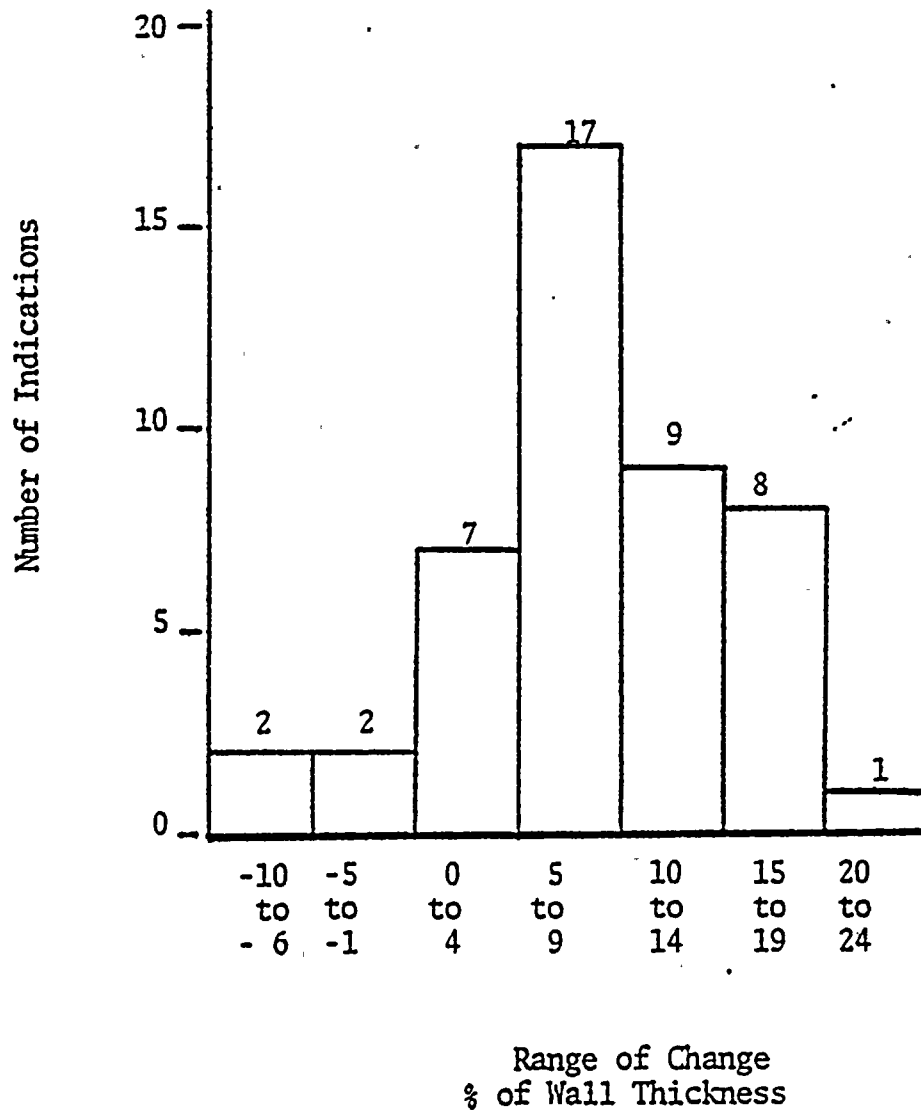
FIGURE A - 10

On the basis of the highest calculated average incremental change from May, 1980 to December, 1980, 8.41% in SG/B cold leg, the apparent degradation for this period of operation consisting of 4.75 Effective Full Power Months (EFPM) is 1.77%/EFPM. Assuming the same rate of thinning over the present operating period, a tube operating with the largest unplugged indication of 39% might experience further wall loss of 10.6% over an additional operating period of 6 EFPM. Allowing for the staff's

DISTRIBUTION OF THE CHANGE IN EDDY CURRENT  
INDICATIONS AT THE TUBESHEET BETWEEN THE  
MAY 1980 AND NOVEMBER 1980 INSPECTIONS

Total Number of Points	46
Average Change	8.41

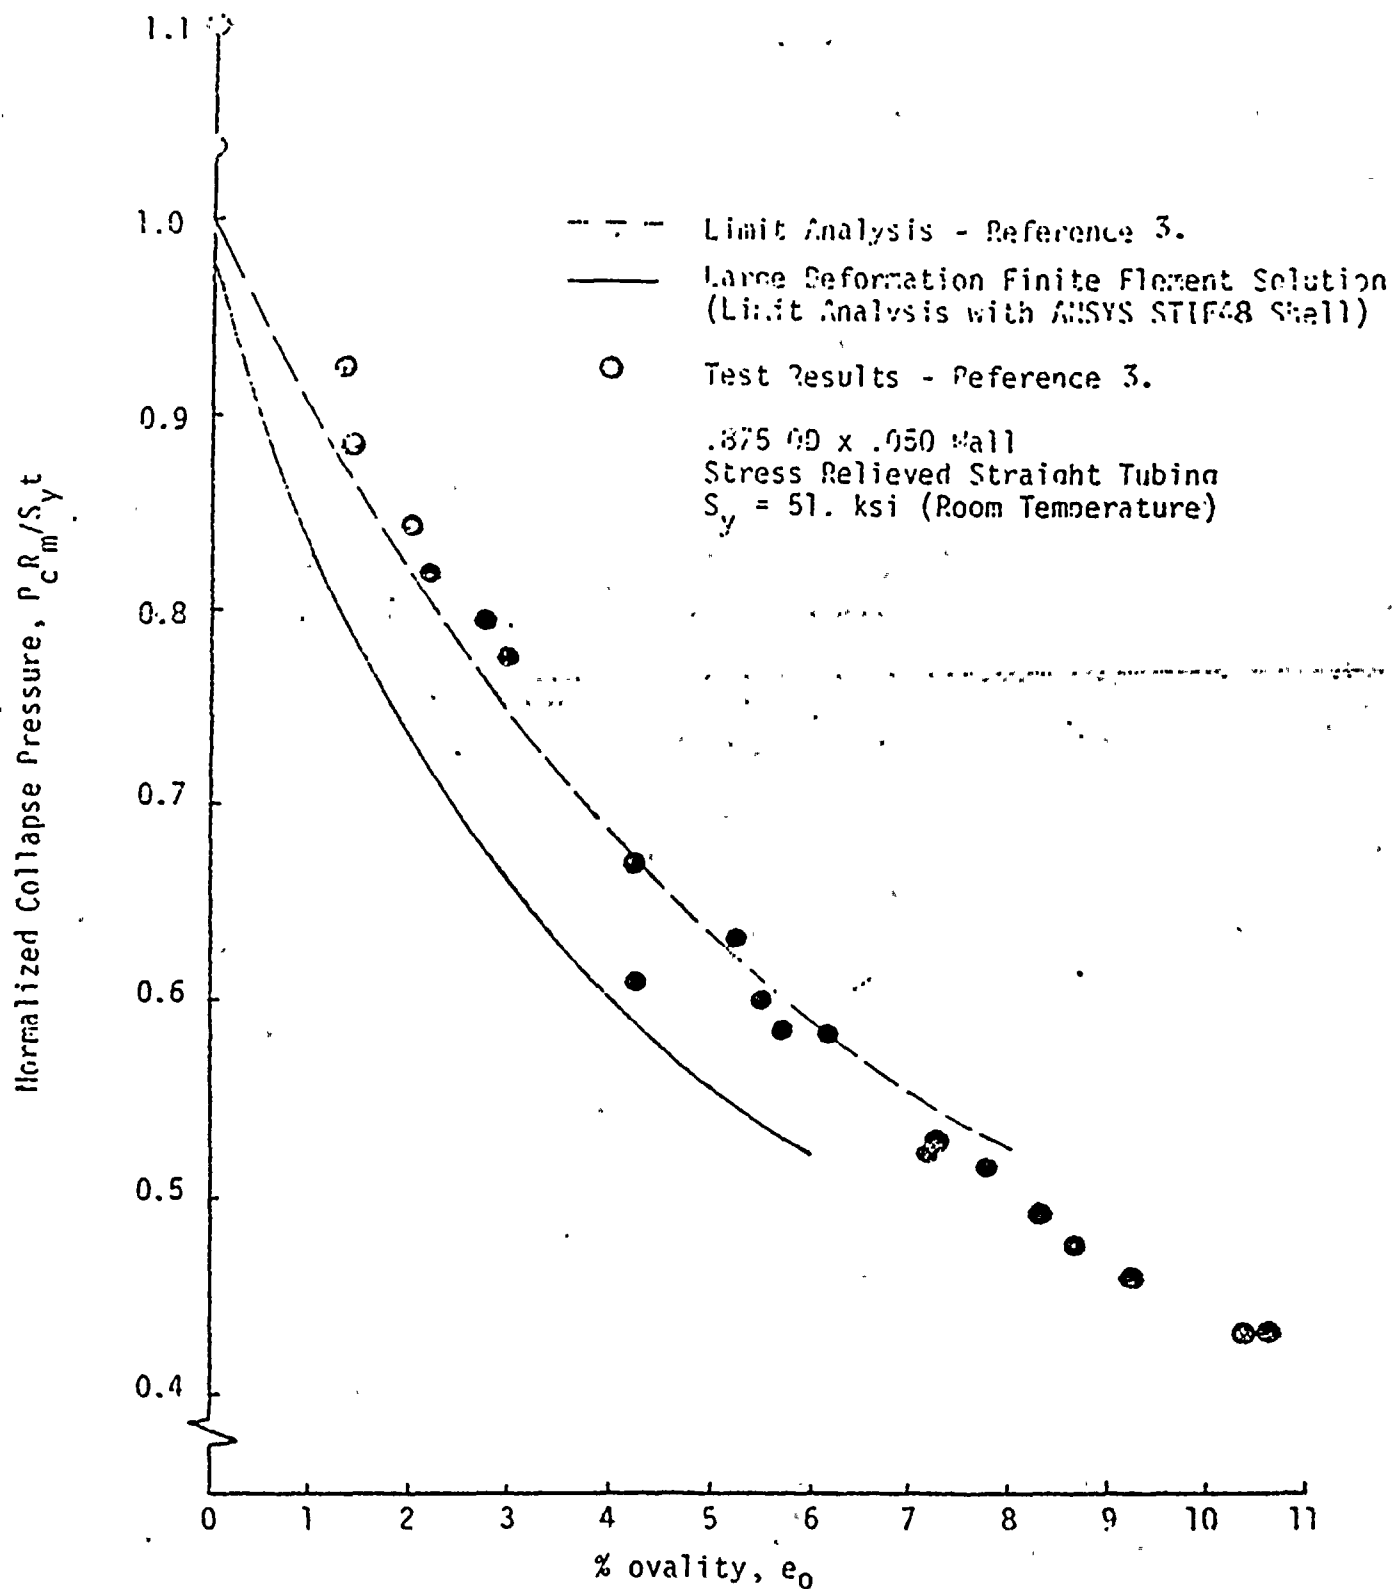
From the results in Reference (3), it is observed that the limit analysis theory correlates well with the test results of stress-relieved tubing which is believed to have less anisotropic yield properties than as-manufactured tubing. The theoretical prediction is rather excellent for specimens with small initial ovalities. Nevertheless, in order to account for continued increase in ovality under the external pressure loading, a large-deformation finite element solution (ANSYS STIF48) using elastic-perfectly plastic shell behavior is utilized for the actual verification. The finite element solution along with the limit analysis theory and actual test results is shown in Figure B-1.

FIGURE B-1 COLLAPSE PRESSURE OF STRAIGHT OVALIZED TUBES - CORRELATION BETWEEN TEST AND ANALYSES

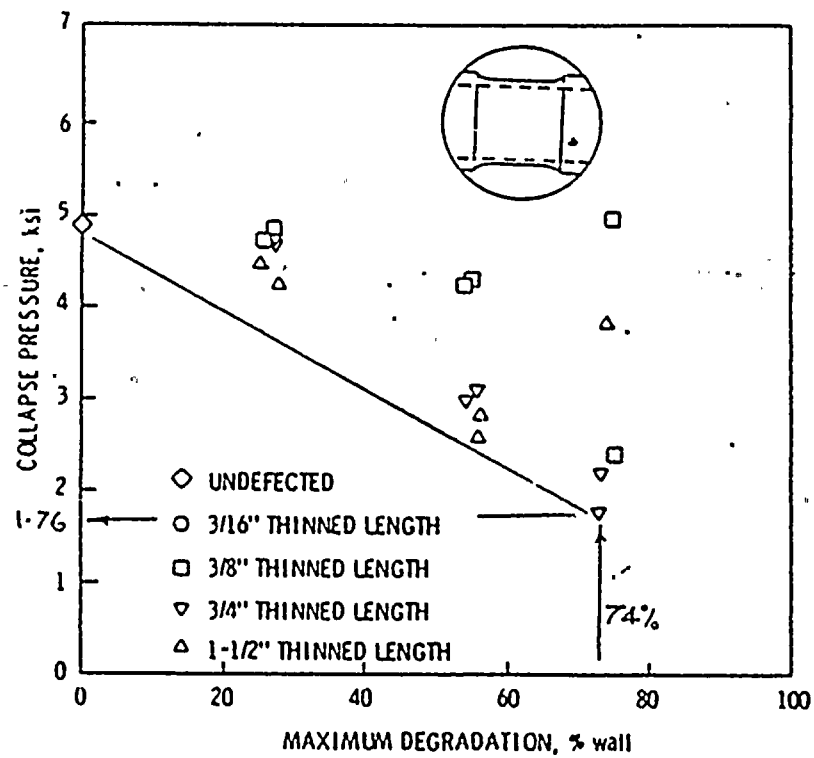
Corresponding to a 74% wall degradation, ( $t_{\min} = .013$  inch) the minimum collapse pressure  $P_c$  from Figure B-2 is obtained to be 1760 psi (for a defect length of .75 inch). This value is used as the reference collapse pressure of a perfectly round, (this is a conservative assumption) as-manufactured tube thinned uniformly to .013 inch ligament. This value is then adjusted for the actual FPL tubing yield strength of 30,100 psi and ovality of 1.5% using the ANSYS solution discussed above.

**FIGURE B-2** Collapse Pressure Data for 0.875 x 0.050 Uniform Thinning Specimens - Re[51]

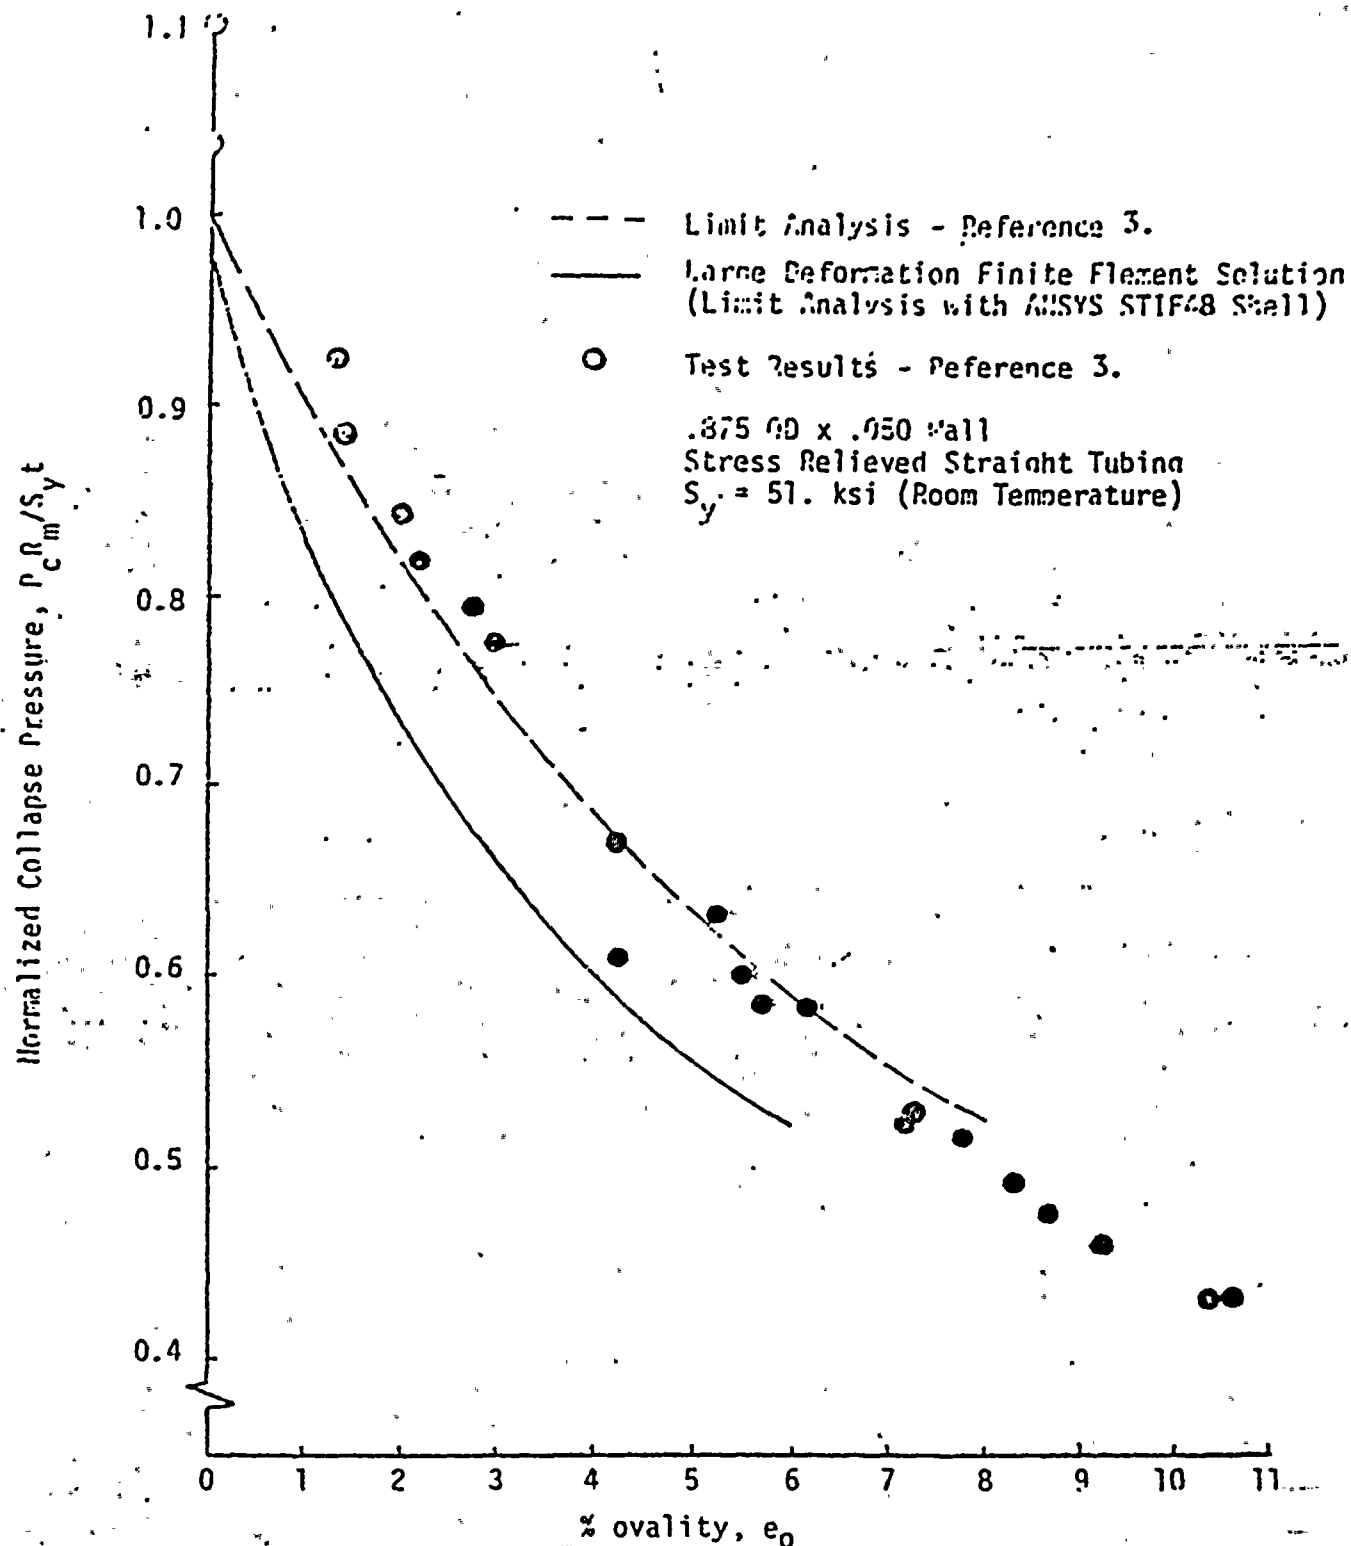
From the results in Reference (3), it is observed that the limit analysis theory correlates well with the test results of stress-relieved tubing which is believed to have less anisotropic yield properties than as-manufactured tubing. The theoretical prediction is rather excellent for specimens with small initial ovalities. Nevertheless, in order to account for continued increase in ovality under the external pressure loading, a large-deformation finite element solution (ANSYS STIF48) using elastic-perfectly plastic shell behavior is utilized for the actual verification. The finite element solution along with the limit analysis theory and actual test results is shown in Figure B-1.

FIGURE B-1 COLLAPSE PRESSURE OF STRAIGHT OVALIZED TUBES - CORRELATION BETWEEN TEST AND ANALYSES

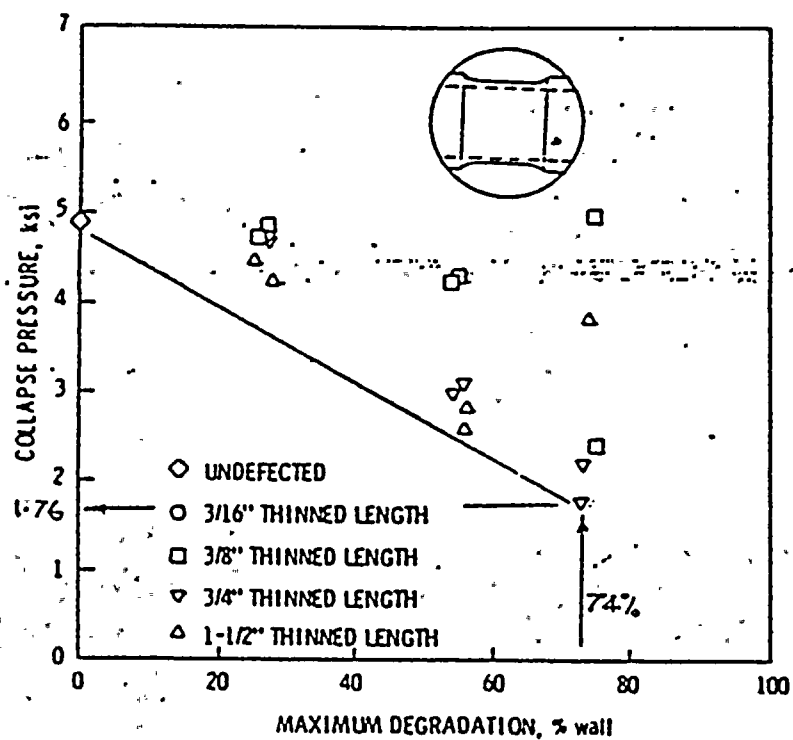
Corresponding to a 74% wall degradation, ( $t_{\min} = .013$  inch) the minimum collapse pressure  $P_C$  from Figure B-2 is obtained to be 1760 psi (for a defect length of .75 inch). This value is used as the reference collapse pressure of a perfectly round, (this is a conservative assumption) as-manufactured tube thinned uniformly to .013 inch ligament. This value is then adjusted for the actual FPL tubing yield strength of 30,100 psi and ovality of 1.5% using the ANSYS solution discussed above.

**FIGURE B-2** Collapse Pressure Data for 0.875 x 0.050  
Uniform Thinning Specimens -  $R = 1.51$
