SUBJECT: Application to amend License DPR-31 requesting permission to
 return facility to power operation for six equivalent full
 power months. Class III amend fee encl.

Re: Turkey Point Unit 3
Docket No. 50-250
Steam Generator Inspections

TURKEY POINT 3 STEAM GENERATOR
INSPECTION PROGRAM
March, 1981

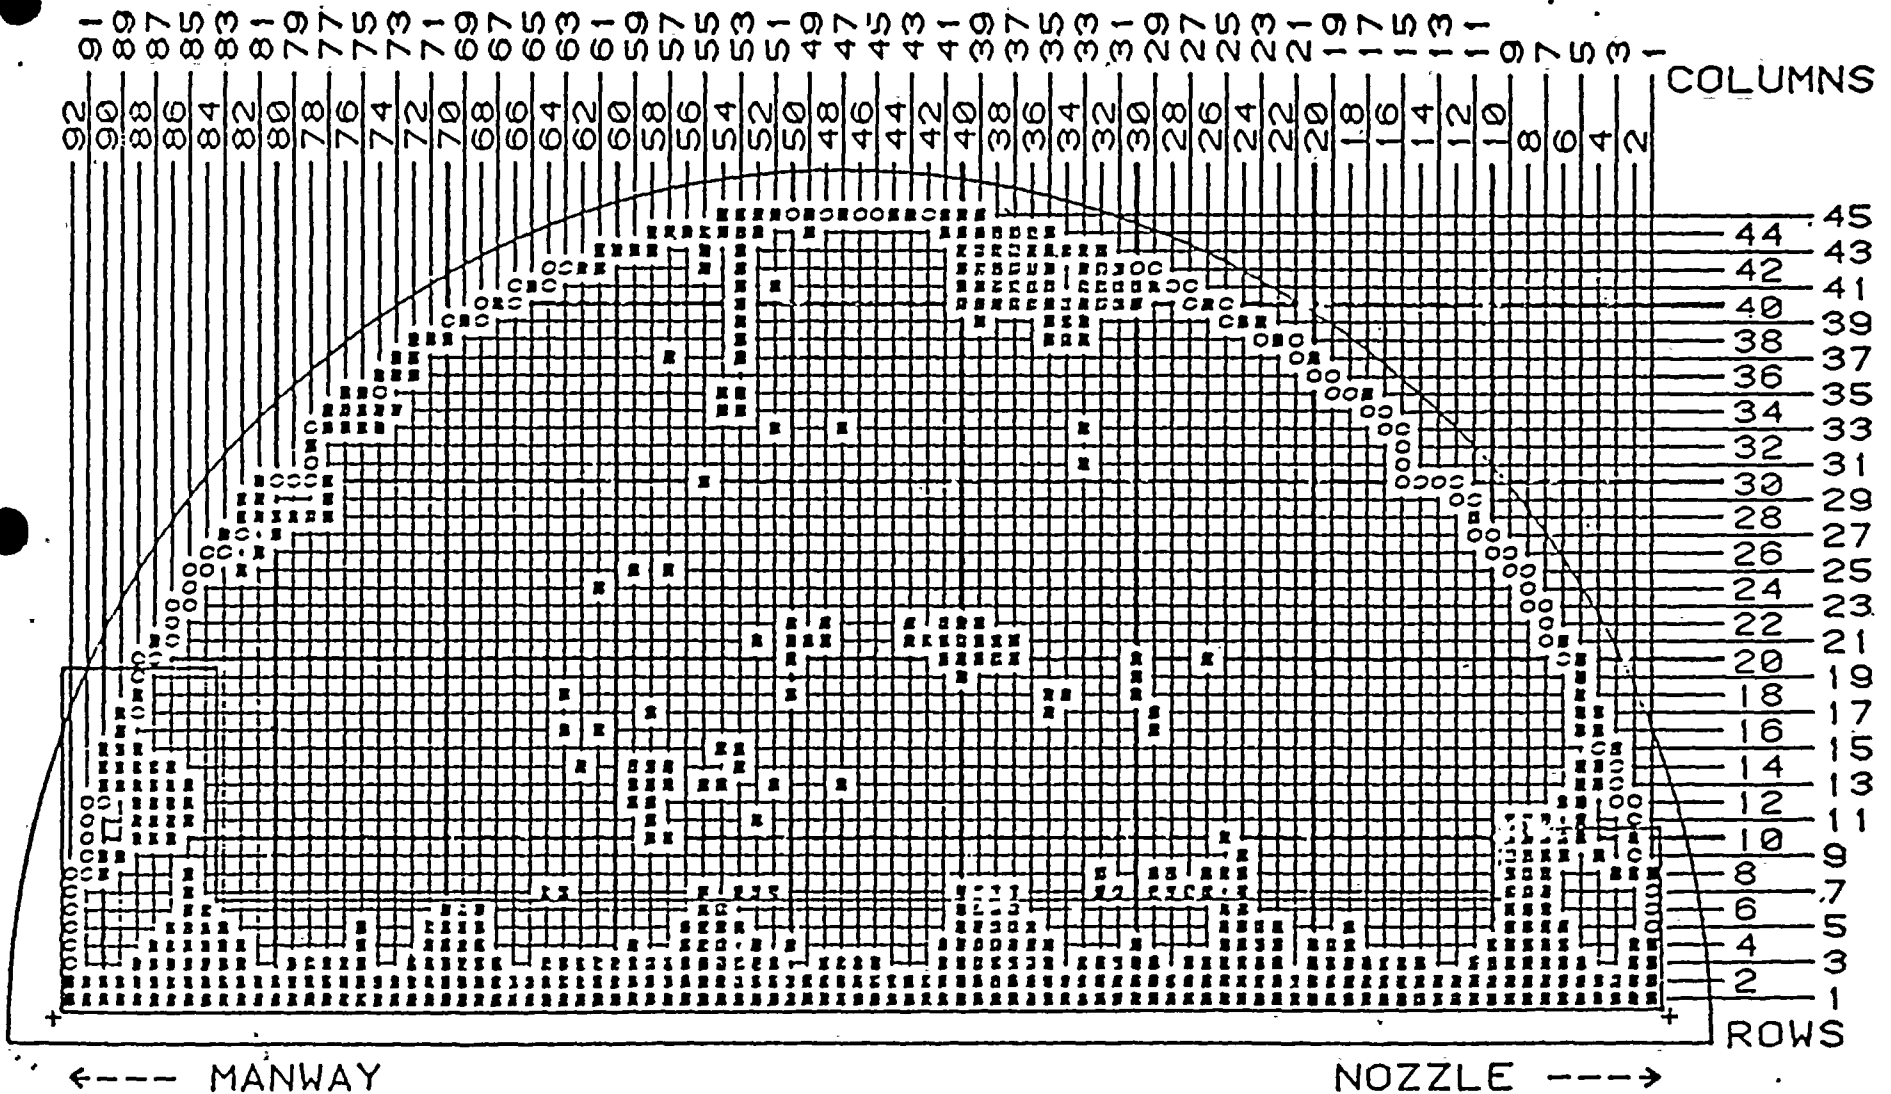
FIGURE 3

TURKEY POINT UNIT #3
STEAM GENERATOR A - HOT LEG
GAUGING PROGRAM

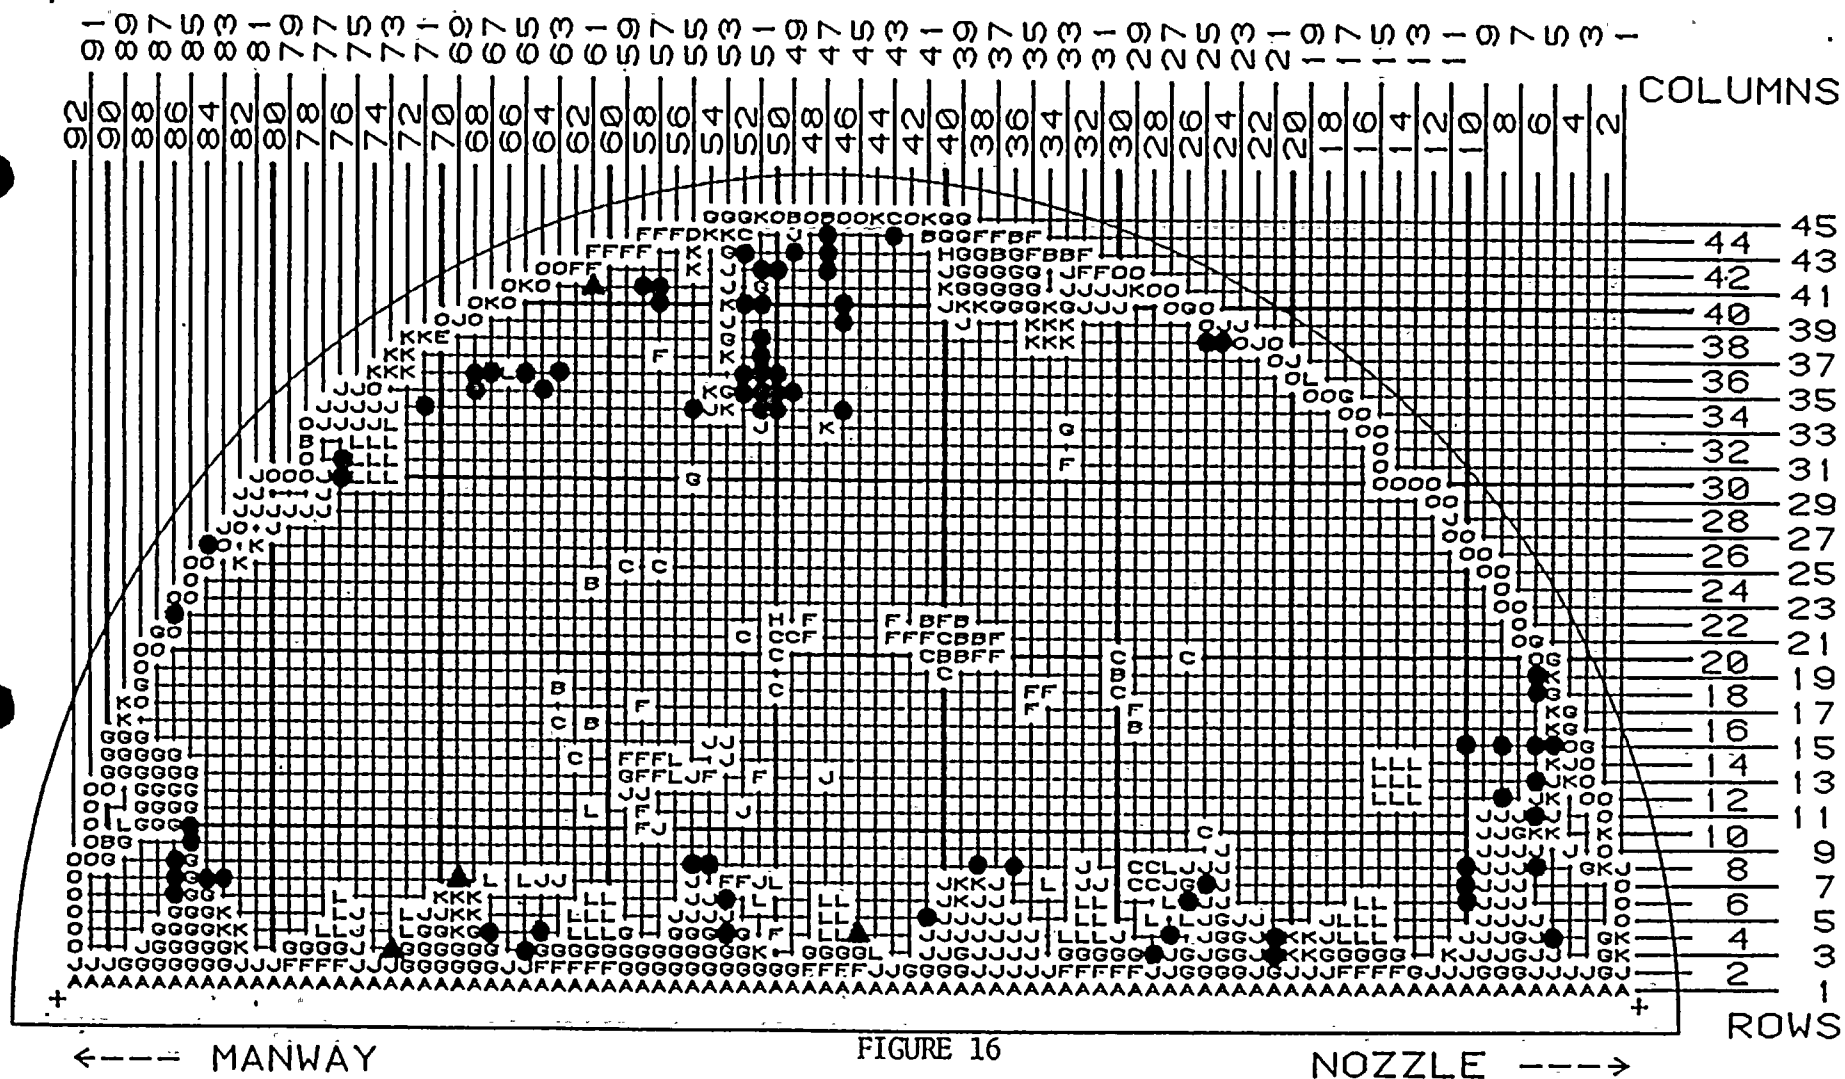
FIGURE 16
TURKEY POINT UNIT #3
GAUGING RESULTS, MARCH, 1981
STEAM GENERATOR A - HOT LEG

RESTRICTED TUBES

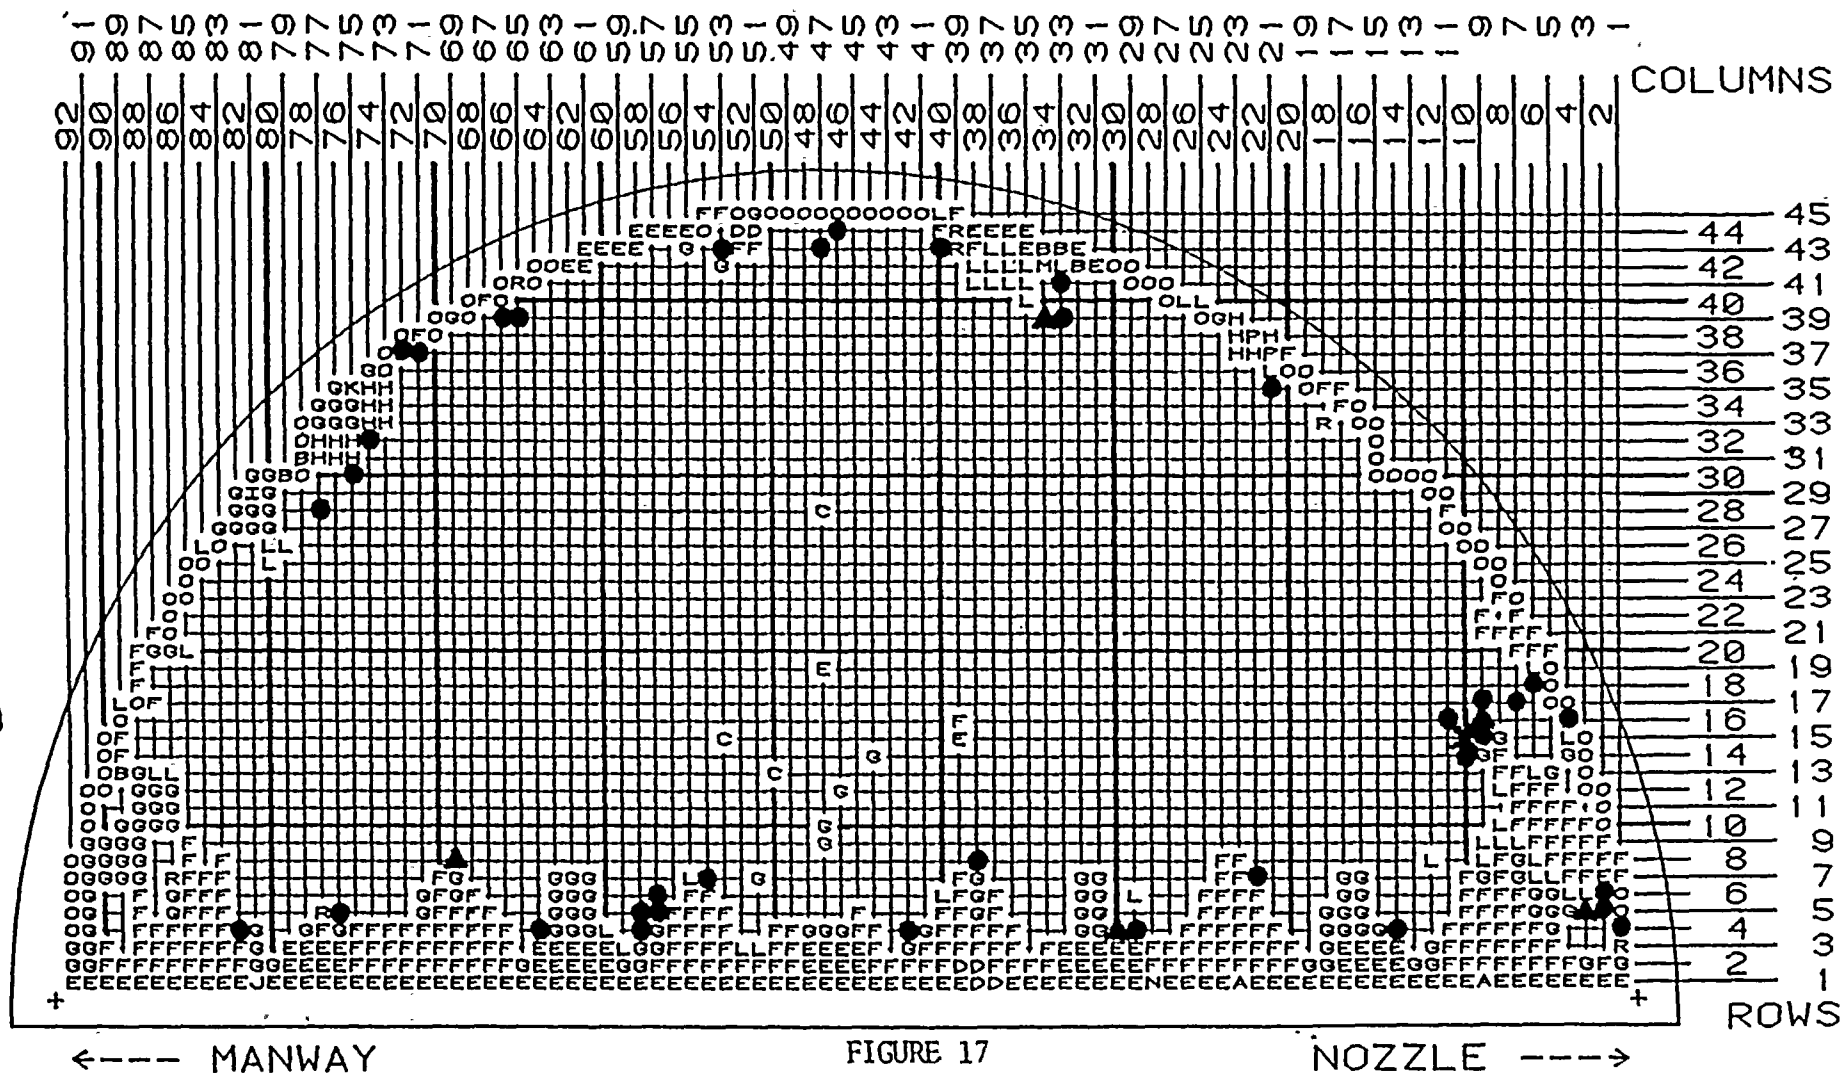
FIGURE 17
 TURKEY POINT UNIT #3
 GAUGING RESULTS, MARCH, 1981
 STEAM GENERATOR B - HOT LEG

RESTRICTED TUBES	NO. OF TUBES
X = .540 Probe	1
▲ = .610 Probe	5
● = .650 Probe	37

1. All tubes which do not pass the 0.540 inch probe will be plugged. Only one such tube (steam generator B, R 15-C10) was observed in this inspection.
2. Additionally, for in excess of ten (10) months operation, two (2) tubes beyond (i.e., higher row numbers) any tube in columns 1-92 in the tubelane region which did not pass the 0.540 inch probe will be plugged. (Calculation of the progression of the 17-1/2% strain contour, as determined from finite element plots through 24 EFPM after closure, results in predicted advancement of this contour by 1.9 tube rows for a 10 month operating period. Given the conservatism of this approach, plugging two additional tubes beyond observed 540 mil restrictions provides adequate margin. This criterion was not applicable in this inspection.)

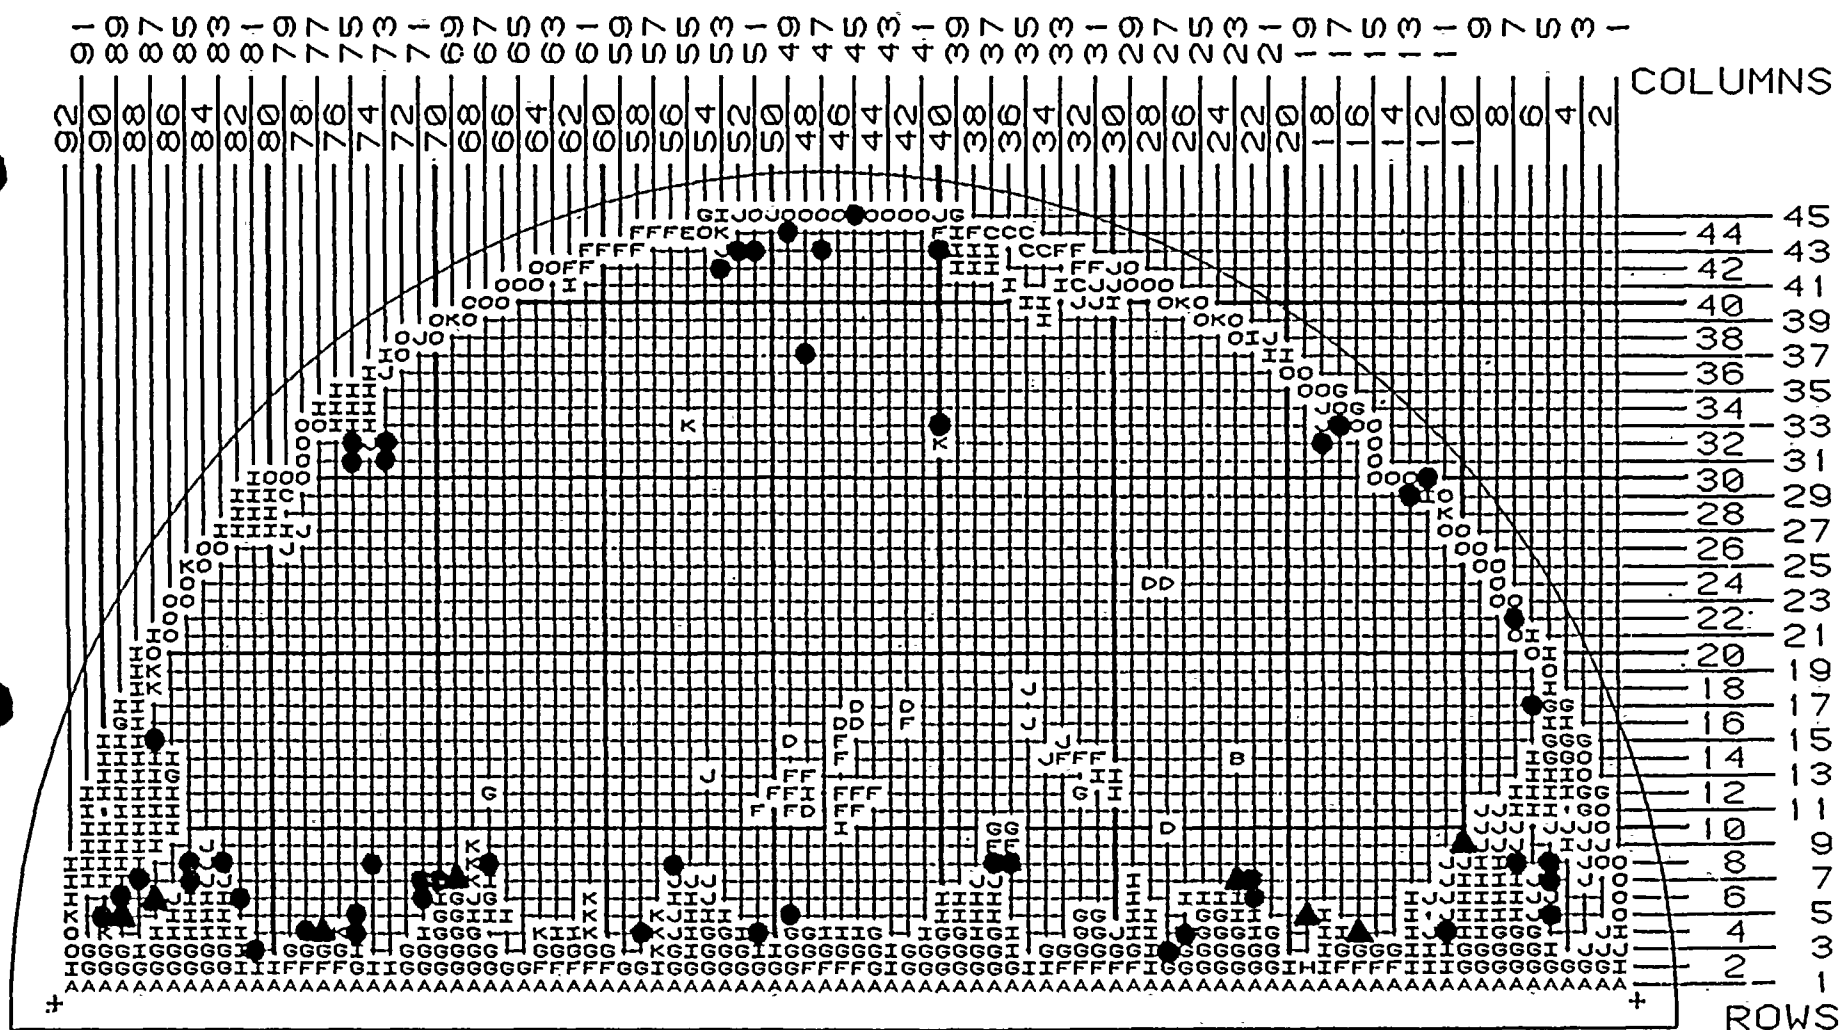
FIGURE 18
TURKEY POINT UNIT #3
STEAM GENERATOR C - HOT LEG
GAUGING RESULTS - MARCH, 1981

RESTRICTED TUBES

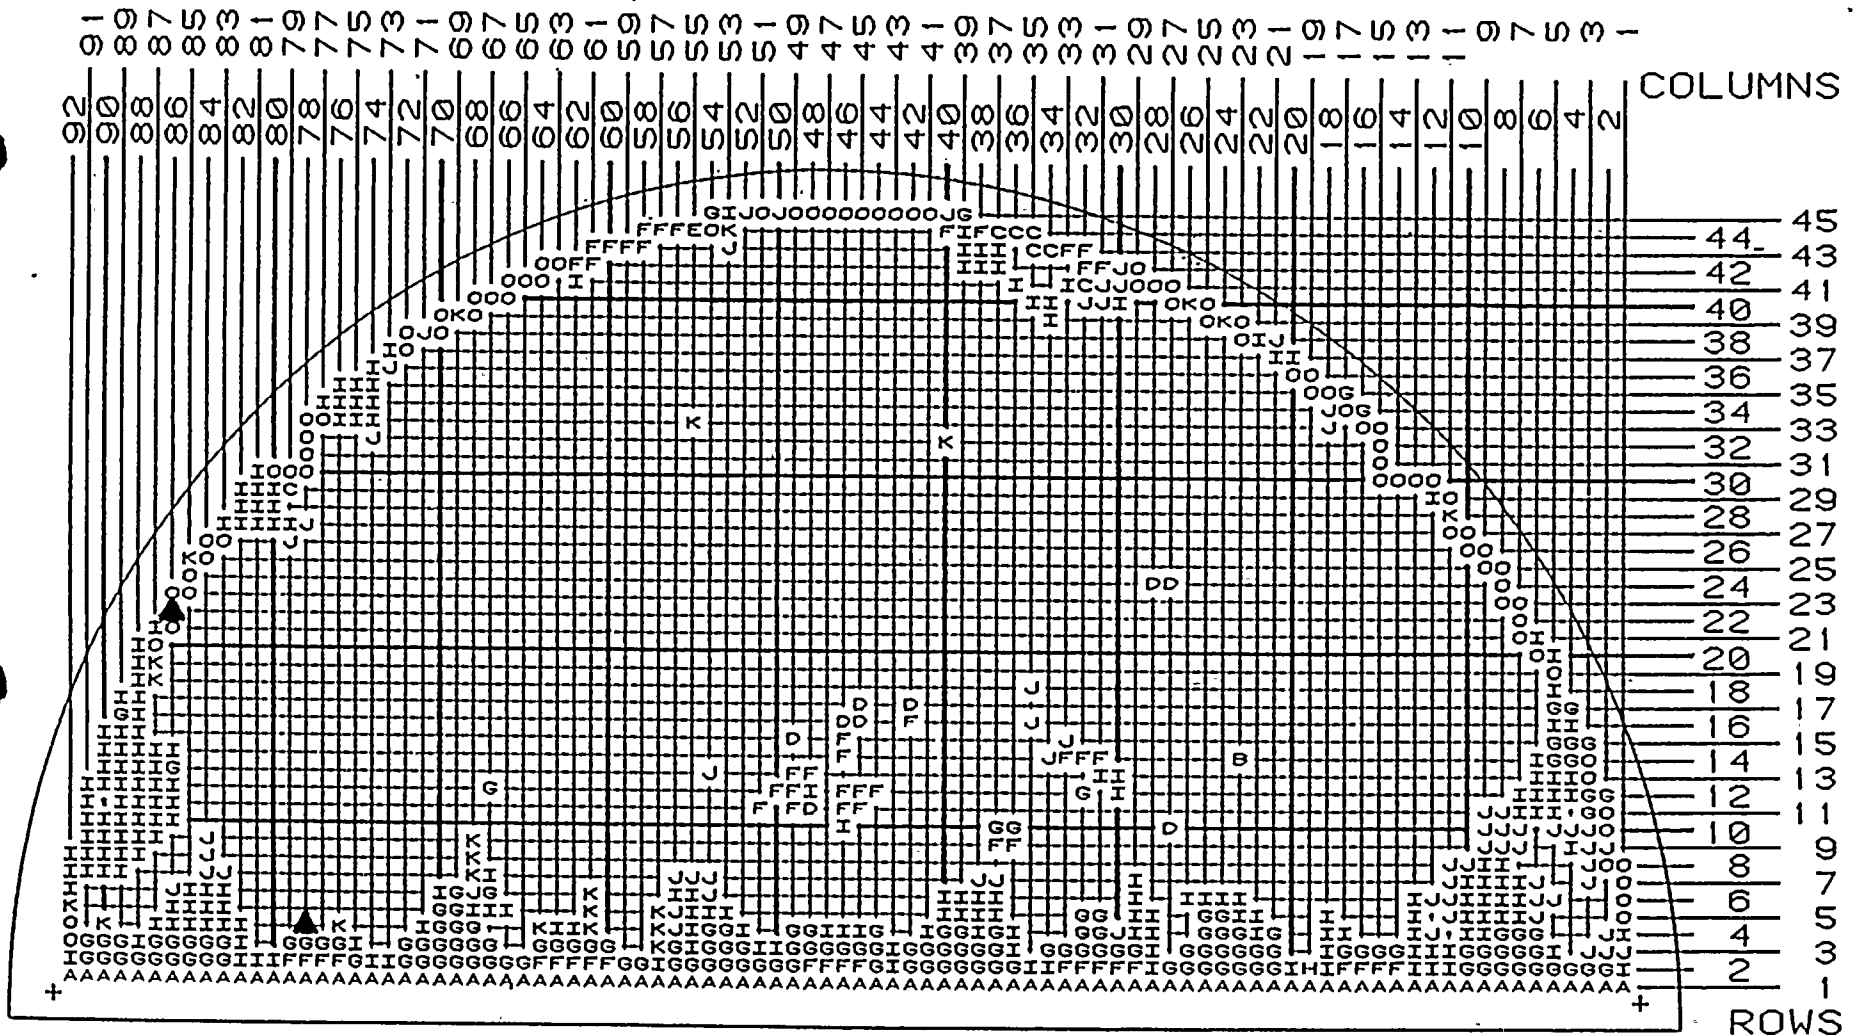
TURKEY POINT UNIT 3
 STEAM GENERATOR C - COLD LEG
 GAUGING RESULTS, MARCH 1981

RESTRICTED TUBES
 X = .540 PROBE
 ▲ = .610 PROBE
 ● = .650 PROBE

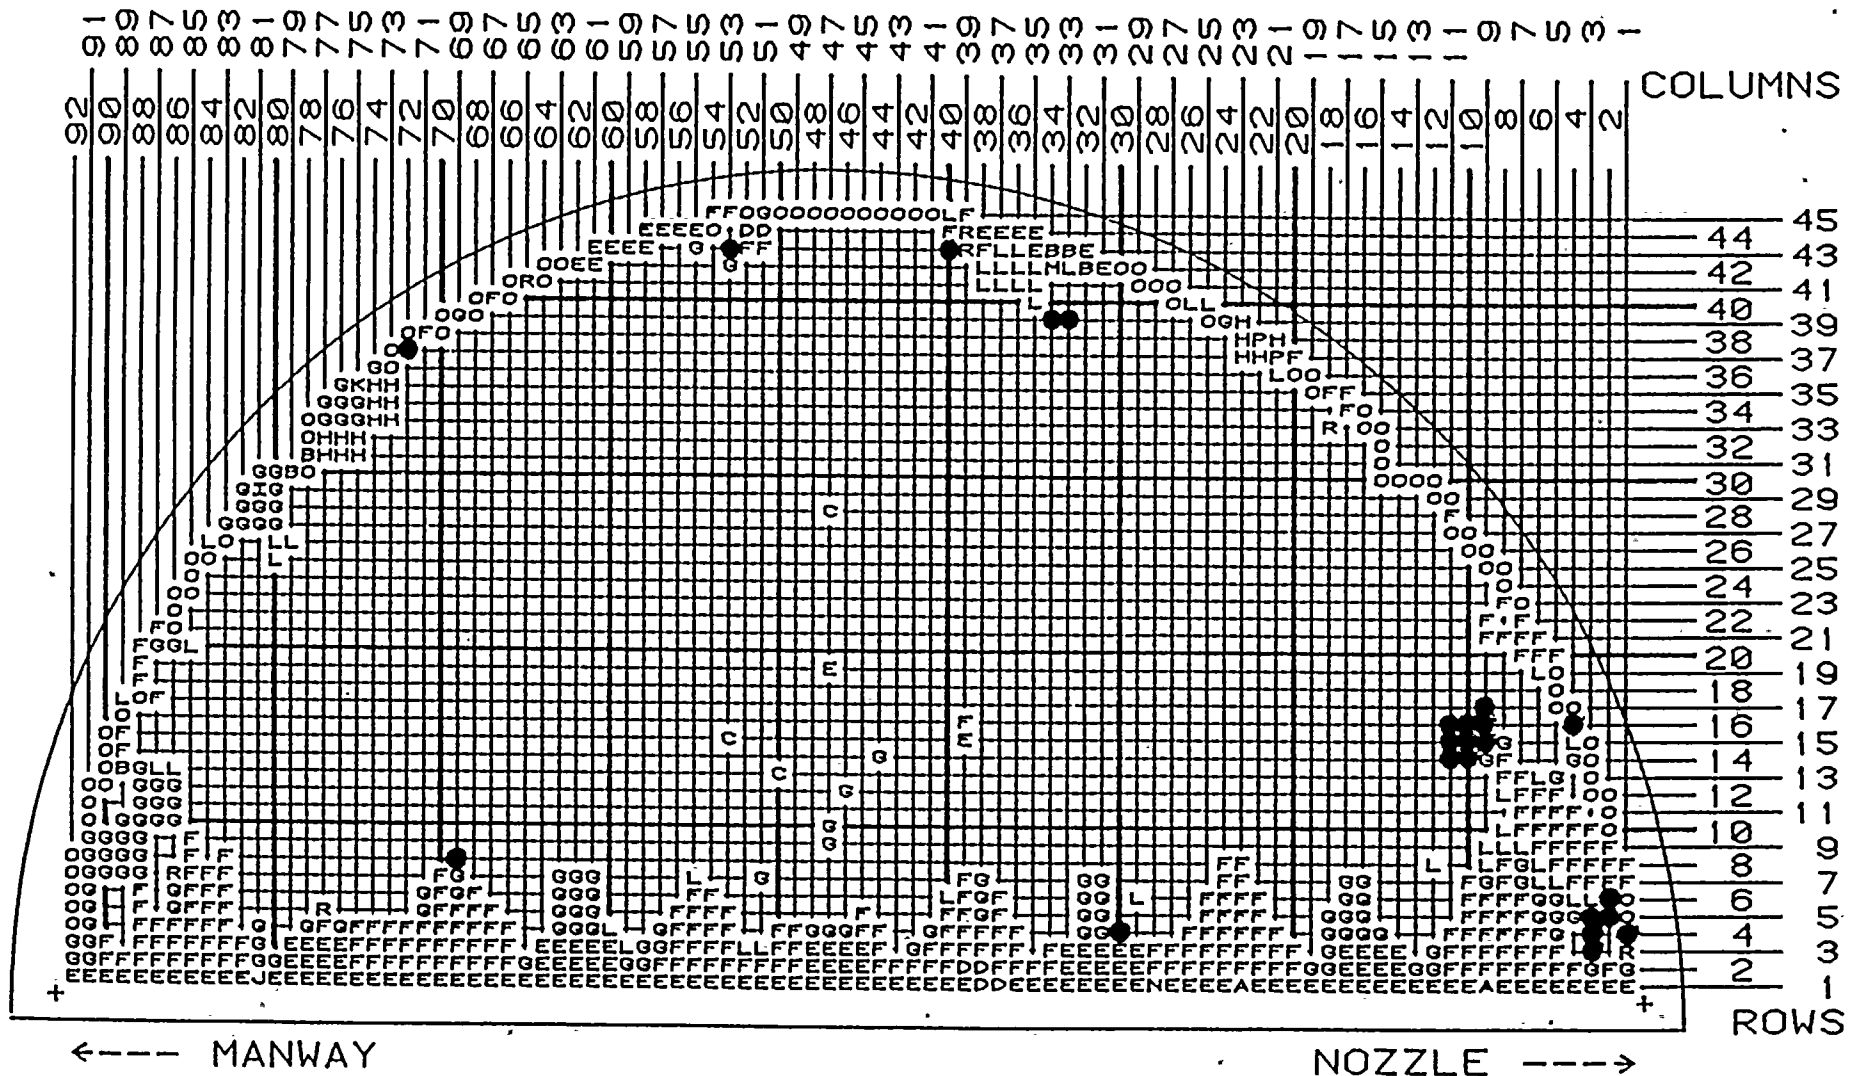
TURKEY POINT UNIT 3
STEAM GENERATOR B
MARCH 1981

RECOMMENDED PLUGGING PER:
● = GAUGING RESULTS (23 TUBES)
X = REG. GUIDE 1.83 (NO TUBES)

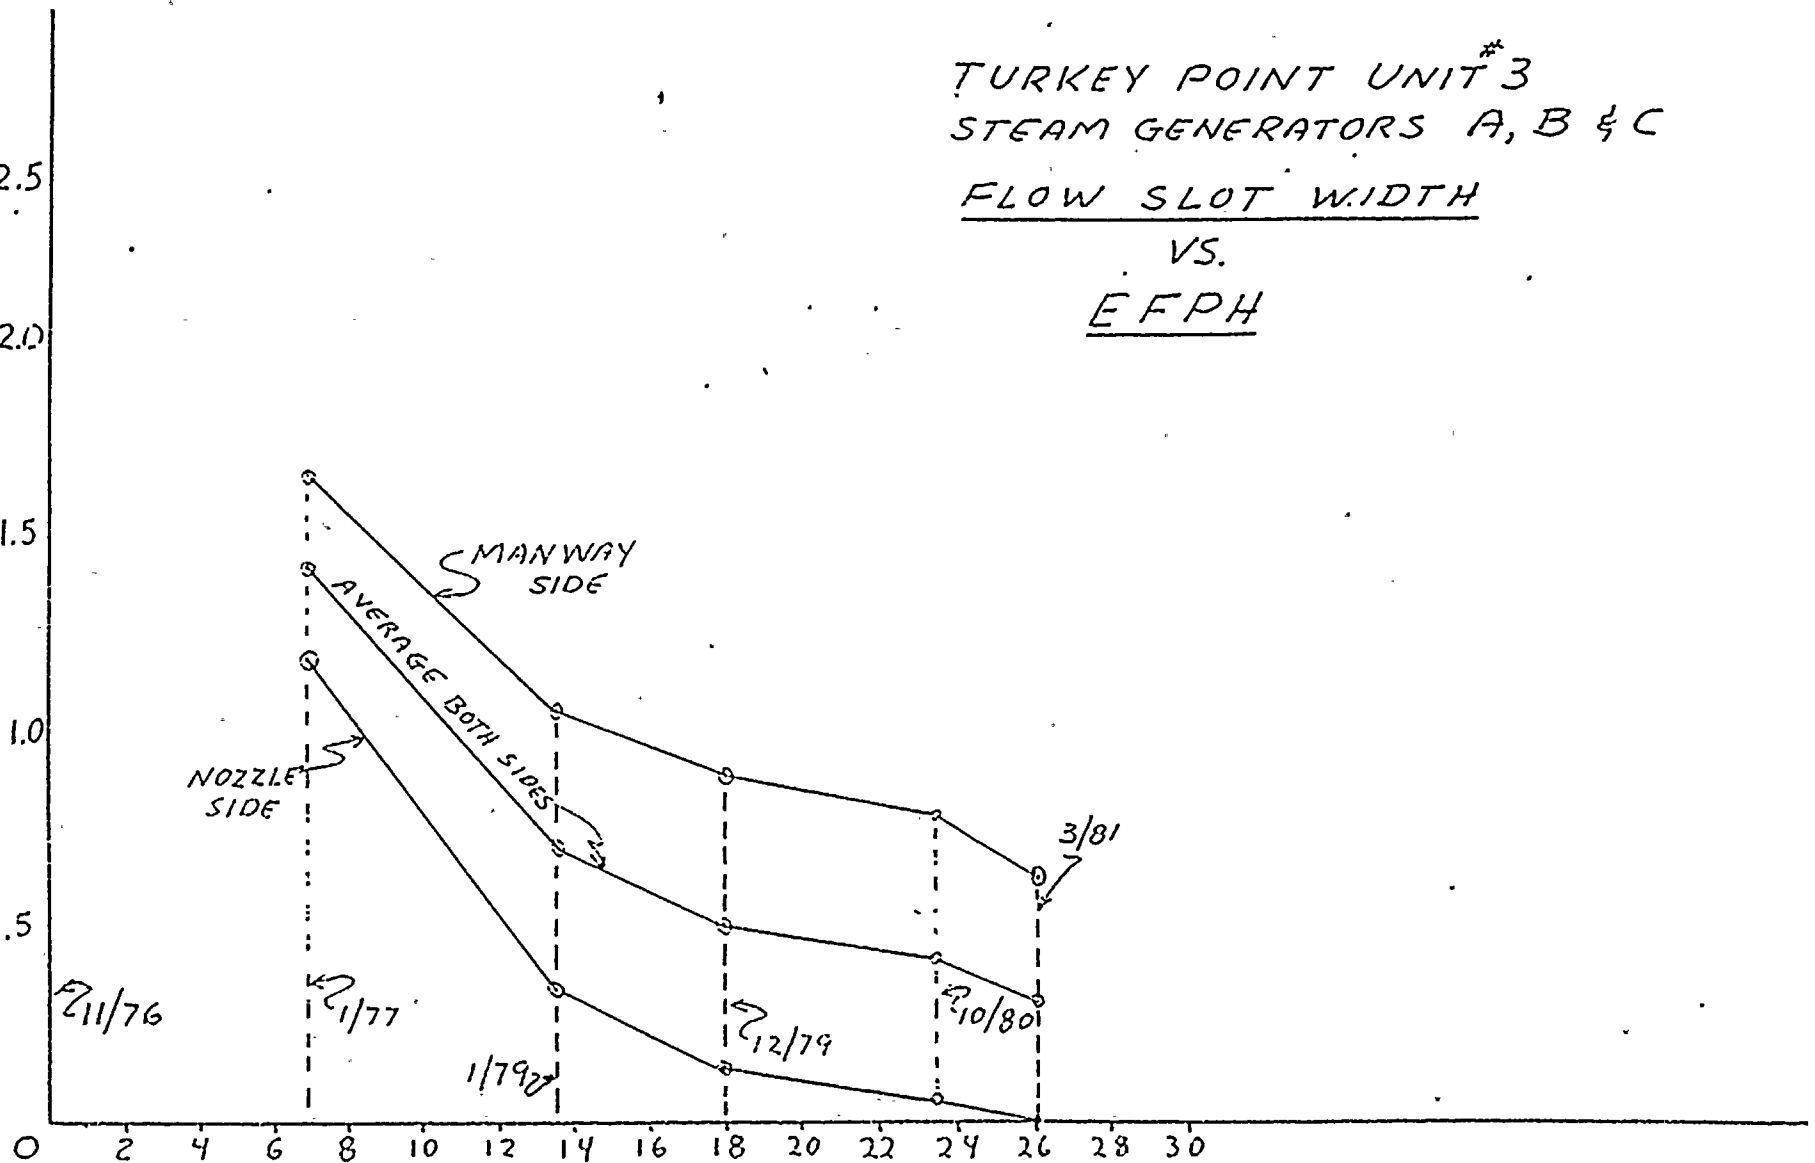
AVERAGE FLOW SLOT MINIMUM WIDTH IN INCHES
(BASED ON FIRST SUPPORT PLATE DATA)

TURKEY POINT UNIT #3
STEAM GENERATORS A, B & C
FLOW SLOT WIDTH
VS.
EFPH
