UNITED STATES OF AMERICA
NUCLEAR REGULATORY COMMISSION

In the Matter of)	Docket Nos. 50-250-SP
)	50-251-SP
FLORIDA POWER & LIGHT COMPANY)	
)	Proposed Amendments to
(Turkey Point Nuclear)	Facility Operating License
Generating Units Nos. 3)	to Permit Steam Generator
and 4))	Repairs)

AFFIDAVIT OF F. G. FLUGGER

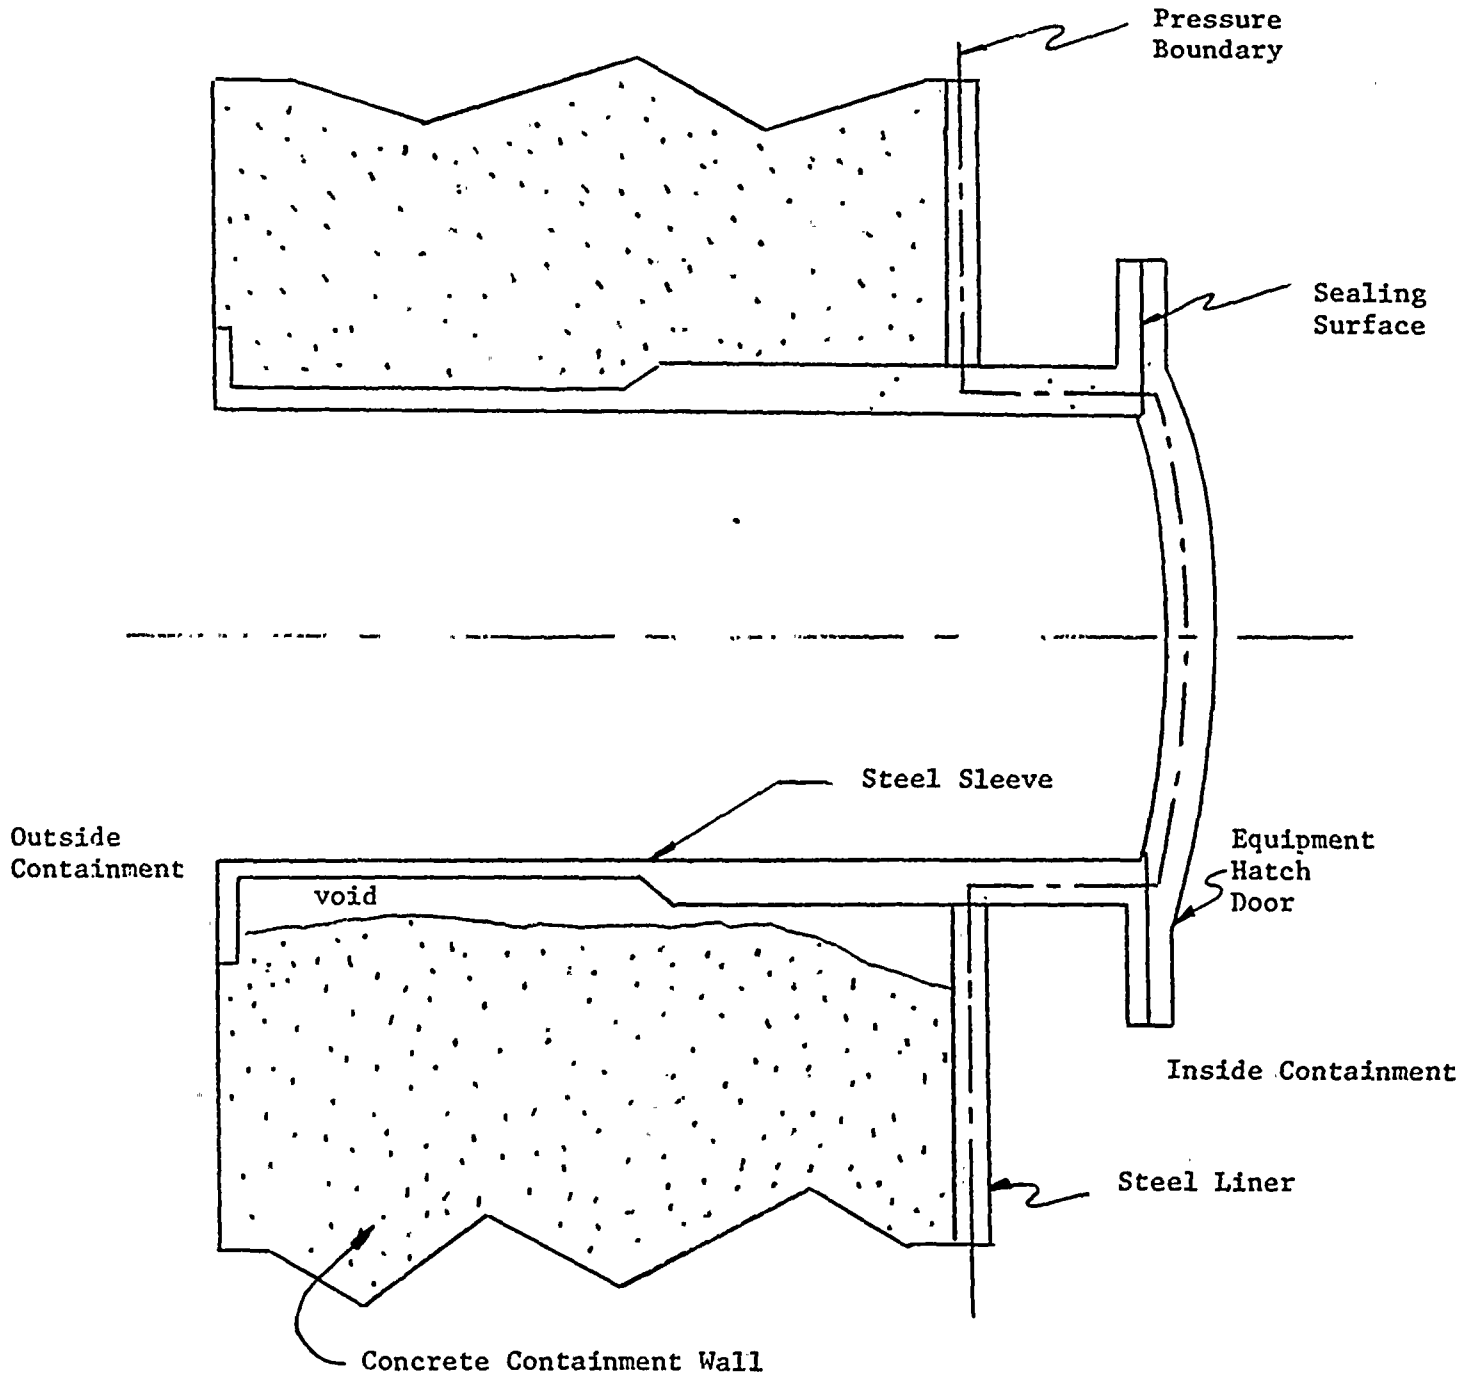
Figure 1
Diagram of Equipment Hatch Area*

Figure 1 depicts the location of the equipment hatch sleeve and the location of the void. As can be seen from the figure, the equipment hatch sleeve varies in thickness. In order to assure load transfer during movement of heavy objects (such as an SGLA) through the equipment hatch during the repairs, FPL planned to replace the thin steel portion of the sleeve with a thick steel plate. During removal of a portion of the affected areas of the sleeve, FPL discovered the void in the concrete underlying the plate. The extent of the void was determined by probing, and a larger portion of the plate was subsequently removed to expose the entire void. The void is not extensive, it was not caused by the repair work, and it was probably formed during construction of Unit 3. It should be noted that upon completion of construction, the containment was subjected to and successfully passed, testing required by the NRC prior to initial operation. Thus, it is reasonable to conclude that the void does not impact upon the integrity of the pressure boundary.

As is apparent from Figure 1, removal and replacement of a portion of the thin section of the sleeve does not affect the containment pressure boundary. The containment pressure boundary consists of the internal containment steel liner, the gasketed equipment hatch closure door, and part of the thick section of the steel sleeve. The equipment hatch sleeve area involved in the removal and replacement of the

thin section of the sleeve is outside of the containment pressure boundary. Consequently, no portion of the containment pressure boundary was modified or affected by removal of the sleeve. The void is exterior to the containment pressure boundary, and neither the void nor procedures followed for repair of the void will affect the containment pressure boundary. Prior to return of Unit 3 to power, appropriate local leak testing will be conducted for areas affected by the steam generator repair activity to ensure integrity of the containment pressure boundary. See SGRR section 4.1.2.

*This diagram is not drawn to scale and omits components which are not relevant to the discovery of the void. It represents the configuration at the time of void discovery.

The void is localized and not large; it will be repaired; the repair procedure is straight forward; and the void will in no way impact the SGLA repair activity. The NRC has been informed of the existence of the void and will be provided with the data necessary to disposition this matter.
