SUBJECT: Forwards results of steam generator insps conducted during
 Nov 1981 outage. Insp revealed no new phenomena & verified
 general pattern of denting is within predictable limits.
 Return to power presents no unresolved safety question.

Re: Turkey Point Unit 4
Docket No. 50-251
Steam Generator Inspections

TURKEY POINT 4 STEAM GENERATOR
INSPECTION PROGRAM

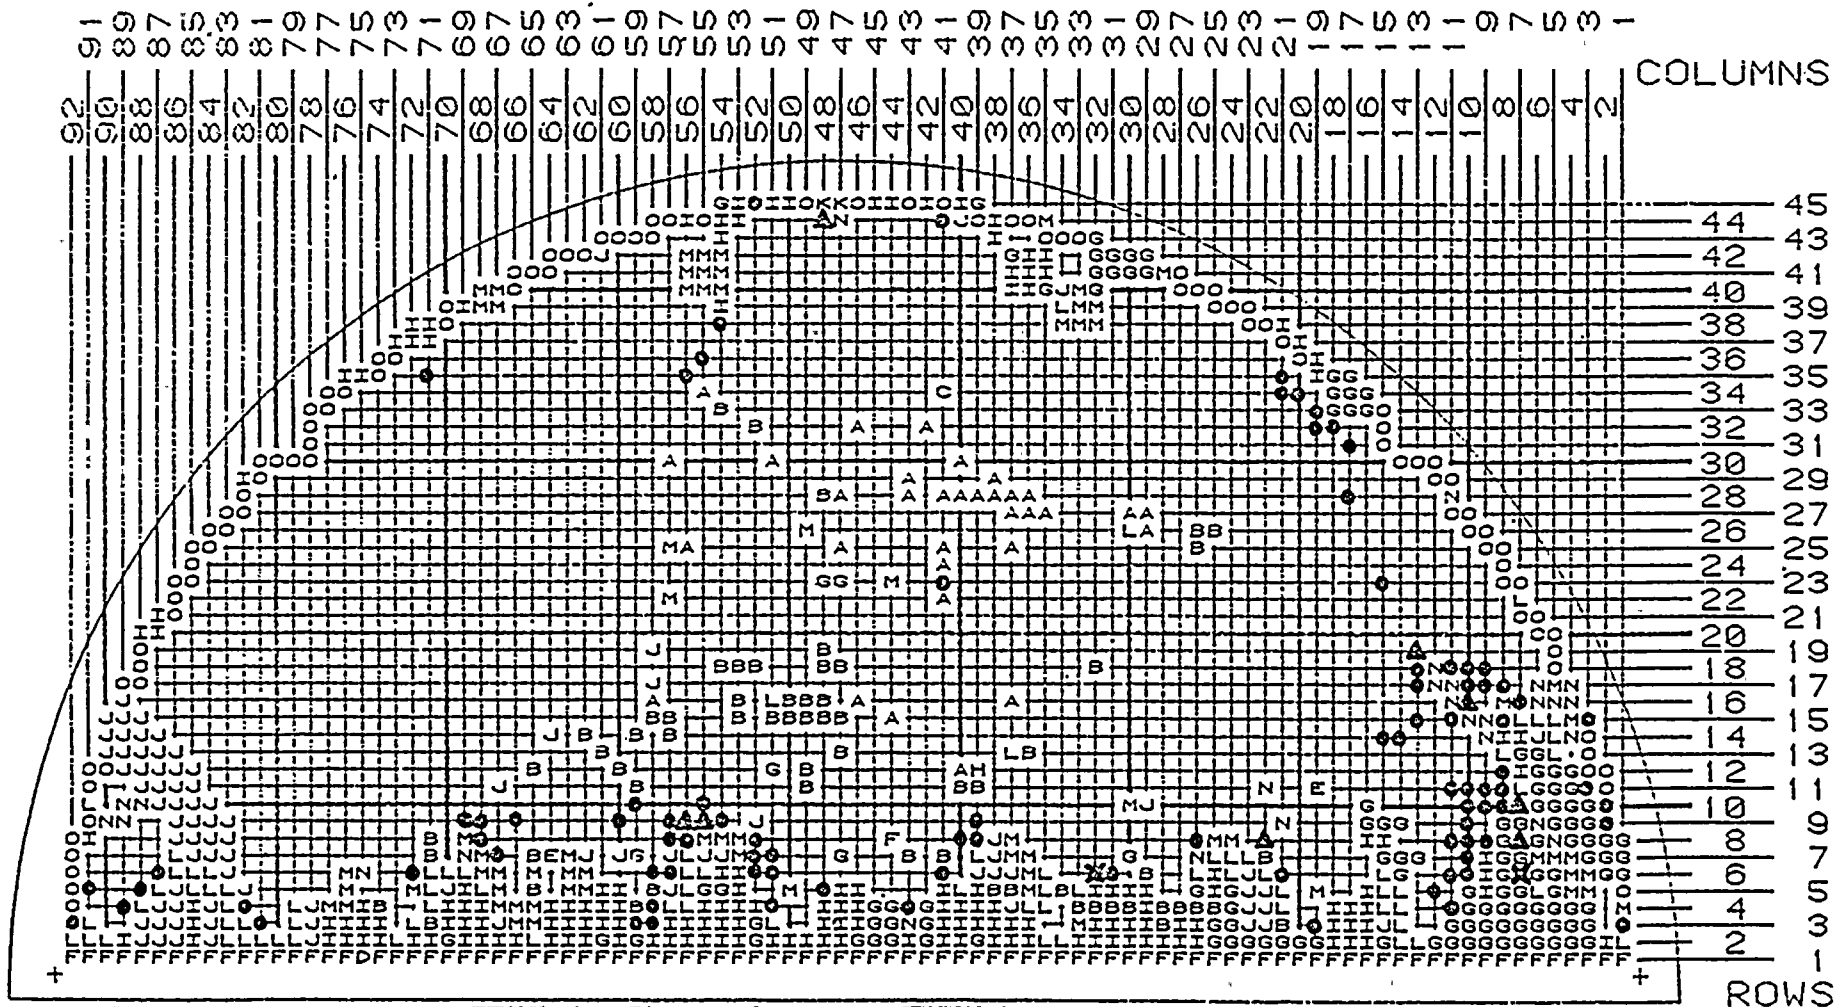
TURKEY POINT UNIT #4
GAUGING RESULTS OCT.-NOV. 1981
STEAM GENERATOR A - INLET

3. Tube restrictions were noted in the wedge areas and the patch plates of all three steam generators; these data appear consistent with previous experience.

4. In steam generator A inlet, 2 tube restrictions appeared away from the pattern of prior inspection results. Both were restricted to passage of the 0.650" probe and passed the next smallest (.610" probe). One of these 0.650" restrictions was located in tube R23-C15 which is located between the 2 o'clock and 3 o'clock wedge regions and may be related to an interactive effect between these regions. The other 0.650" restriction reported away from the previously observed results is in tube R23-C41, located near the center of the tube bundle.

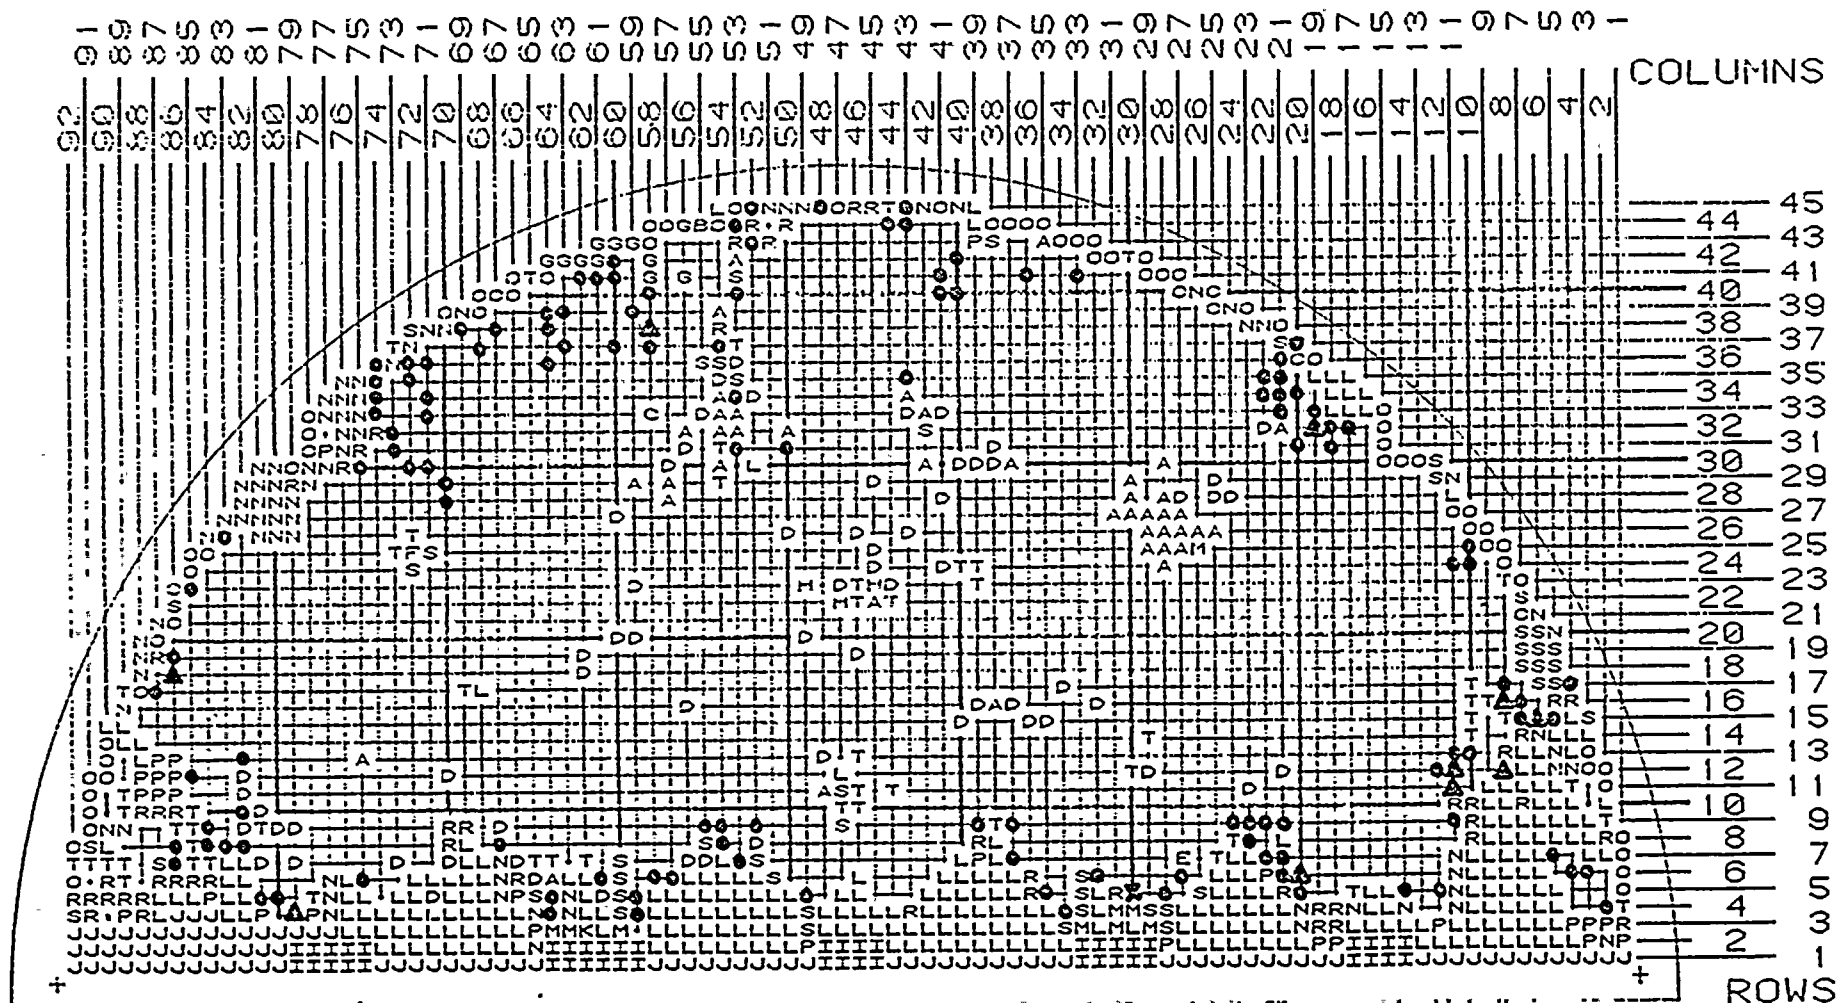
TURKEY POINT UNIT #4
GAUGING RESULTS OCT.-NOV.1981
STEAM GENERATOR B - INLET

5. In the previous inspection (Nov. 1980), four tube restrictions in steam generator B inlet were reported away from the pattern of prior inspection results. Two of the restrictions, R25-C73 (0.650" restriction) and R26-C72 (0.610" restriction), were located immediately adjacent to a tube which had been pulled in September, 1975. No restrictions were reported in tubes immediately adjacent to this area in the present inspection.

The other two steam generator B inlet tube restrictions reported as being located in regions away from the pattern of previous results were R37-C60 and R38-C64 (both 0.650" restrictions), both in an area adjacent to the patch plate. In the present inspection, additional restrictions, ten to the 0.650" probe and one to the 0.610" probe, have been reported in the same general area. It appears that this activity may be related to an interactive effect between the 10 and 11 o'clock wedge areas and the patch plate.

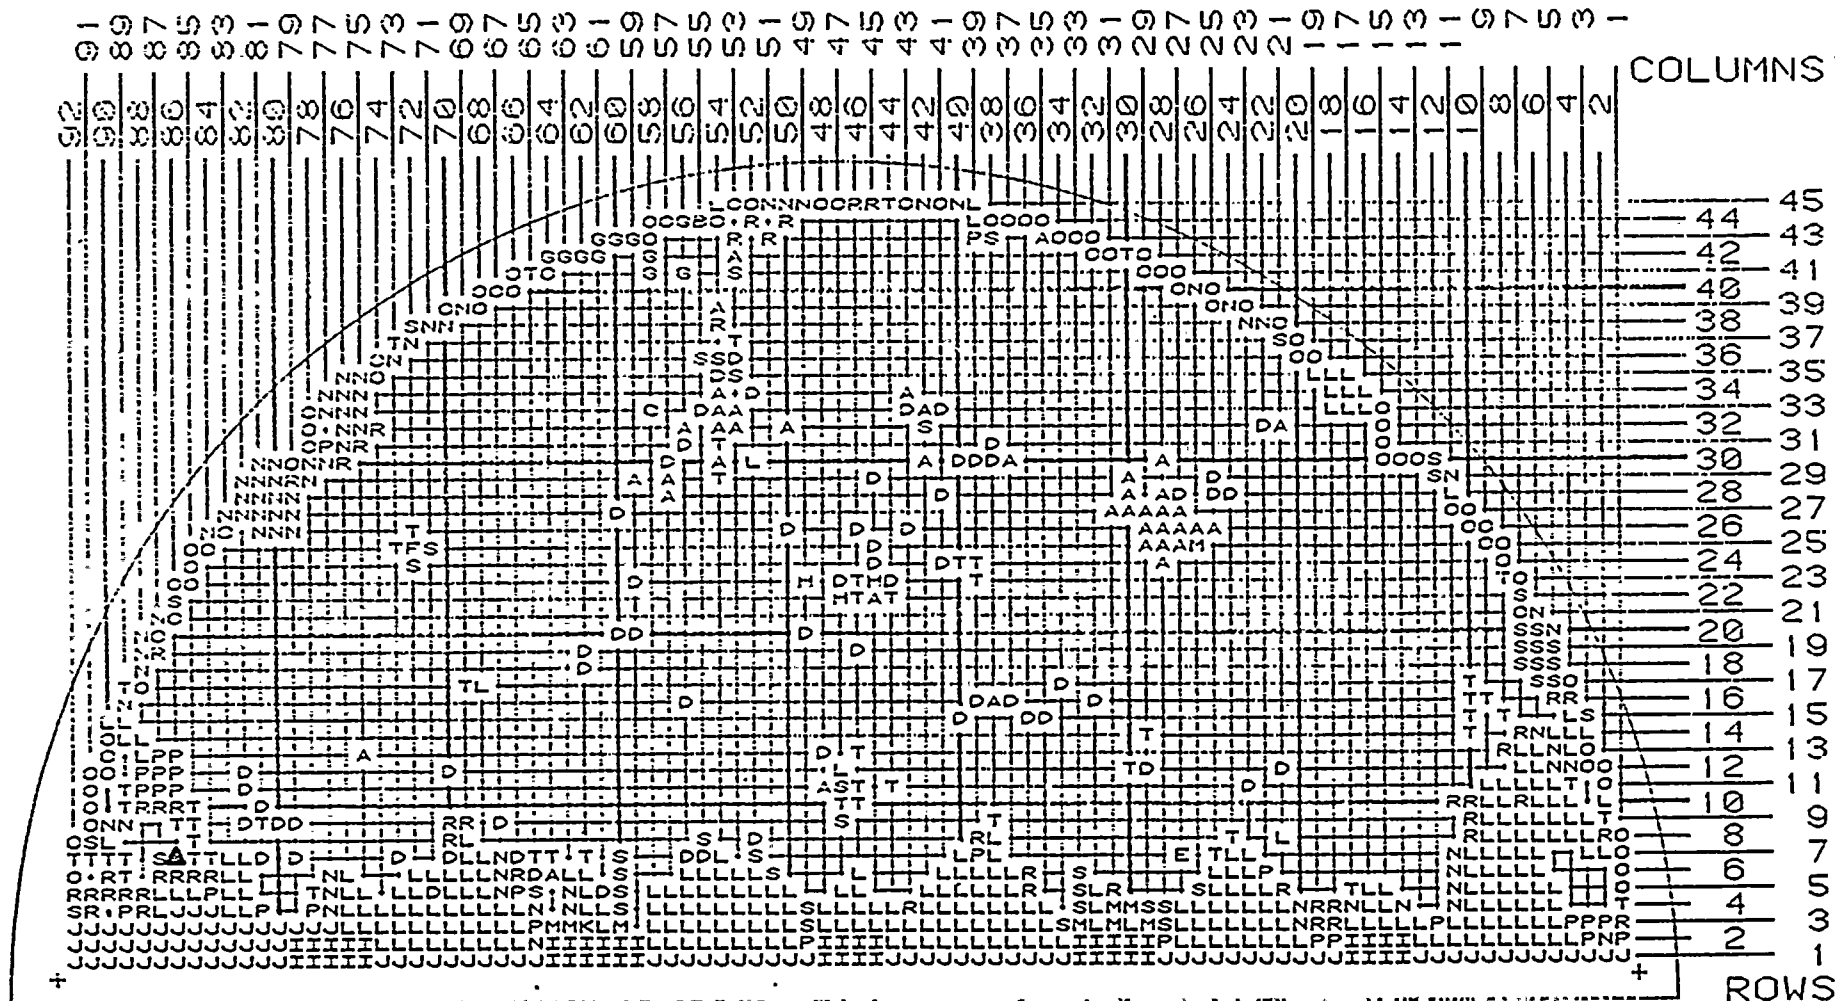
TURKEY POINT UNIT #4
GAUGING RESULTS OCT.-NOV.1981
STEAM GENERATOR.B - OUTLET

TUBE RESTRICTIONS	NO OF TUBES
X=.540 PROBE	None
A=.610 PROBE	1
G=.650 PROBE	Not Tested

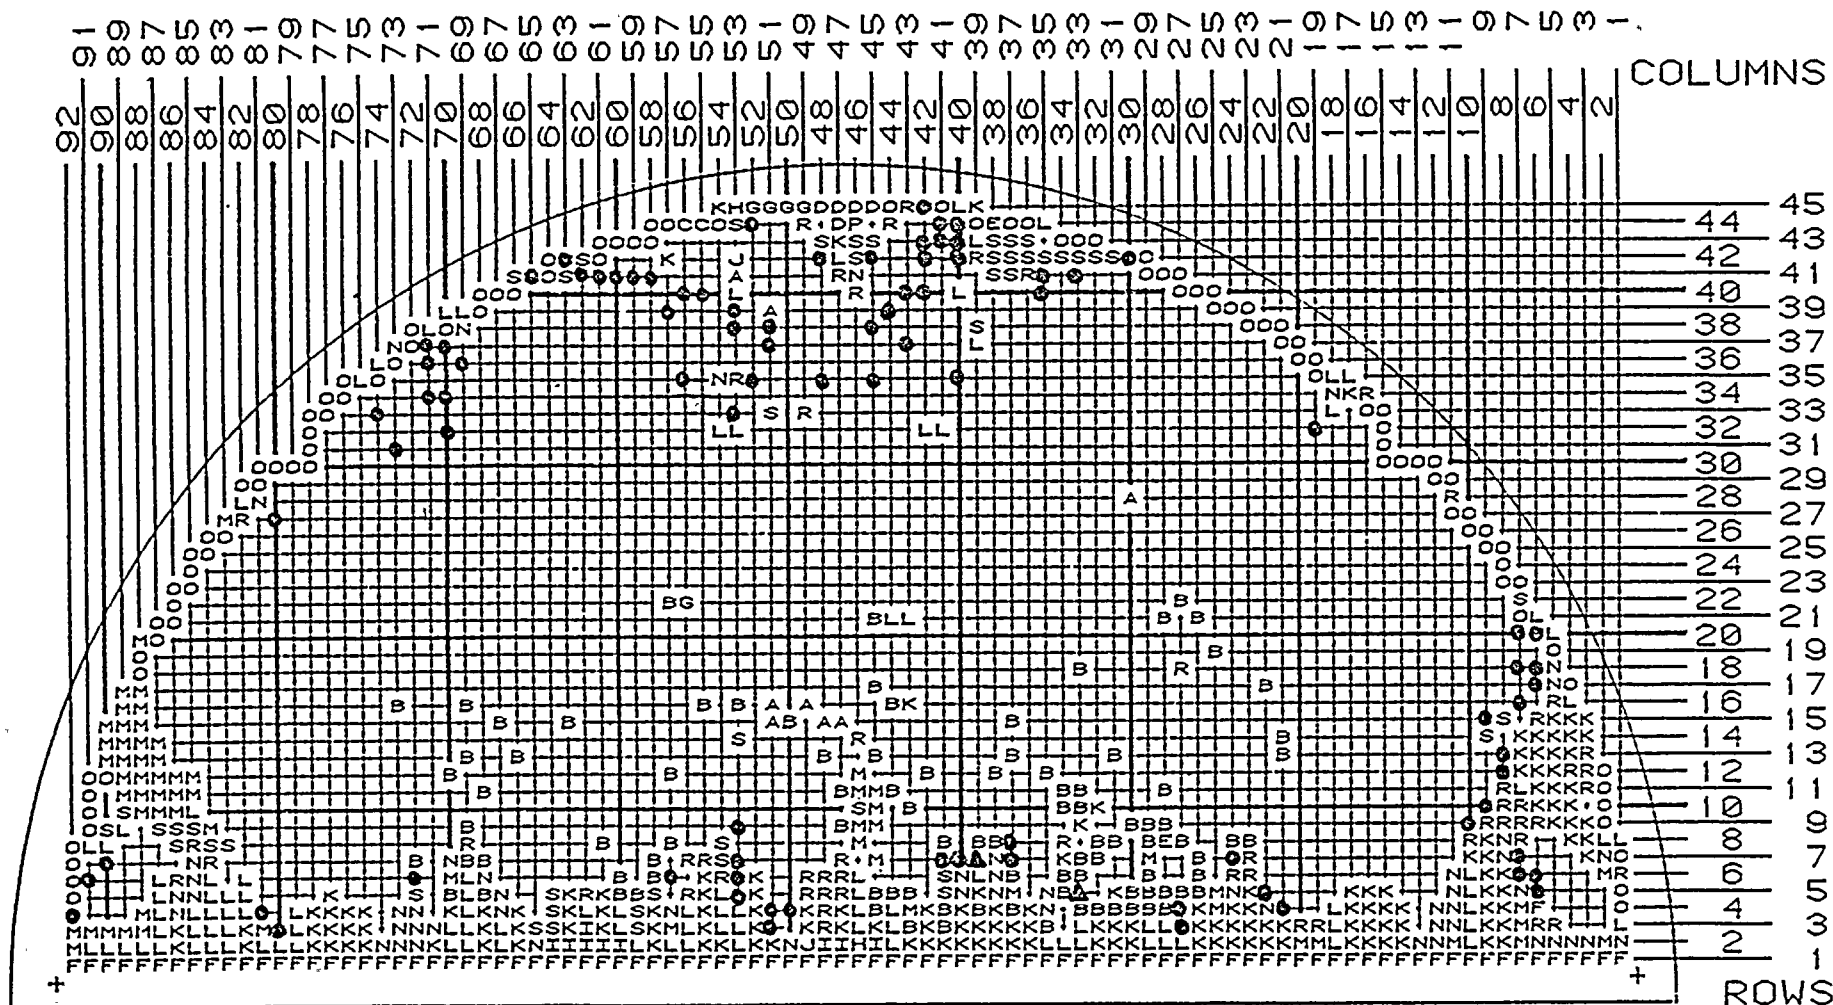
TURKEY POINT UNIT #4
GAUGING RESULTS OCT.-NOV. 1981
STEAM GENERATOR C - INLET

In the November, 1980 inspection, one tube in steam generator C inlet, R35-C56, was reported restricted to the 0.650" probe away from the pattern of prior inspection results, in an area near the patch plate. No additional tube restrictions were reported in the immediate vicinity of this tube in the present inspection.

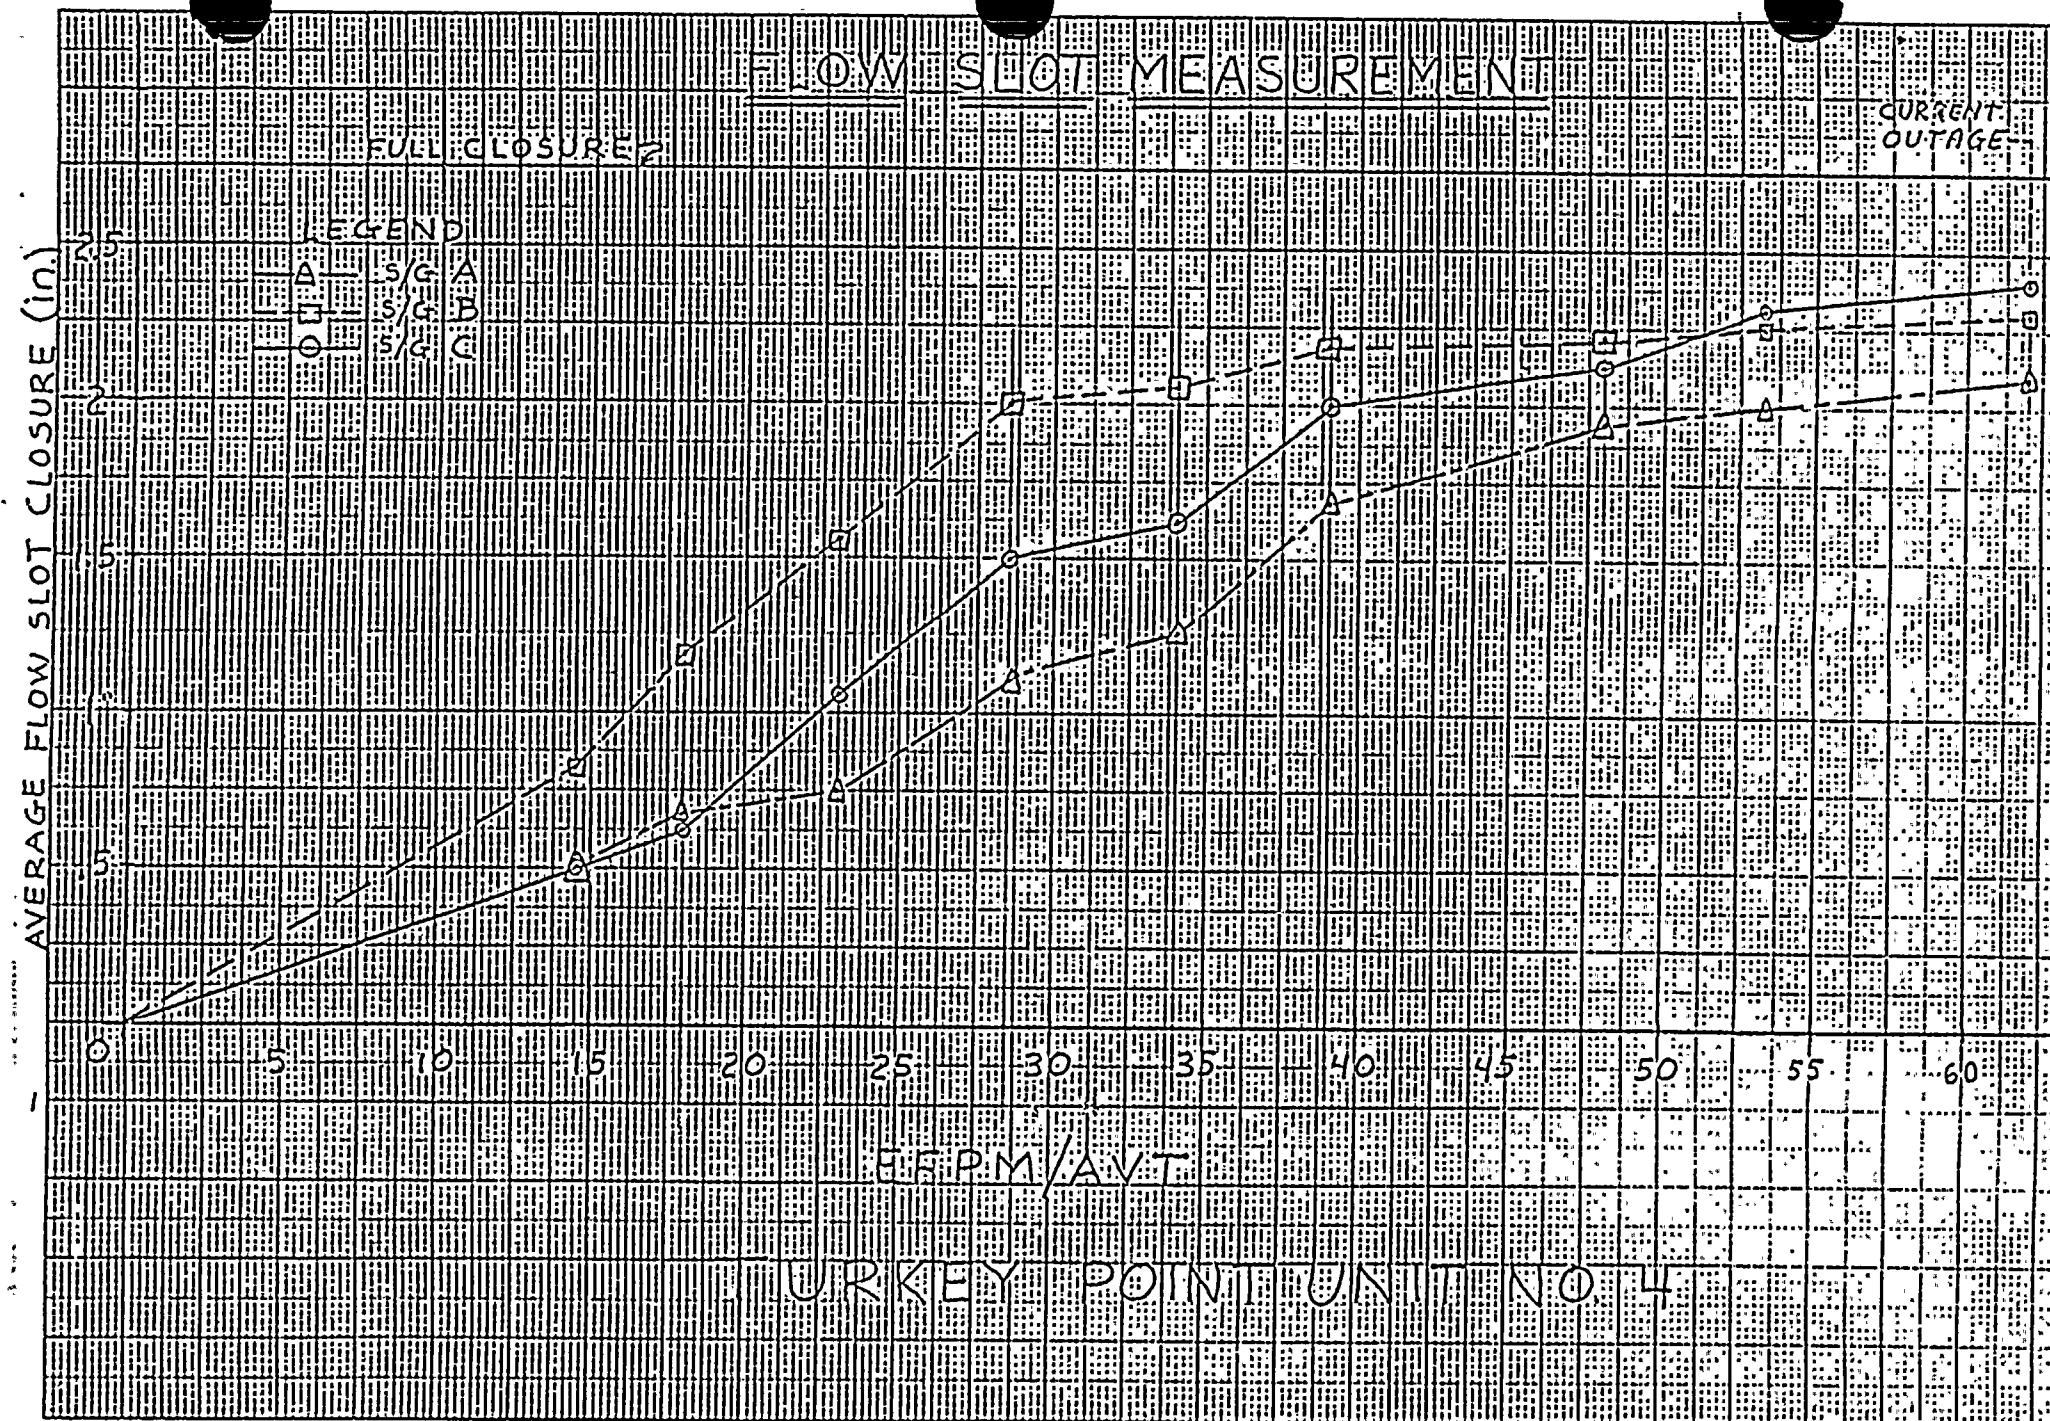
FIG. 22

The results of the #1 TSP flow slot measurements are indicated in Fig. 22. Results are consistent with previous behavior.
