REPORT OF STEAM GENERATOR INSPECTION AND TUBE REPAIR

TURKEY POINT UNIT 4

JULY 1982 OUTAGE

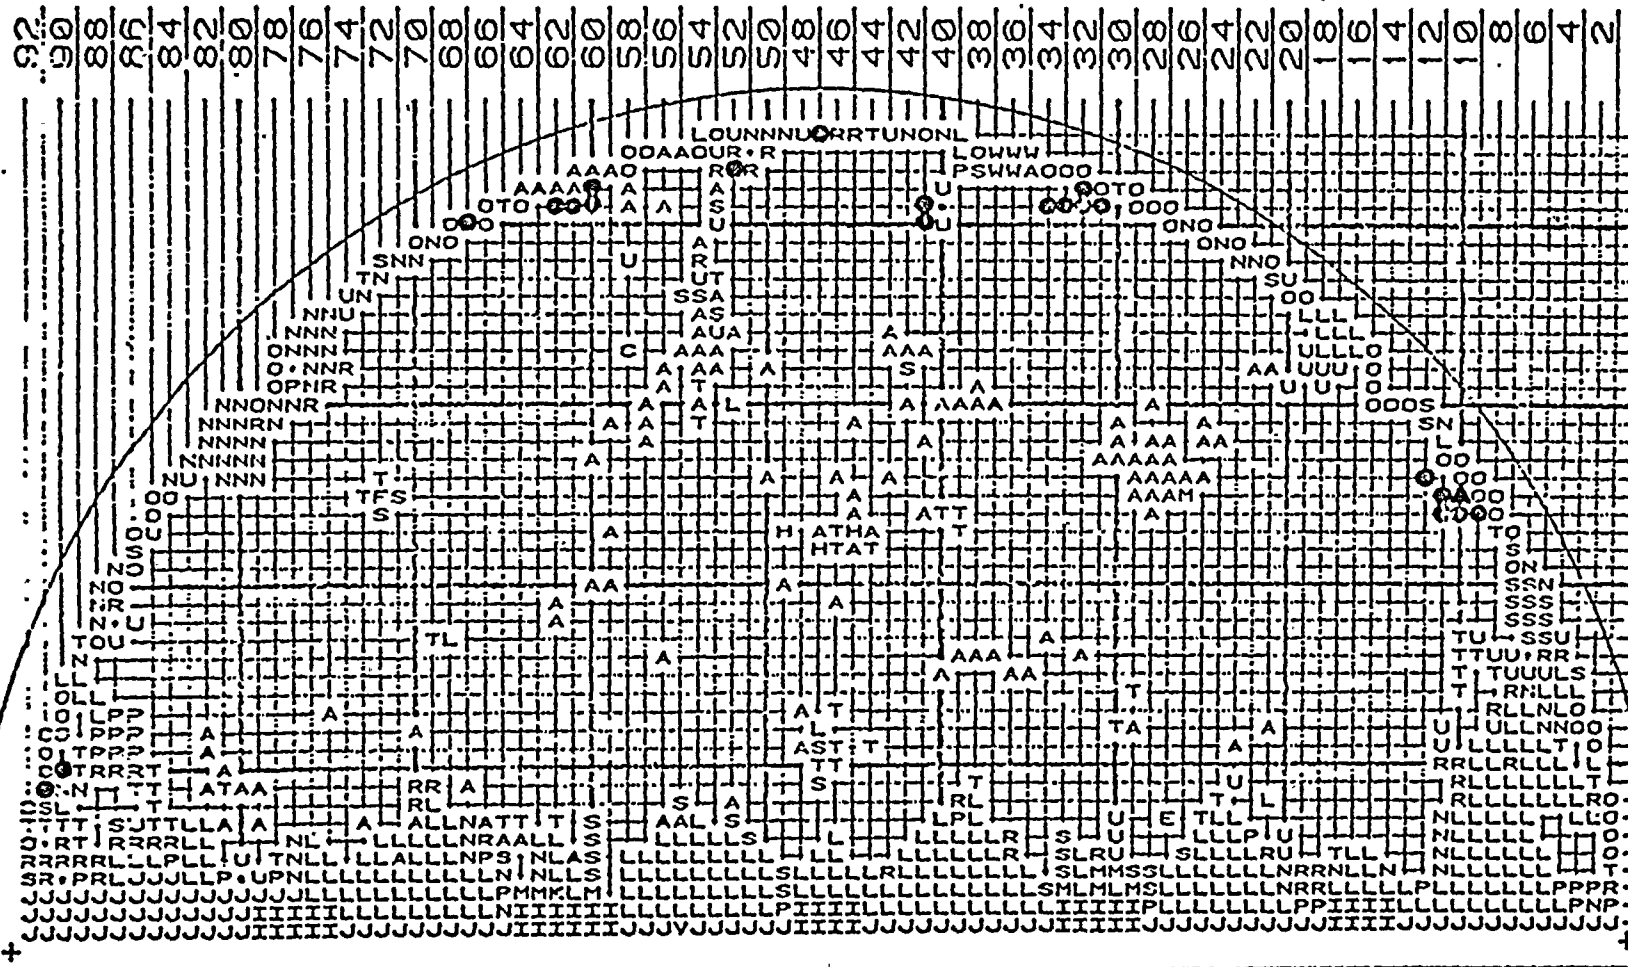
FIGURE 7

B inlet, since the eddy current inspection was initiated in this leg, where the leaker was located, prior to the availability of results of the secondary-side visual examinations. As these results were made available and it became evident that the leak as well as other reported indications and tube damage were associated with foreign objects observed at or near tube sheet elevations, further EC inspections were made only in the region of interest i.e., up to the first tube support plate, in order to reduce unnecessary exposure. The numbers of tubes restricted to the various-sized probes are listed in Table 4. The locations of the 0.650 and 0.610 inch restrictions in Steam Generator B inlet are shown in Figure 7.

TUBE RESTRICTIONS

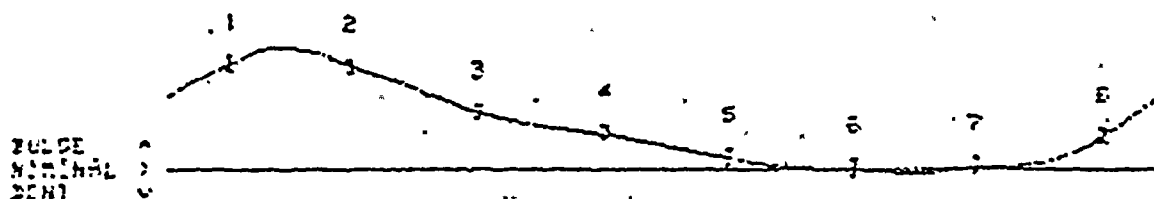
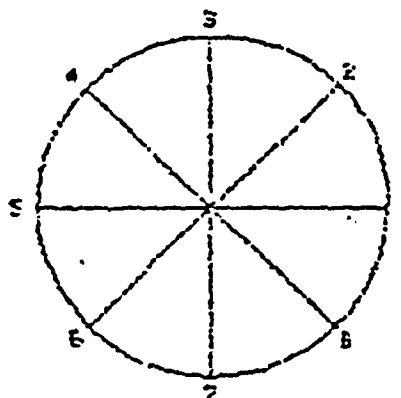
FIGURE 8
 TURKEY POINT UNIT 4
 RESULTS OF PROFILOMETRY INSPECTION
 OF TUBE R44-C57, STEAM
 GENERATOR B, INLET

The five (5) tubes inspected by this method in Steam Generator B were the leaker (R44-C57) and four adjacent tubes (R44-C58, and R43-C55, 57, 58). Evaluation of the profilometric data clearly shows bulges in Tubes R44-C57 and 58, where the largest bulges were observed visually, but does not show bulges in the other three tubes in Steam Generator B. In tube R44-C57, the maximum bulge size (inner diameter) was measured as 0.799 inches. This is 24 mils in excess of the nominal tube I.D. of 0.775 inches. In tube R44-C58, the maximum I.D. of the bulge was measured as 0.802 inches. This is 27 mils in excess of the nominal tube I.D. The orientation of the bulges was in the direction of the tube bundle periphery, where one of the foreign objects was observed lying on the tubesheet. Plots of the resulting data for these two tubes along eight radii at the elevation of the maximum bulge radius are shown in Figures 8 and 9.

MAXIMUM BULGE IN TUBE IS .802 OCCURRING AT BULGE
 PLOTS OF THIS BULGE ARE SHOWN BELOW

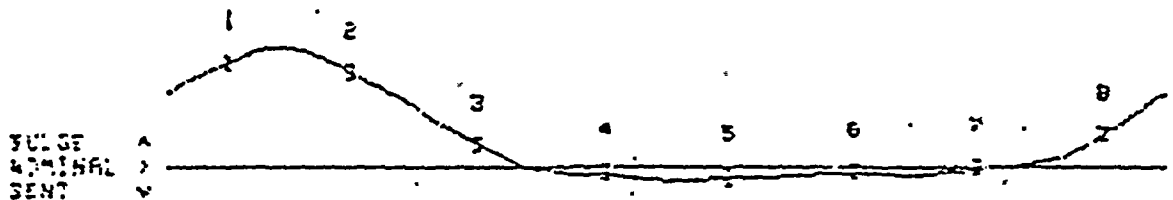
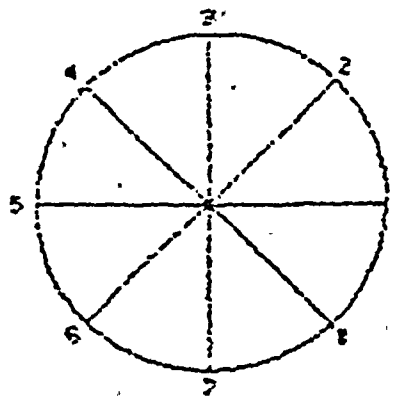
FIGURE 9
 TURKEY POINT UNIT 4
 RESULTS OF PROFILOMETRY INSPECTION
 OF TUBE R44-C58, STEAM GENERATOR B, INLET

MAXIMUM BULGE IN TUBE IS .799 OCCURRING AT BULGE
 PLOTS OF THIS BULGE ARE SHOWN BELOW

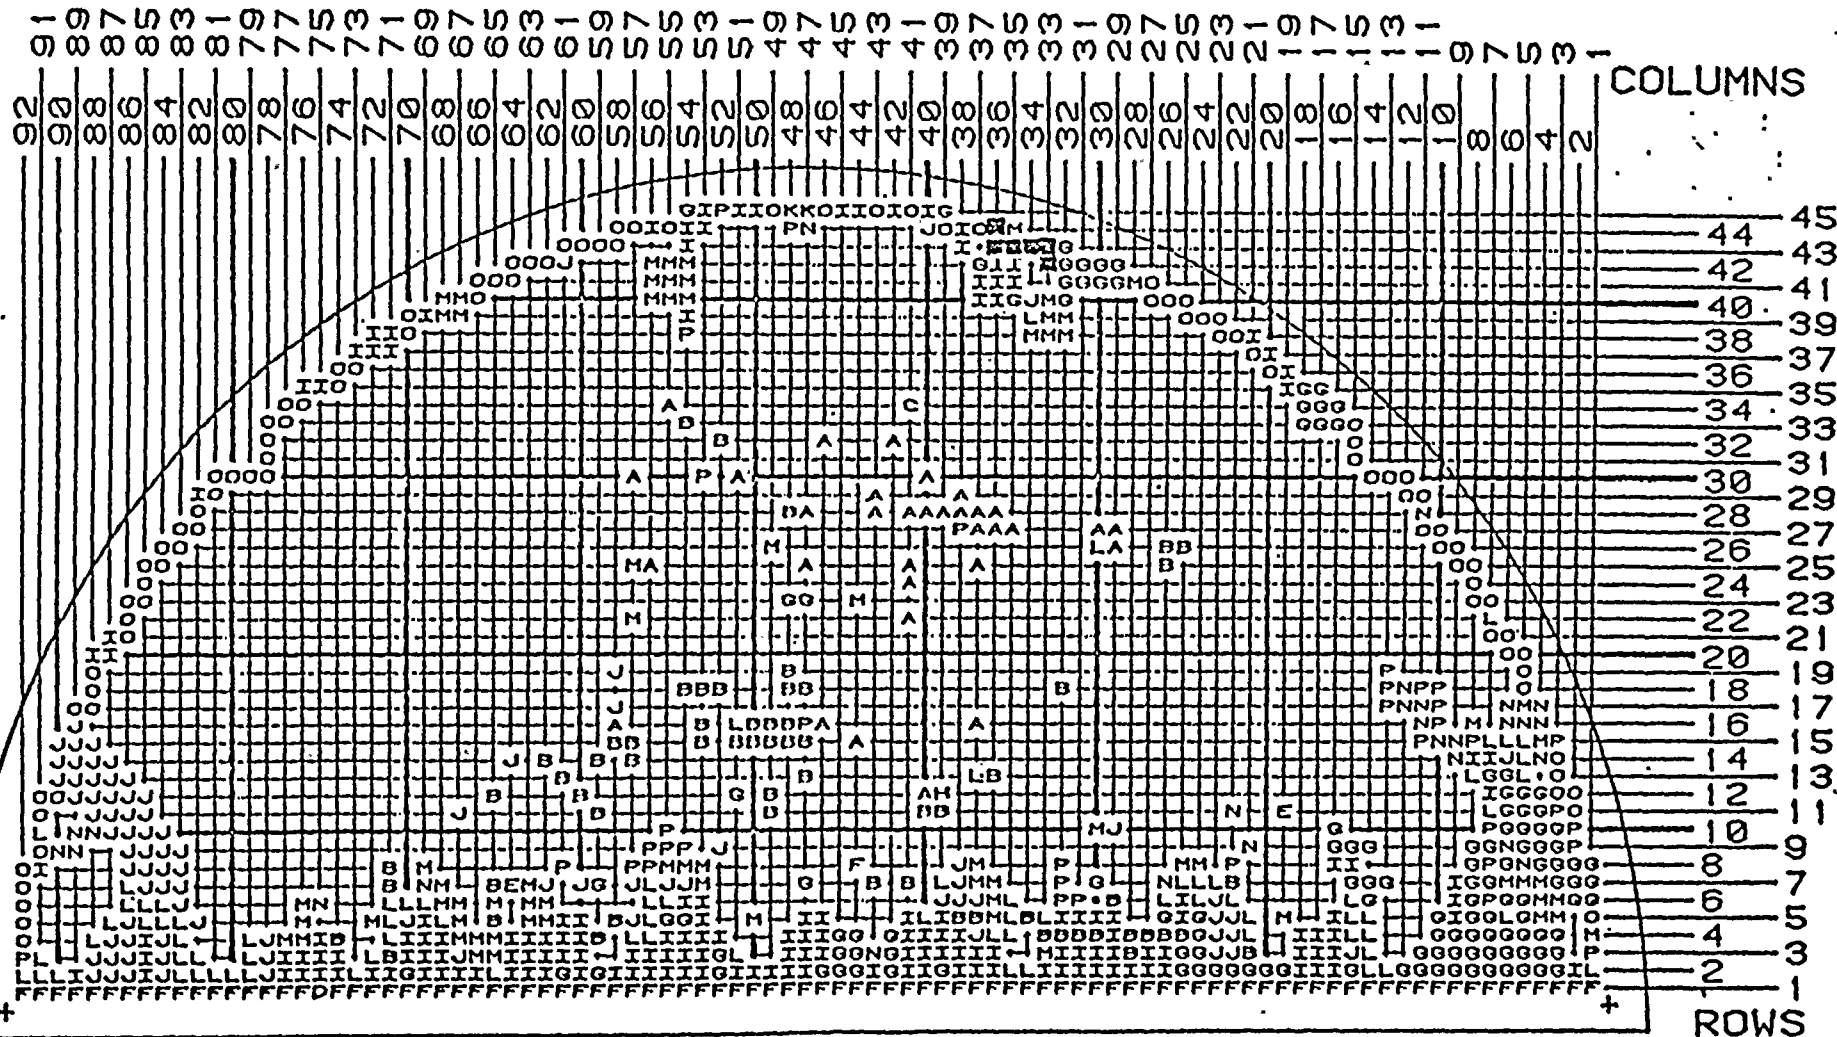
FIGURE 12
TURKEY POINT UNIT 4
STEAM GENERATOR A
JULY, 1982 OUTAGE
RECOMMENDED PLUGGING

Tubes R43-C32, R44-C35: Local wear marks near tubesheet due to loose weld rod: wear pattern about 3/8" long axially and deepest penetration may be approaching through-wall. Both tubes are structurally stable and were previously plugged.

Sentinels: R44-C36, R43-C33-36, R42-C33 (6 total).

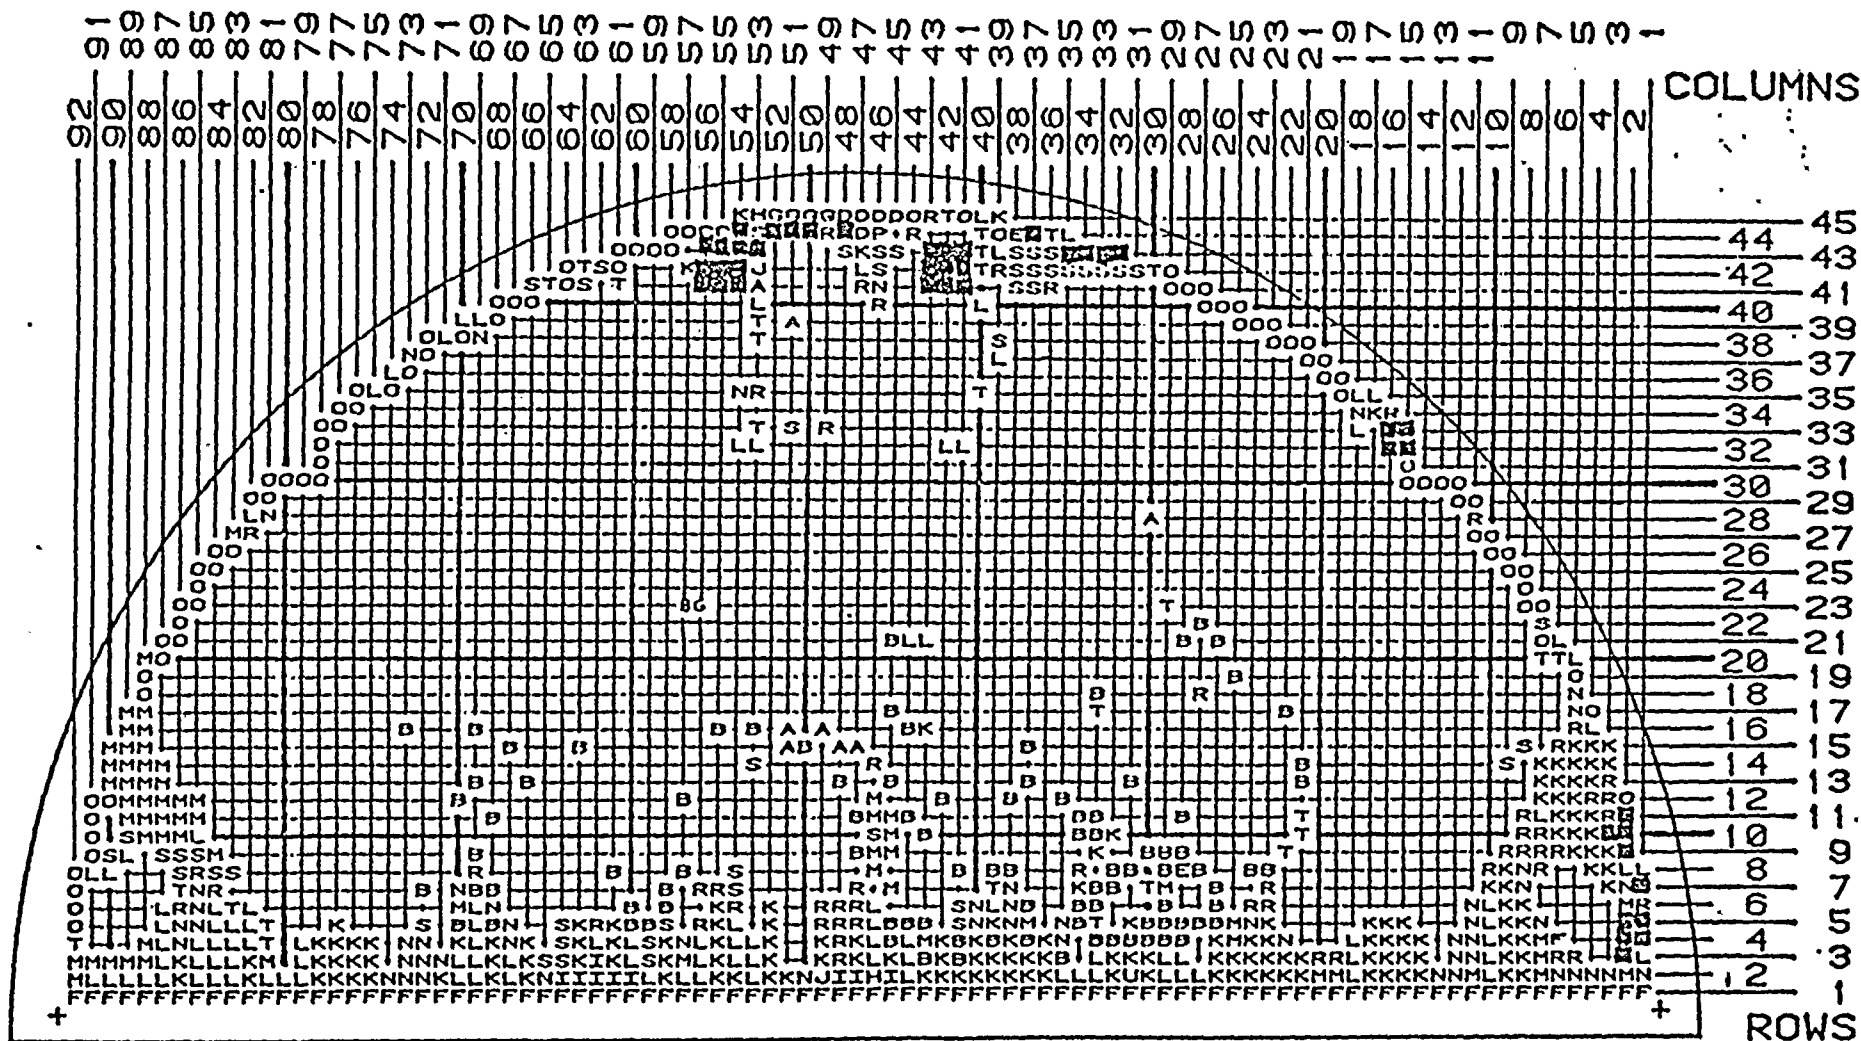
Tubes R45-C51-54, R44-C55: Indented locally due to impacting by a loose pin; damage somewhat more severe than R45-C54 in S/G-B, with possible thru-wall penetrations on R45-C52 and 53.
