SUBJECT: Proposes mod to turbine runback sys, deleting flux rat input.
 Sys prone to spurious runbacks due to single failure of
 single electrical component. Encl safety evaluation discusses
 consequences of single dropped rod control cluster assembly.

Re: Turkey Point Units 3 & 4
Docket No. 50-250 and 50-251
Turbine Runback System

MODIFICATION OF THE TURBINE RUNBACK SYSTEM

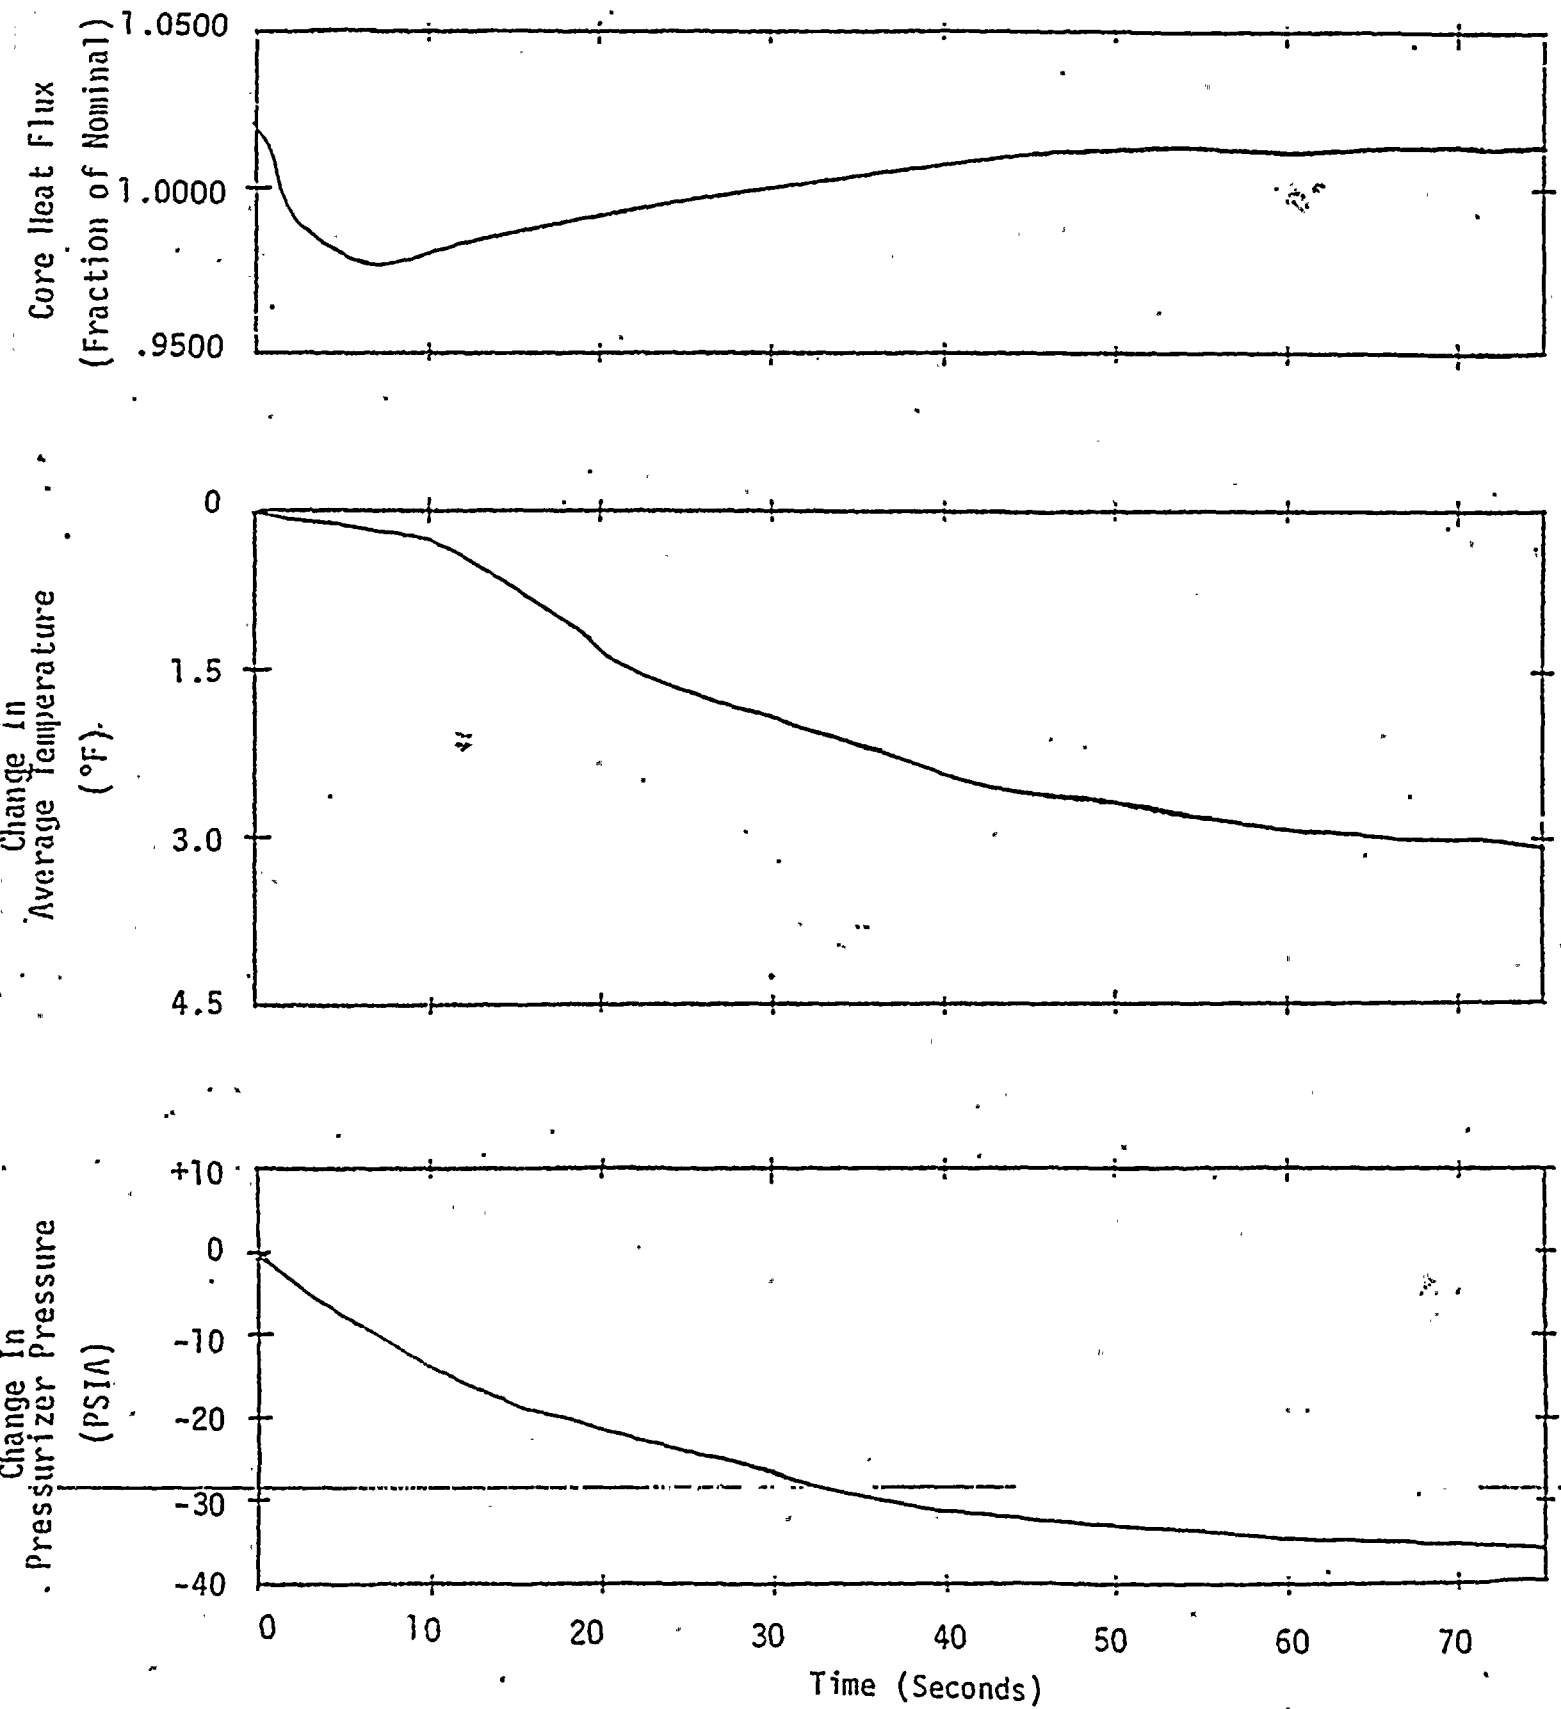
FIGURE 1

Figure 1 illustrates the transient for a typical dropped rod worth of 150 pcm in manual rod control. The core heat flux initially drops and then returns to the initial power level due to reactivity feedback. Temperature and pressure drop to a lower value. New equilibrium conditions are reached with the core at full power and reduced temperature and pressure. These conditions are less limiting than those for which the static full length misalignment of an RCCA is analyzed in the Reload Safety Evaluation for each cycle. In this analysis, the reactor is at full power with nominal temperature and pressure (including uncertainties). At the same power level, the DNBR benefit due to the reduction in temperature which occurs in the transient case more than compensates for the DNBR penalty caused by the transient drop in pressure. Thus, the single dropped RCCA analysis assuming manual rod control and no turbine runback is bounded by static RCCA misalignment. A dropped RCCA in automatic rod control is not bounded by this analysis since a power overshoot above 102% could occur.
