**TURKEY POINT UNIT 4  
FLUX MAP THIMBLE TUBE  
EDDY CURRENT TEST REPORT  
FOR  
NRC BULLETIN 88-09**

## Introduction

An eddy current examination (ECT) of the Turkey Point Unit 4 flux map thimble tubes was performed during the Cycle XI to Cycle XII refueling outage. The examination was performed by the Florida Power and Light (FPL) Materials, Codes, and Inspections group using standard eddy current techniques. The results showed that none of the thimble tubes required immediate replacement or repositioning.

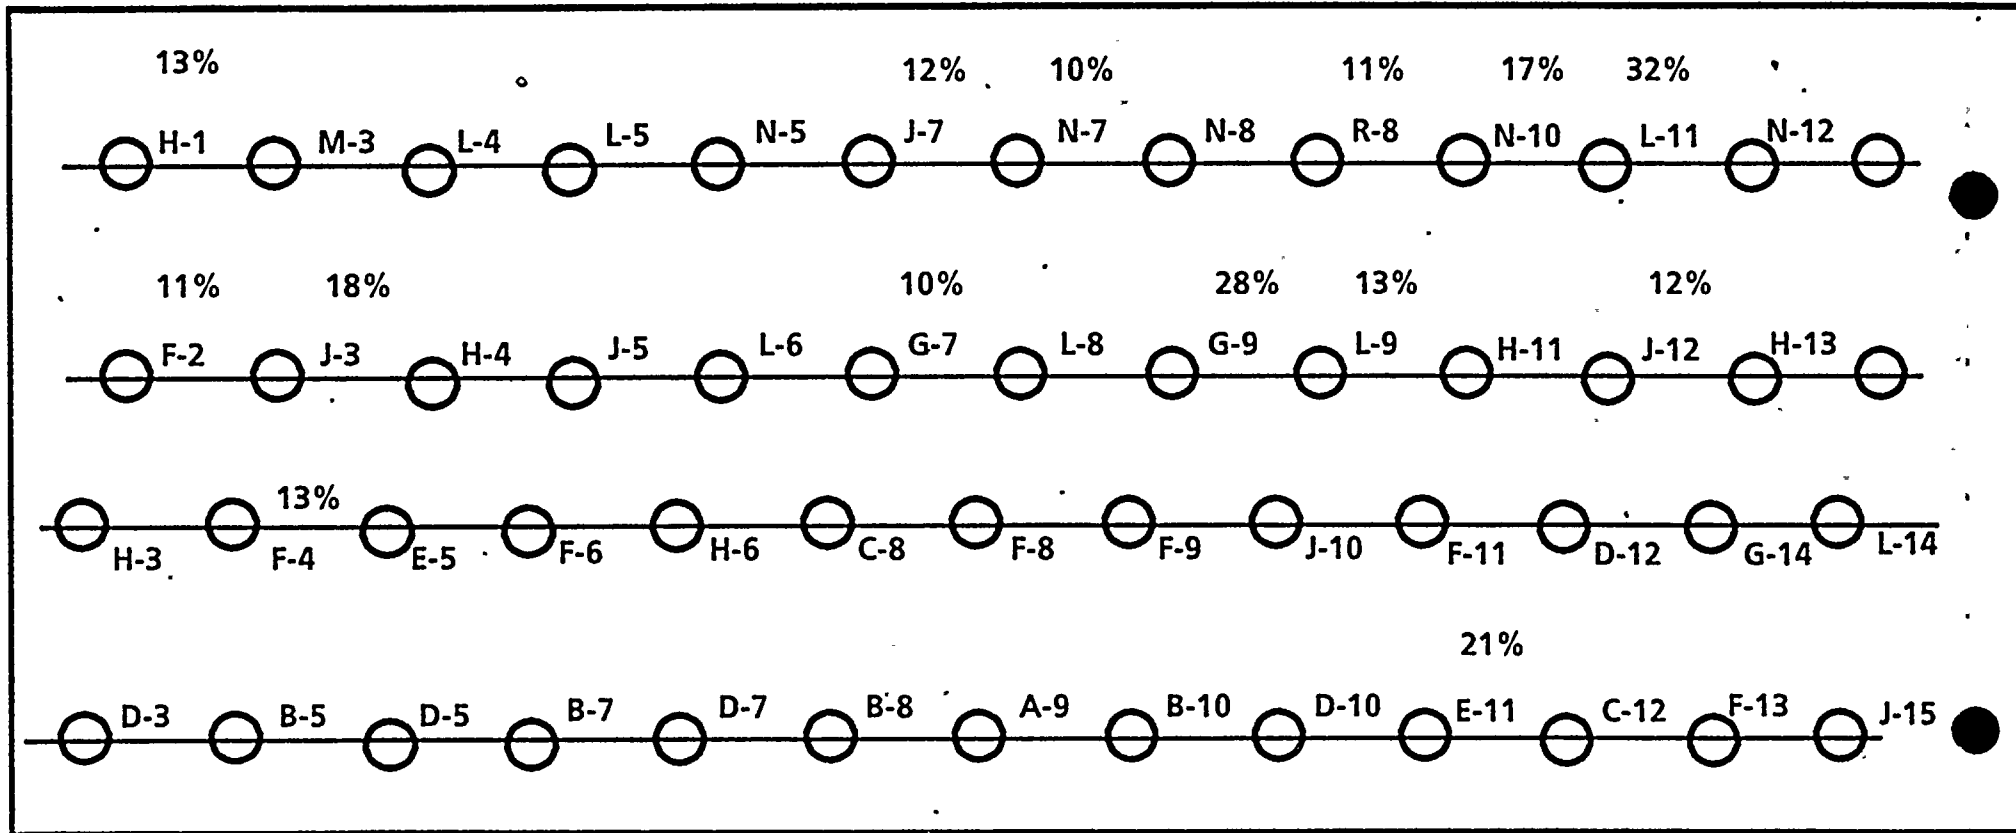
## ATTACHMENT 2

The ECT data was analyzed by the FPL Materials, Codes, and Inspections group to determine the percent wall loss and wear scar length for each thimble tube. The results from the data analysis identified the thimble tube locations with 10% or greater wall loss. A total of 13 thimble tubes showed a wall loss of 10% or more. Two of these thimble tubes showed a wall loss exceeding the test acceptance criteria of 23%, with the worst location indicating a 32% wall loss.

#### Seal Table Location of Flux Map Thimble Tube Inspection Results

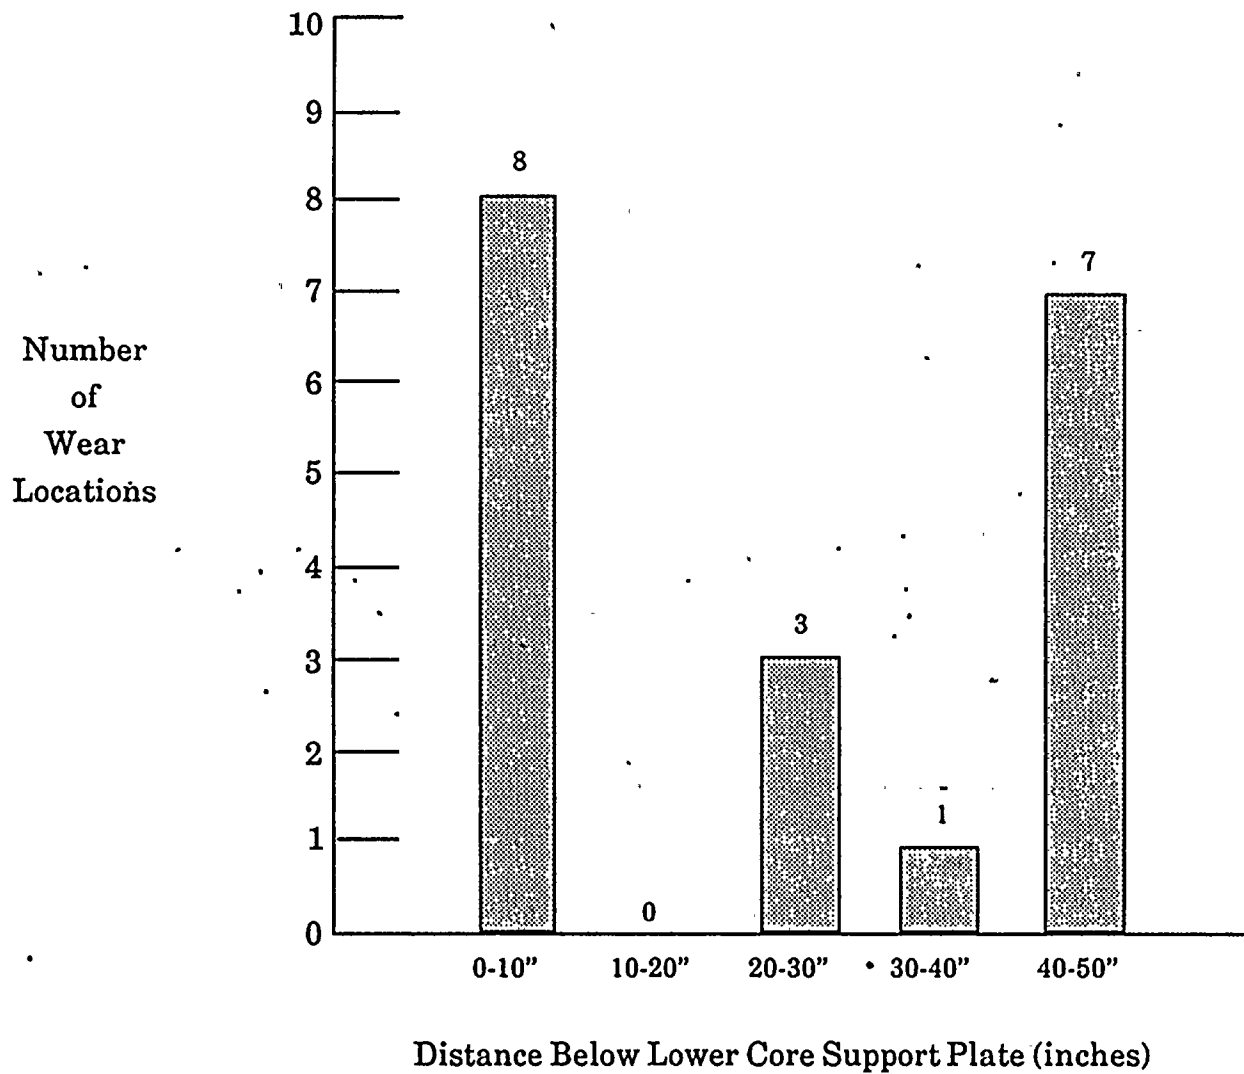
### ATTACHMENT 3

#### Turkey Point Unit 4 Cycle XI to Cycle XII Chart of Wear Locations of Flux Map Thimble Tube Inspection Results
