SUBJECT: LER 89-009-00: on 890320, both channels of boric acid piping
 heat tracing inoperable.

LICENSEE EVENT REPORT (LER)

FACILITY NAME (1) Turkey Point Unit 3										DOCKET NUMBER (2) 0 5 0 0 0 2 5 0										PAGE (3) 1 OF 14										
TITLE (4) Both Channels of Boric Acid Piping Heat Tracing Inoperable																														
EVENT DATE (5)						LER NUMBER (6)						REPORT DATE (7)						OTHER FACILITIES INVOLVED (8)												
MONTH	DAY	YEAR	YEAR	SEQUENTIAL NUMBER	REVISION NUMBER	MONTH	DAY	YEAR	FACILITY NAMES						DOCKET NUMBER(S)															
0	3	2	0	8	9	8	9	0	0	8	0	0	0	4	1	9	8	9	Turkey Point Unit 4						0 5 0 0 0 2 5 1					
OPERATING MODE (9) 1						THIS REPORT IS SUBMITTED PURSUANT TO THE REQUIREMENTS OF 10 CFR §: (Check one or more of the following) (11)																								
POWER LEVEL (10) 0 7 4						20.402(b)						20.405(c)						50.73(a)(2)(iv)						73.71(b)

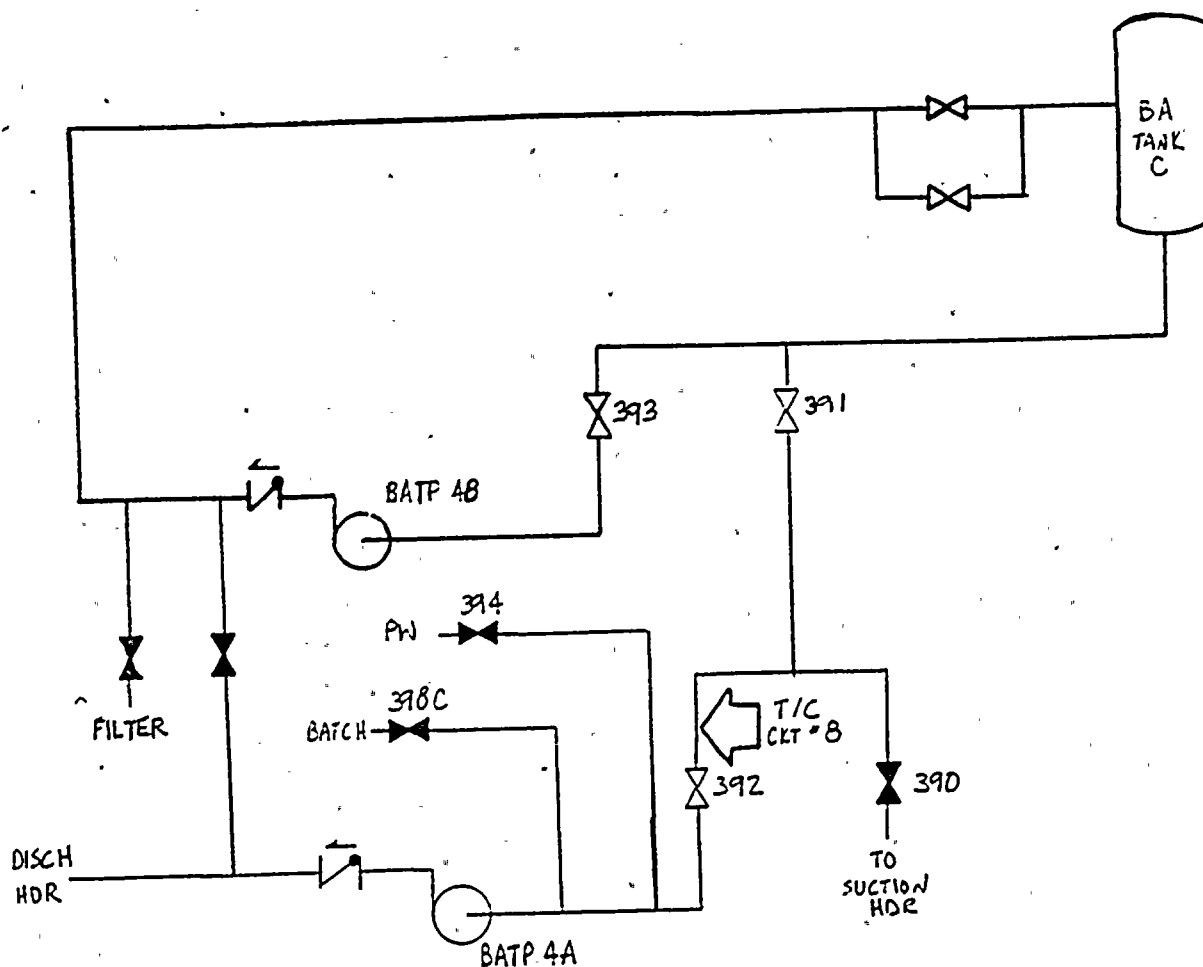
Four root causes have been postulated. First is the possibility that (relatively) cold water was drawn back into the suction header through the OOS 4A transfer pump. Investigation has thus far been inconclusive. Although the pump was OOS, its own heat trace circuit was apparently re-energized on March 18 following post-maintenance testing. This would have precluded the postulated cold water slug in the pump casing. A second and similar possibility is that cold water was drawn into the suction header from the Primary Water system (EIIS:KC) through a leaking isolation valve (394). A third possibility is that either of two isolation valves (394 or 398C) may have leaking diaphragms, allowing air inleakage around the stem into the suction header. The fourth possibility is that one or more sections of an individual heat trace circuit may be failed. A one-line drawing of the 4A and 4B transfer pumps, the C storage tank, and associated piping is attached for reference.

- 1) The two isolation valves (394 and 398C) will be disassembled for inspection of their diaphragms, and repaired as necessary. This action will be completed by April 30, 1989.
- 2) If Corrective Action (1) is inconclusive, thermography techniques will be applied to suspect areas of Circuit #8 and adjacent circuits, to determine if a particular section of a circuit is failed. Faulty sections will be repaired or replaced. This action will be completed by May 15, 1989.
