Prairie Island Nuclear Generating Plant, Unit 2
Docket No. 50-306
Renewed Facility Operating License No. DPR-60

LER 50-306/2017-002-00, Reactor Coolant System Shutdown Communication Line Vent
Through Wall Defect

Licensee Event Report 50-306/2017-002-00

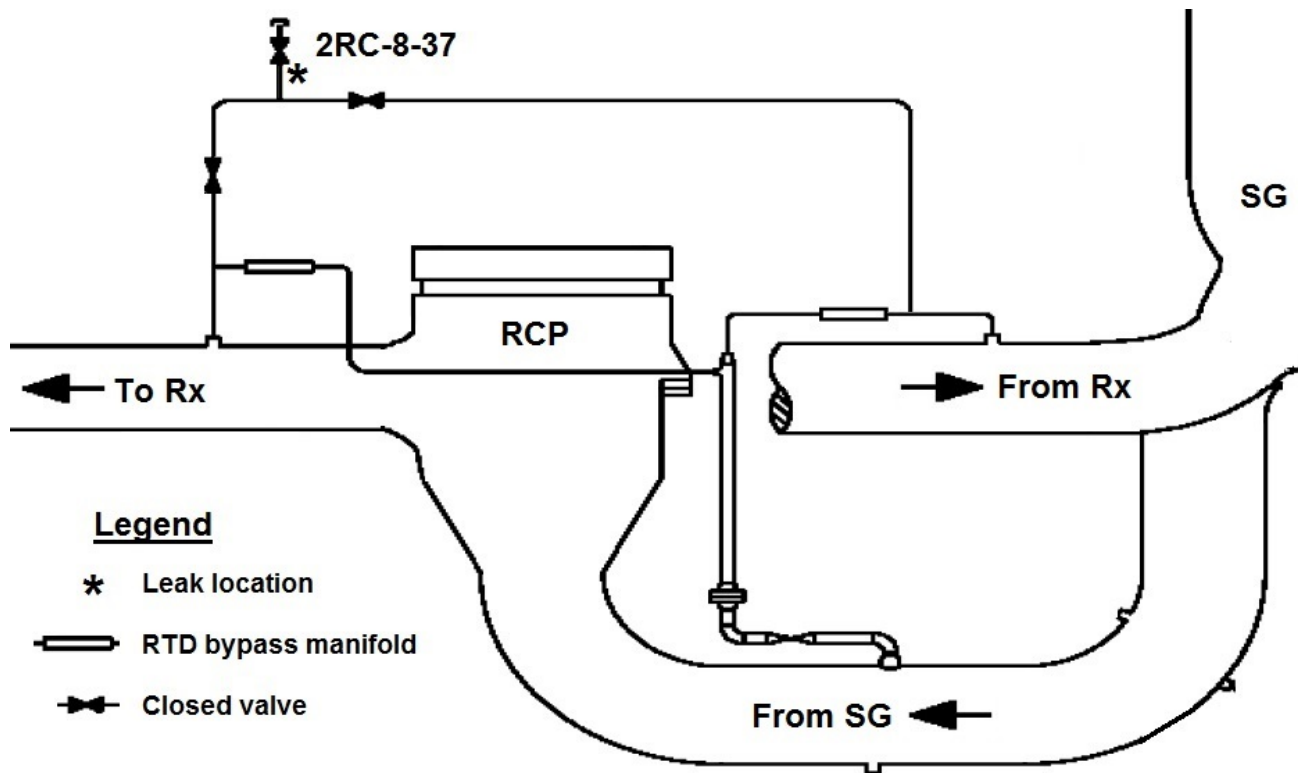
Figure

There was no actual safety consequence associated with this event. The quantity of dry boric acid at the location was small (estimated at 1/2 teaspoon in volume). Even if the weld had experienced a complete circumferential failure, the leak was isolated by closed valves that would have limited primary coolant leakage to within the capacity of the charging system when the reactor coolant system was pressurized (see figure next page).
