# 2017 Annual Site Inspection and Monitoring Report for Uranium Mill Tailings Radiation Control Act Title II Disposal Sites

December 2017

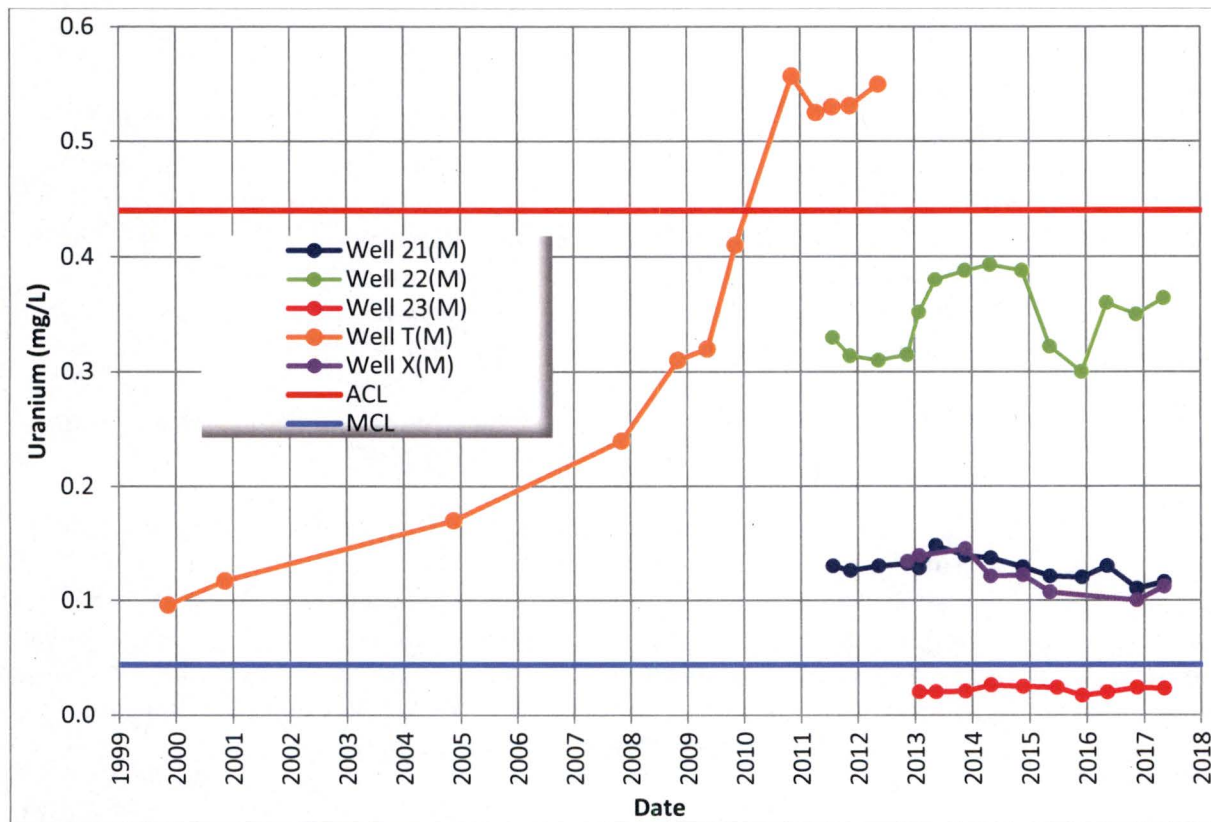
Figure 1-4. Uranium Concentrations in Alluvial Aquifer POC Well T(M) and Downgradient Wells at the Bluewater, New Mexico, Disposal Site

wells, shown in Figure 1-4, continue to exceed the UMTRCA MCL of 0.044 mg/L (40 CFR 192, Table 1) and the State of New Mexico drinking water standard of 0.03 mg/L. The elevated uranium concentrations in well 21(M) and POE well X(M) indicate that alluvial groundwater with uranium concentrations exceeding the drinking water standard is leaving the site.

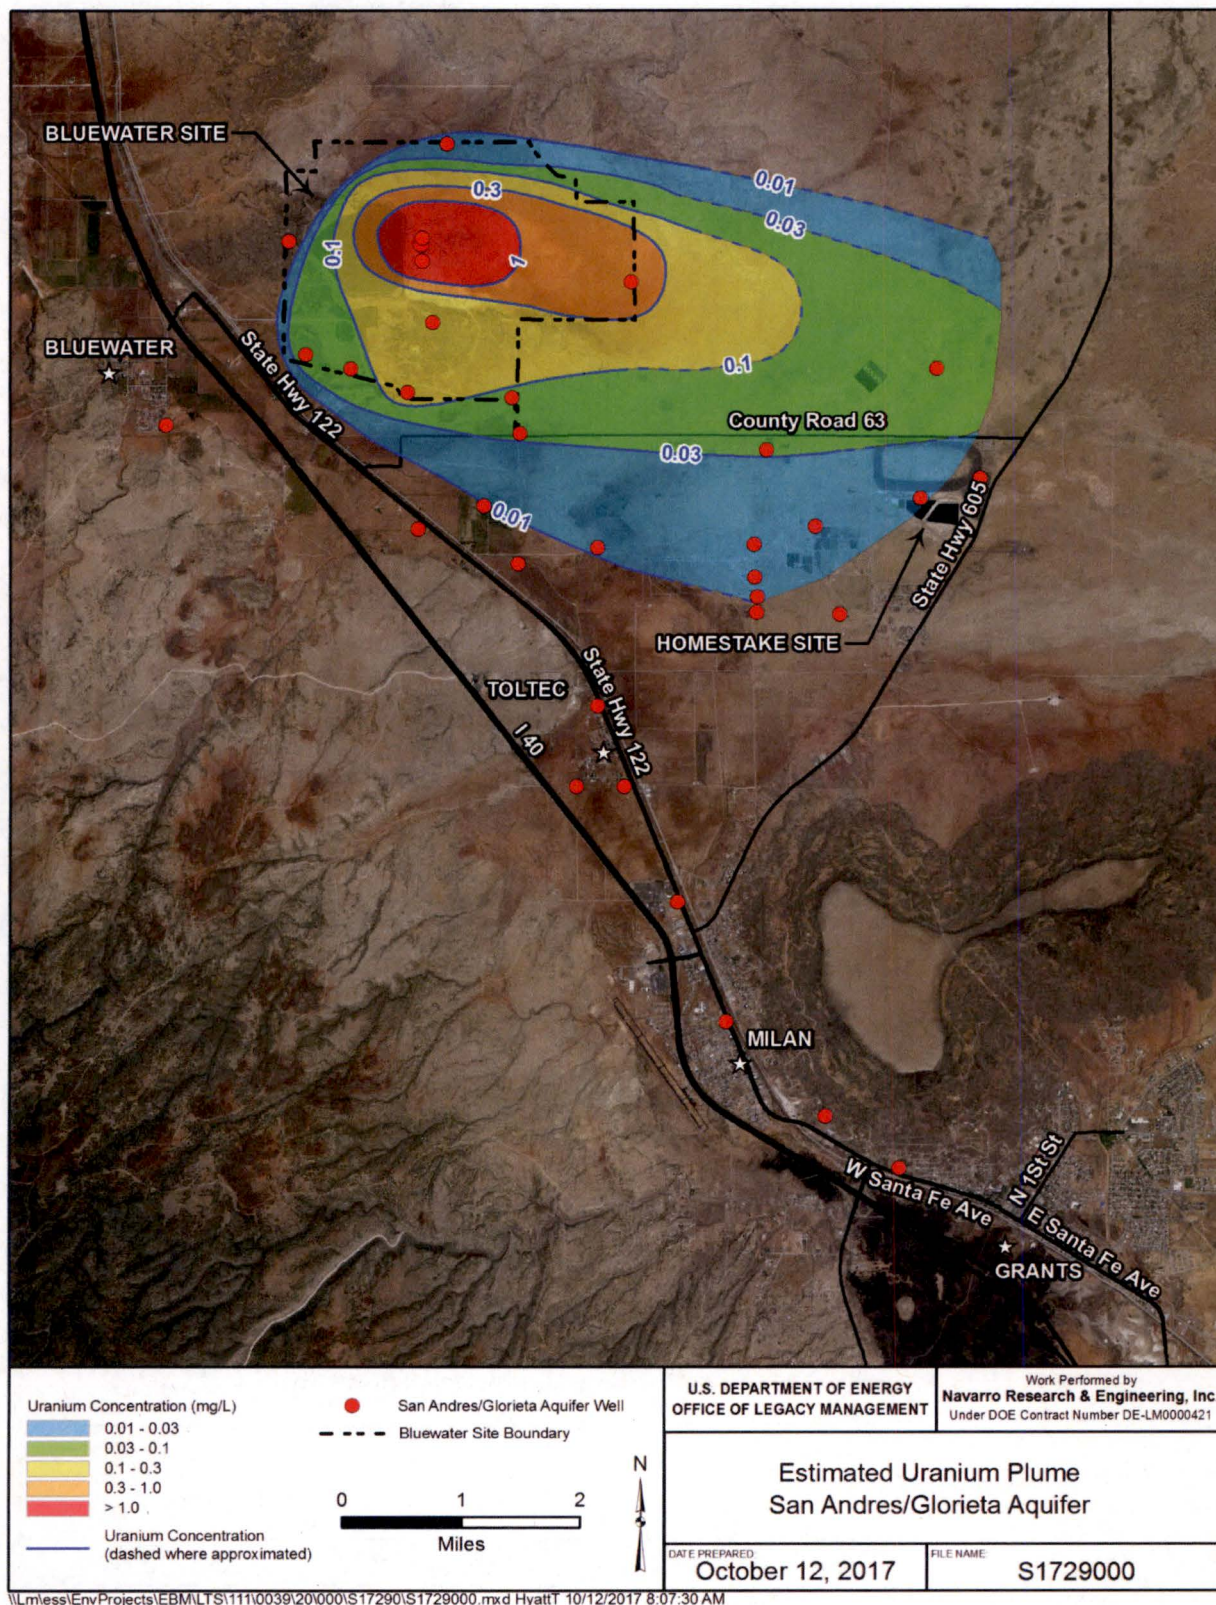
Figure 1-7. 2014 Estimated Uranium Plume in the San Andres/Glorieta Aquifer (DOE 2014)

The estimated extent of the uranium plume, described in the conceptual groundwater model (DOE 2014), is shown in Figure 1-7. The uranium plume follows the groundwater flow path, and the leading portion is near the Homestake site. The blue area on the figure represents impacted groundwater with uranium concentrations between the site background concentration of 0.01 mg/L and the New Mexico drinking water standard of 0.03 mg/L. Groundwater monitoring results obtained by various entities over the last several decades indicate that uranium contamination from Bluewater mill operations reached the Homestake site by 1980 and that the plume has essentially stabilized. Uranium concentrations attenuate with distance from the site primarily through dispersion instead of chemical reduction because of the absence of a reducing environment in the aquifer formations (DOE 2014). No known drinking water wells are completed within the uranium plume, and site-derived uranium contamination in the San Andres/Glorieta aquifer is not expected to impact the Milan or Grants municipal water supplies. The extent of the plume and potential impacts to existing wells will be reevaluated in 2018.

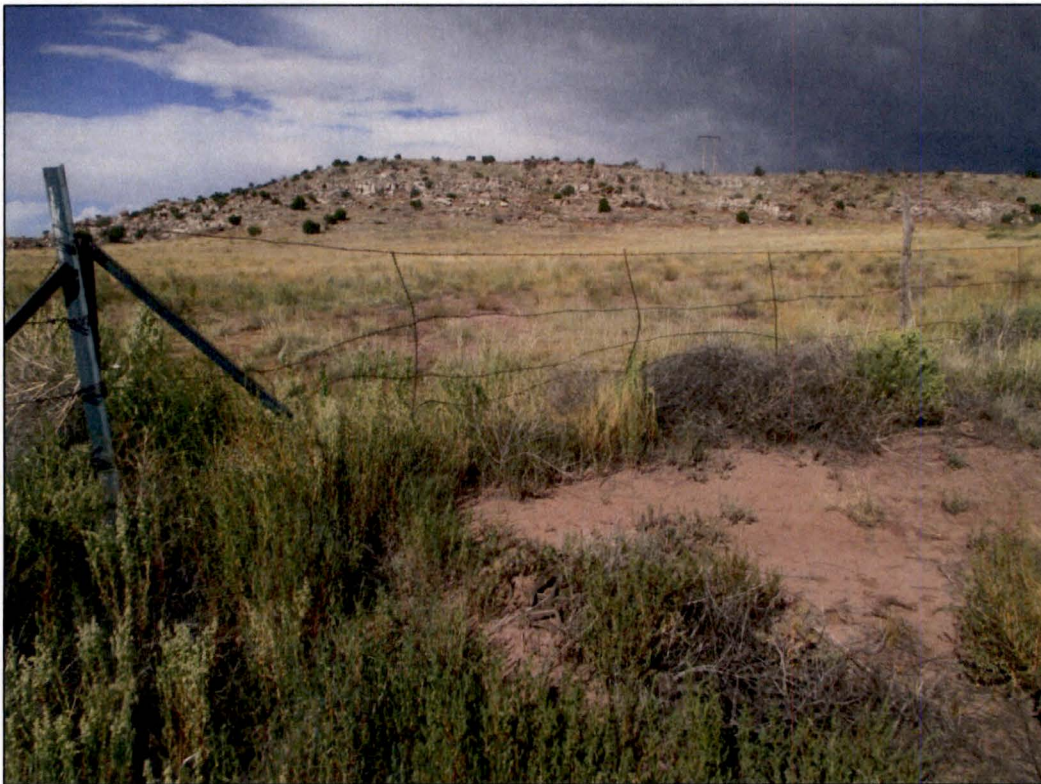
A four-strand barbed-wire fence encloses the site to facilitate land management by DOE, which retained a local subcontractor to periodically check the site perimeter fence and to remove trespassing cattle. Minor fence repairs are conducted as needed. Numerous sections of the fence are in remote areas of the site and cannot be observed from site access roads. The entire perimeter fence was inspected in spring 2016, and no maintenance needs were identified at that time. Loose strands were observed during the inspection near perimeter sign P7 (PL-1) and were repaired after the inspection.

*PL-1. Loose Fence Strands Near Perimeter Sign P7*

Loose fence strands were repaired. Scattered tamarisk shrubs and other noxious weeds were treated with herbicide. Small depressions near the perimeter of the asbestos disposal area and a small settlement area on Disposal Area No. 1 will be repaired in 2018. No other maintenance needs were identified.

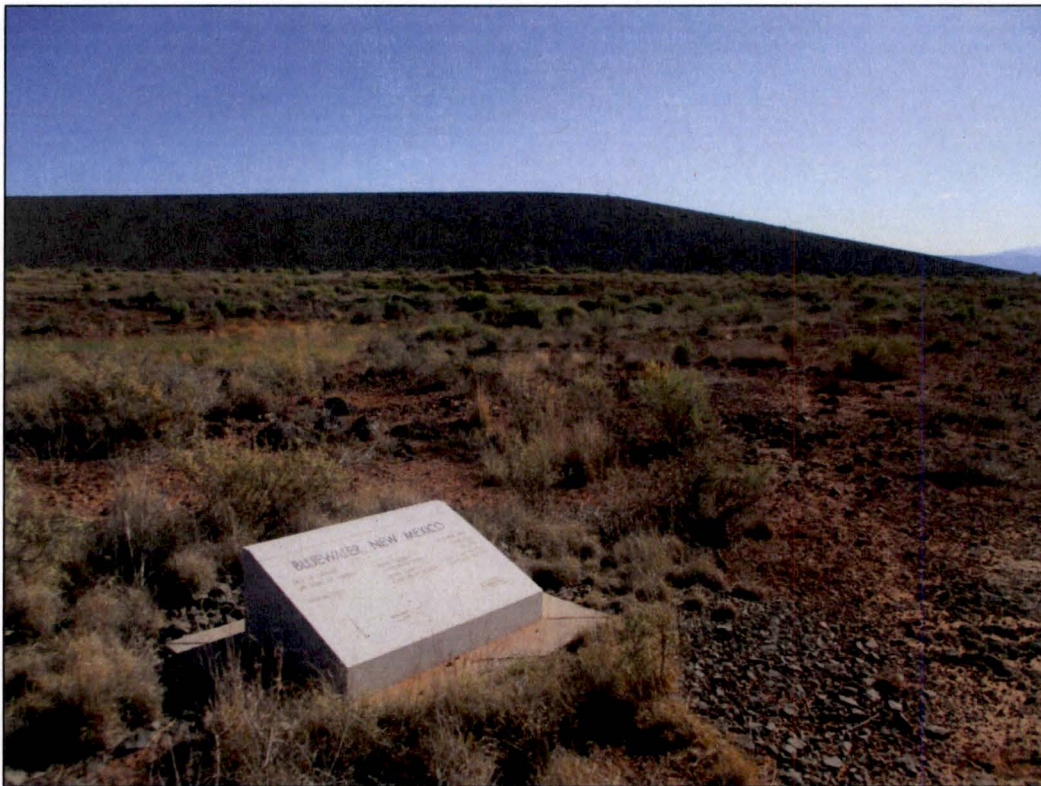
*PL-2. Site Marker and Main Tailings Disposal Cell*

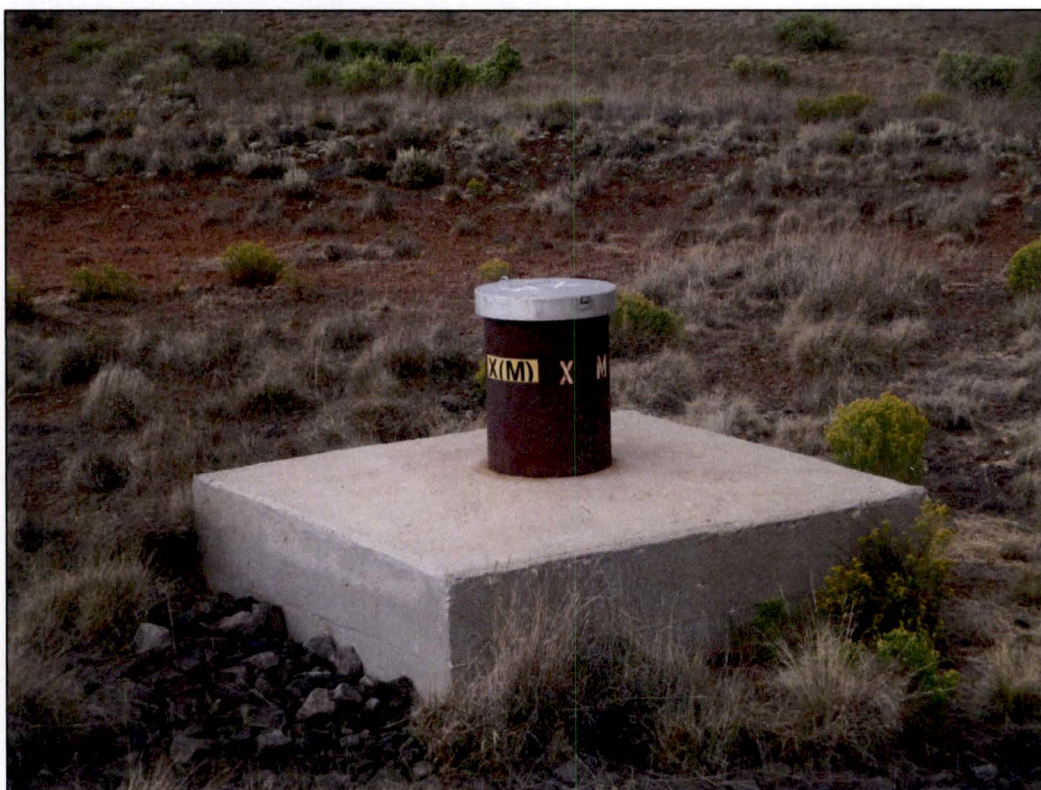
*PL-3. Monitoring Well X(M)*

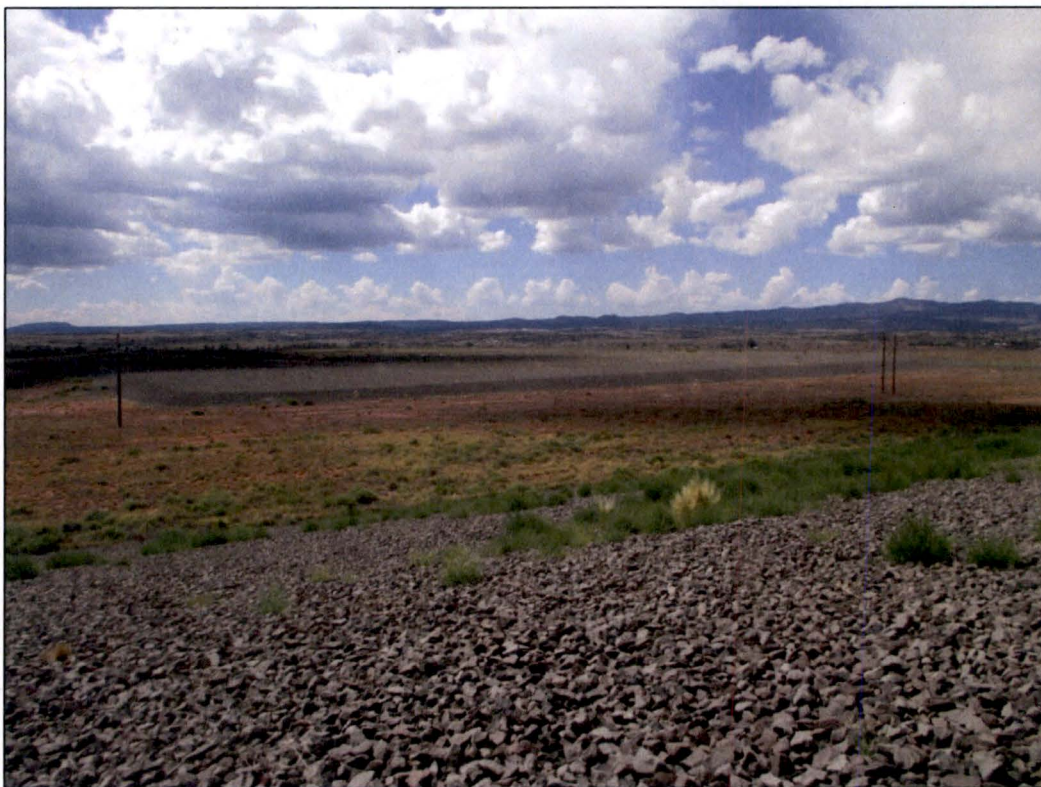
*PL-10. Carbonate Tailings Disposal Cell*

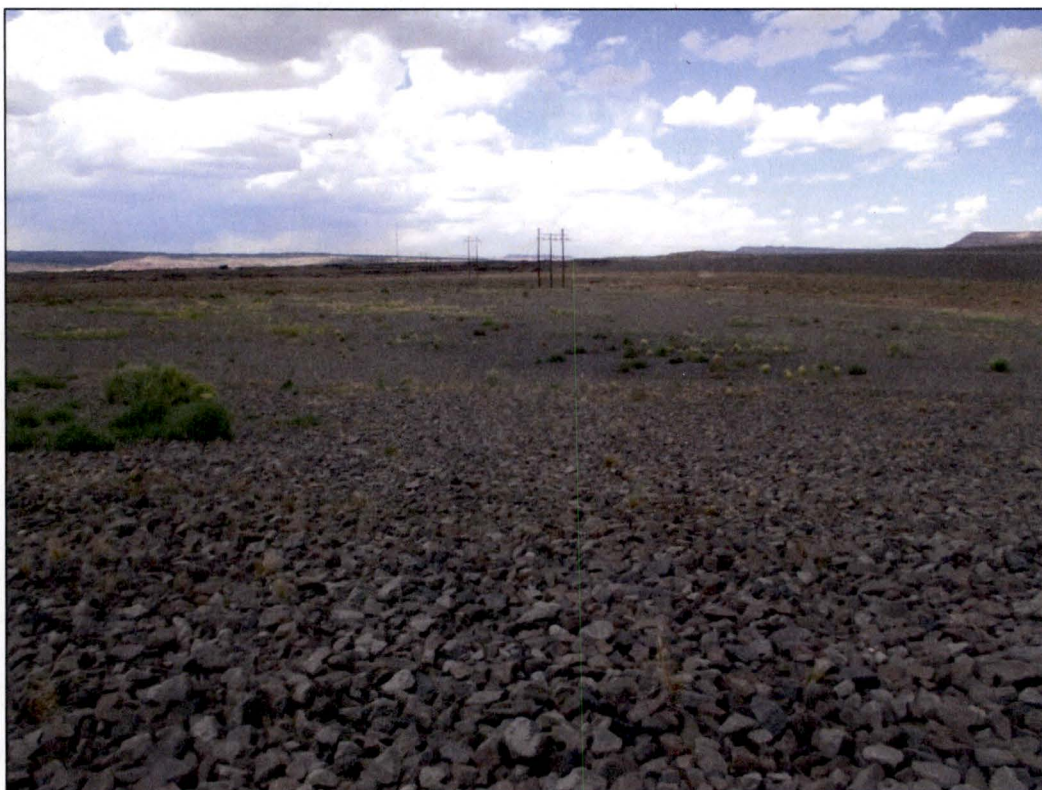
*PL-11. Northwest Extension of Carbonate Tailings Disposal Cell*

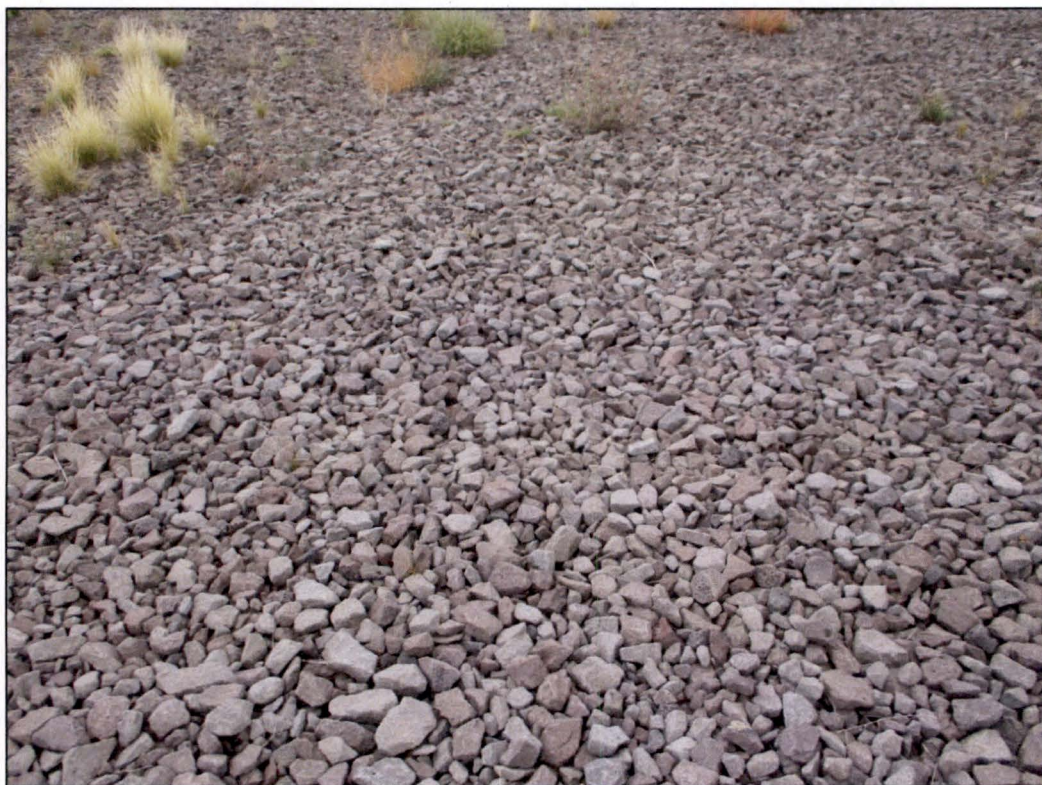
Two test pits were dug and sampled on the top slope of the carbonate tailings disposal cell as part of the NRC/DOE radon study. The test pits were reclaimed after completion of field investigations, and the locations were observed and photographed during the annual inspection. No indications of settlement or erosion were visible (PL-12), as was also noted during the 2016 annual inspection; therefore, annual inspections of the reclaimed tests pits will be discontinued.

*PL-12. Reclaimed Test Pit 8 on Carbonate Tailings Disposal Cell Top Slope*

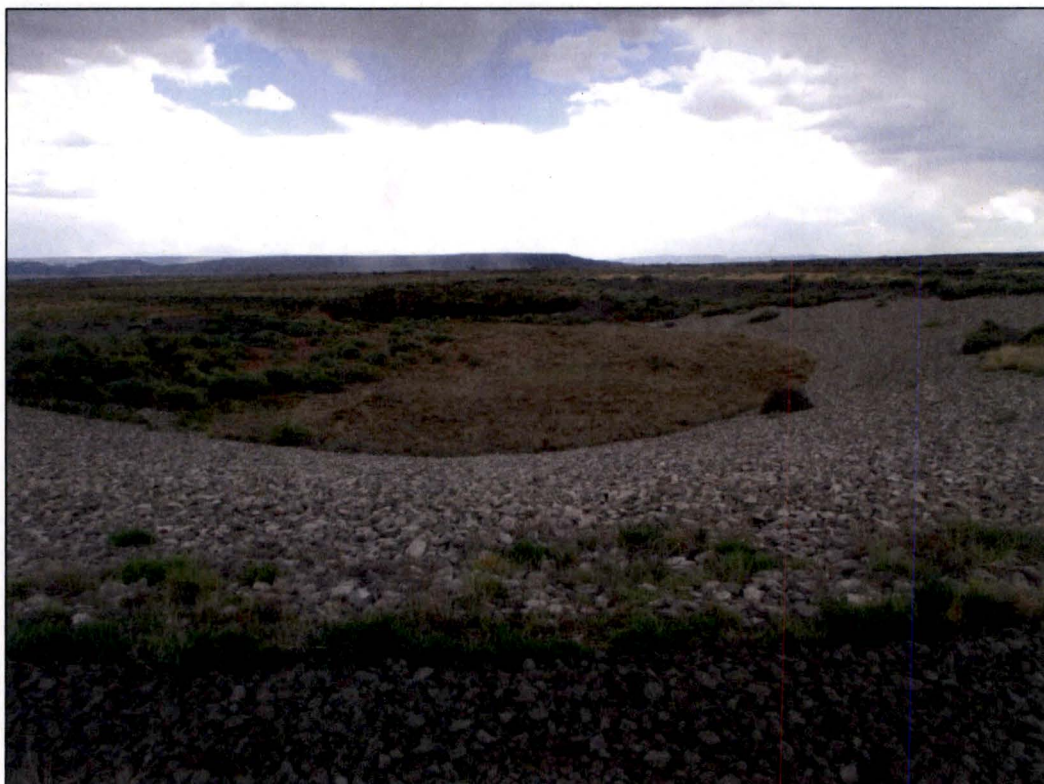
The 2-acre asbestos disposal area is a bowl-like feature just south of the carbonate tailings disposal cell (PL-13). The north, west, and south side slopes of this feature are covered by limestone riprap; the bottom of the bowl (the asbestos cell cover) is grass-covered. Several small depressions are present around the perimeter of the disposal area where relocated clean soil (placed for slope grading) and small-diameter riprap has filtered down through basalt joints and fractures. These depressions do not affect the integrity of the disposal area, but will be filled with riprap (crushed basalt) during other site maintenance activities. No other maintenance needs were identified.

*PL-13. Asbestos Disposal Area*

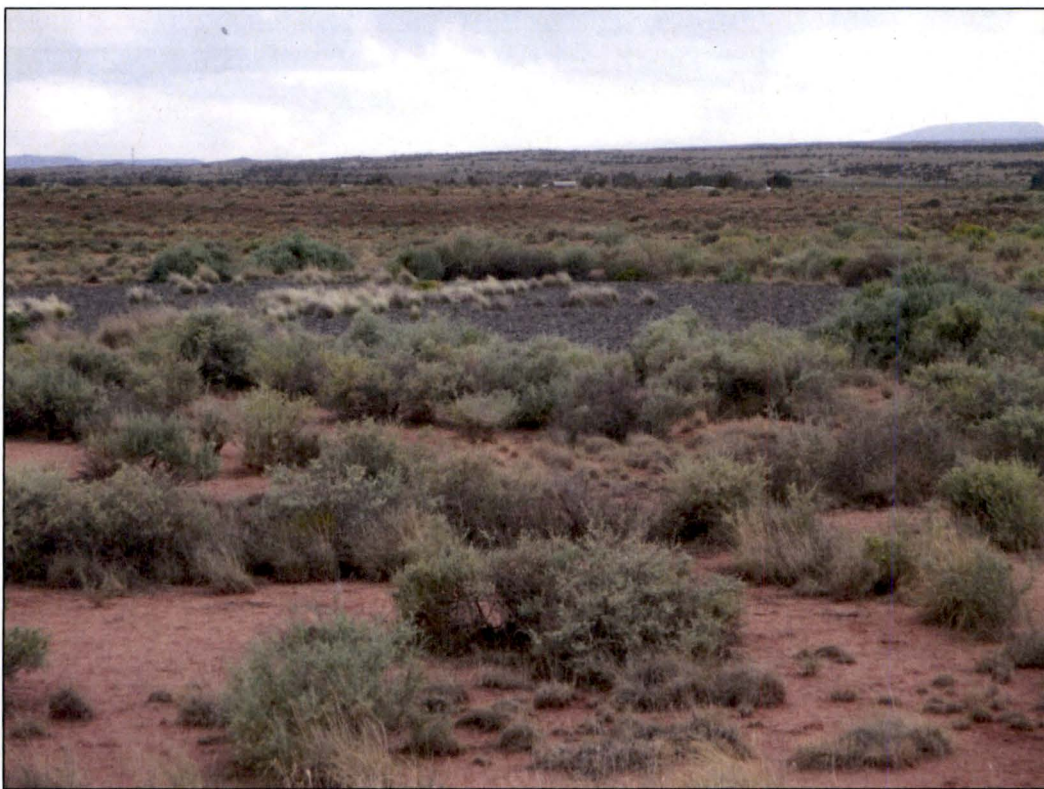
There is an 11-acre grass-covered disposal area south of the asbestos disposal area. A small riprap-covered PCB cell (less than 1 acre) is located within the disposal area (PL-14). Two grass-covered dumps, totaling about 2 acres, are east of the carbonate tailings disposal cell (PL-15). The disposal areas and dumps were inspected. A small area of settlement was observed on the soil cover of Disposal Area No. 1, which does not contain mill tailings (PL-16); the settlement area will be repaired in 2018. No other maintenance needs were identified.

*PL-14. PCB Disposal Area*

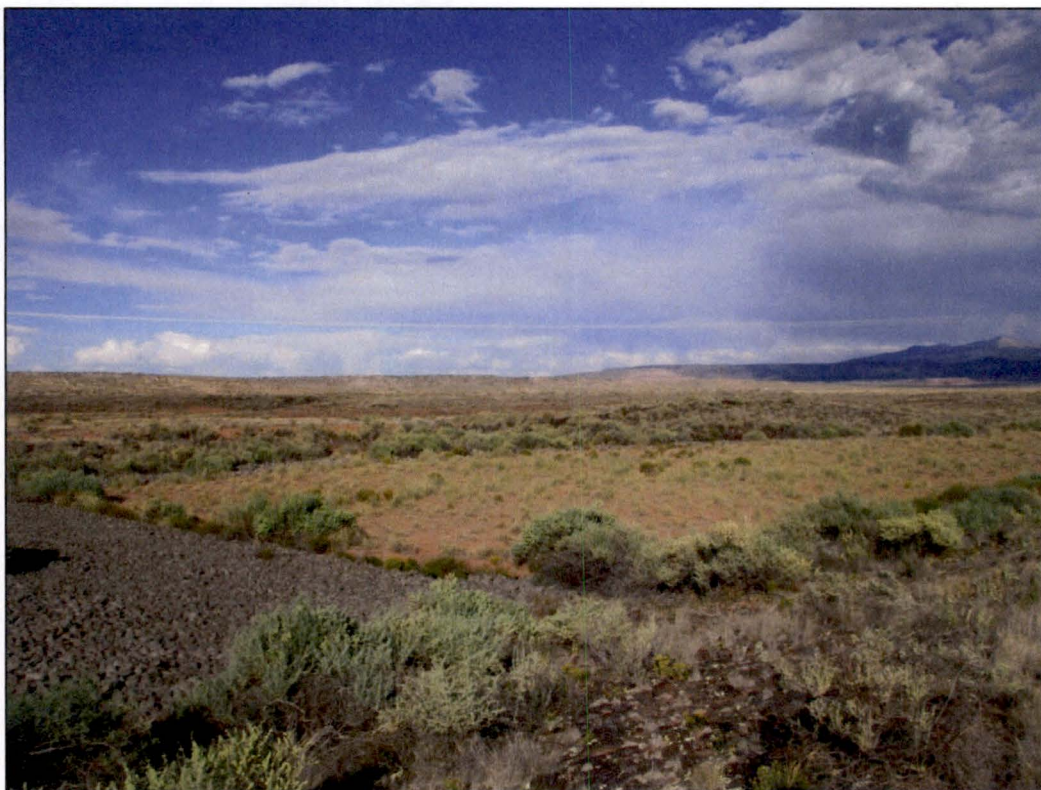
*PL-15. East Dump*

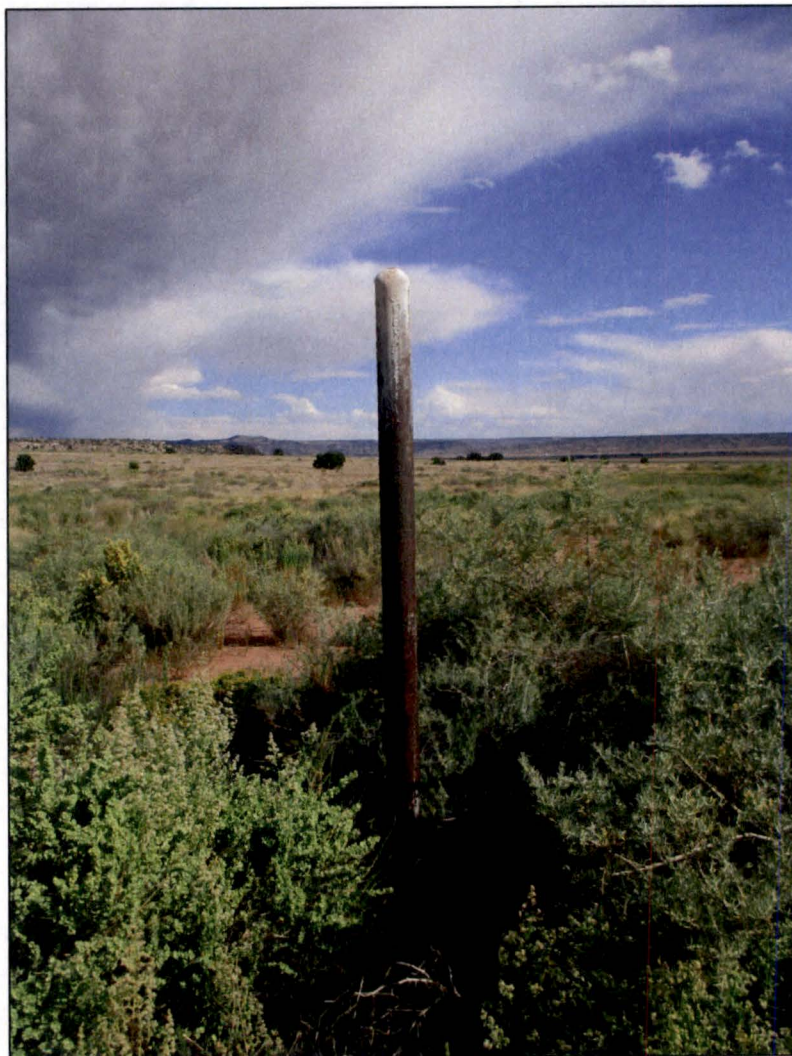
*PL-17. Bluewater Injection Well Monument*

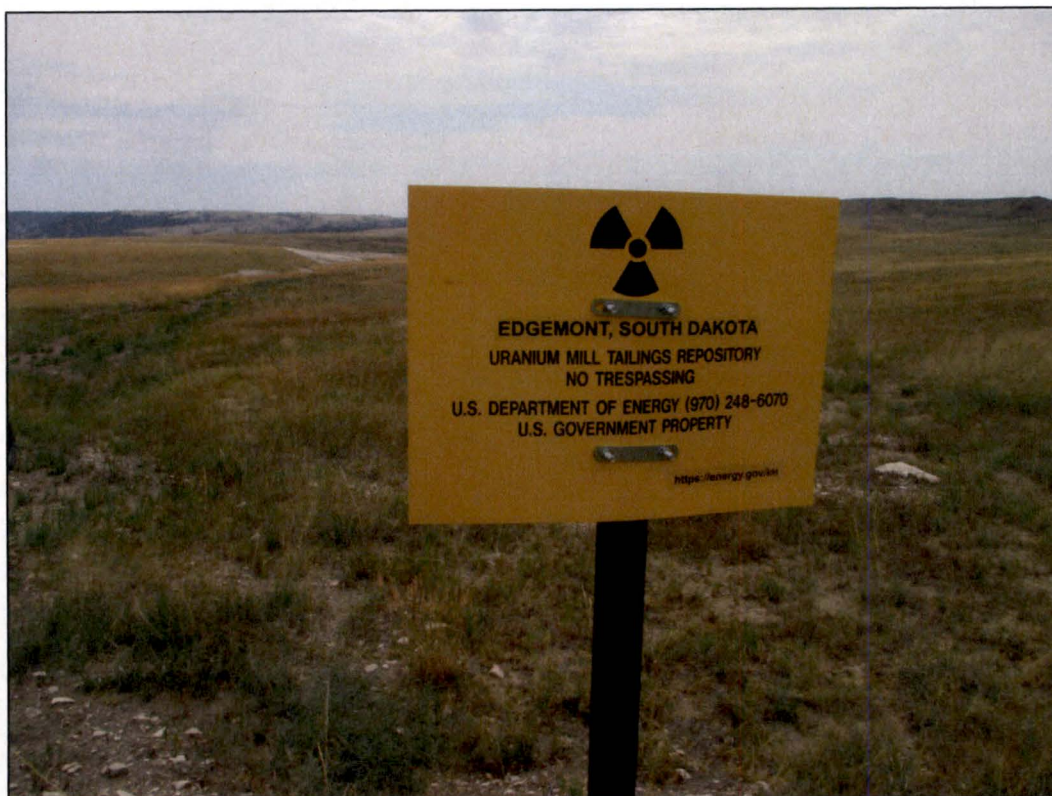
Access to the site is from County Road 6N. On July 17, 2016, a natural wildfire occurred on the site. The entrance sign was knocked over and bent during firefighting efforts. The post was reset by the grazing licensee, and the entrance sign has been replaced. The entrance sign was updated with the new DOE website address (PL-1).

*PL-1. Entrance Sign*

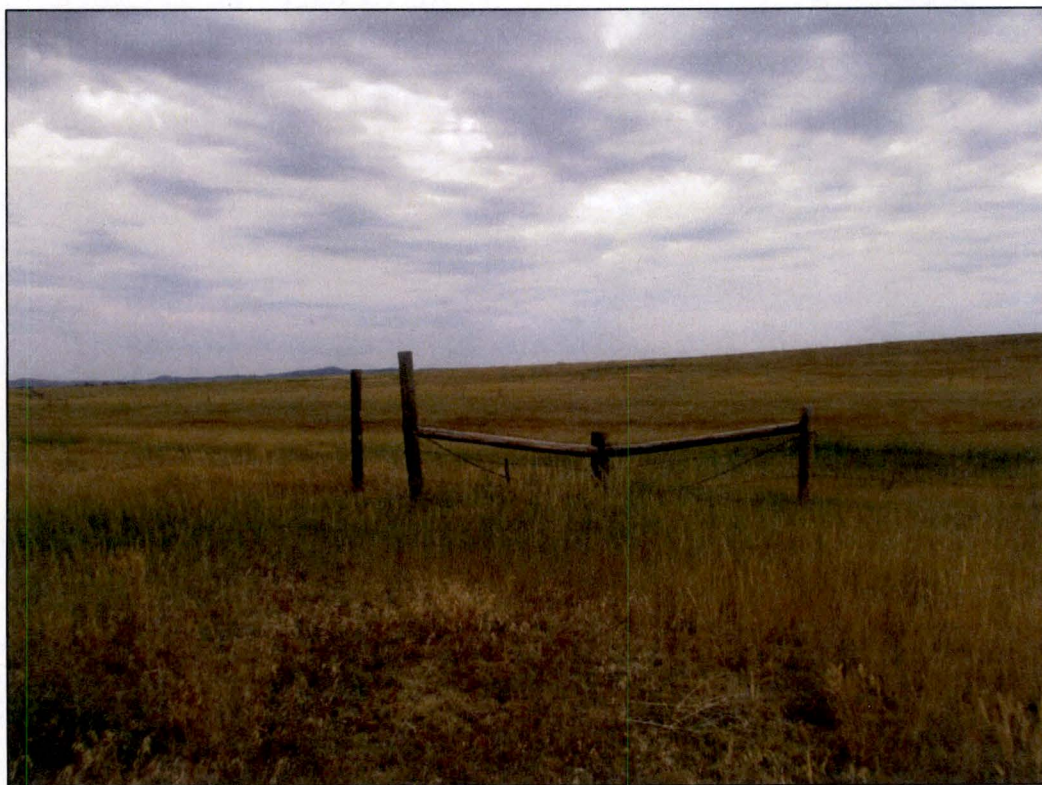
A four-strand barbed-wire fence encloses the site, truncating at the southeast corner to allow livestock access to a preexisting stock pond. The fence was intact except for a broken fence strand at one location that was repaired by the grazing licensee following the inspection. Two perimeter signs are attached to the perimeter fence. Both perimeter signs were present and legible. The grazing licensee monitors site security and maintains the perimeter fence. The licensee proposed to remove the unmaintained interior fence later in 2017 (PL-4). It was installed to prevent grazing during vegetation establishment following closure of the disposal cell. The DOE site manager concurred with this approach as this fence is no longer required.

*PL-4. Interior Fence (Will Be Removed by Grazing Licensee)*

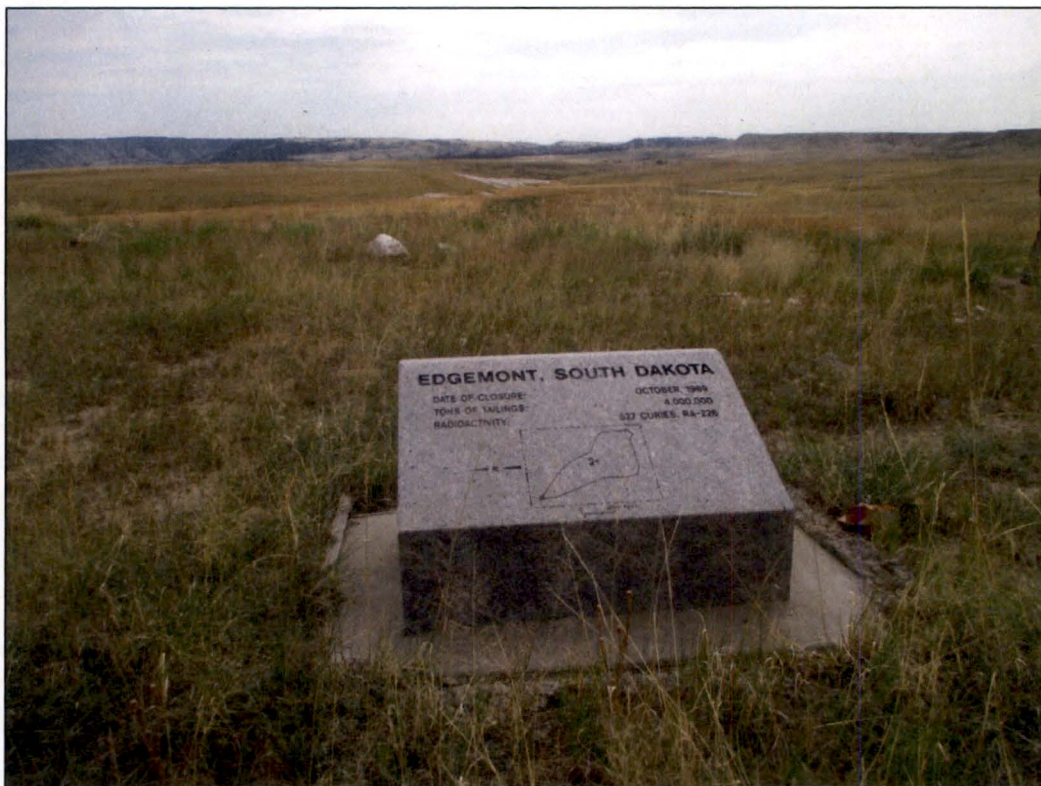
The site has one granite site marker just inside the site entrance gate (PL-5). No maintenance needs were identified.

*PL-5. Site Marker*

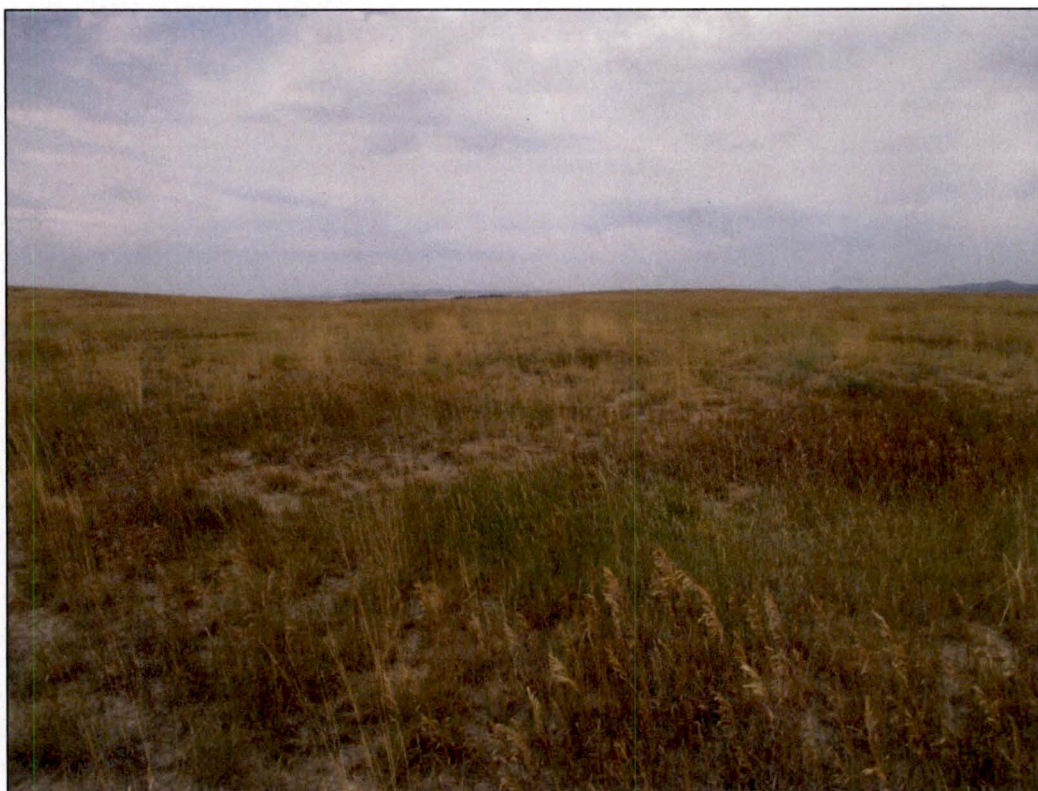
*PL-7. Disposal Cell Cover (Recovered Vegetation After 2016 Wildfire)*

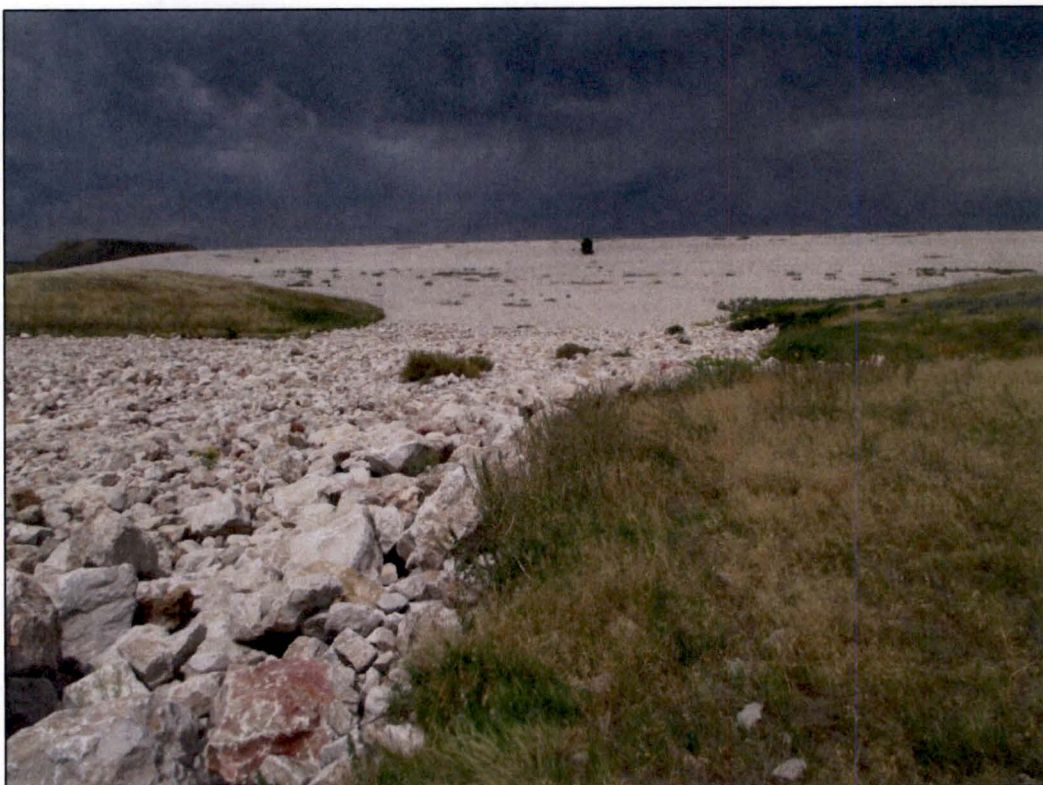
*PL-9. Riprap-Armored Drainage Channel Below Containment Dam*

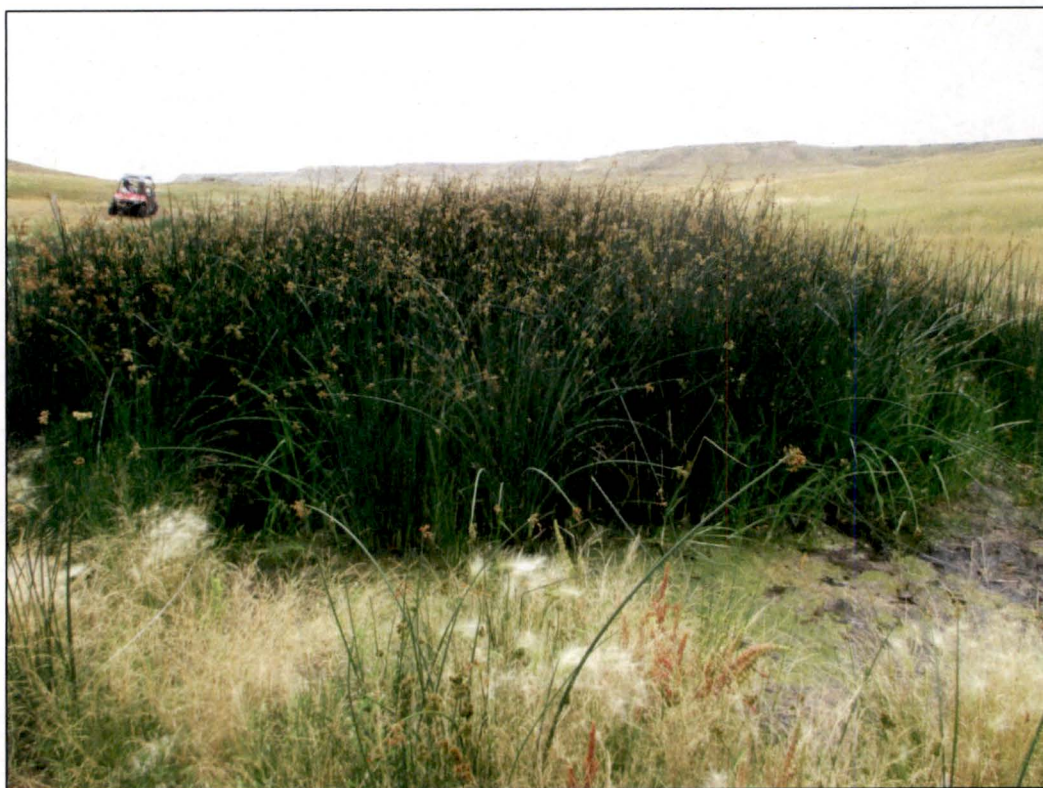
*PL-10. Wetland Vegetation at Outlet of Riprap-Armored Diversion Channel*

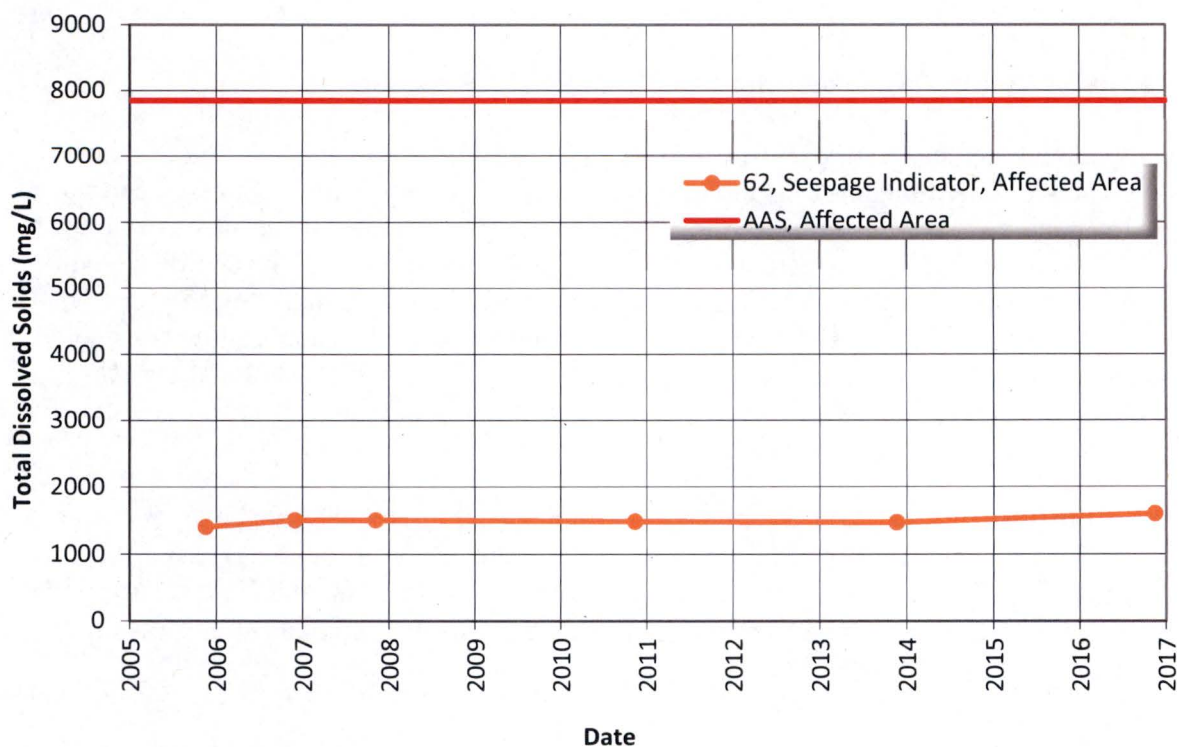
Figure 3-9. Time Concentration Plots of Total Dissolved Solids in Groundwater at the L-Bar Disposal Site (Affected Area Wells)

Since sampling commenced in 2005, no ACL or AAS Source Zone levels have been exceeded in any of the POC wells, and no AAS Affected Area levels have been exceeded in monitoring well 62. Therefore, groundwater at the site is in compliance with the LTSP requirements. Results from the 2016 sampling event are consistent with historical results. Increases in chloride and nitrate concentrations occurred in well 69 and 17B, respectively, but there are no trends that suggest that an ACL, AAS Source Zone, or AAS Affected Area concentration will be exceeded (Figure 3-3, Figure 3-4). Selenium concentration decreased or remained stable in all POC wells (Figure 3-5), and sulfate concentration remained stable in both AAS Source Zone wells and the AAS Affected Area well (Figure 3-6, Figure 3-7). TDS concentration decreased in all AAS Source Zone wells (Figure 3-8) and remained stable in the AAS Affected Area well (Figure 3-9).

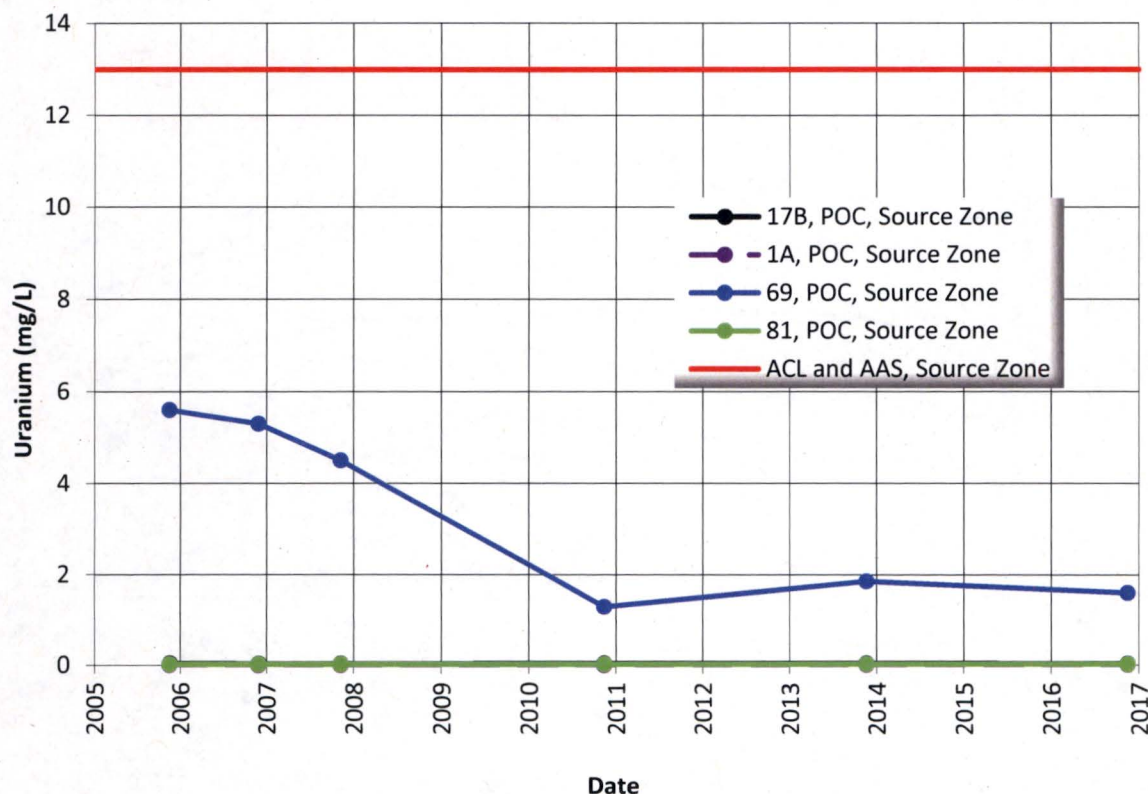
Figure 3-10. Time Concentration Plots of Uranium in Groundwater at the L-Bar Disposal Site

Uranium concentration decreased or remained stable in all POC wells (Figure 3-10). At least one New Mexico standard is exceeded in six of the DOE wells, including background well 29A (sulfate and total dissolved solids).

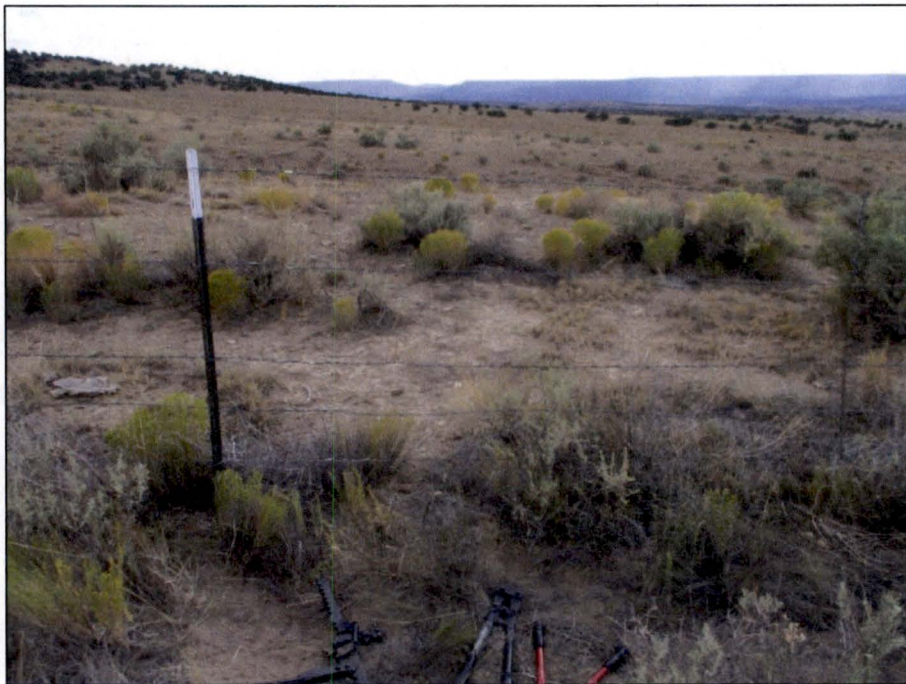
*PL-1. Repaired Cut Perimeter Fence Near Perimeter Sign P20*

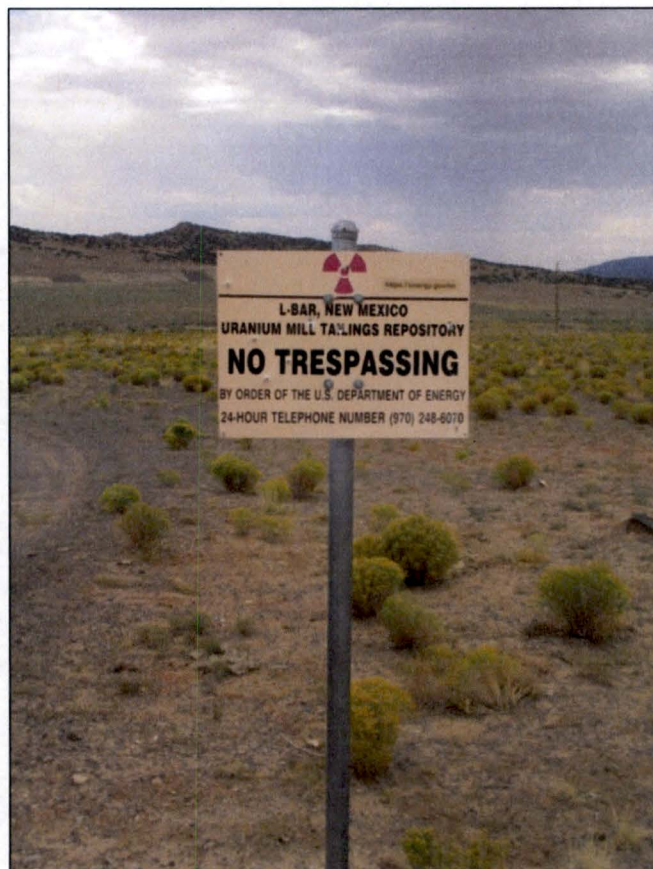
*PL-2. Entrance Sign*

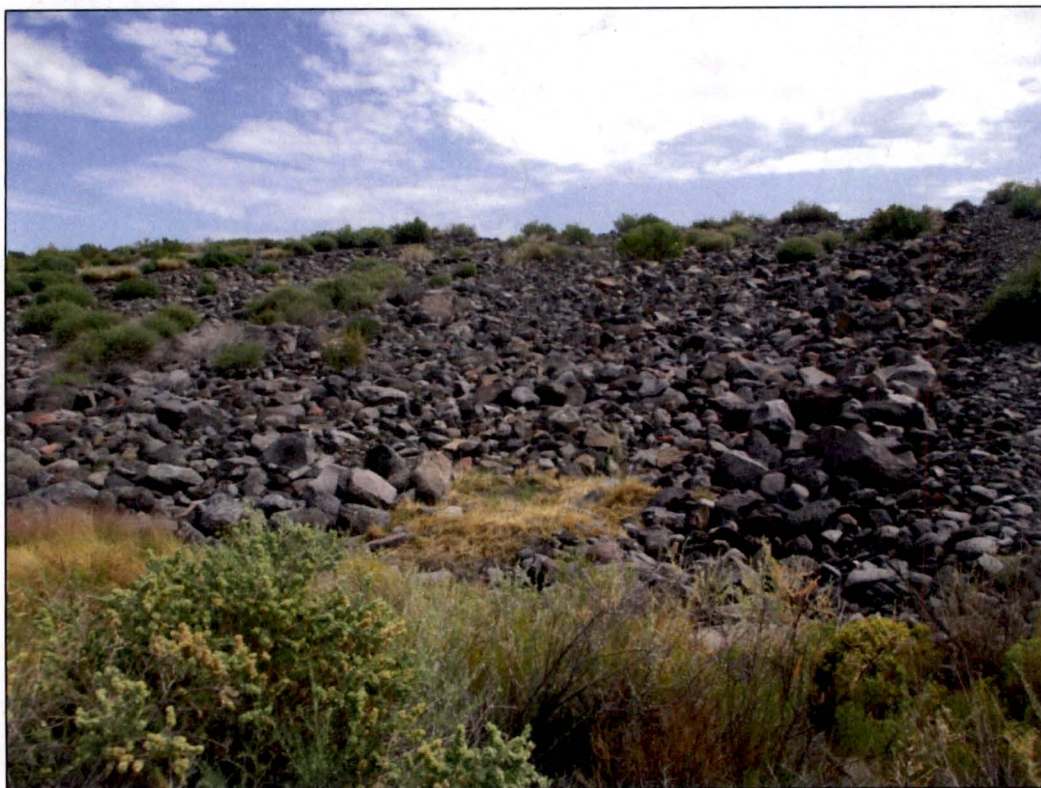
*PL-8. Containment Dam Spillway*

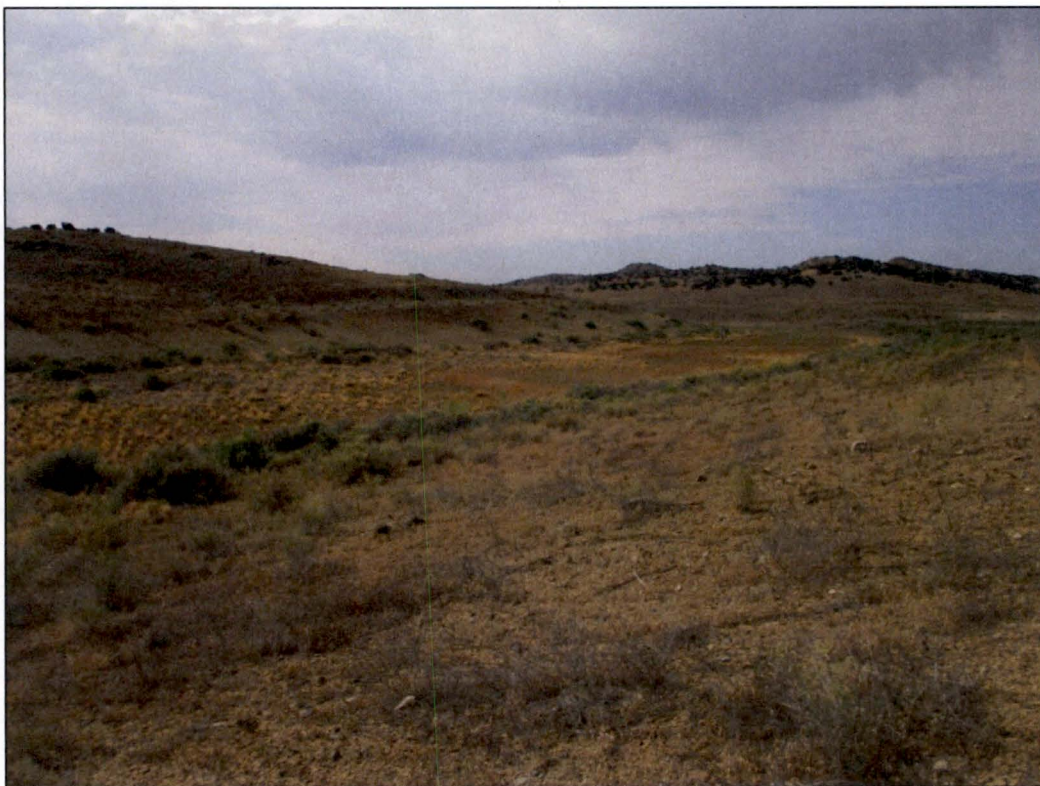
*PL-9. East Channel*
