# 2017 Annual Site Inspection and Monitoring Report for Uranium Mill Tailings Radiation Control Act Title II Disposal Sites

December 2017

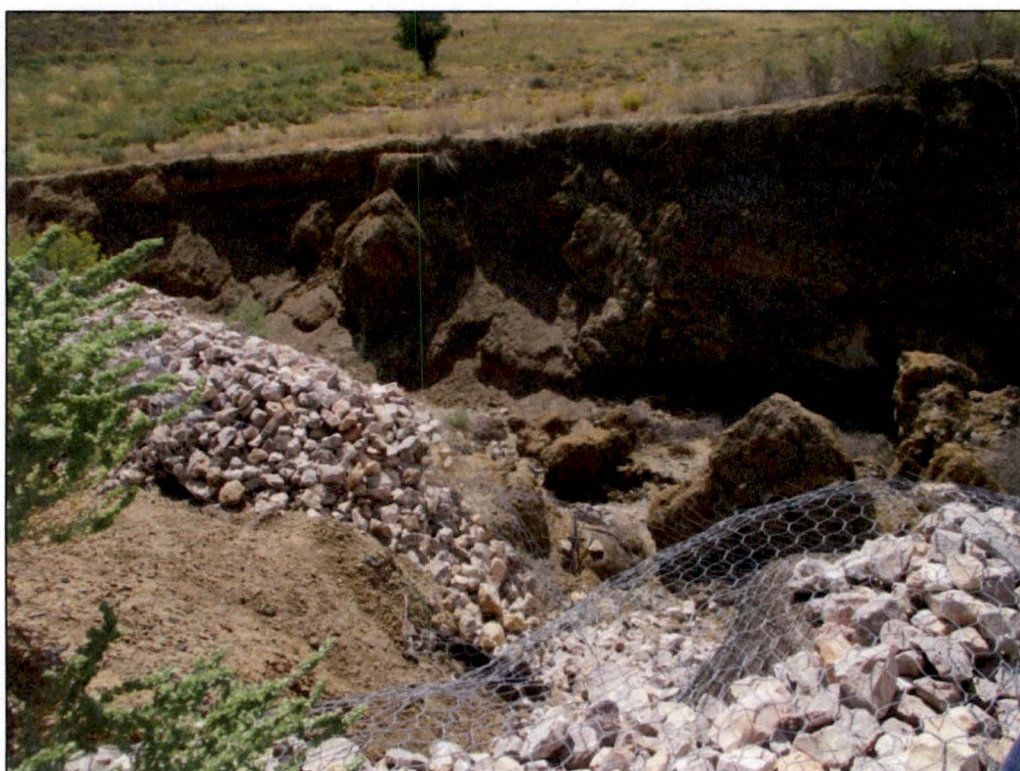
*PL-14. Damaged Runoff Control Structure G*

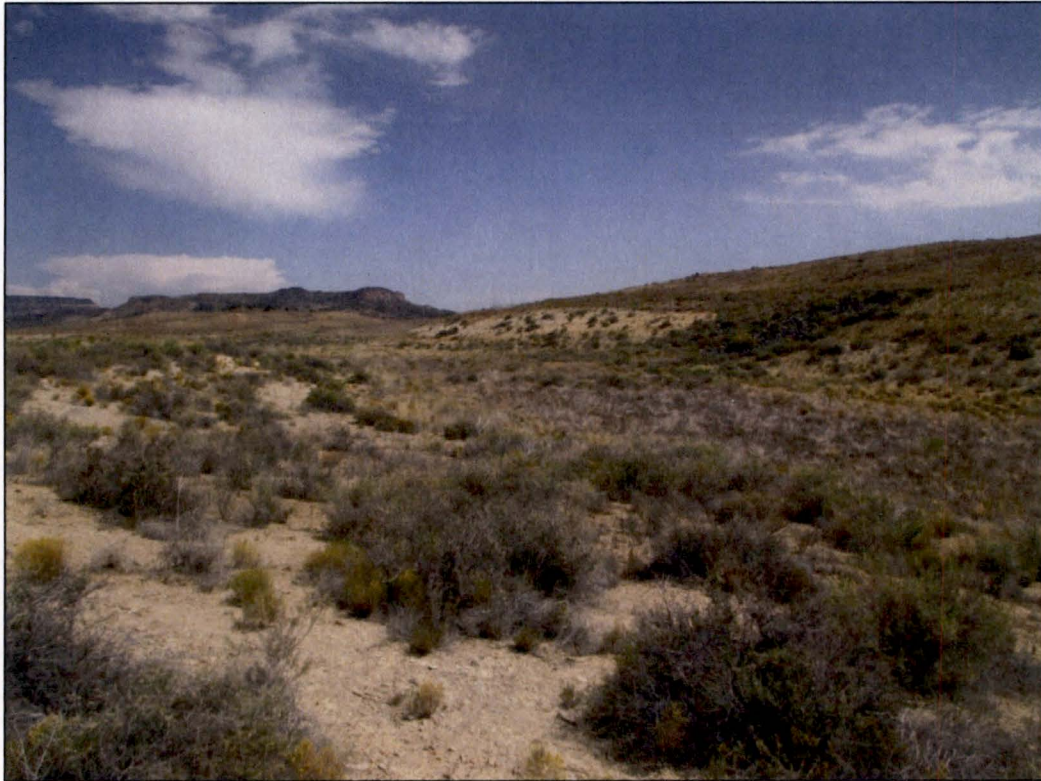
*PL-15. South Channel*

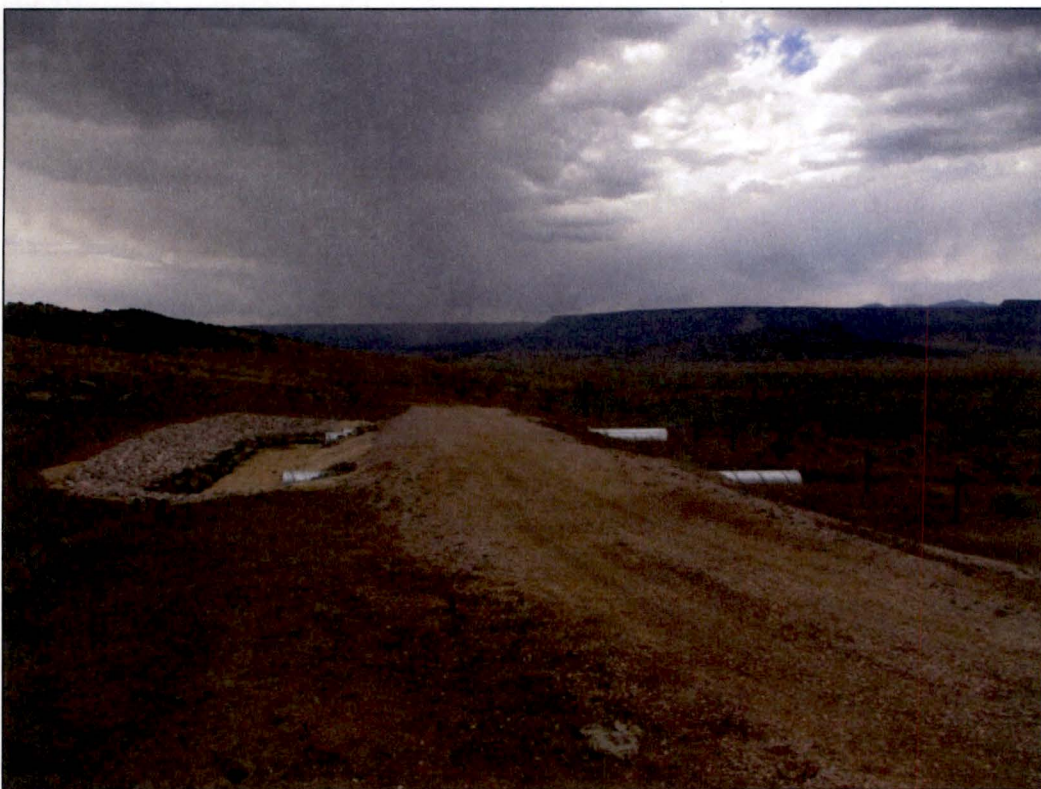
*PL-16. Culverts Constructed in 2016*

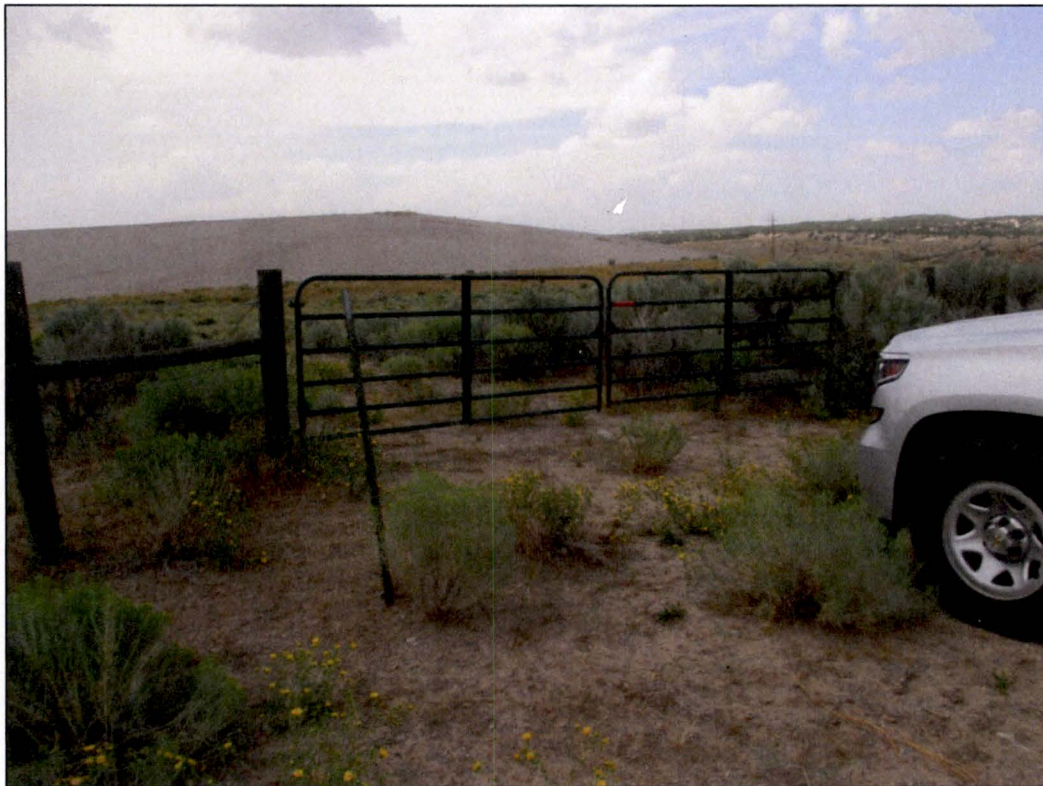
*PL-1. Entrance Gate; Disposal Cell in Background*

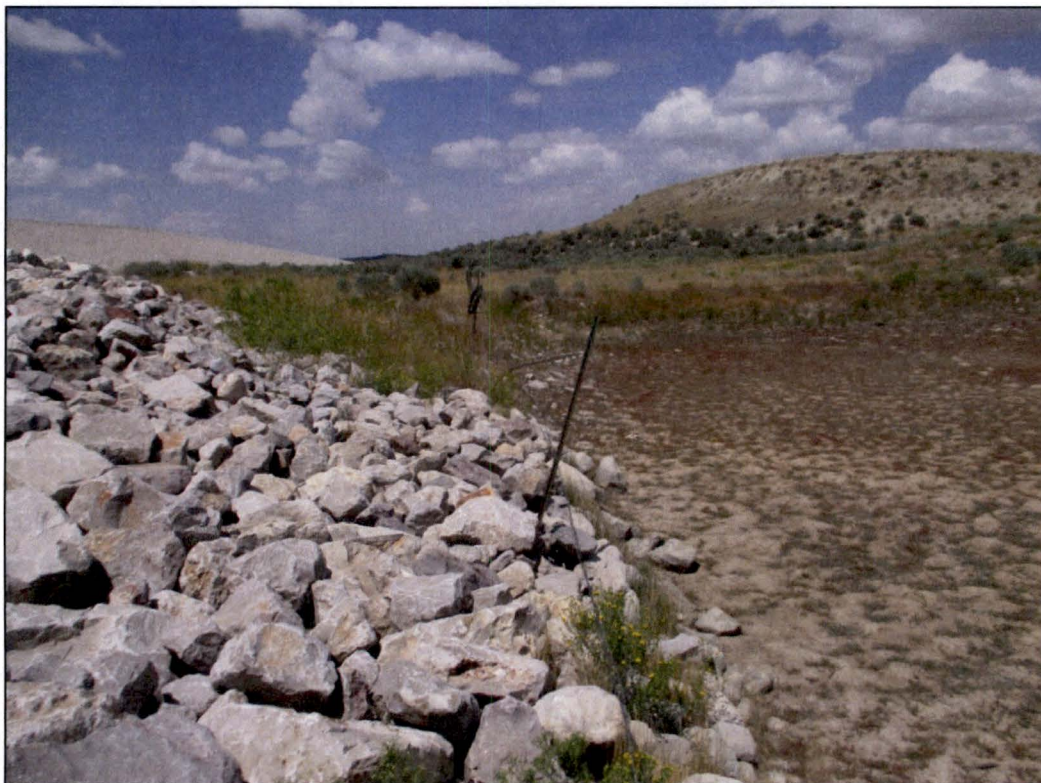
*PL-2. Perimeter Fence Damage*

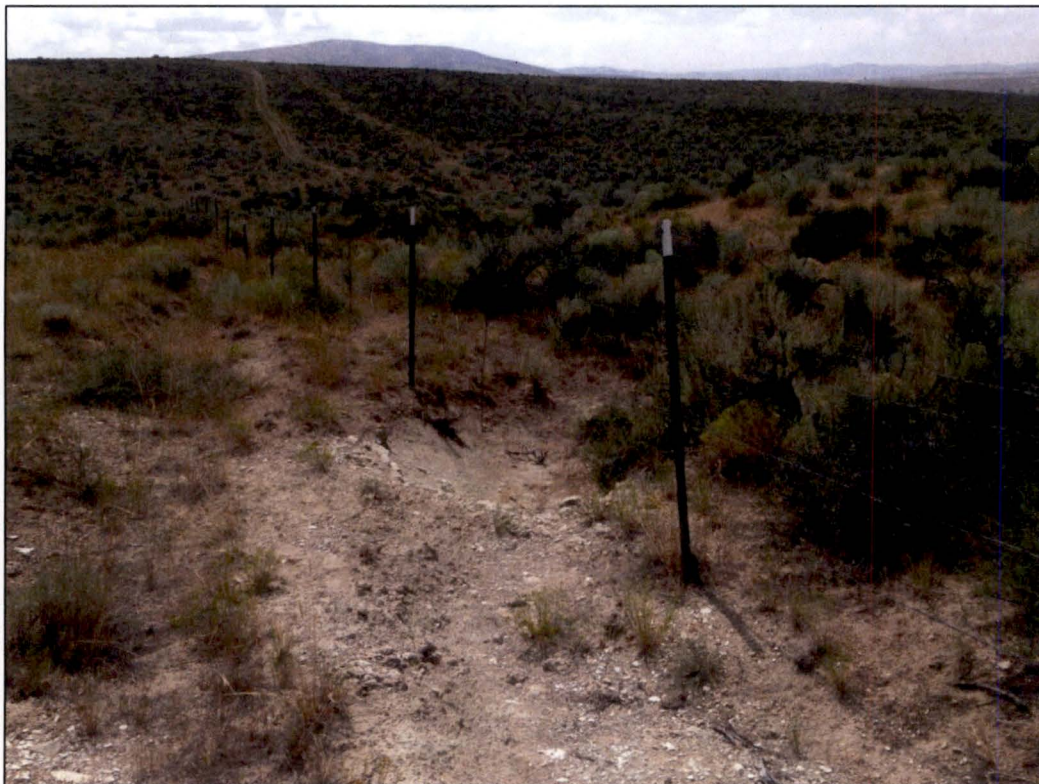
*PL-3. Erosion Along Perimeter Fence*

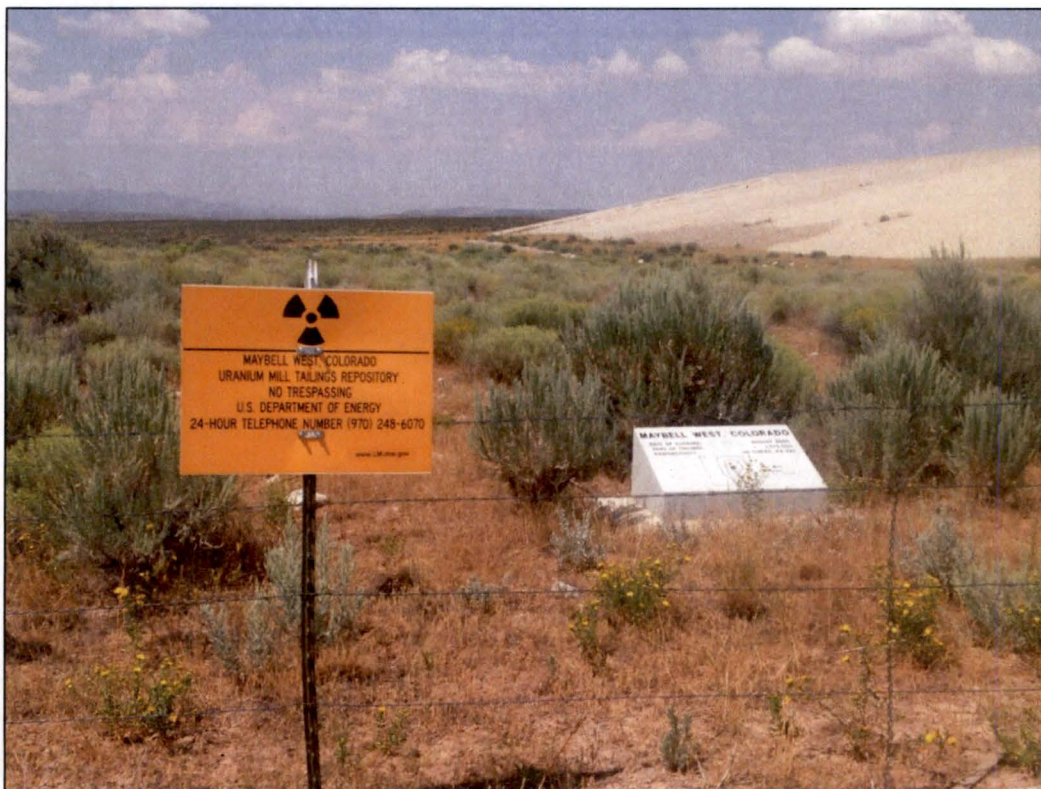
*PL-4. Entrance Sign; Site Marker and Disposal Cell in Background*

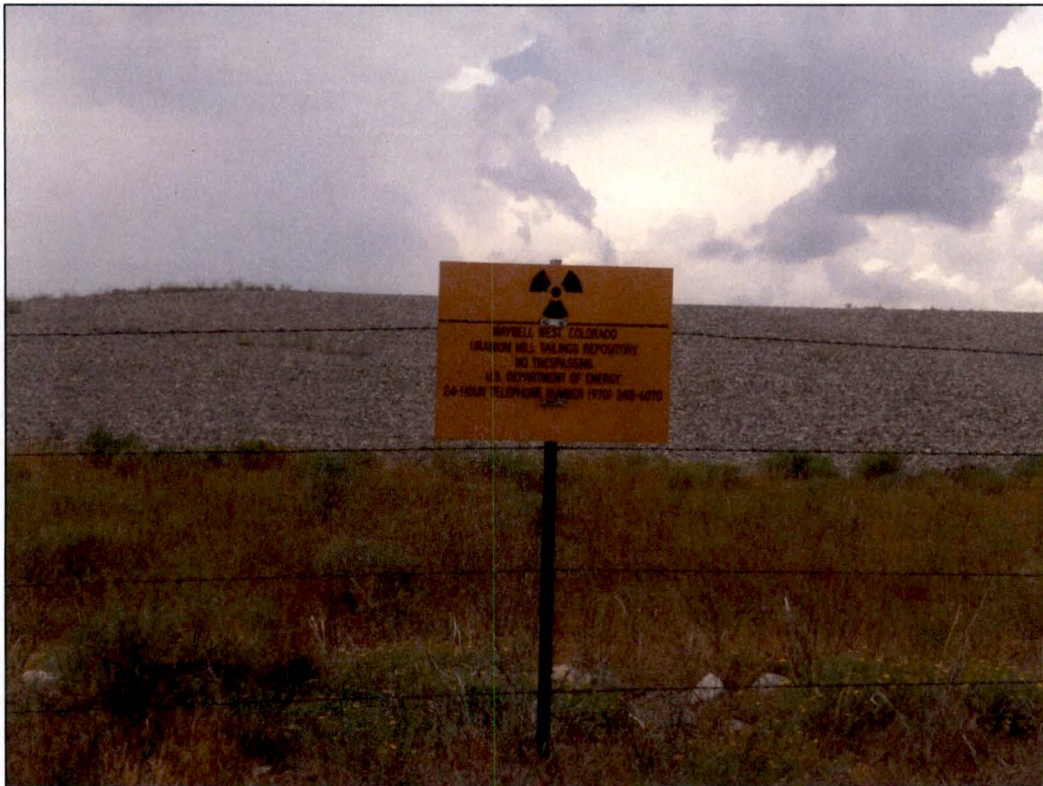
*PL-5. Perimeter Sign P1 with Disposal Cell in Background*

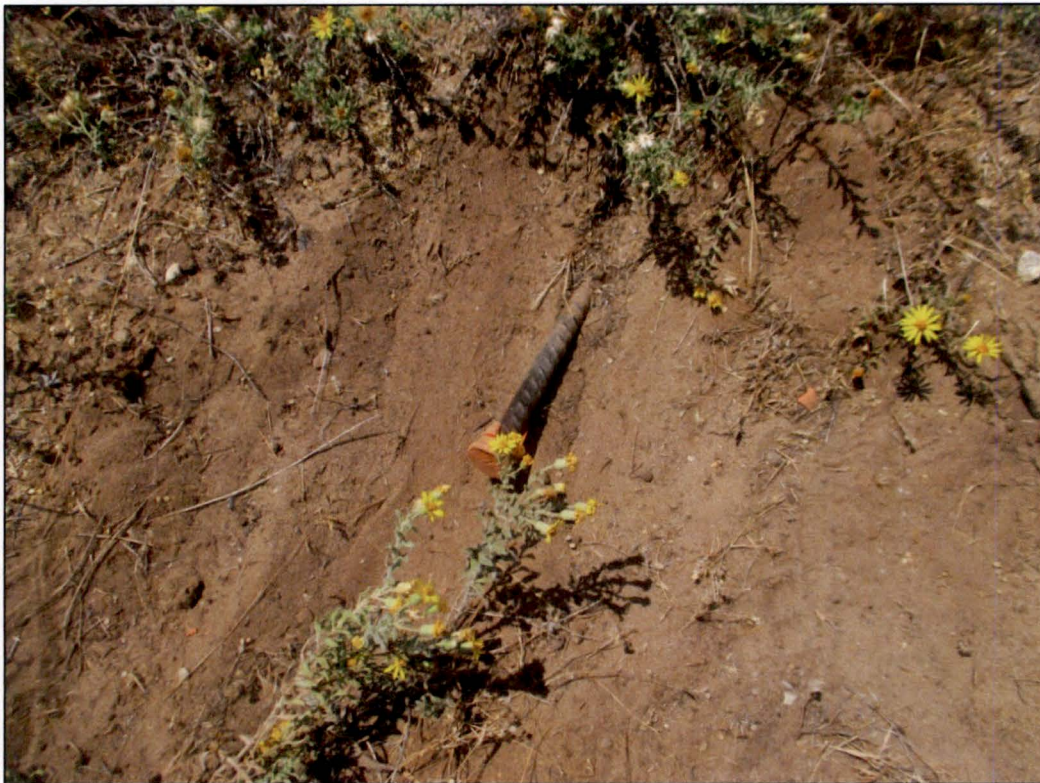
*PL-7. Damaged Boundary Monument BM-3*

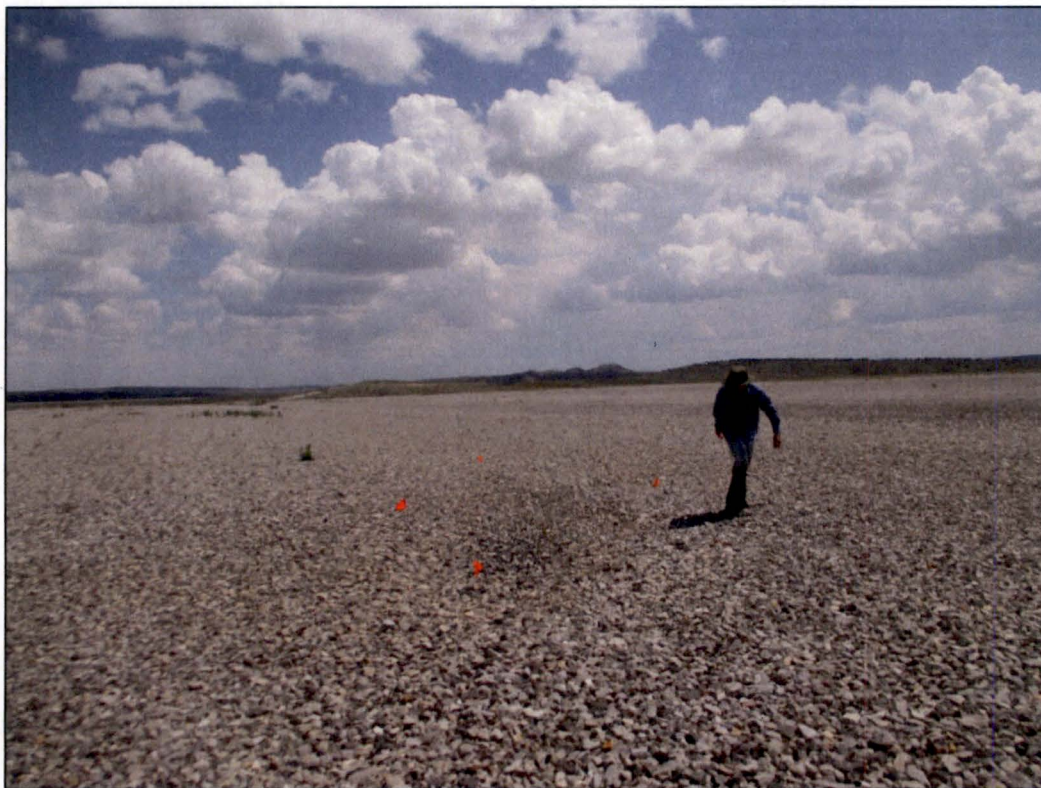
*PL-8. Depression No. 1 on Disposal Cell Top Slope*

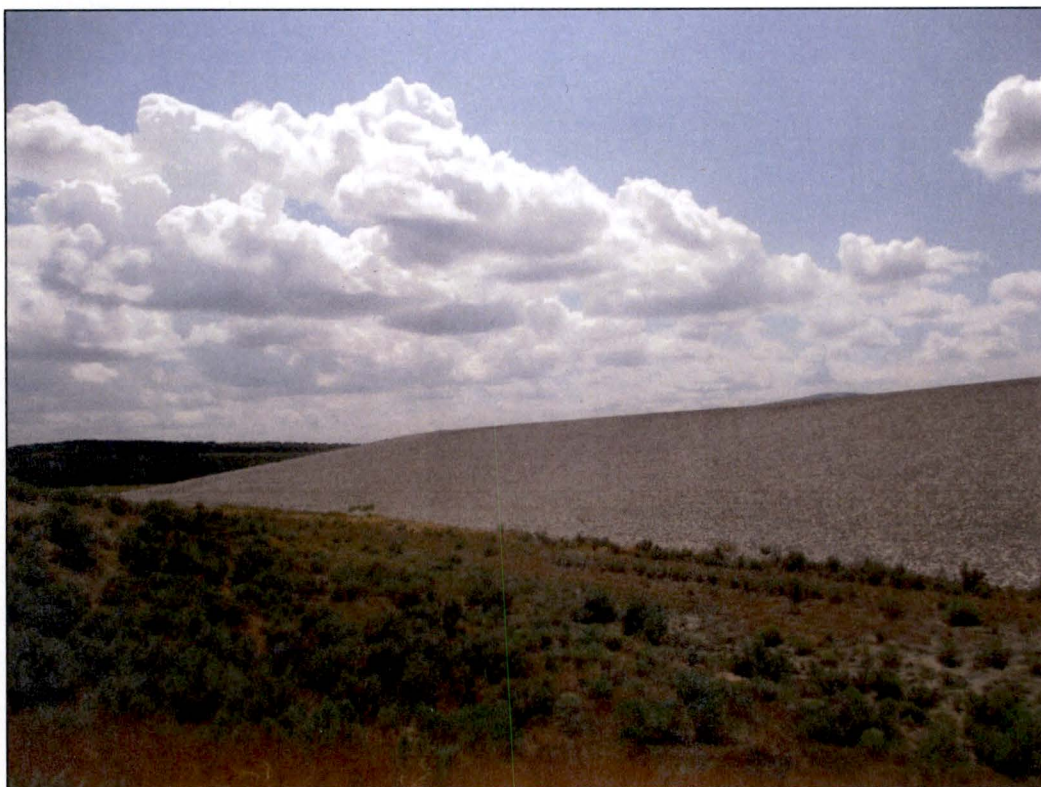
*PL-9. Northeast Side Slope of Disposal Cell*

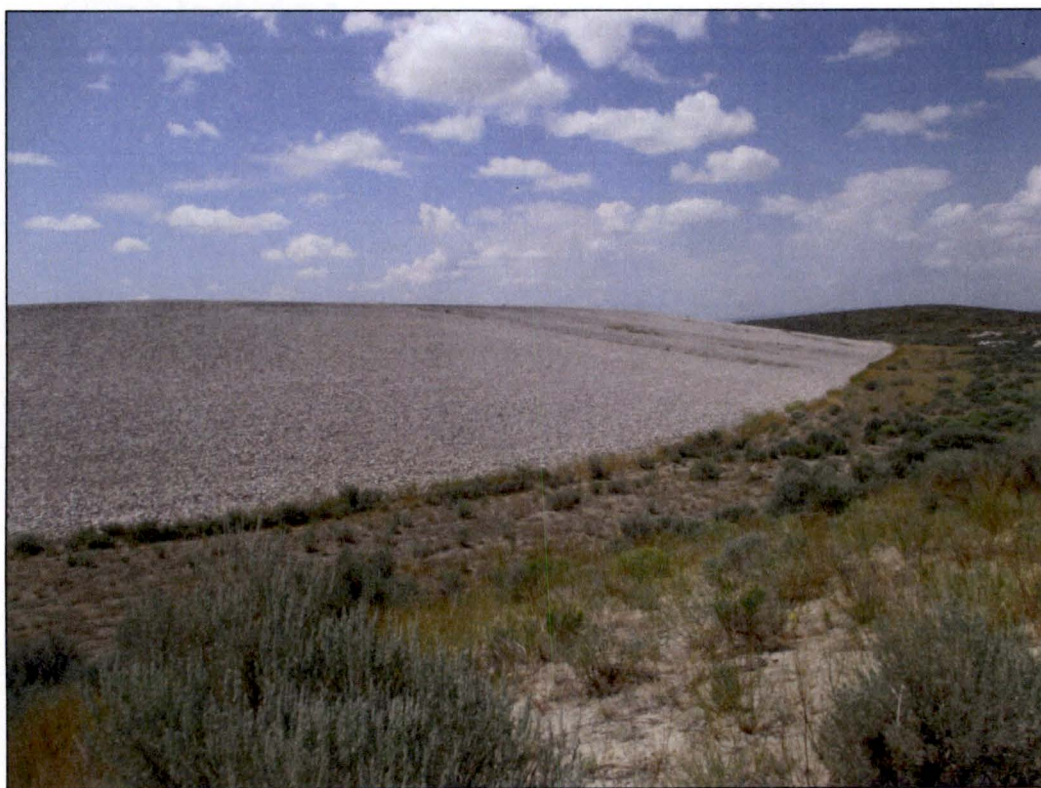
*PL-10. North Side Slope of Disposal Cell*

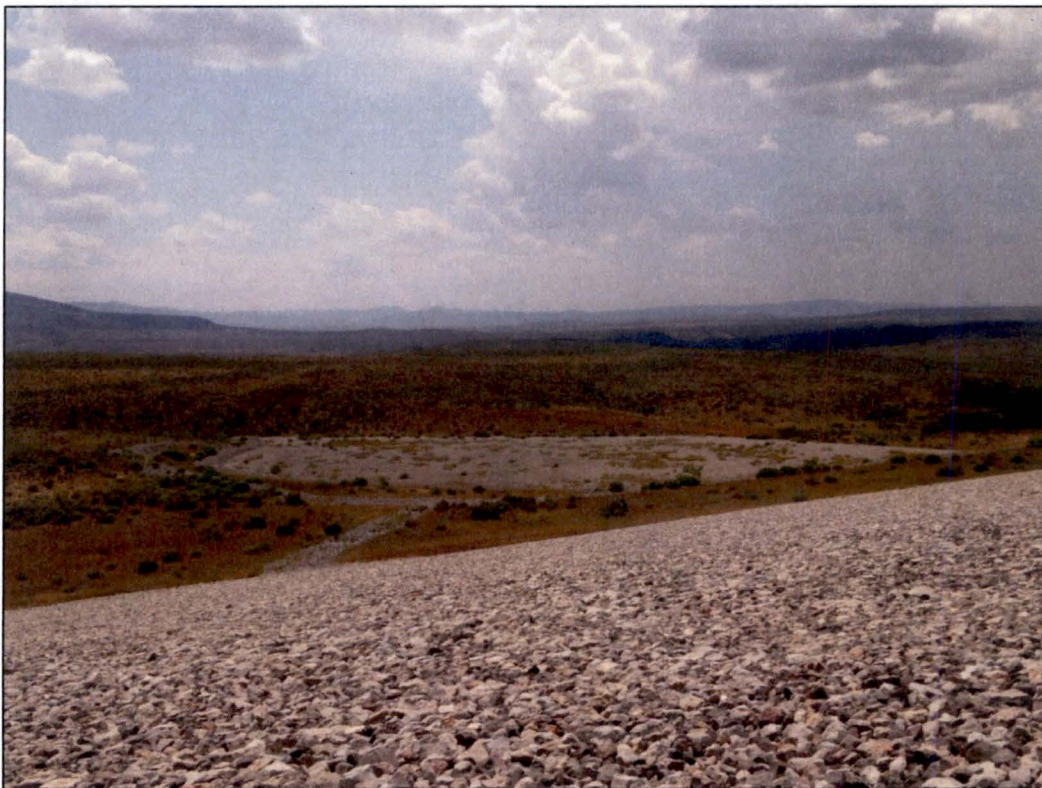
*PL-12. Ancillary Cell from Disposal Cell Top Slope*

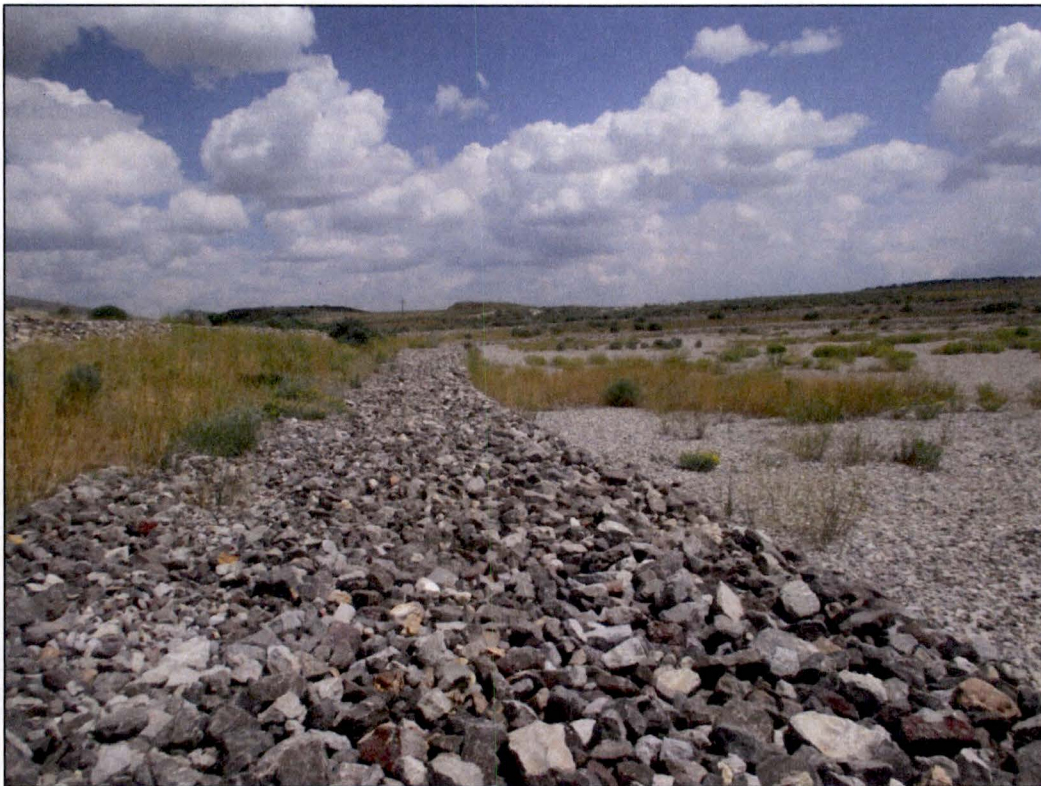
*PL-13. Rock Berm Upslope of Ancillary Cell*

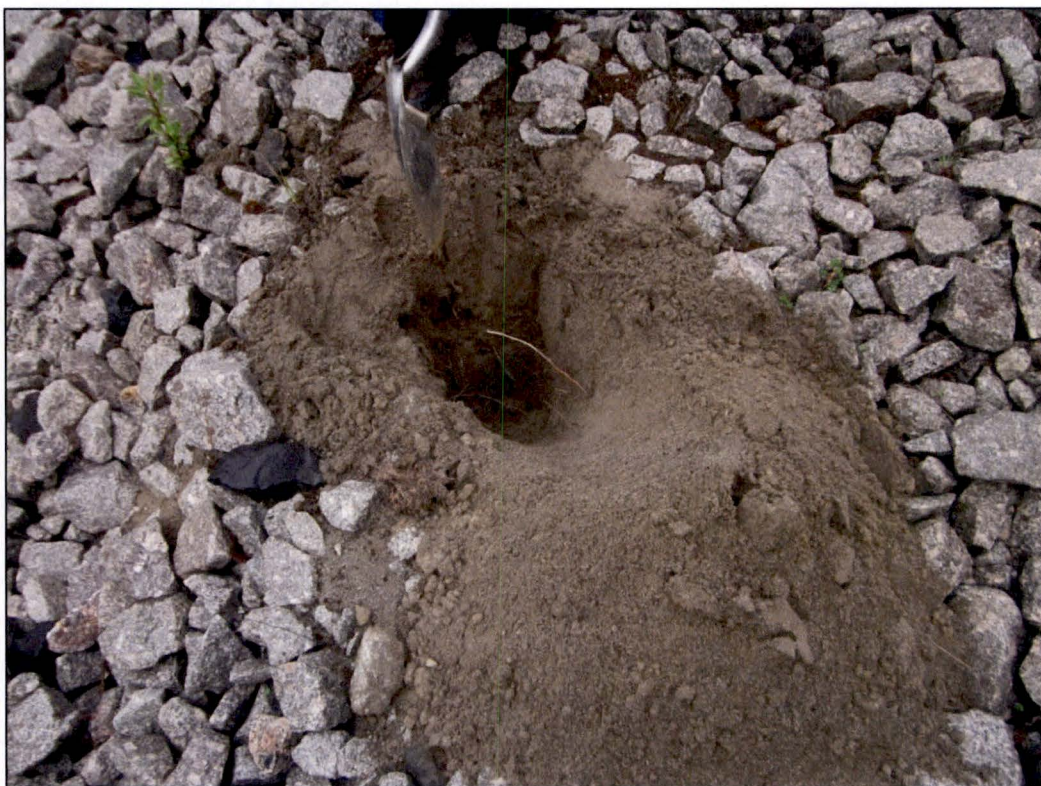
*PL-7. Test Hole in Outslope Material Above Washout Area*

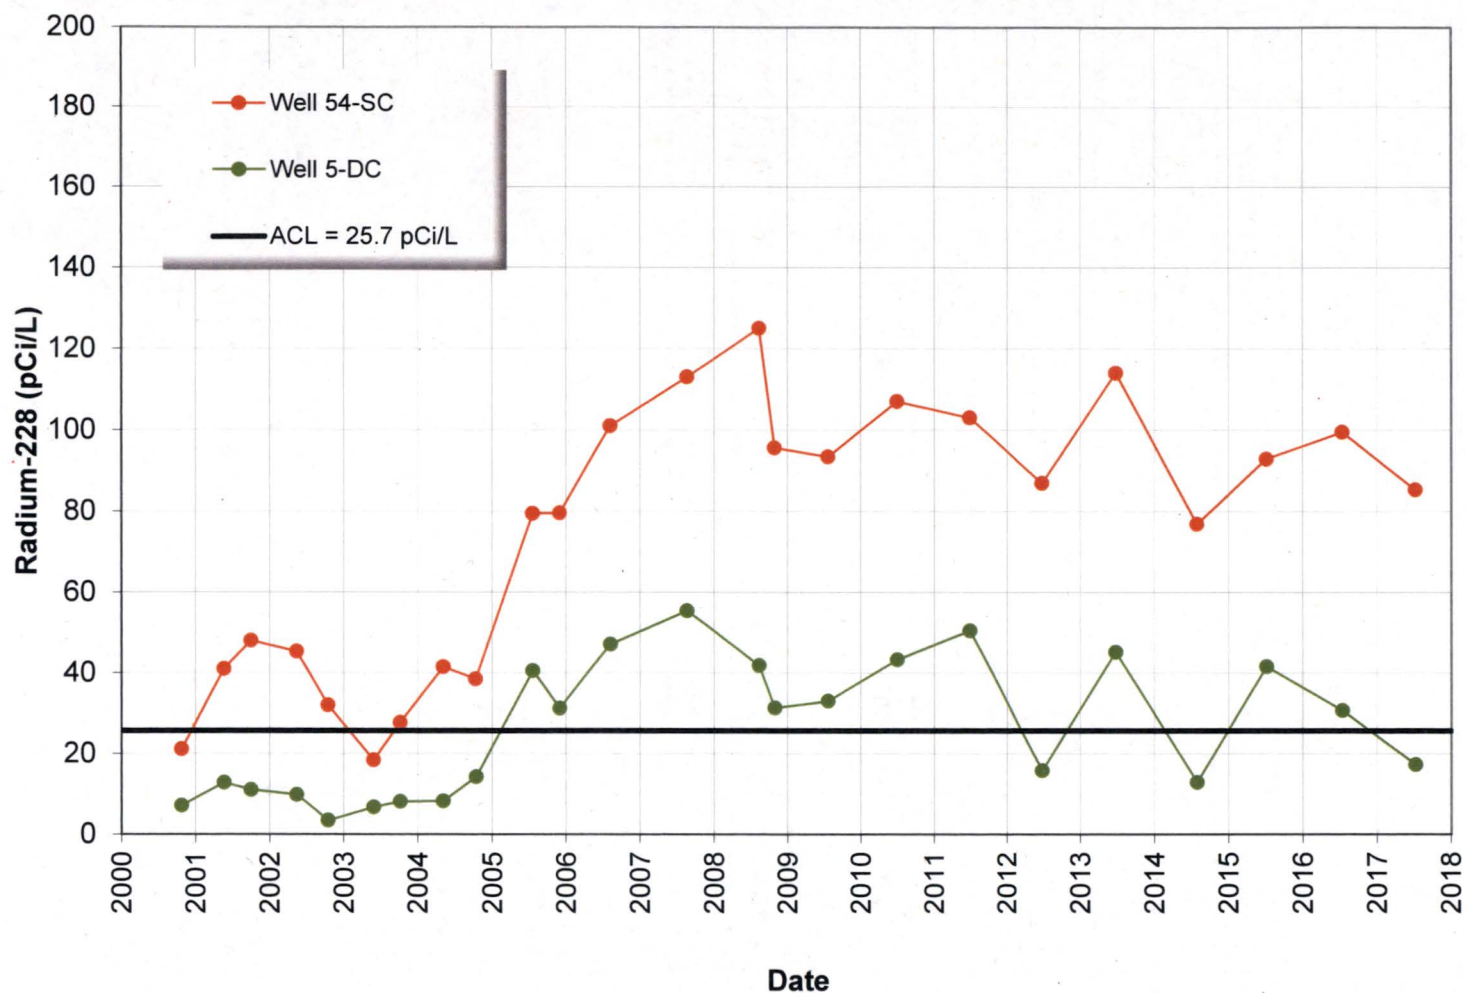
Figure 6-3. Radium-228 Concentrations in Wells 5-DC and 54-SC Since Completion of the Disposal Cell at the Shirley Basin South, Wyoming, Disposal Site

The concentration of cadmium in well 5-SC remained less than the ACL as it has since 2005. Radium-228 continued to exceed the ACL in well 54-SC but dropped below the ACL in well 5-DC (Figure 6-3). Additionally, the ACL for <sup>226</sup>Ra continues to be exceeded in well 110-DC (Figure 6-4).

Although  $^{228}\text{Ra}$  concentration is elevated in 54-SC, it is less than the highest concentration measured in this well in the early 1990s during site groundwater remediation activities. Radium-228 is a decay product of thorium-232 ( $^{232}\text{Th}$ ), which is highly immobile. Because the half-life of  $^{228}\text{Ra}$  is relatively short,  $^{232}\text{Th}$  sources must be near monitoring wells 5-DC and 54-SC. DOE attributes the cause of elevated  $^{226}\text{Ra}$  and  $^{228}\text{Ra}$  in the site wells to natural mineralization in the aquifers, rather than concluding it is evidence of diminished disposal cell performance or contaminant plumes migrating offsite. Both of the aquifers at the site were dewatered during mining and remediation and are still in the process of recovering; therefore, as the sand units are resaturating, groundwater may be coming back into contact with thorium and other minerals in the ore body, and the quality is returning to preremediation concentrations.

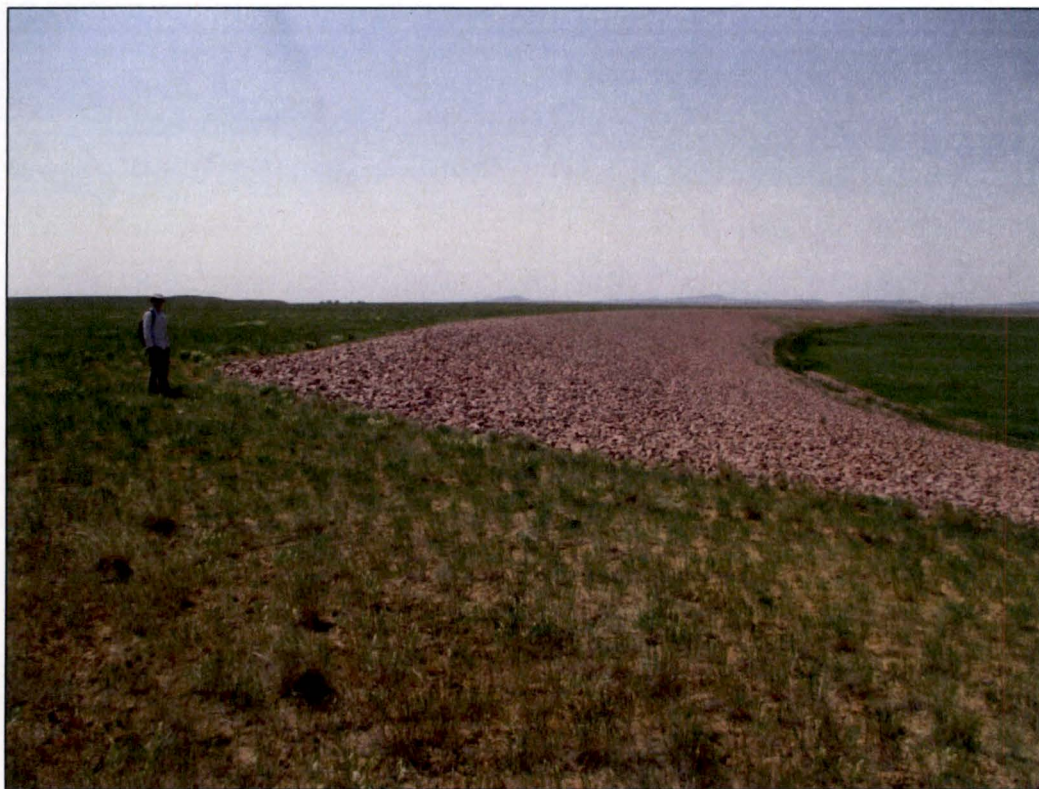
*PL-6. Junction of Upper and Lower Surfaces of Disposal Cell*

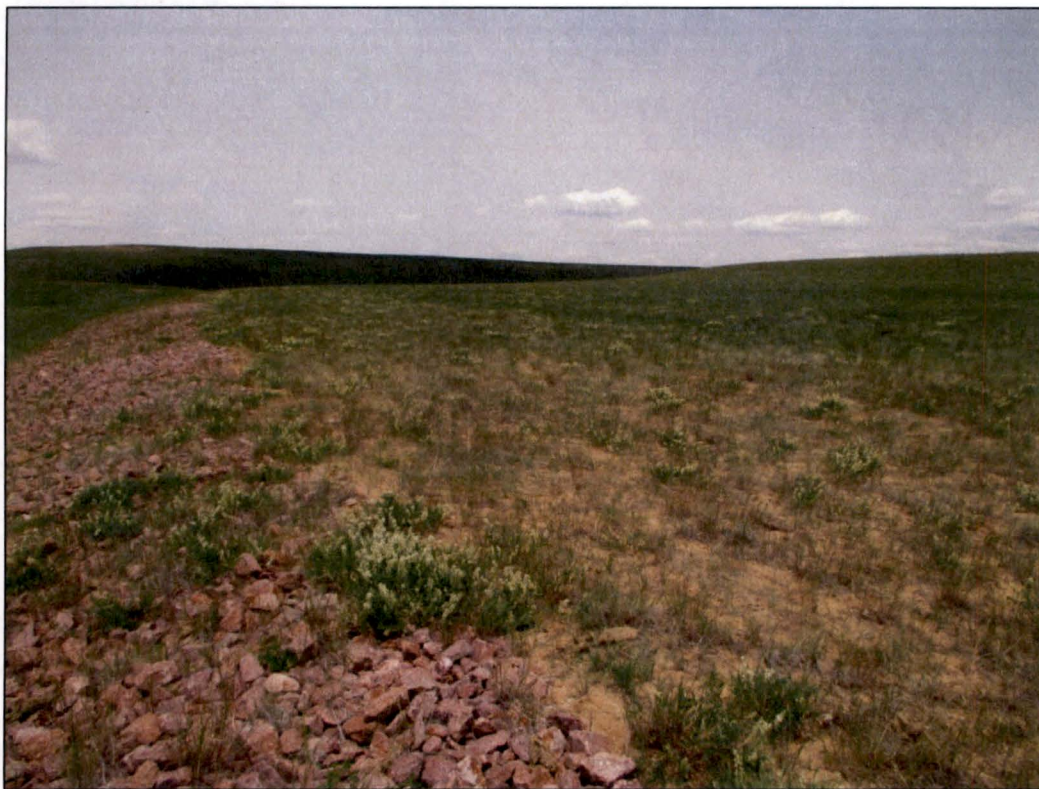
*PL-10. Riprap-Armored Dam Outslope of Disposal Cell*

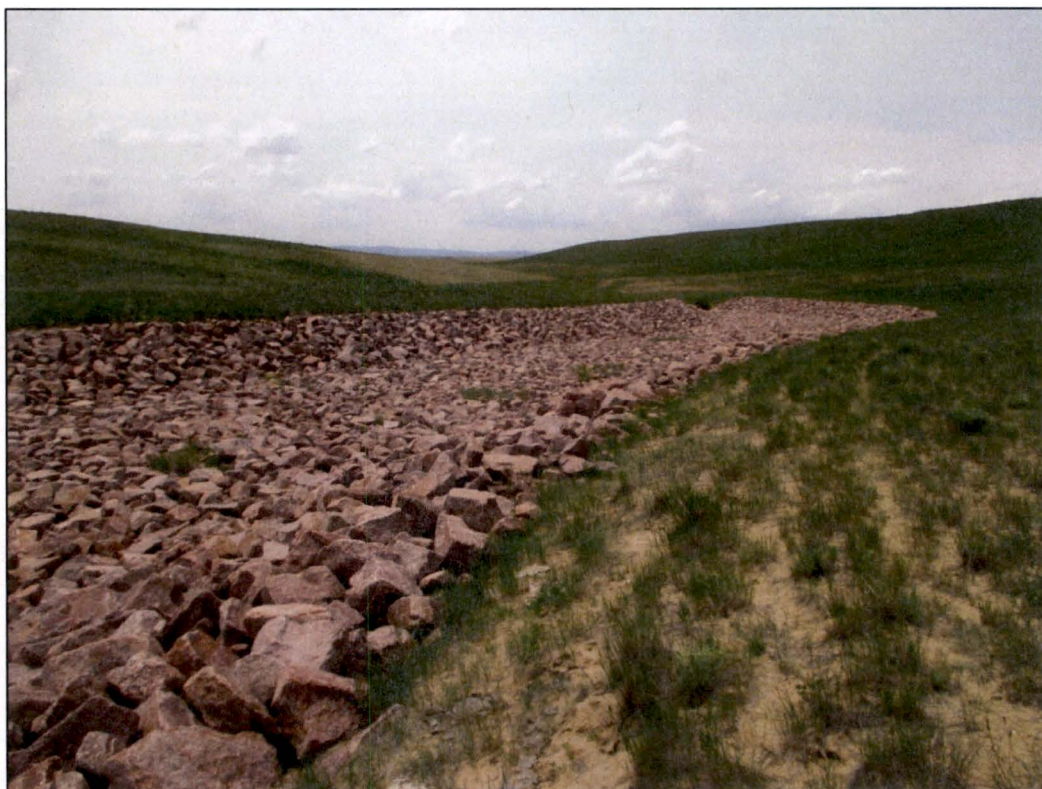
*PL-11. Downgradient View of Riprap-Armored Portion of North Channel*

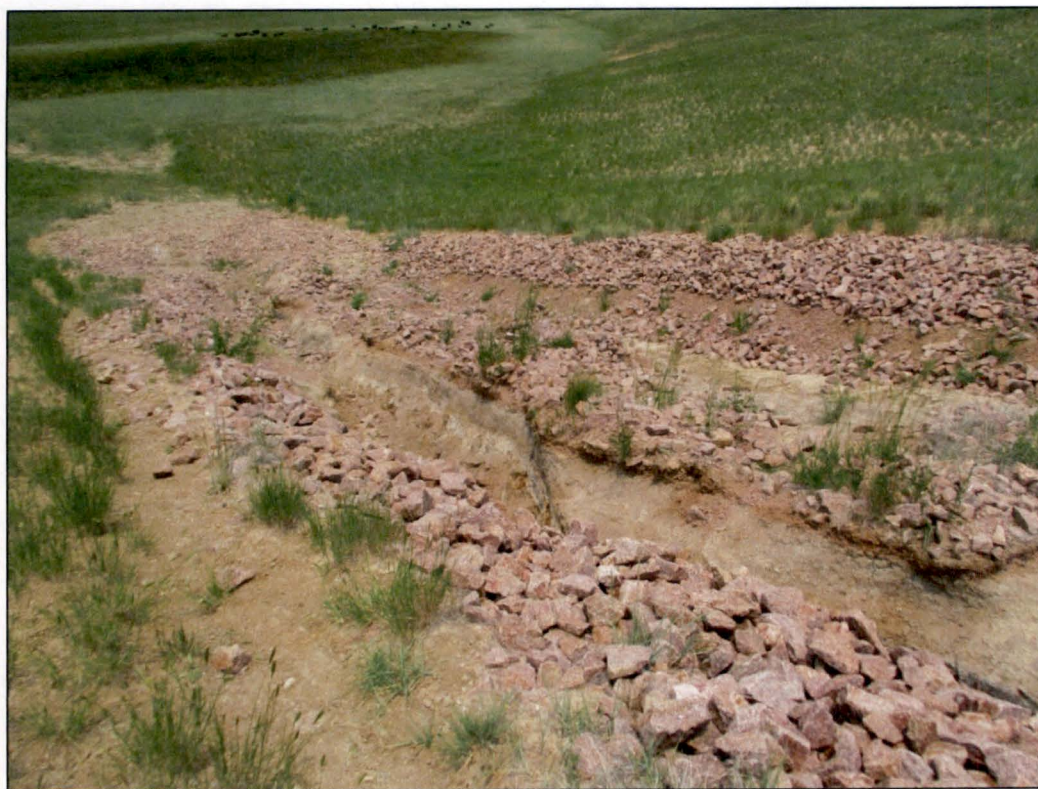
*PL-14. Eroded Riprap at Bottom of Pit 4*
