REPORT ON INSTRUMENTATION PORT

COLUMN ASSEMBLY LEAKAGE

FLORIDA POWER & LIGHT COMPANY

TURKEY POINT UNIT 4

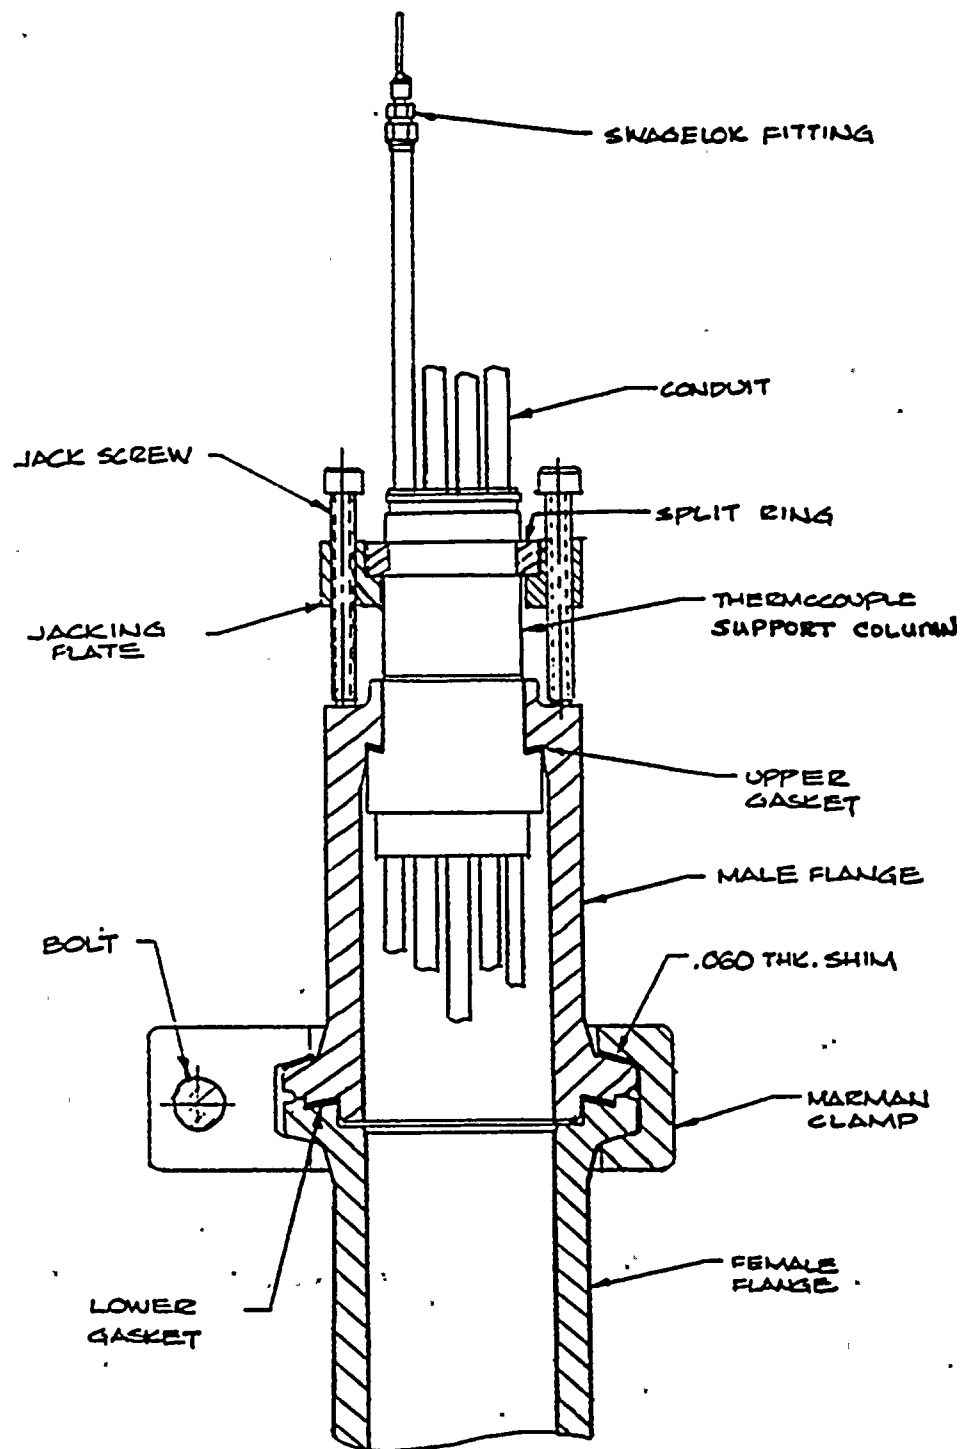
Figure 3-2: Instrumentation port column assembly

As shown in Figure 3-2, each assembly consists of a lower and upper seal joint, each of which use a conoseal gasket for leak tightness. The lower seal is between a male flange and female flange, which is threaded and seal welded to the reactor vessel head penetration. The upper seal is between the male flange and a thermocouple support column. Each conoseal gasket is used only once and is replaced with a new gasket each time the thermocouple column is re-assembled.

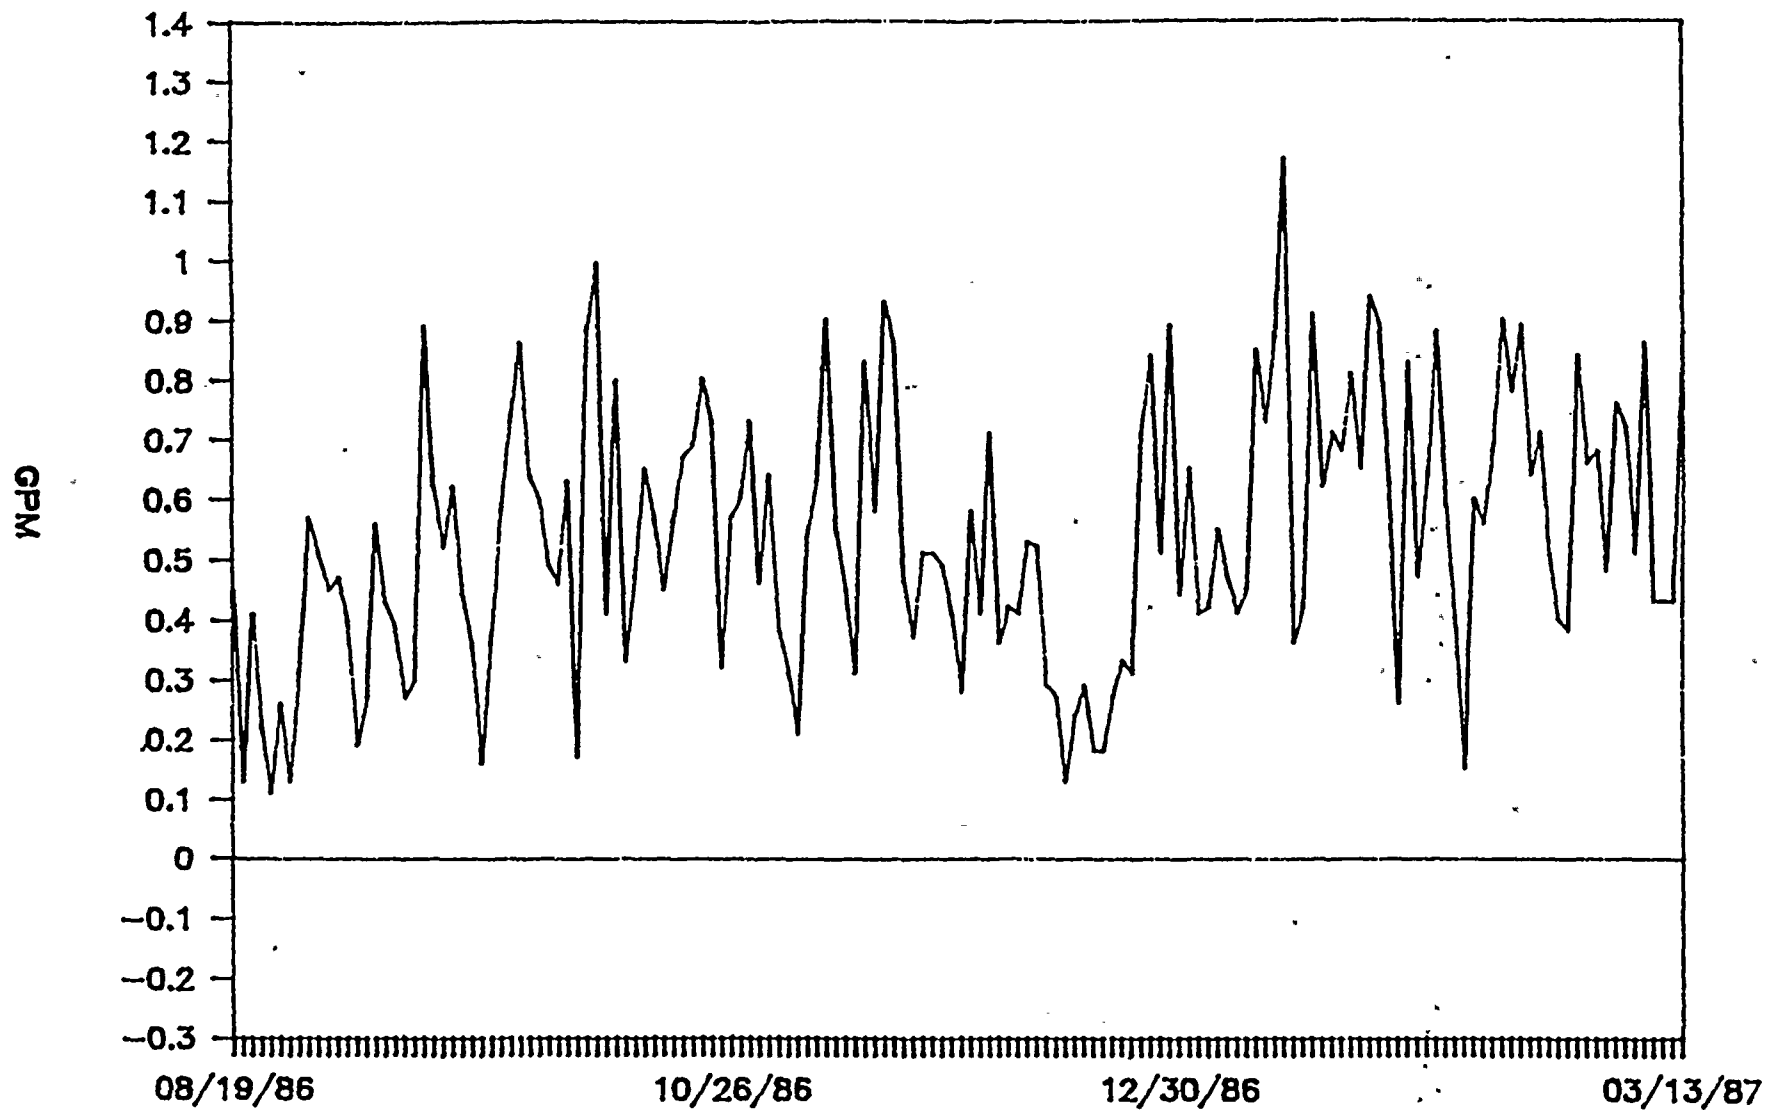
Figure 3-3: Unit 4 RCS Leakage

FPL continued to monitor RCS leakage in accordance with procedures. Figure 3-3 identifies the RCS leakage of Unit 4 from August 1986 to March 1987, calculated in accordance with the methods provided in NUREG-1107. As this figure indicates, the calculated leak rates were scattered during this period, primarily due to uncertainties in the calculational methods and changes in plant operating conditions. Of importance, Figure 3-3 shows that there was no evidence of an increasing trend in RCS leakage during this period. Although the calculated RCS leakage did exceed 1.0 gpm on several occasions during this period, in each case FPL evaluated the leakage as required by the Technical Specifications and determined that the specific occasional increases in the calculated leakage was attributed to causes other than the conoseal leakage (e.g., identified packing leakage, etc.).

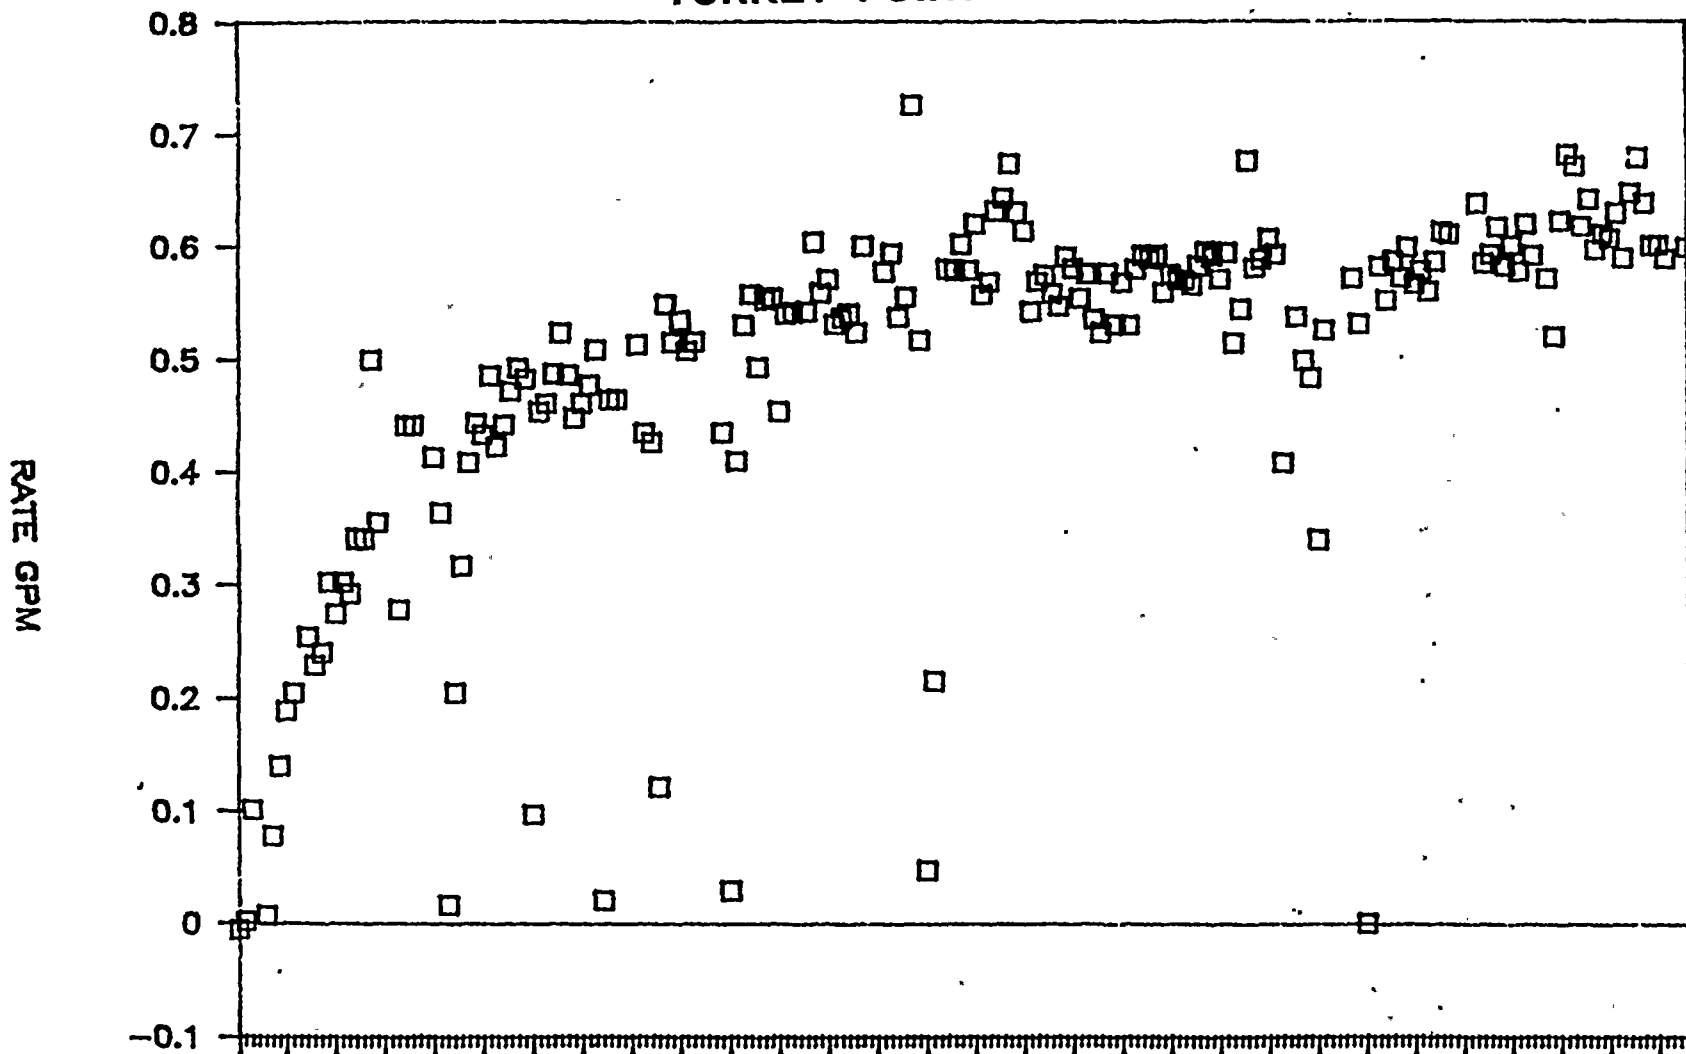
Figure 3-4: Unit 4 RCS Sump Change

Similarly, other plant indicators did not experience any unexplained increase during this period which could be attributed to conoseal leakage. For example, Figure 3-4 shows that the flow rates on the sump did not increase from November 1986 to March 1987. Although the sump flow rate did increase in September and October 1986, this increase was attributable to the fact that the containment atmosphere in the earlier months was not yet saturated and at equilibrium temperature (i.e. leakage would have a greater tendency to remain in the containment atmosphere rather than to condense as a liquid and flow to the sump). Additionally, as shown in Figure 3-5, the applicable radiation monitor did not register any increase in radiation levels, with the exception of an increase attributable to higher RCS activity. Therefore, plant personnel had no indication of any increase in the conoseal leakage prior to March 13, 1987.

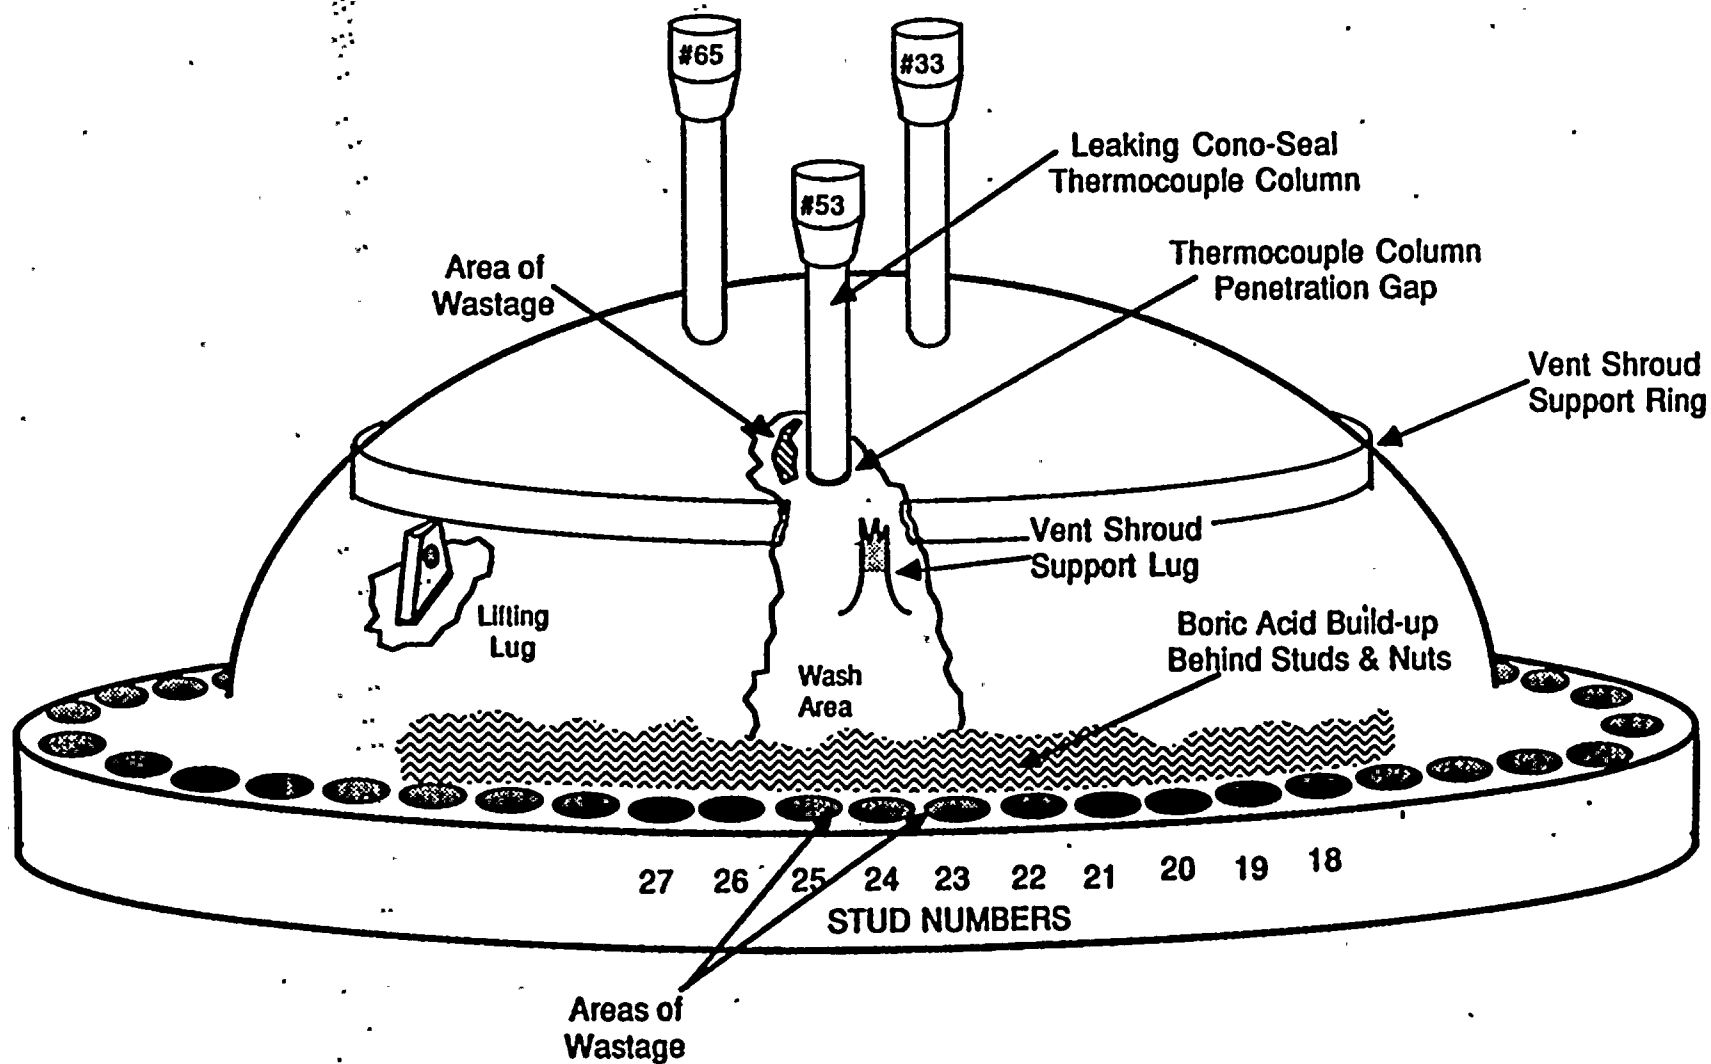
Figure 4-1: Identification of areas on the reactor vessel head affected by boric acid

Several areas of the head were noted to be affected by the boric acid accumulation, including a segment of the head dome originating at the instrumentation port column penetration below the NE conoseal and extending down the head to studs 24 through 26 and down the side of the vessel flange and partially filling the head to vessel flange closure area. Boric acid accumulation partially filled the vessel flange to seal ledge annulus and spilled below onto the vessel insulation and the A loop hot and cold leg nozzle insulation. Boric acid also dripped onto the reactor vessel supports for the A hot and cold leg and into the primary shield wall penetration for the loop A hot leg nozzle. The boric acid also accumulated on the closure head flange knuckle region and ligaments from studs 5 through 37, around those studs, nuts and washers to varying depths and inside the vent shroud support ring in the vicinity of the leaking conoseal.

Detectable wastage was observed in the instrumentation port column penetration counterbore (No. 53), a small area on the head base metal adjacent to the penetration, a three foot arc of vent shroud support, a vent shroud support lug, studs 24, 25 and 26, nuts 23 through 28, washers and small areas on the head flange ligament between the washers. (See Figure 4-1)

Two areas, each less than 4 square inches and located in the ligaments between studs 23 and 24 and between studs 24 and 25 on the top of the head flange, had wastage to a maximum depth of 1/16 inch. An evaluation of the two depressions in the ligament top surface region concluded that the condition is acceptable because the critical

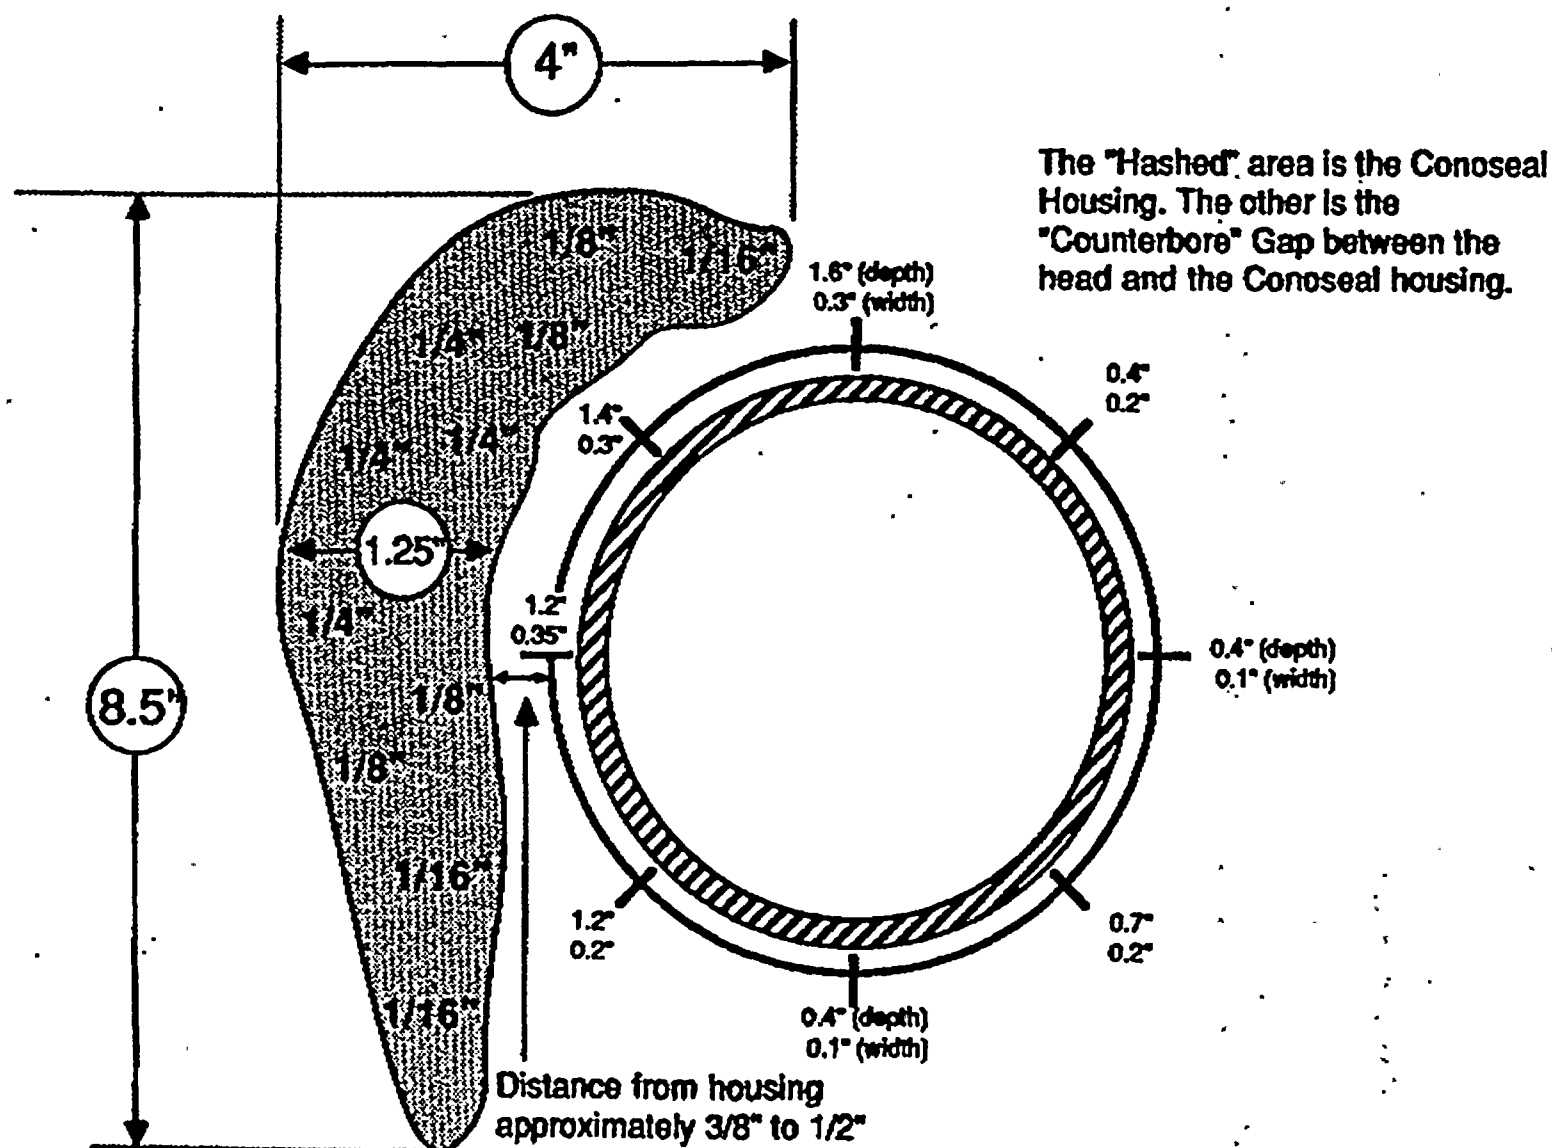
The instrumentation port, column Penetration No. 53 associated with the leaking conoseal was inspected. The counterbore of the penetration had been enlarged by wastage from 0.005 inches to a maximum of 0.35 inches at the top of the head. The maximum depth of the counterbore gap corrosion was measured to be 1.6 inches. (See Figure 4-2).

The sketch below is a plan view as looking down on the penetration.  
The numbers circled are dimensions, the others are depth measurements.

A calculation was performed which verified the acceptability of this condition under the ASME Code Section III criteria for the head minimum thickness, ligament efficiency, and penetration reinforcement requirements.
