ACCESSION NBR: 8706100221 . DOC. DATE: 87/06/02 NOTARIZED: NO DOCKET #
 FACIL: 50-250 Turkey Point Plant, Unit 3, Florida Power and Light C 05000250
 AUTH. NAME AUTH. AFFILIATION
 WOODY, C. O. Florida Power & Light Co.
 RECIP. NAME RECIPIENT AFFILIATION
 Document Control Branch (Document Control Desk)

SUBJECT: Requests relief from visual (VT-2) exam required by
 IWA-5246, "Repaired or Replaced Components & Alteration of
 Sys." required by ASME Boiler & Pressure Vessel Code Section
 XI. Basis for request encl. Fee paid.

Re: Turkey Point Unit 3
Docket No. 50-250
Request for Relief for the
Second Inservice Inspection Interval

RELIEF REQUEST NO. 15

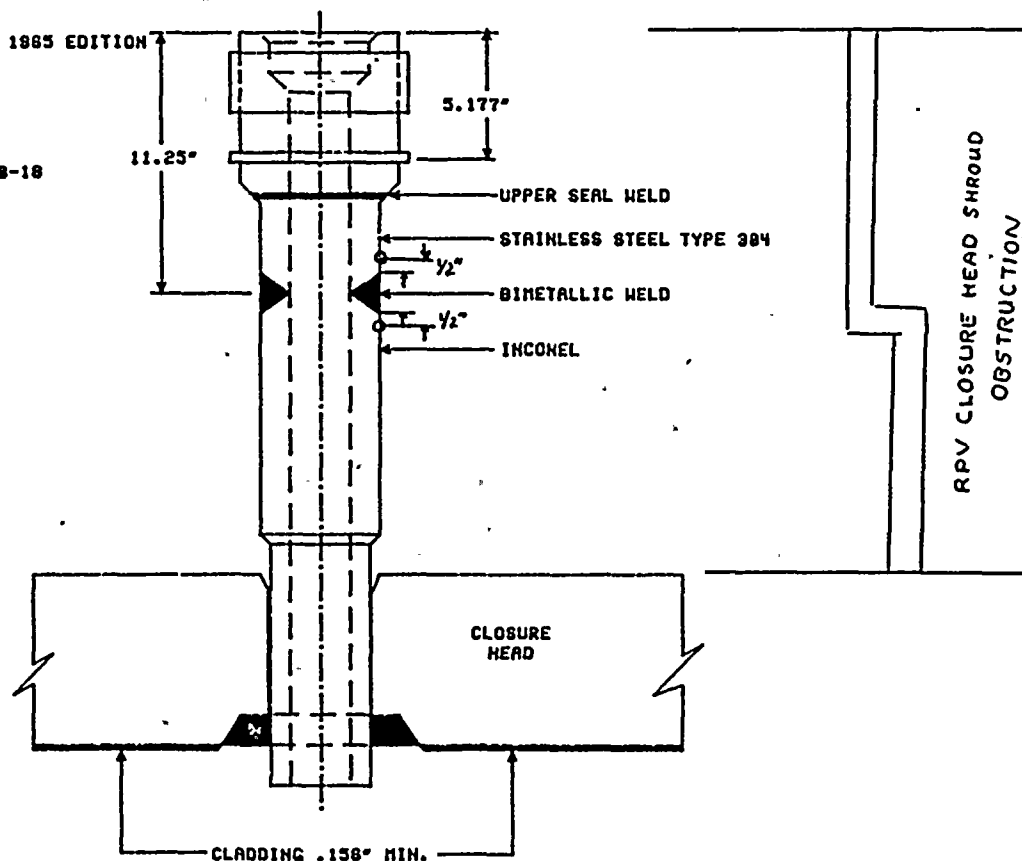
- a. THE RPV HEAD SHROUD OBSTRUCTS THE ENTIRE LENGTH OF THE CRDM HOUSINGS. SEE DRAWING NO. CIS-V-02B FOR AREA OF OBSTRUCTION.
- b. THE CRDM COIL STACKS AND RPI CABLES ARE INSTALLED ON THE INSTRUMENT PORTS.
- c. THE INSULATION SOCK IS INSTALLED ON THE REPAIRED DUMMIES. SEE DRAWING NO. CIS-V-02D FOR DETAILS.
- d. A BLANK COIL STACK IS INSTALLED OVER THE INSULATED SOCK, AND IS ATTACHED BY A CLAMP TO THE ADJACENT CRDM HOUSING. SEE DRAWING NO. CIS-V-02G FOR DETAILS.

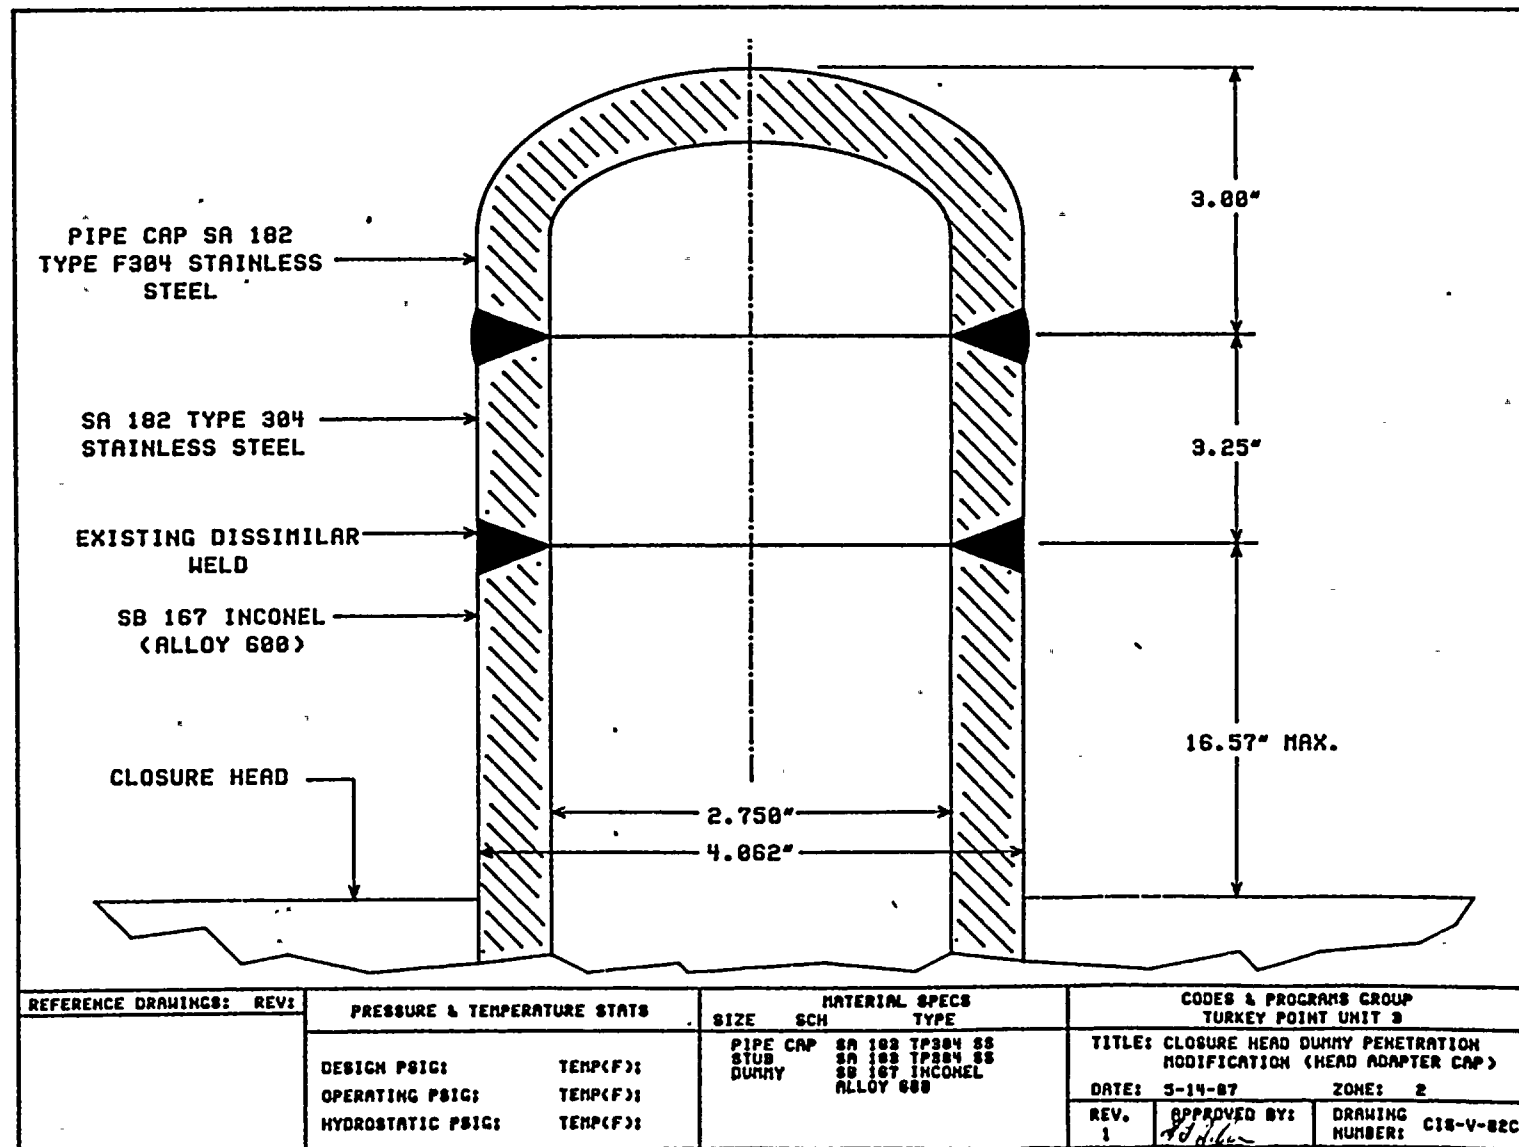
THE REPAIR OF THE LEAKING CRDM DUMMIES CONSISTED OF REMOVING THE EXISTING WELD AND REPLACING IT WITH A STAINLESS STEEL CAP WELDED BY A FULL PENETRATION BUTT WELD. DRAWING NUMBER CIS-V-02C PROVIDES A DETAIL OF THE REPAIR WELD AND CAP CONFIGURATION.

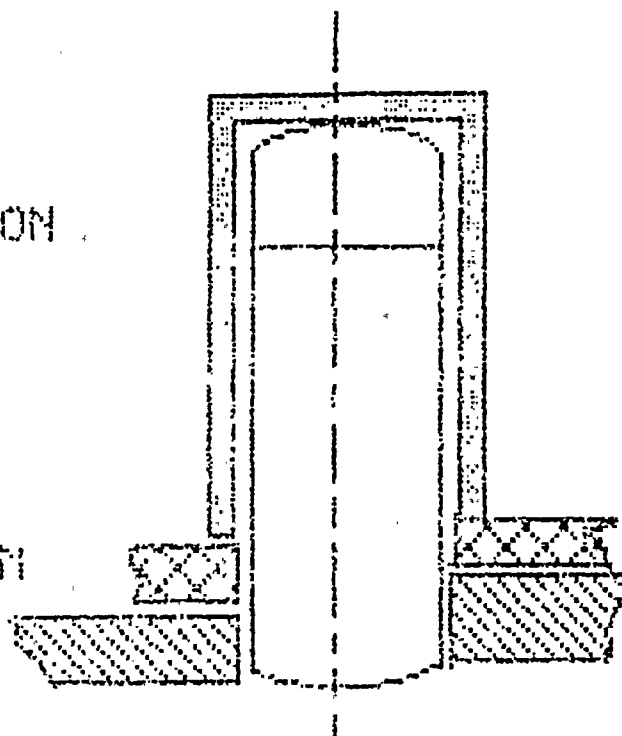
TURKEY POINT UNIT NO. 3
RELIEF REQUEST NO. 15
CIS-U-020
CFDM INSULATION SOCK

THE CURRENT DESIGN CONFIGURATION OF THE REPAIR DUMMIES REQUIRE THE CRDM TO BE INSULATED WITH A SOCK. THE INSULATION SOCK AS IDENTIFIED IN ATTACHED DRAWING NO. CIS-V-02D RESTRICTS BOTH THE DIRECT OR REMOTE VISUAL EXAMINATION BY COMPLETELY COVERING THE ENTIRE CRDM HOUSING, THEREFORE OBSTRUCTING THE DIRECT OR REMOTE VISUAL EXAMINATION OF THE NEW WELD.

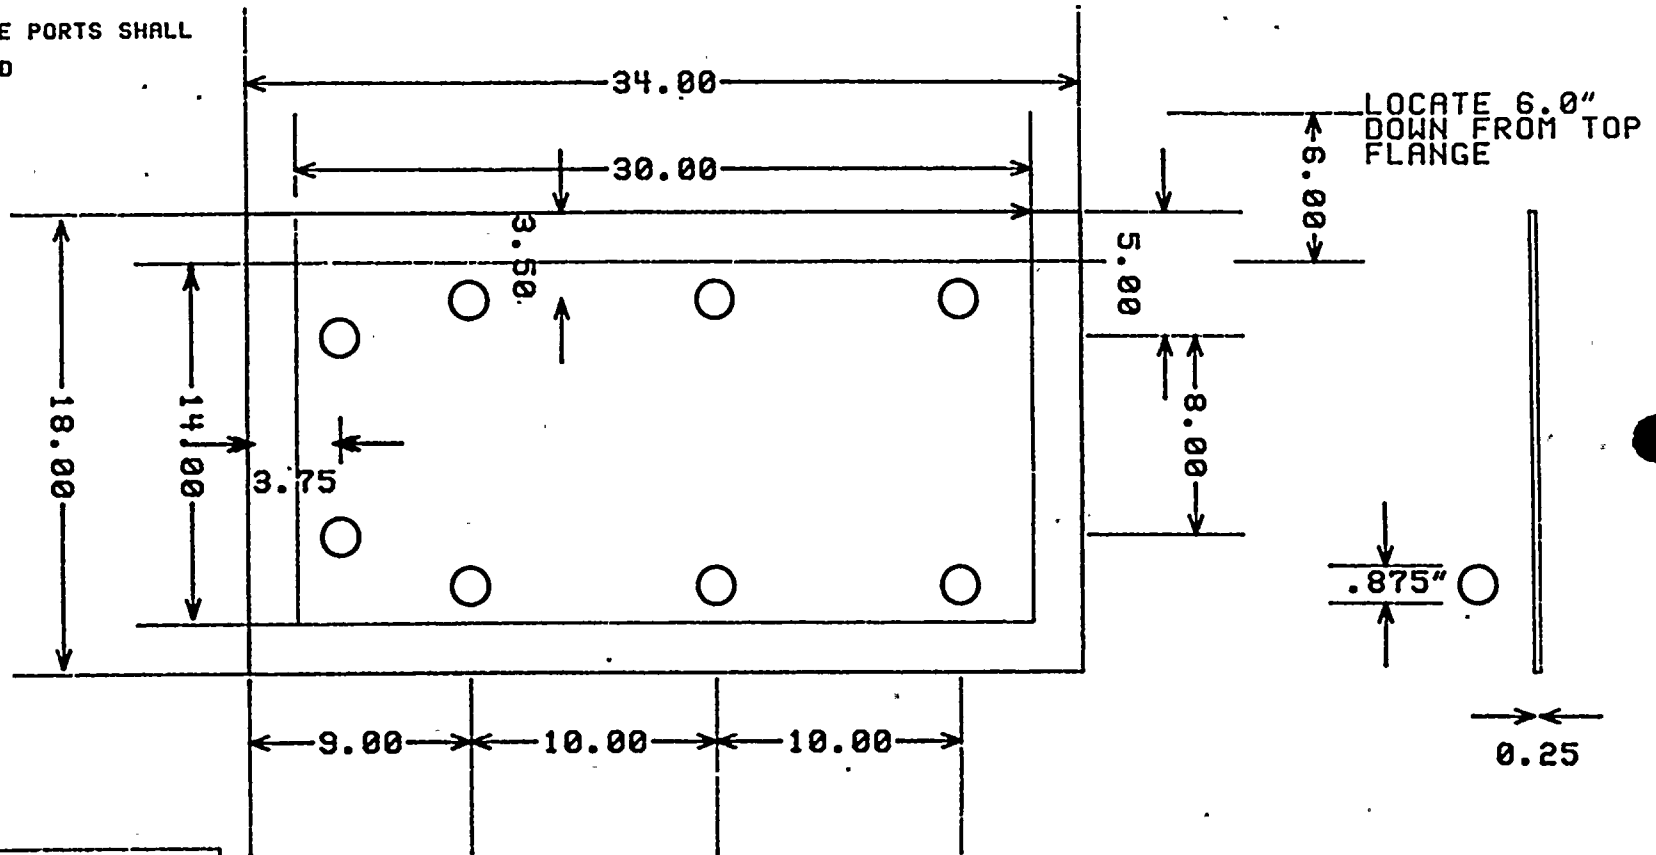
RELIEF REQUEST NO. 15
 TURKEY POINT PLANT
 UNIT 3 & 4
 21 MAY 1987
 CIS-V-02E

- b. FPL FEELS THAT WITH THE ADDITION OF THE THREE INSPECTION PORTS THAT EARLY IDENTIFICATION OF LEAKS FROM THE CRDM PORTS WILL ASSURE A CONTINUED ACCEPTABLE LEVEL OF QUALITY AND REDUCE THE RADIATION EXPOSURE TO THE EXAMINERS.

1. (3) SEPERATE PORTS SHALL BE INSTALLED

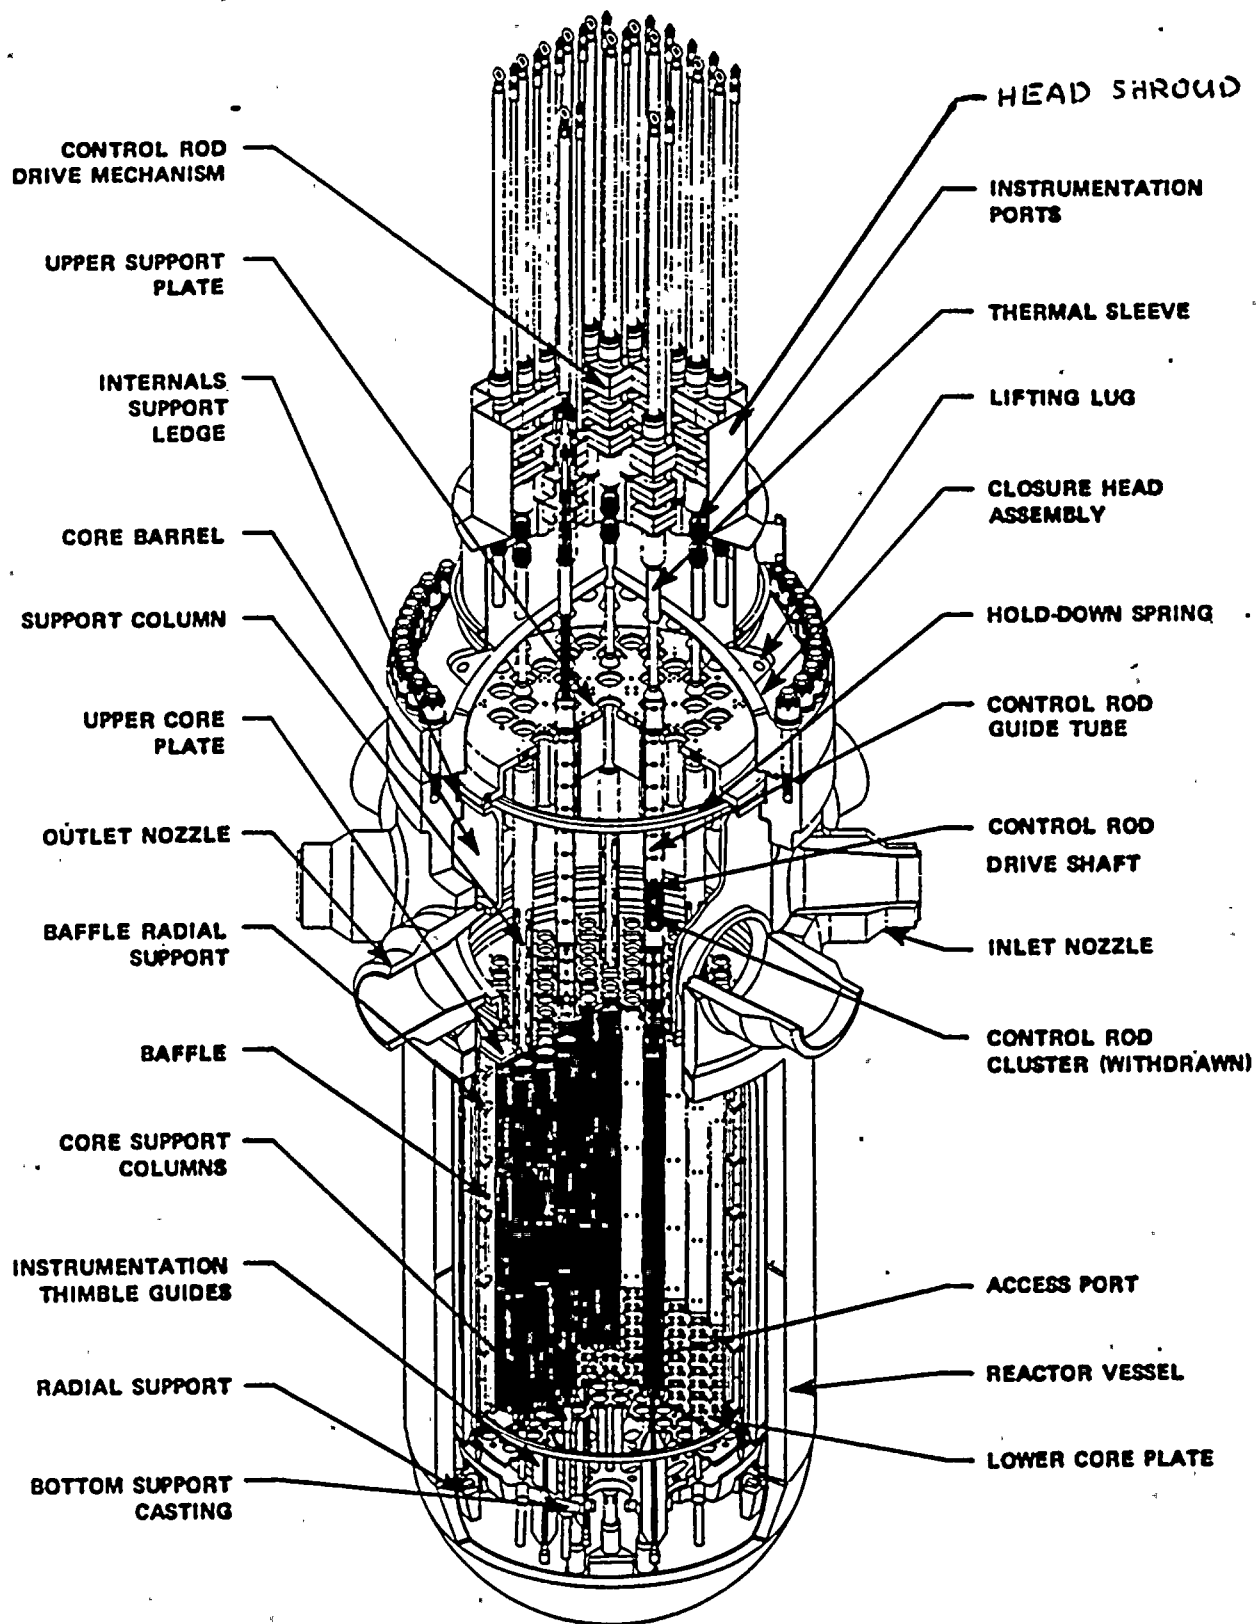
RELIEF REQUEST NO. 15
CIS-V-02F

FOLLOWING THE REPAIR AND AFTER THE CLOSURE HEAD IS BACK ON THE VESSEL, THE FOLLOWING RESTRICTIONS PROHIBIT THE VT-2 EXAMINATION DURING THE RCS OVER PRESSURE TEST: SEE DRAWING NO. CIS-V-02F FOR GENERAL ARRANGEMENT DETAIL.

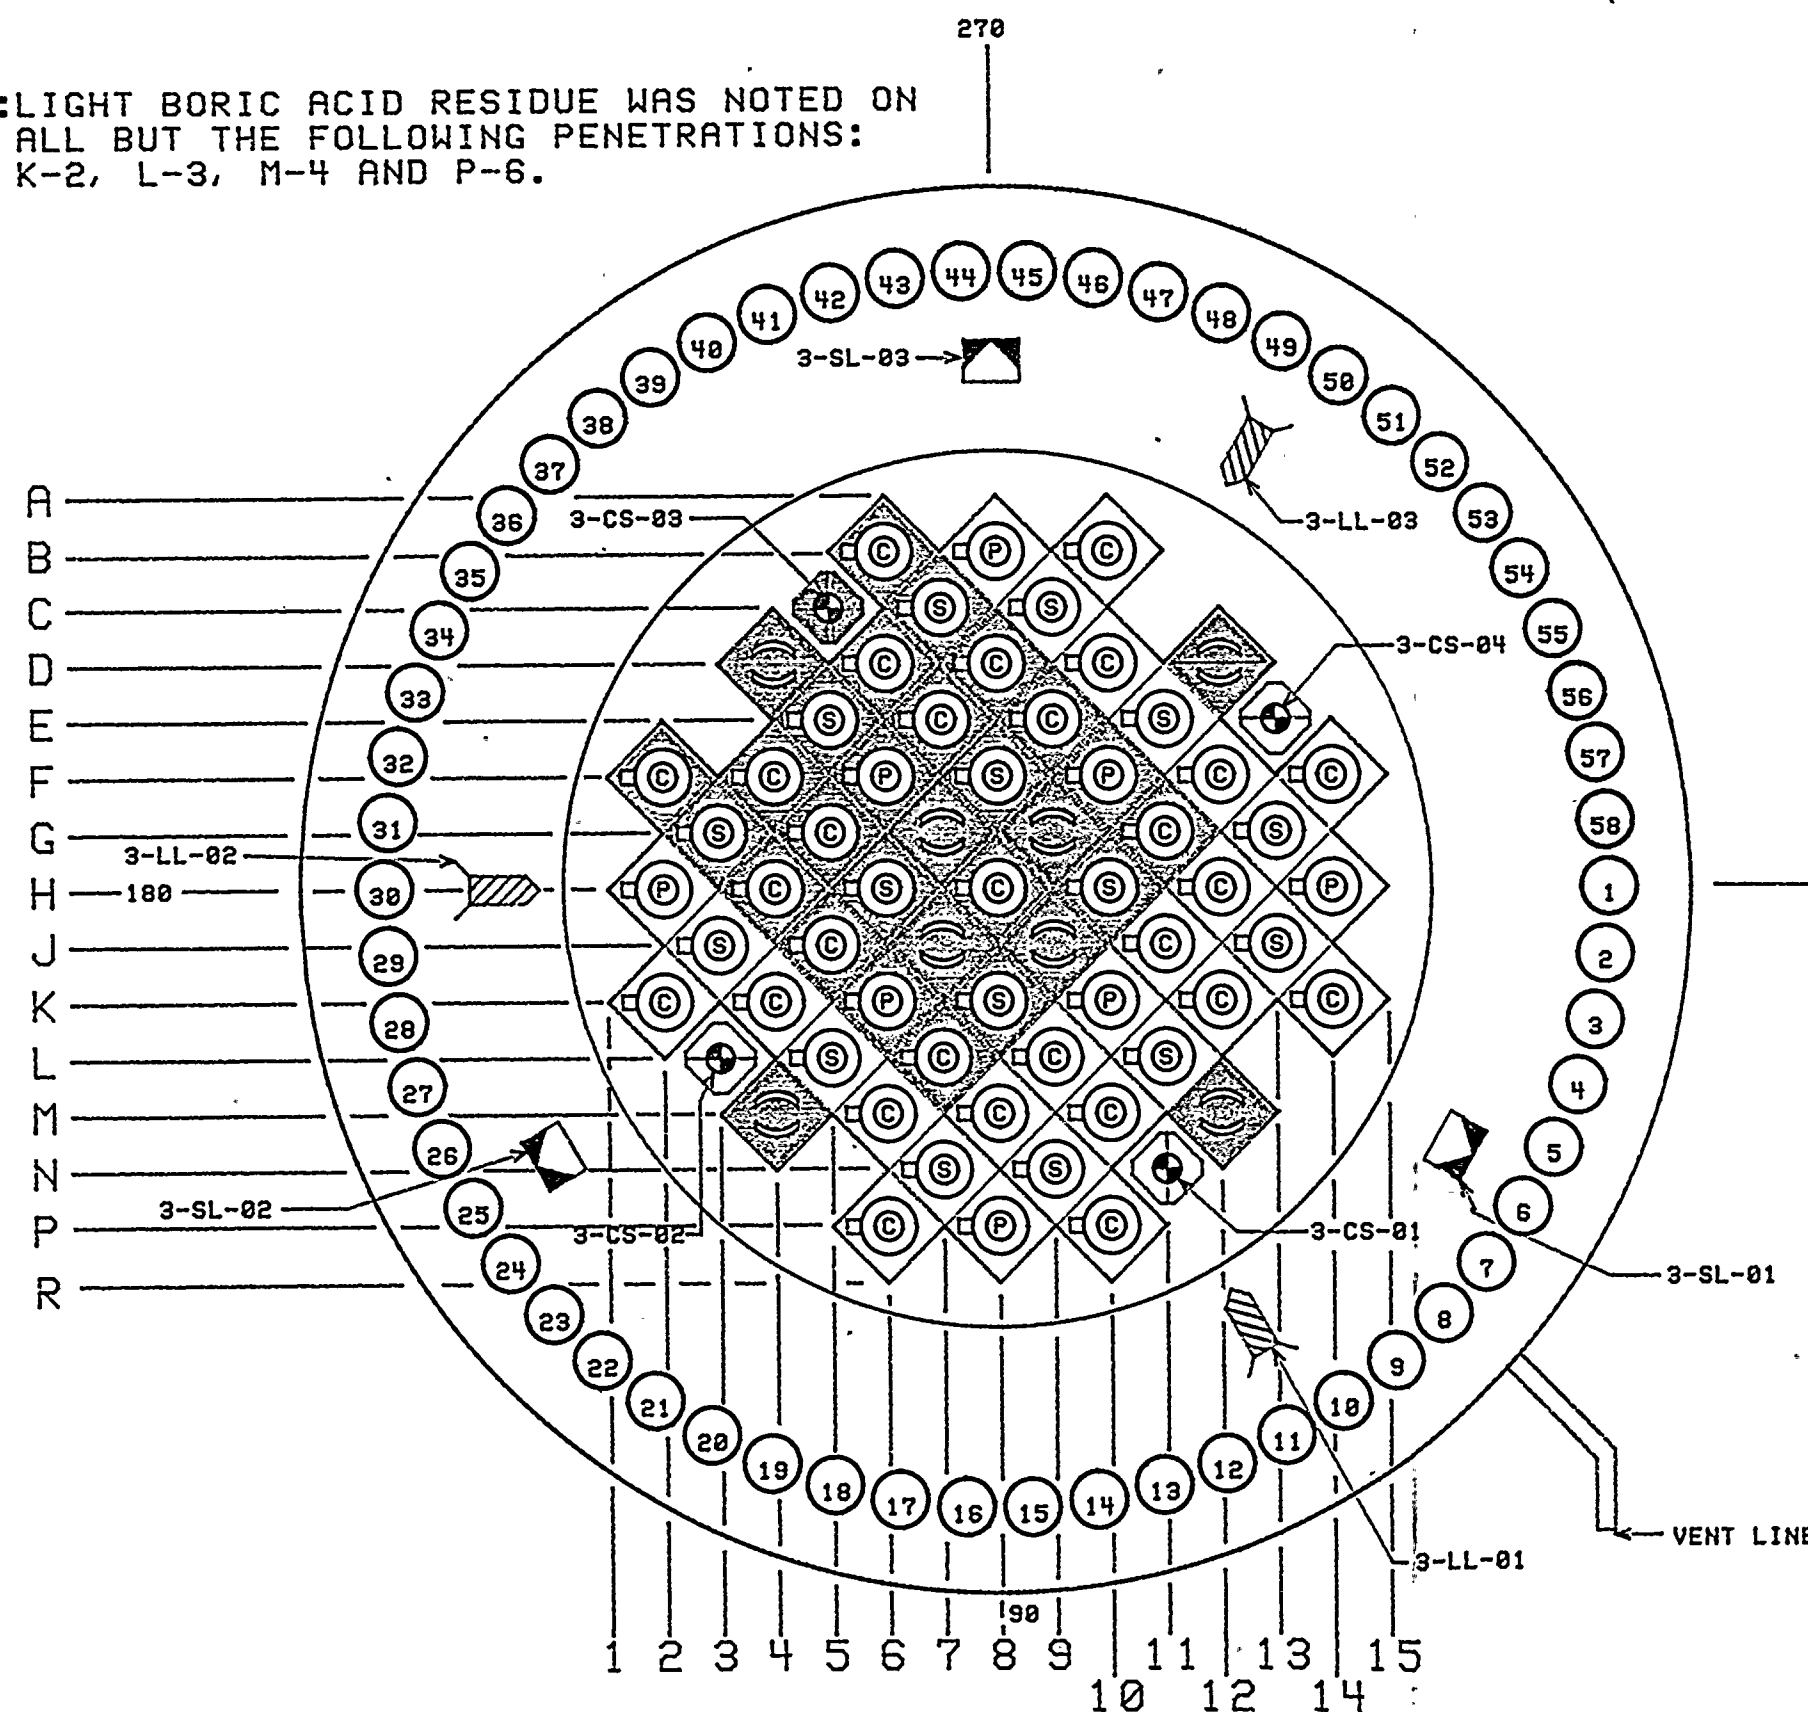
TURKEY POINT UNIT 3
RPV CLOSURE HEAD LEAK DETAIL
CIS-V-02A

THE (2) TWO REPAIRED CONTROL ROD DRIVE HOUSINGS (BOTH DUMMIES) ARE LOCATED IN THE CENTER OF THE REACTOR PRESSURE VESSEL HEAD. DRAWING NUMBER CIS-V-02A, COLOR CODED IN RED, PROVIDES THE LOCATION OF THE (2) TWO REPAIRED HOUSINGS WELDS NUMBERS G7 AND G9.

- c. FOLLOWING THE ABOVE EXAMINATIONS, A REMOTE VISUAL EXAMINATION WAS CONDUCTED AND RECORDED ON VIDEO TAPE. THE CRDM HOUSINGS EXAMINED ARE IDENTIFIED ON DRAWING NO. CIS-V-02A. THESE EXAMINATIONS INCLUDED THE TWO LEAKING DUMMIES (RED), THE FOUR ADJACENT CRDM WHICH HAD EVIDENCE OF RECIEVING THE MOST SPRAY (BLUE), THE SURROUNDING CRDMS IN WHICH TO BOUND IN THE LEAKERS (GREEN), THE ADDITIONAL THREE DUMMIES (TURQUOISE), AND THE TWO ADDITIONAL CRDMS CODED IN (PURPLE) RECIEVED A VISUAL AND LIQUID PENETRANT EXAMINATION IN ORDER TO SATISFY THE TEN-YEAR INSPECTION REQUIREMENTS.

NOTE: LIGHT BORIC ACID RESIDUE WAS NOTED ON ALL BUT THE FOLLOWING PENETRATIONS:
K-2, L-3, M-4 AND P-6.

RED = LEAKERS G-7 INITIAL LEAKER CONFIRMED PT.
G-9 SUSPECT LEAKER CONFIRMED PT.
H-8 SUSPECT PT NRI. PLANT QC, VT-2 & PT.

BLUE = BORIC ACID ACCUMULATION
