REGULATORY INFORMATION DISTRIBUTION SYSTEM (RIDS)

SUBJECT: Forwards mgt-on-shift weekly rept.

Re: Turkey Point Units 3 and 4
Docket Nos. 50-250 and 50-251
Management-on-Shift Weekly Report

MANAGEMENT ON SHIFT (MOS)

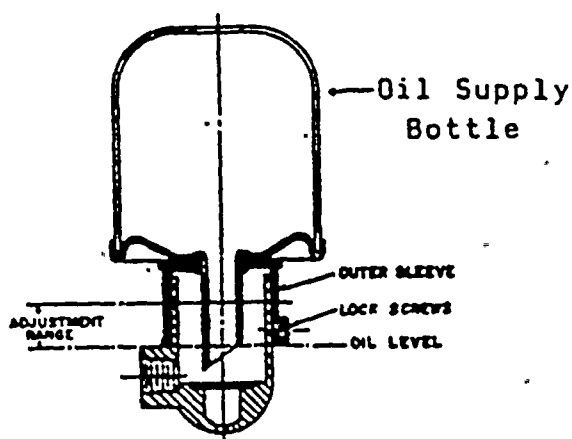
1. Upon further review of item 1 (9/22/88), it was determined that the loose oilers may have gotten that way due to the method used in filling them. The majority of the oilers found loose on 9/22/88 were of the "tube" type as shown in the 9/16/88 "To the Point" flyer. In the past these oilers have been refilled by removing the bottle as well as the outer sleeve, rather than unscrewing the bottle from the outer sleeve. The 9/16/88 "To the Point" flyer was provided to plant staff in order to improve worker understanding of these components. The document provides excellent guidance, however does not appear to have been read by all personnel affected. It is recommended that this information be provided to all appropriate personnel as soon as possible. (MOS item 88-2520.)

On tube oilers, only the supply bottle is unscrewed from the oiler assembly. There is no need to lift the upper portion of the assembly. In fact, doing so will cause inadvertent change of the oil setpoint.

Tube Oiler: Oil supply bottle unscrews from assembly.

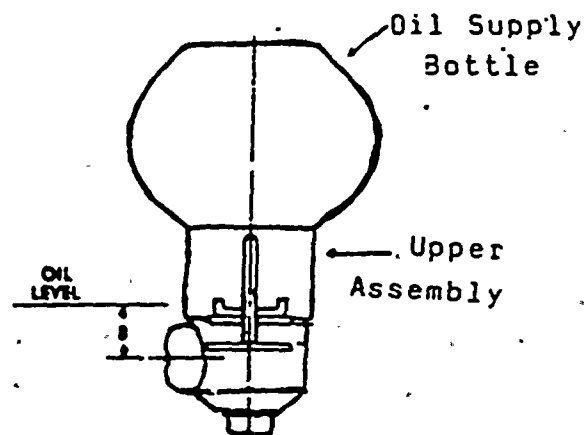
When oil is added to cross-bar oilers, the upper portion of the oiler assembly is removed along with the supply bottle. This is accomplished by loosening a thumb screw on the side of the assembly and lifting it from the oiler.

Cross-bar Oiler: Remove bottle and upper assembly together.
