SUBJECT: LER 89-006-00: on 890713, degraded intake cooling water flow condition, to component cooling water heat exchangers.  
 W/8 Ltr.

Re: Turkey Point Unit 4  
Docket No. 50-251  
Reportable Event: 89-06  
Date of Event: July 13, 1989  
Degraded Intake Cooling Water Flow Condition to Component  
Cooling Water Heat Exchangers and Unit Shutdown Required  
by Technical Specifications due to Valve Failure

## LICENSEE EVENT REPORT (LER)

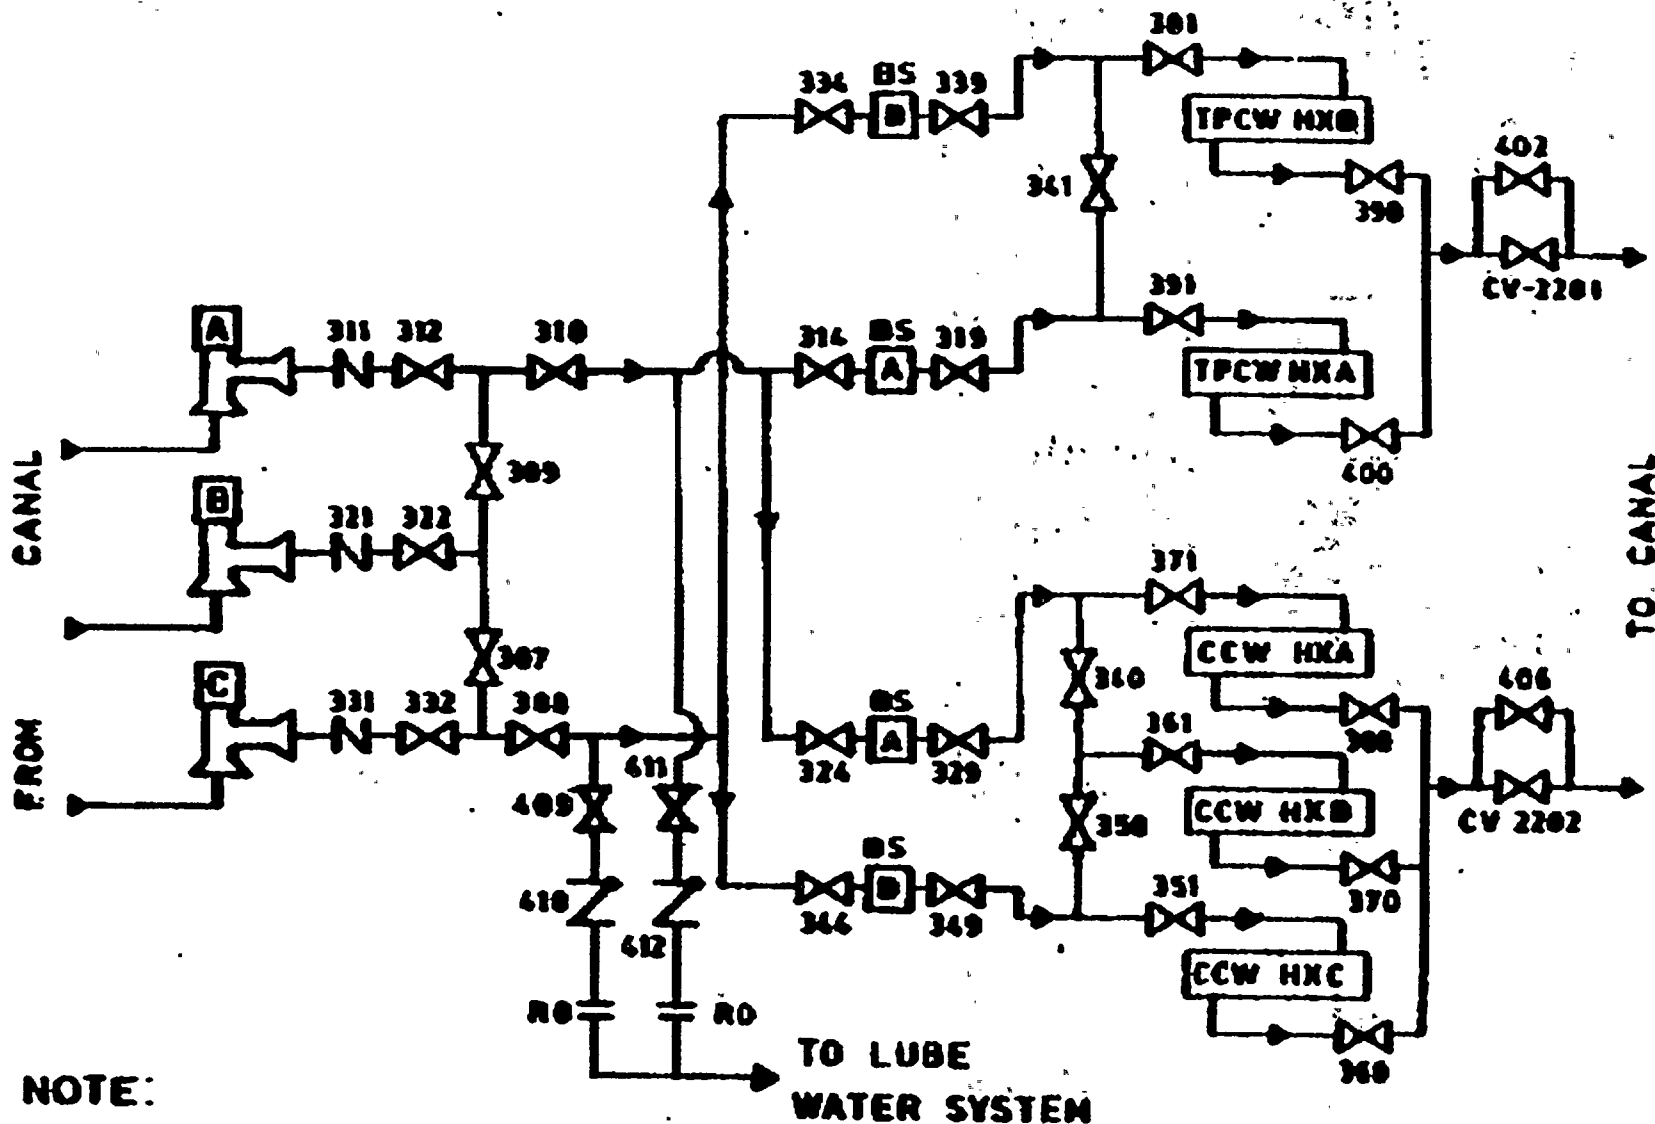
At 1625 on July 13, 1989, with Unit 4 in Mode 1 at 25% power, the 4A Intake Cooling Water (ICW)/Component Cooling Water (CCW) basket strainer (EIS system BI, component: BSKT) was taken out of service for cleaning. (See simplified drawing of the ICW system attached.) At 1635 the Nuclear Operator observed a degraded flow condition on the CCW heat exchangers (EIS System: CC, component: HX) and immediately notified the Control Room operator. The Nuclear Operator was instructed to valve the 4A ICW/CCW basket strainer back in service. At 1640 ICW flow was restored to the CCW heat exchangers. The Operations personnel believed the source of reduced ICW flow to the CCW heat exchangers to be clogging of the 4B ICW/CCW basket strainer. Between 1725 and 2125 the 4B ICW/CCW basket strainer was out of service for cleaning. The basket strainer was found to be more clogged than normal.

The cause of the degraded ICW flow to the CCW heat exchangers was due to failure of 4B ICW header isolation valve 4-50-308. Upon disassembly, the valve disc was found to be in the partially opened position and separated from the valve stem. The tapered pins (2) which connect the disc to the valve upper stem failed in the threaded region. Preliminary indications are that the tapered pins experienced fatigue failure due to oscillations set up in the valve internals by turbulent flow conditions.

- 1) Caution statements have been added to procedures 3/4-OP-019, "Intake Cooling Water System," for operators to ensure that total ICW flow to the CCW heat exchangers does not drop below 15,400 gpm while valving an ICW/CCW basket strainer out of service for backwashing.
- 2) While valve 4-50-308 was removed from the 4B ICW header, a "crawl-through" inspection was conducted to ensure removal of any obstructions to the 4B ICW/CCW basket strainer.
- 3) Valve 4-50-308 was replaced. After ensuring valve integrity and operability, the 4B ICW header was returned to service.
- 4) A disc/stem tapered pin from the 4-50-308 valve has been recovered from the 4B ICW header. This pin will be analyzed to determine its failure mechanism.
