SUBJECT: Forwards thimble tube eddy current insp rept re NRC Bulletin 88-009.

Subject: Turkey Point Unit 3
Docket No. 50-250
IE Bulletin 88-09
Thimble Tube Thinning in Westinghouse Reactors

TURKEY POINT UNIT 3
END OF CYCLE XI
FLUX MAP THIMBLE TUBE
EDDY CURRENT TEST REPORT
FOR
NRC BULLETIN 88-09

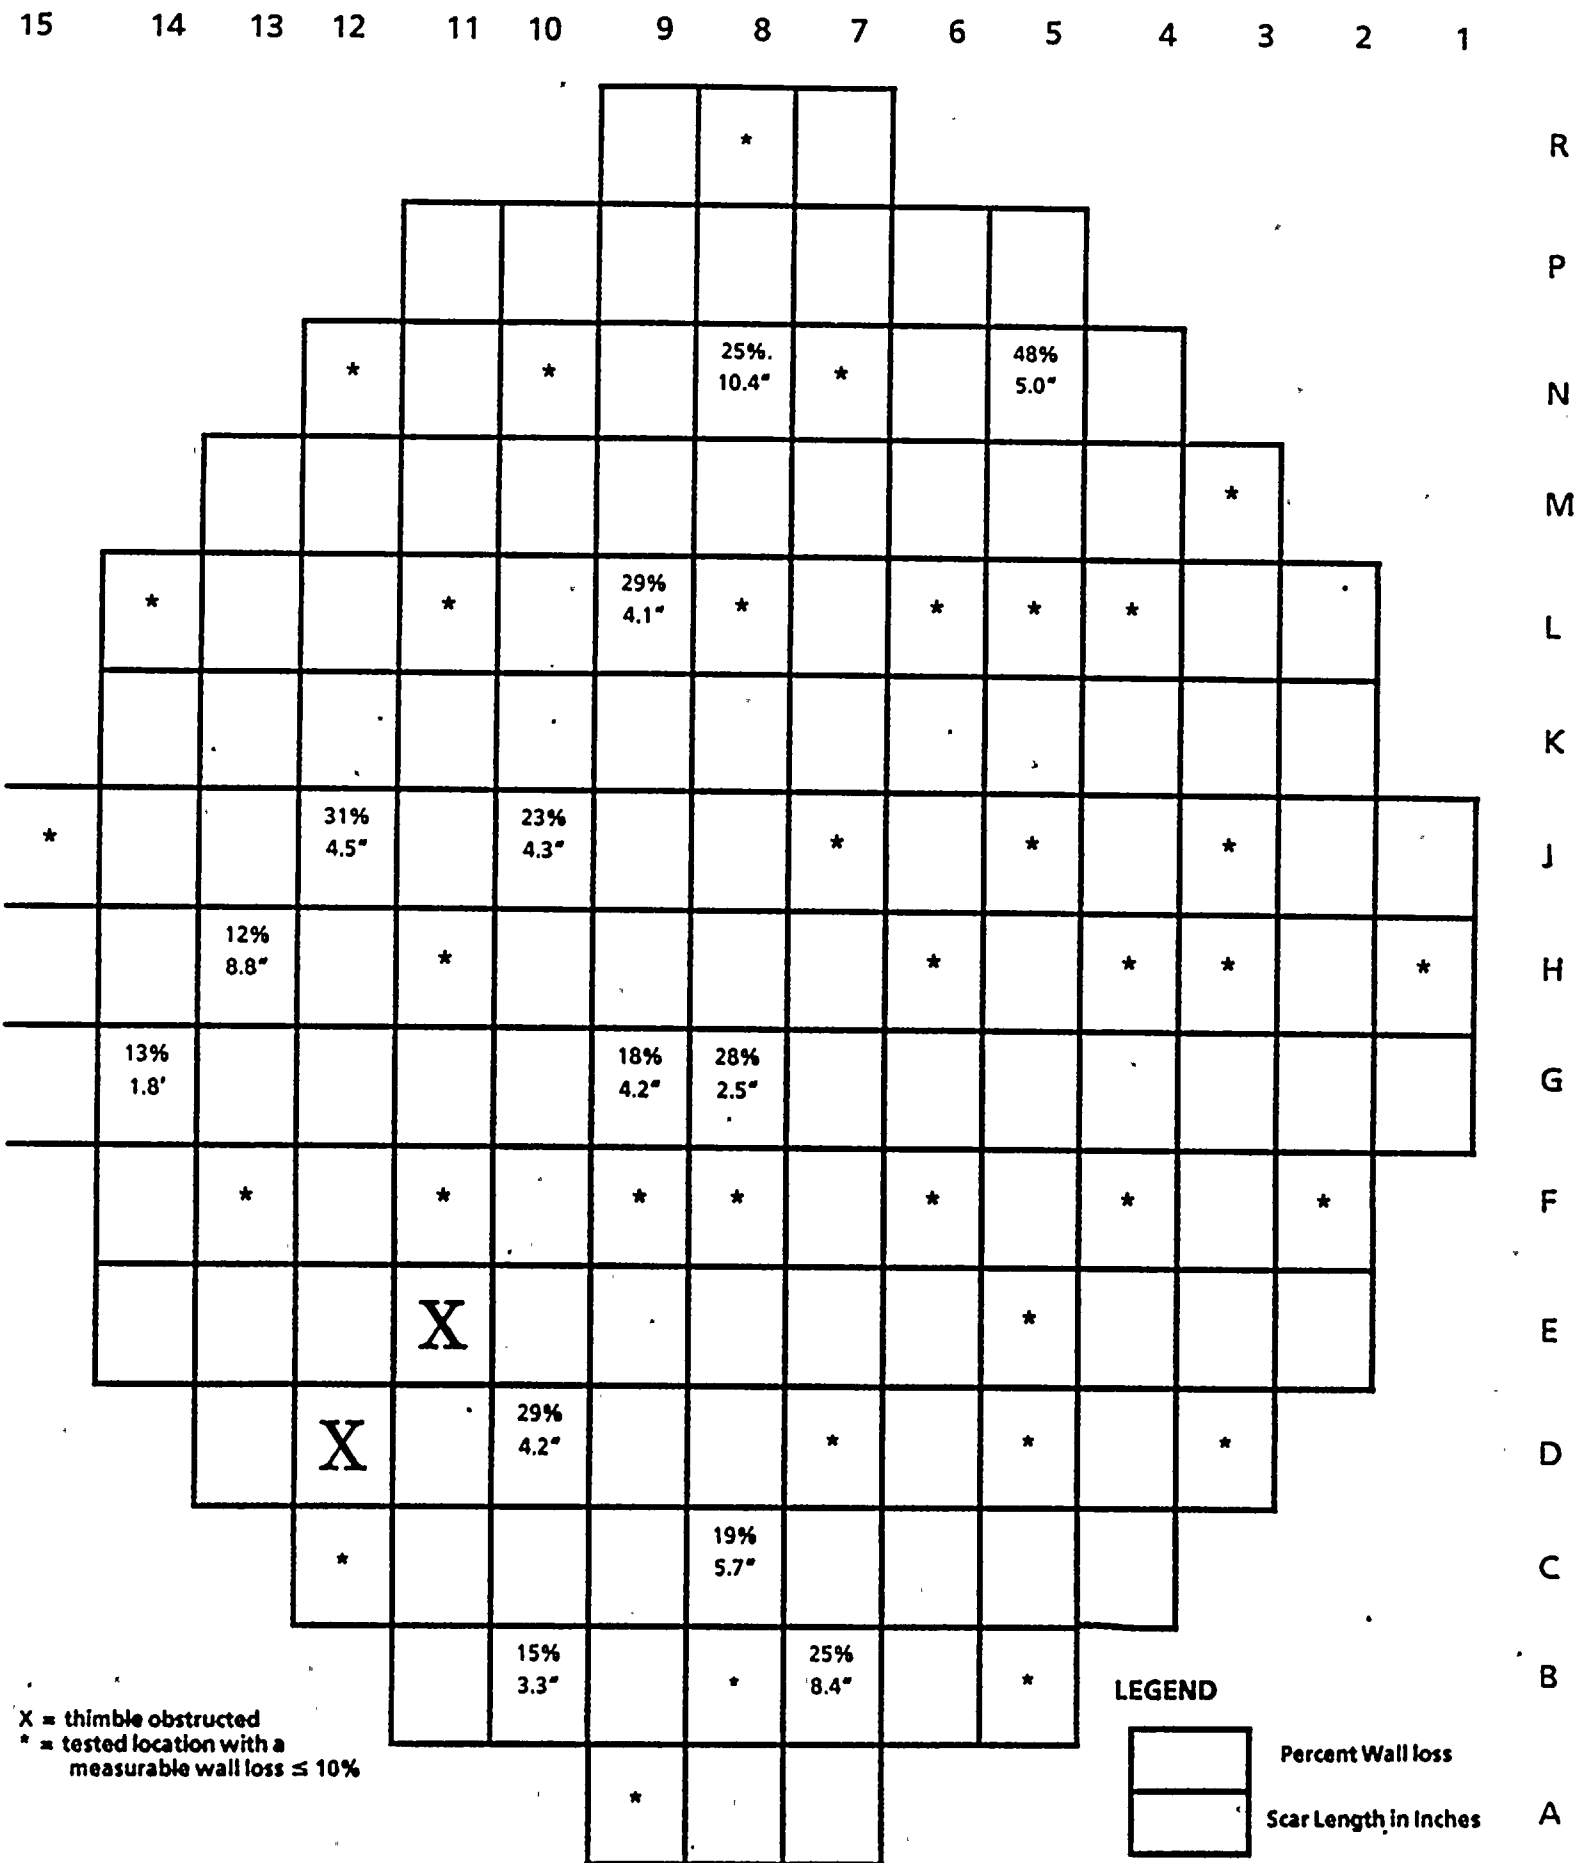
ECT RESULTS OF FLUX MAP THIMBLE TUBE INSPECTION FOR THIMBLE WITH WEAR >10%

The ECT data was analyzed by the FPL Materials, Codes, and Inspections group to determine the percent wall loss and wear scar length for each thimble tube. The results from the data analysis identified the thimble tube locations with 10% or greater wall loss. A total of 13 thimble tubes showed a wall loss greater than 10%. Attachment 1 summarizes the results of the inspection. All of the 48 thimble tubes inspected met the acceptance criteria.

The ECT results were reviewed by Nuclear Engineering to determine if there were any operability concerns. The evaluation by Nuclear Engineering recommended the closing of isolation valves on the two thimbles not inspected. Also thimble N5, which indicated a wall loss of 48%, was recommended to have its isolation valve closed until further measurements can be taken to determine its wear rates.

The ECT inspection of forty-eight out of fifty flux map thimble tubes indicated that one thimble needed to be isolated until a wear rate could be determined. The two thimble locations not inspected shall also be isolated until they can be properly evaluated or replaced.
