SUBJECT: Supplement to 910812 Part 21 rept re potential generic
defects in ABB Type RHHM2 Model RK223068-EA & 069-EA relays.
Caused by tape fold back condition. New method for
installing insulation tape initiated.

December 12, 1991

Subject: Investigation Results Of Potential Generic Defect Of
ABB Type RHHM2 Model RK223068-EA and 069-EA Relays

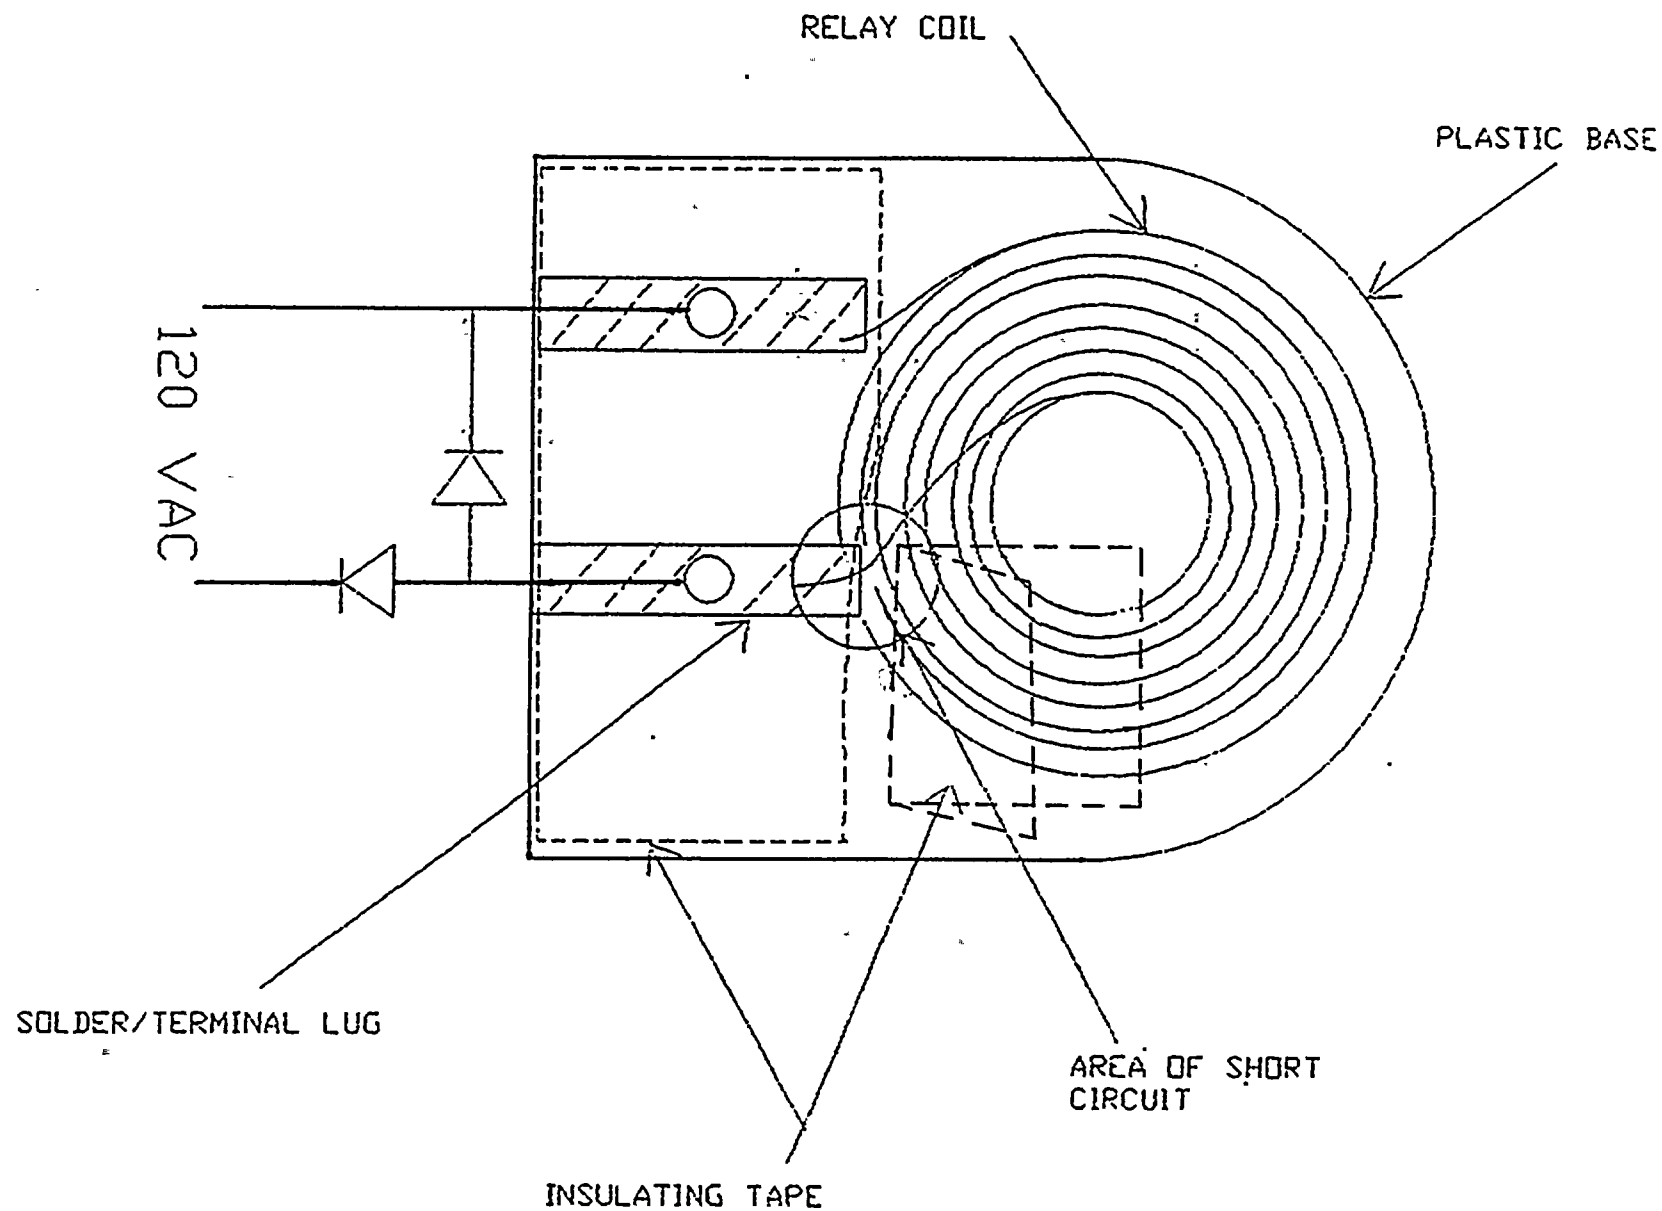
It was not until the last day of the audit that the UCI representatives were able to examine (for the first time) the actual Turkey Point failed relay coil. The coil exhibited a blackened burn area where the lead wire had shorted against the coil windings. This was clearly caused by a lack of the required insulation tape. However, the tape placement on the coil was not what caused this particular burnout. Rather the tape end had been folded back over its self (see attached drawing). This left about 3mm of the lead wire completely exposed to the windings. Even with this condition, the relay passed functional testing at the ABB factory and at United Controls, and several pre-operational tests at Turkey Point before failure occurred. The ABB Relays Manger of Protection Equipment was asked, if the failed coil may have had the tape folded back by the rotating wire on the winding machine. He thought this was a definite possibility.

Since it is evident that the only known failed coil suffered from an entirely different problem than the coils that were rejected by ABB from the sample checked at Turkey Point, there is the possibility that no generic defect exists. If only coils possessing a folded back condition on the insulating tape are subject to failure, then it may not be correct to define a lead wire in violation of the 1mm distance to the tape edge criteria, as a generic defect. To test this hypothesis, it was decided to run endurance cycling on a relay that fails the 1mm inspection criteria.

1. The new method of installing insulation tape nearly eliminates the possibility of inadequate lead wire coverage.
2. There is no conclusive evidence to define what time frame(s) may limit the relays that possess coils which violate the 1mm tape coverage inspection criteria.
3. The relay that actually failed was the result of a tape fold back condition that has not been found on any other coil.
4. The functional/endurance testing performed on a relay possessing a coil that violated the 1mm tape coverage criteria, significantly exceeded normal lifetime cycling expectations in the subject application.
5. There is no previously known pattern of failure for the Type RXMH relay.

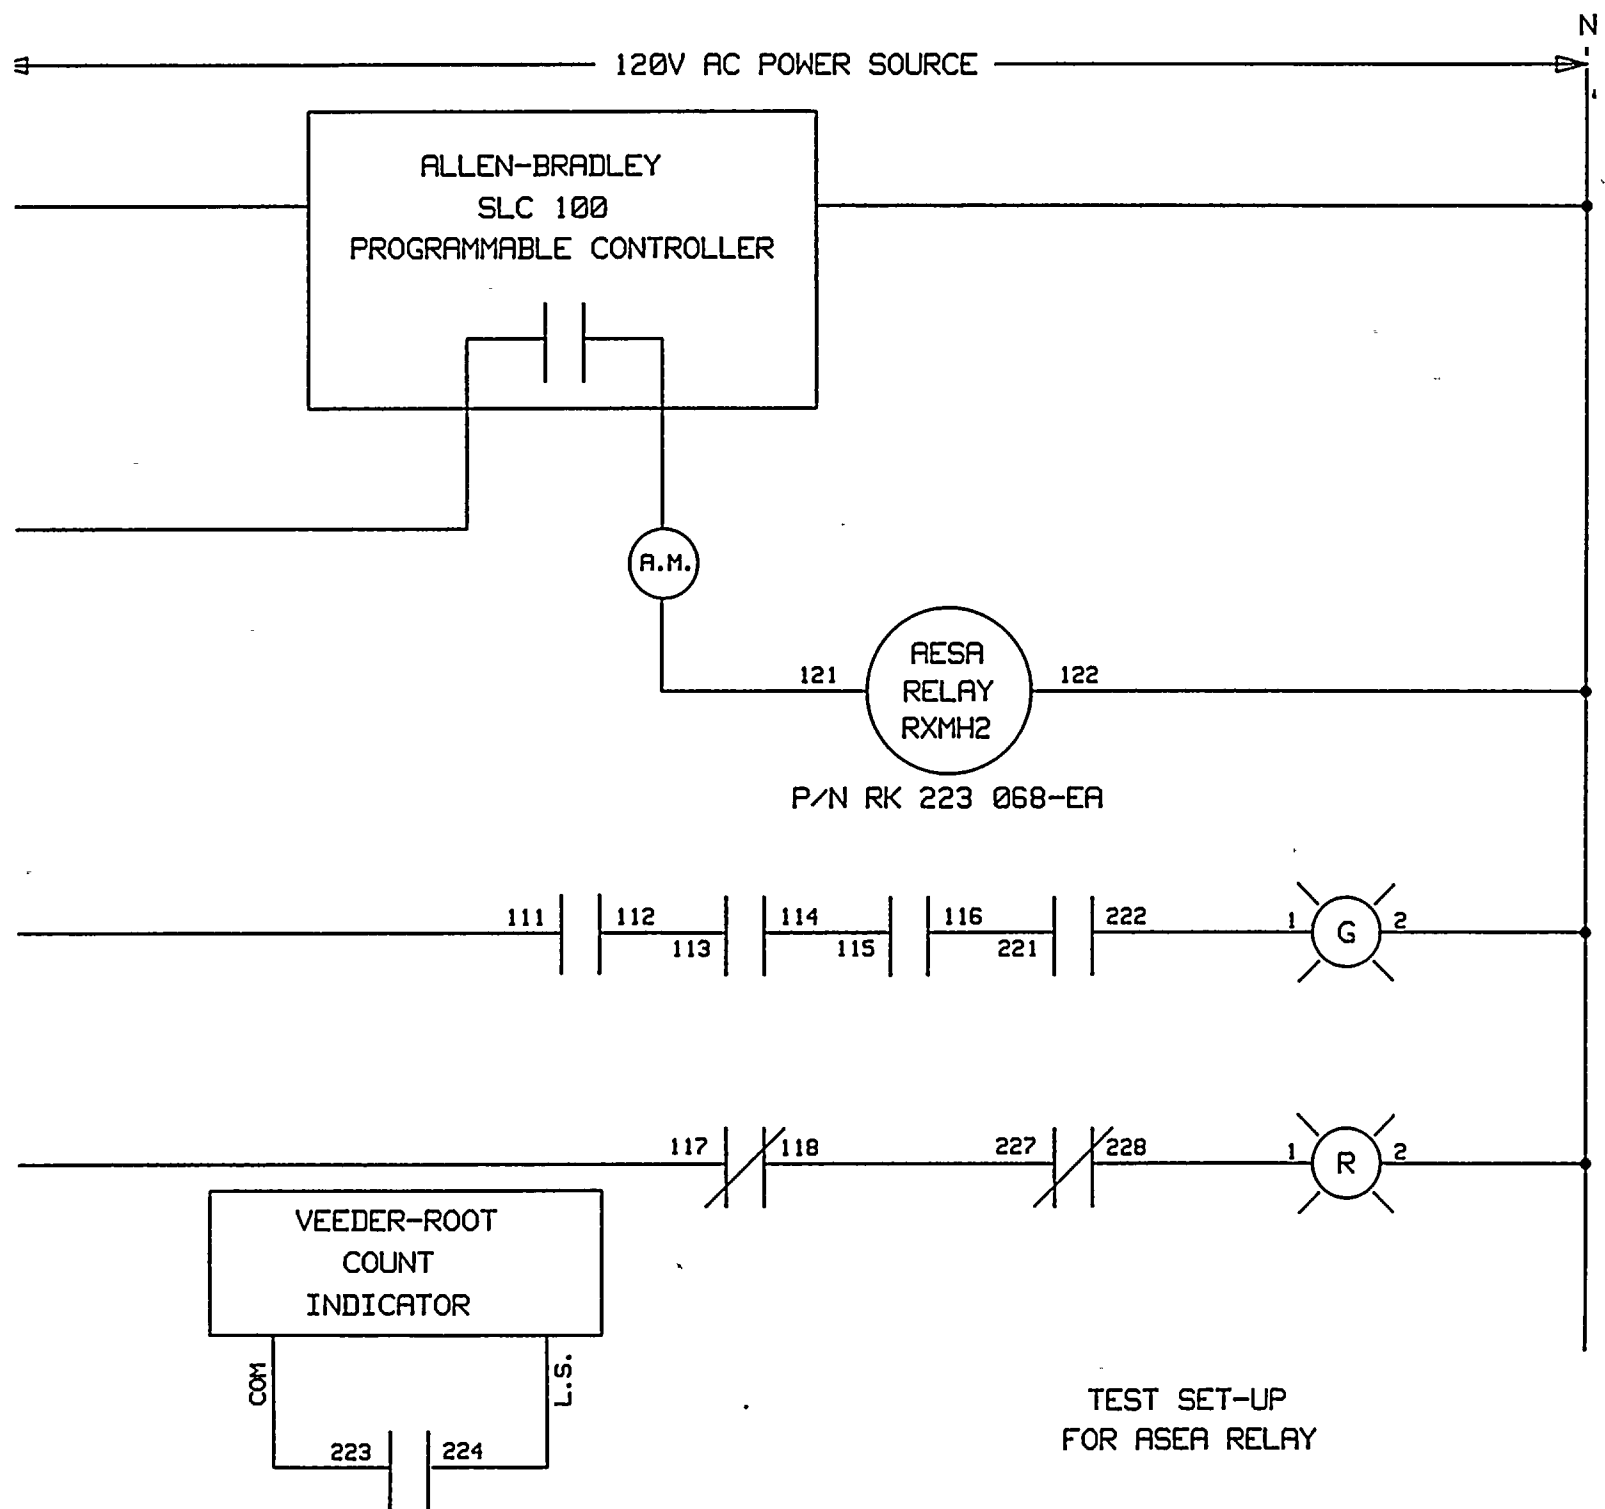
A test apparatus was designed to allow any time sequence for relay actuation desired. This was accomplished with an Allen-Bradley

programmable logic controller. The test was designed to achieve a simulation of actual relay use in the FP&L sequencers, and to establish cycling endurance capabilities. A diagram of the test set-up is attached.
