Re: Turkey Point Unit 4
Docket No. 50-251
Request for Relief From ASME Code
Repair Requirements for Code Class 2 Piping

**RELIEF REQUEST FOR ENGINEERED MECHANICAL
CLAMP ON MAIN STEAM DRAIN LINE PIPING ELBOW**

TURKEY POINT UNIT 4
MAIN STEAM DRAIN PIPING
ENGINEERED CLAMP
INFORMATIONAL SKETCH

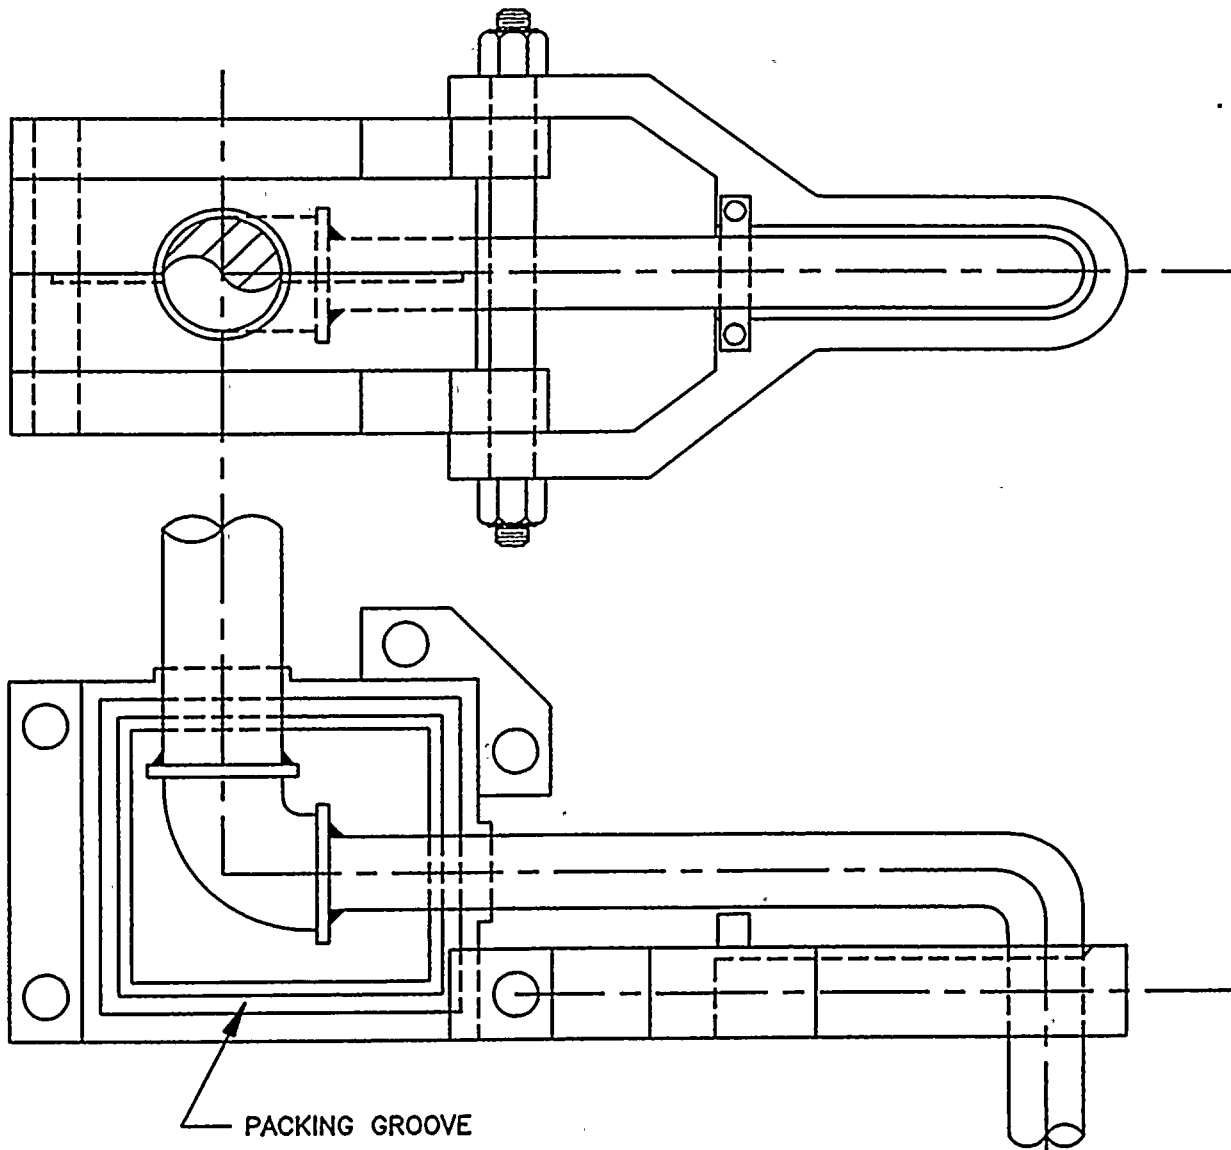
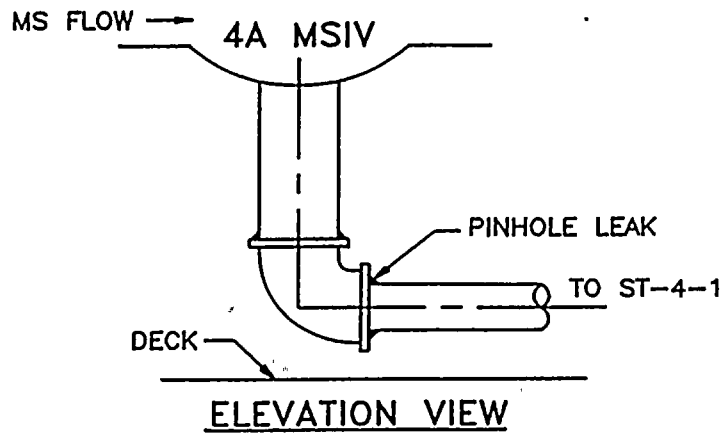
Fig. 1

On June 16, 1992 a small steam leak was discovered on a 1/2" Main Steam drain line on the 4A steam header, upstream of the Main Steam Isolation Valve. This leak is a result of a through wall pinhole located at the toe of the weld on a pipe elbow (see Figure 1). The leak location in the drain line is unisolable and is subjected to full steam header pressure during plant operation.

This relief request involves an unisolable portion of the "A" loop of a steam trap drain pipe off the Main Steam Header at Turkey Point Unit 4. The leak developed at the 1/2" Schedule 80 pipe at the exit of the first elbow between the 26" Main Steam Isolation Valve 4-POV-2604 and valve 4-10-121 (see Figure 1). This piping is categorized as Class 2 piping. The process fluid is saturated steam.

The engineered mechanical clamp is designed to maintain the pressure integrity and to perform the load bearing requirements of the steam drain piping system (1085 psig at 600 °F design) as required by Generic Letter 90-05. The engineered mechanical clamp design assumes that the weld defect is completely through the wall for the entire pipe circumference at the location of the flaw.

The engineered mechanical clamp consists of two halves bolted together to maintain the high energy main steam system pressure integrity. The mechanical joint seal between the two halves of the clamp and between the pipes and the clamp is maintained by graphite packing. The packing sealing force is maintained by a predetermined compression and a mechanical interference fit to ensure a proper mechanical seal. The load bearing capability required should a 360° circumferential flaw develop is provided by a restraining element of the clamp that prevents movement of the severed 1/2" nominal diameter pipe. This will maintain the Class 2 system pressure integrity under any operating conditions.
