SUBJECT: Forwards revised request for relief from ASME Code repair requirements for engineered mechanical clamp on main steam drain line piping elbow to perform temporary repair.

Re: Turkey Point Unit 4
Docket No. 50-251
Request for Relief From ASME Code
Repair Requirements for Code Class 2 Piping

**RELIEF REQUEST FOR ENGINEERED MECHANICAL
CLAMP ON MAIN STEAM DRAIN LINE PIPING ELBOW**

Turkey Point Unit 4
Main Steam Drain Piping
Engineered Clamp
Informational Sketch

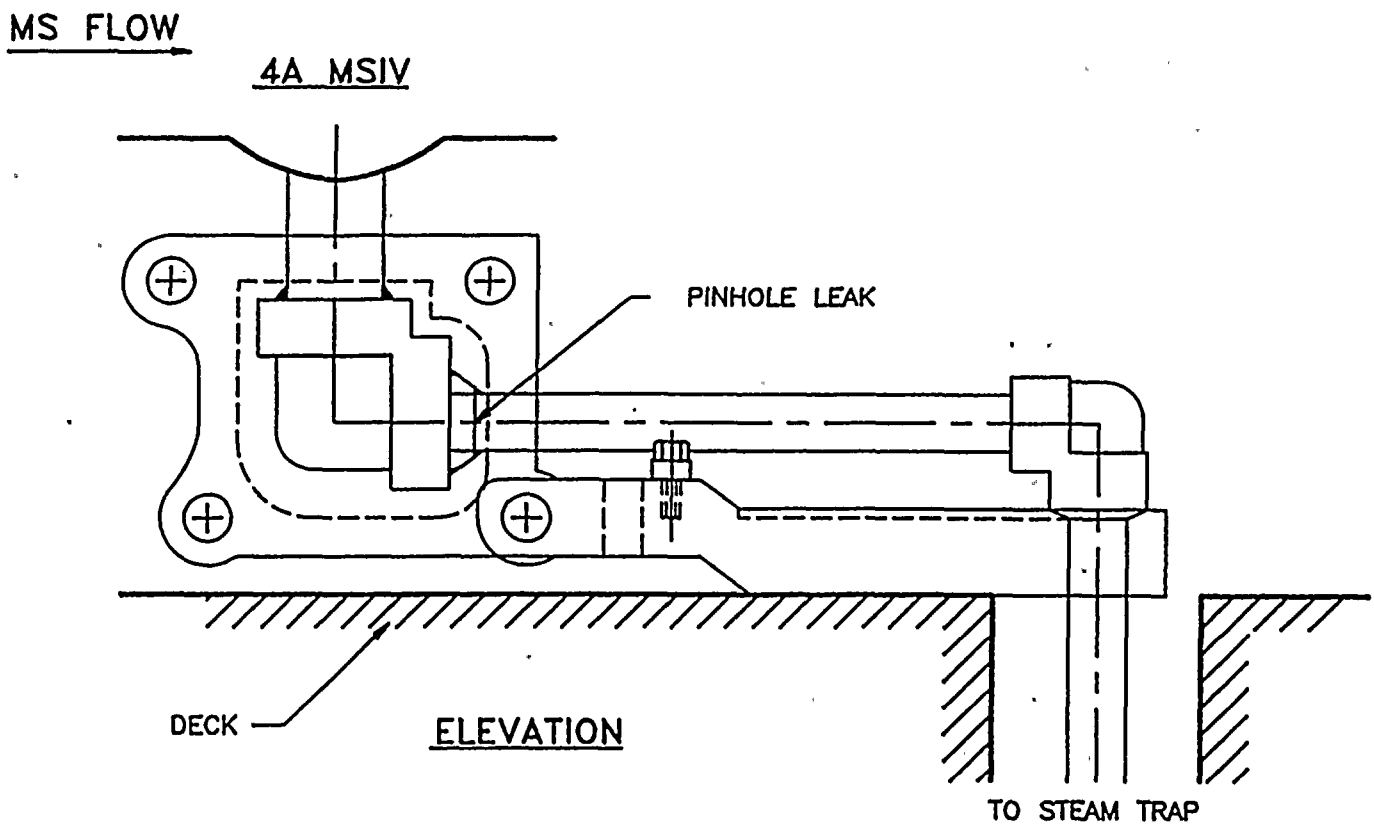
FIGURE 1

On June 16, 1992 a small steam leak was discovered on a 1/2" Main Steam drain line on the 4A steam header, upstream of the Main Steam Isolation Valve. This leak is a result of a through wall pinhole located at the toe of the weld on a pipe elbow (see Figure 1). The leak location in the drain line is unisolable and is subjected to full steam header pressure during plant operation.

This relief request involves an unisolable portion of the "A" loop of a steam trap drain pipe off the Main Steam Header at Turkey Point Unit 4. The leak developed at the 1/2" Schedule 80 pipe at the exit of the first elbow between the 26" Main Steam Isolation Valve 4-POV-2604 and valve 4-10-121 (see Figure 1). This piping is categorized as Class 2 piping. The process fluid is saturated steam.

engineered mechanical clamp secured on the leaking elbow (see Figure 1). This relief is requested to remain in effect until a permanent ASME Code repair is completed. The permanent repair will be performed during the outage following the next Unit 4 entry into Mode 5.

The engineered mechanical clamp is designed to maintain the pressure integrity and to perform the load bearing requirements of the steam drain piping system (1085 psig at 600 °F design). The engineered mechanical clamp design assumes that the weld defect is completely through the wall for the entire pipe circumference at the location of the flaw.

The engineered mechanical clamp consists of two halves bolted together to maintain the high energy main steam system pressure integrity. The mechanical joint seal between the two halves of the clamp and between the pipes and the clamp is maintained by graphite packing. The packing sealing force is maintained by a predetermined compression and a mechanical interference fit to ensure a proper mechanical seal. The load bearing capability required should a 360° circumferential flaw develop is provided by a restraining element of the clamp that prevents movement of the severed 1/2" nominal diameter pipe. This will maintain the Class 2 system pressure integrity under any operating conditions.
