# ACCELERATED DISTRIBUTION DEMONSTRATION SYSTEM

SUBJECT: LER 92-006-00: on 920610, discovered that recirculation of waste monitor tank, prior to liquid release, not conducted per TS & tank recirculated to less than one tank vol. Caused by overestimation of flow rate. Calibrs verified. W/920710 ltr.

Re: Turkey Point Units 3 and 4  
Docket Nos. 50-250 and 50-251  
Reportable Event: 92-006-00  
Recirculation of Waste Monitor Tanks not in Accordance  
With Offsite Dose Calculational Manual Prior to Sample  
Acquisition.

FACILITY NAME (1) <b>Turkey Point Unit 3</b>												DOCKET NUMBER (2) <b>05000250</b>		PAGE (3) <b>1 OF 3</b>	
TITLE (4) <b>Recirculation of Waste Monitor Tanks not in Accordance With Offsite Dose Calculational Manual Prior to Sample Acquisition.</b>															
EVENT DATE (5)			LER NUMBER (6)			RPT DATE (7)			OTHER FACILITIES INV. (8)						
MON	DAY	YR	YR	SEQ #	R#	MON	DAY	YR	NAME			DOCKET # (S)			
06	10	92	92	006	00	07	10	92	Turkey Point Unit 4			05000251			
OPERATING MODE (2)		1 <u>10 CFR 50.73(a)(2)(i)(B)</u>													
POWER LEVEL (10)		100													
LICENSEE CONTACT FOR THIS LER (12)															
James E. Knorr, Regulation and Compliance Specialist

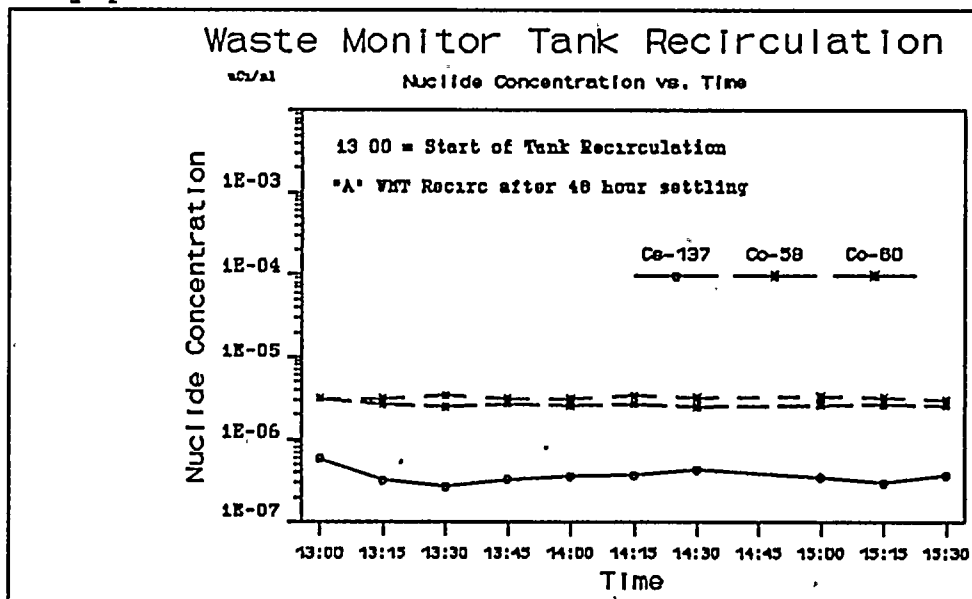
Following the discovery of the flow discrepancy, chemistry personnel performed a mixing analysis of the tank concentration. The tank was allowed to settle for 48 hours. A sample was taken prior to the beginning of a mixing of the tank by recirculation as normally performed.

Further samples were taken each 15 minutes for the following 2 hours. The graph on the right shows the result of that test. Virtually no concentration change occurred after 15 minutes.

The measurable nuclides contents of the tank appear to be colloidal in nature and reach equilibrium within 15 minutes of the beginning of the recirculation process. Therefore little recirculation time is required to obtain a representative sample of the tank contents.
