SUBJECT: LER 92-007-00: on 920716, discovered that valve & motor operator position for RWST outlet valve not verified when unit in Mode 3 or 6. Caused by less than adequate procedure. Checkoff procedure revised. W/920812 ltr.

Re: Turkey Point Units 3 and 4  
Docket Nos. 50-250 and 50-251  
Reportable Event: 92-007-00  
Missed Surveillance for MOV 3-864A and B and MOV 4-864A  
and B Valves and Power Breakers Open While Unit 4 or Unit  
3 Respectively Were in Mode 5 or 6.

FACILITY NAME (1) <b>TURKEY POINT UNITS 3 AND 4</b>	DOCKET NUMBER (2) <b>05000250</b>	PAGE (3) <b>1</b> OF <b>5</b>
--	--------------------------------------	----------------------------------

TITLE (4) **MISSED SURVEILLANCE FOR MOV 3-864A AND B and 4-864A AND B VALVES AND POWER BREAKERS OPEN WHILE UNIT 4 OR UNIT 3 RESPECTIVELY IS IN MODE 5 OR 6.**

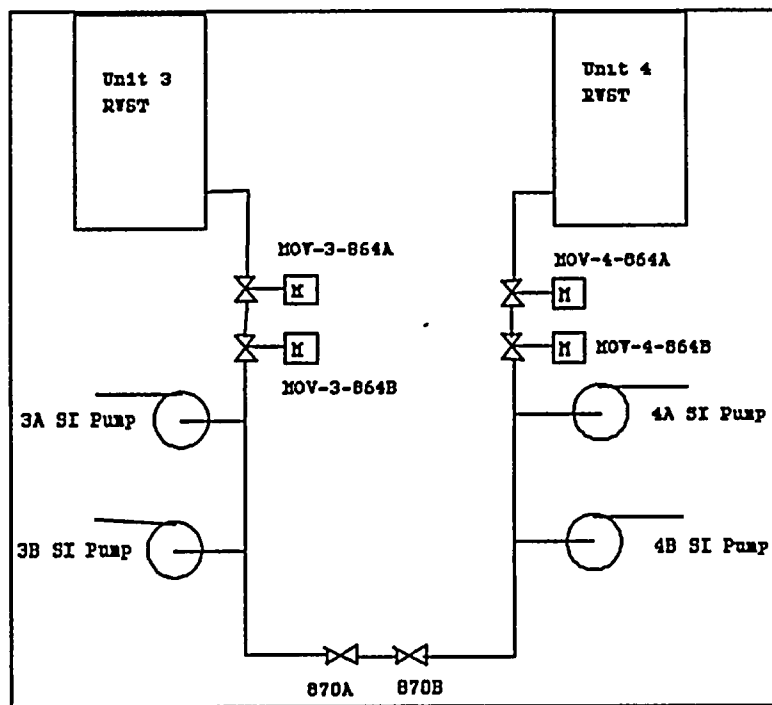
Turkey Point Nuclear Plant Units 3 and 4 share four safety injection pumps (see sketch on Page 5). Unit 3 and Unit 4 each has a 320,000 gallon RWST. Each RWST is normally aligned to two safety injection pumps. The safety injection pumps have a common suction header with normally closed series cross-connect valves (870A and B). With the cross connect valves open, the pumps can draw water from either the Unit 3 or Unit 4 RWST. With these cross-connect valves closed, both RWSTs must be operable for 3 or 4 safety injection pumps to be considered operable. For single unit operation with the opposite unit in Mode 5 or 6, three safety injection pumps must be operable. To ensure this operability Turkey Point procedures required the verification of valve positions and breaker positions for valve operators. Specific line items were checked off in the logsheets each eight hour shift for Modes 1 through 4. However, for one of two series outlet valves for each RWST, the breaker position, and for all motor operated series outlet valves, control room indication verification of valve open position was not verified by the check-off of a specific line item for each valve. All 864 A and B RWST outlet valves were locally verified to be in the locked open position.
