SUBJECT: LER 94-005-00: on 940924, Unit 4 manually tripped. Caused by manual actuation. Light bulb & socket replaced. W/941020 ltr.

Re: Turkey Point Unit 4
Docket No. 50-251
Reportable Event: 94-005-00
Manual Reactor Trip

FACILITY NAME (1) TURKEY POINT UNIT 4										DOCKET NUMBER (2) 05000251		PAGE (3) 1 OF 3	
TITLE (4) MANUAL REACTOR TRIP DUE TO PARTIAL LOSS OF ROD POSITION INDICATOR													
EVENT DATE (5)			LER NUMBER(6)			RPT DATE (7)			OTHER FACILITIES INV. (8)				
MON	DAY	YR	YR	SEQ #	R#	MON	DAY	YR	FACILITY NAMES			DOCKET # (5)	
09	24	94	94	005	00	10	20	94					
OPERATING MODE (9)		3		<u>10 CFR 50.73(a)(2)(iv)</u>									
POWER LEVEL (10)		0%											
LICENSEE CONTACT FOR THIS LER (12)

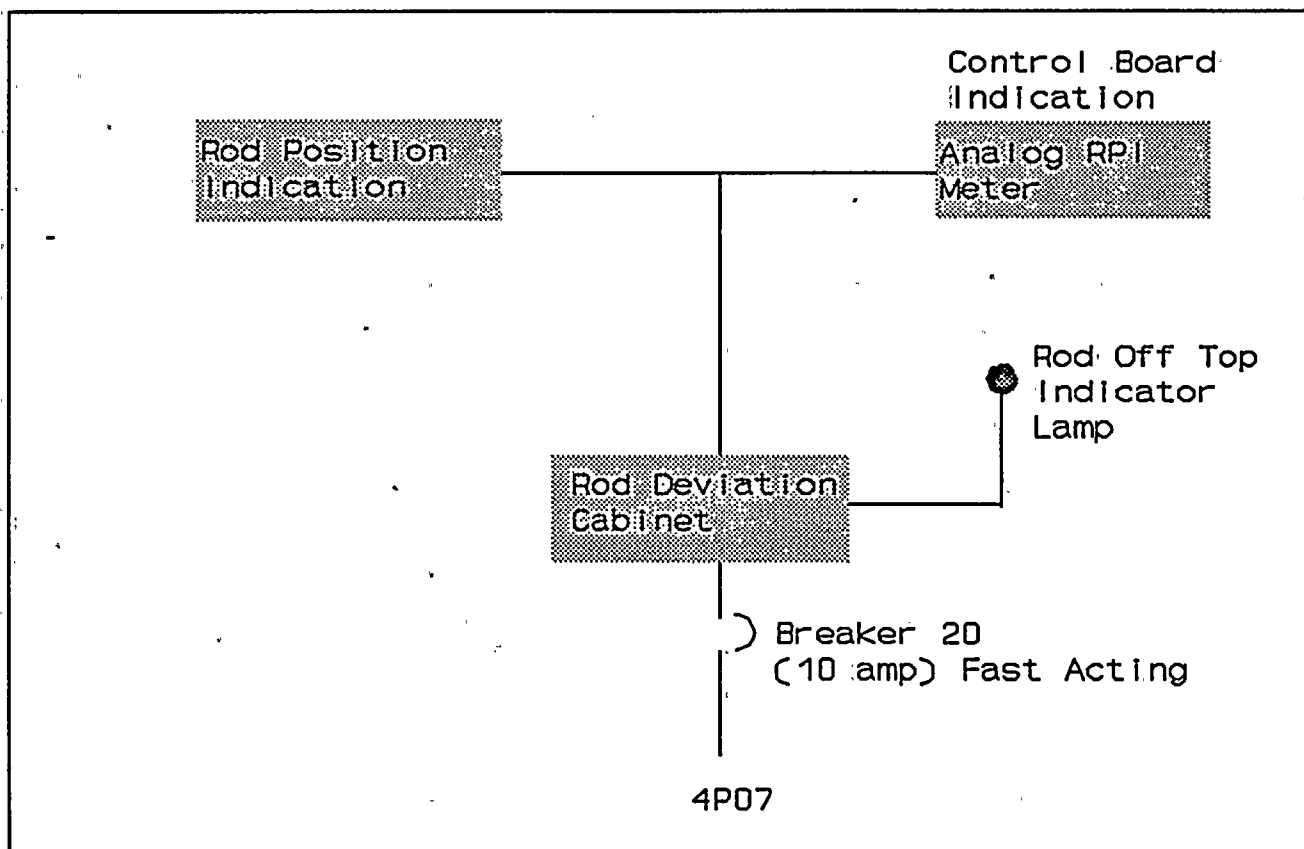
Figure 1.

The mismatch was caused by the following chain of events. When the operator touched the light bulb on the number 4 control board status light, the remaining short filament on the burned out bulb relanded inside the bulb and caused a higher current than usual. The fast acting breaker (# 20 on panel 4P07) for the rod deviation cabinet opened due to the higher current. This breaker provides power to the rod deviation cabinet. Upon the opening of the breaker, the impedance in the common circuit between the rod deviation cabinet and the rod position indication circuit decreased causing an approximate 60% of full scale reading on the analog rod position indication meter for shutdown bank A. See figure 1 on page 3.

1. The light bulb and socket were replaced.
2. The cause of the change in the analog rod position indication was verified by test.
