TECHNICAL REPORT
L-1521(6) / 5-93

ASSESSMENT OF AGING
DEGRADATION OF CIVIL/STRUCTURAL FEATURES
AT SELECTED OPERATING NUCLEAR POWER PLANTS

J. Braverman
R. Morante
C. Hofmayer

May 1993

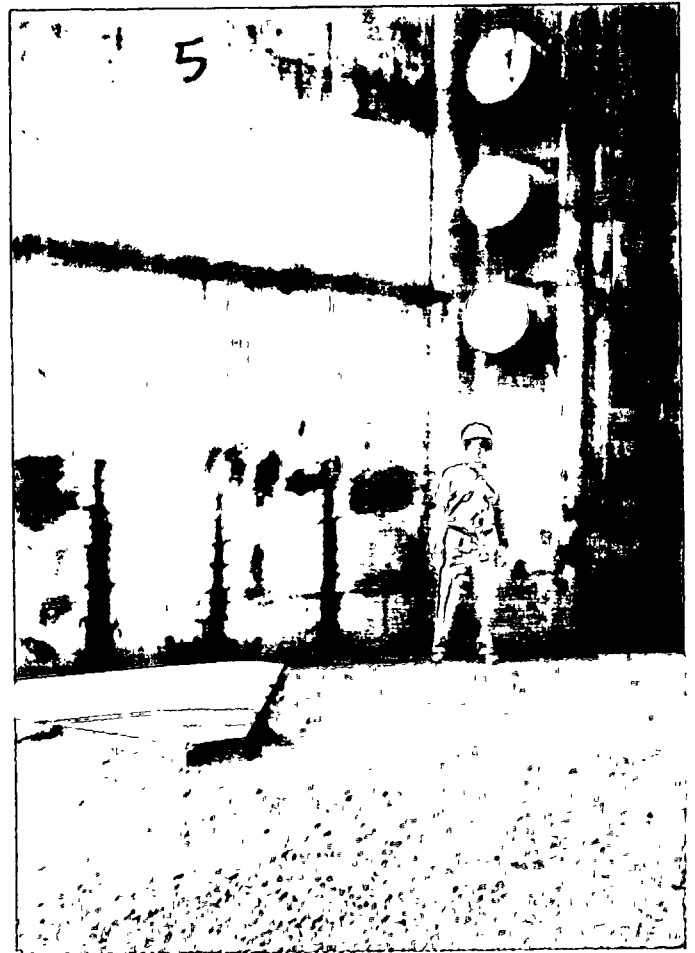
Grease Leakage From Tendon Casings

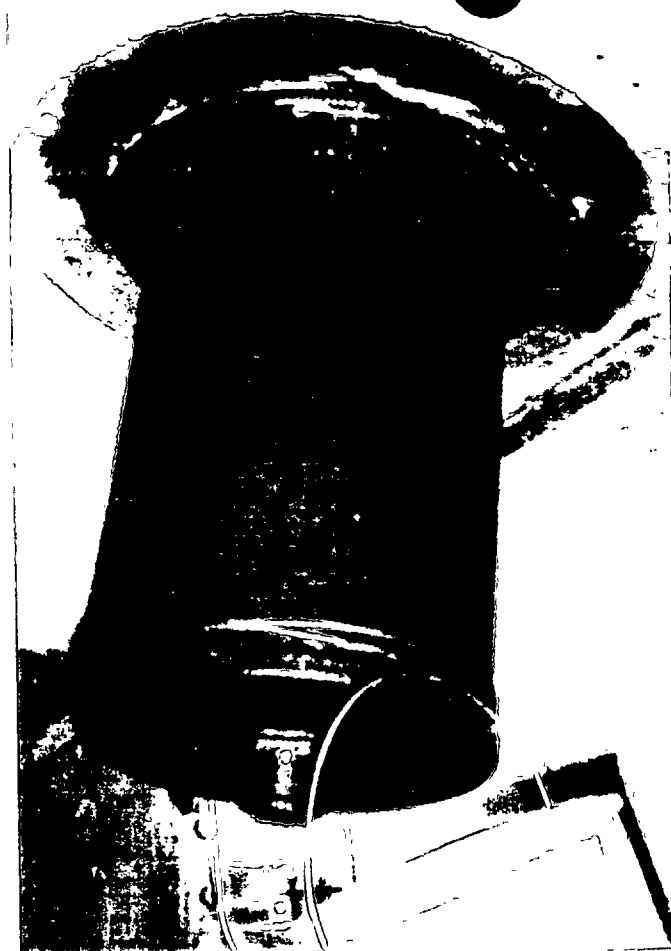
Grease Leakage at
Tendon 291

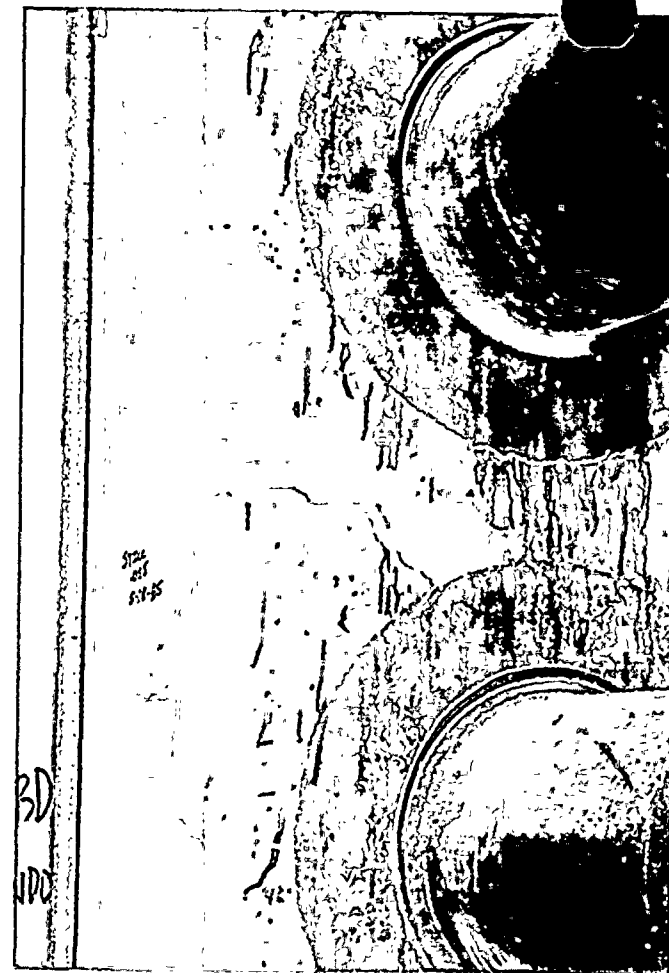
Concrete Damage/Grease Leakage
from Tendon Anchors

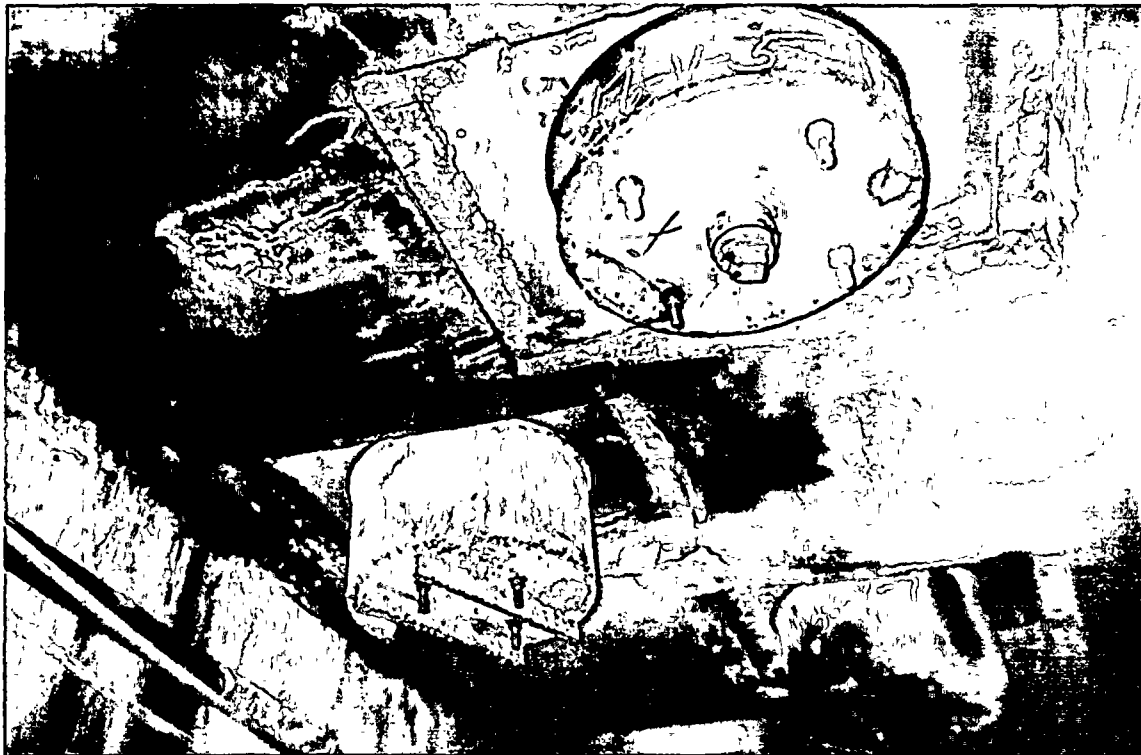
Grease Leakage at Tendon 56-V-5 (typical)

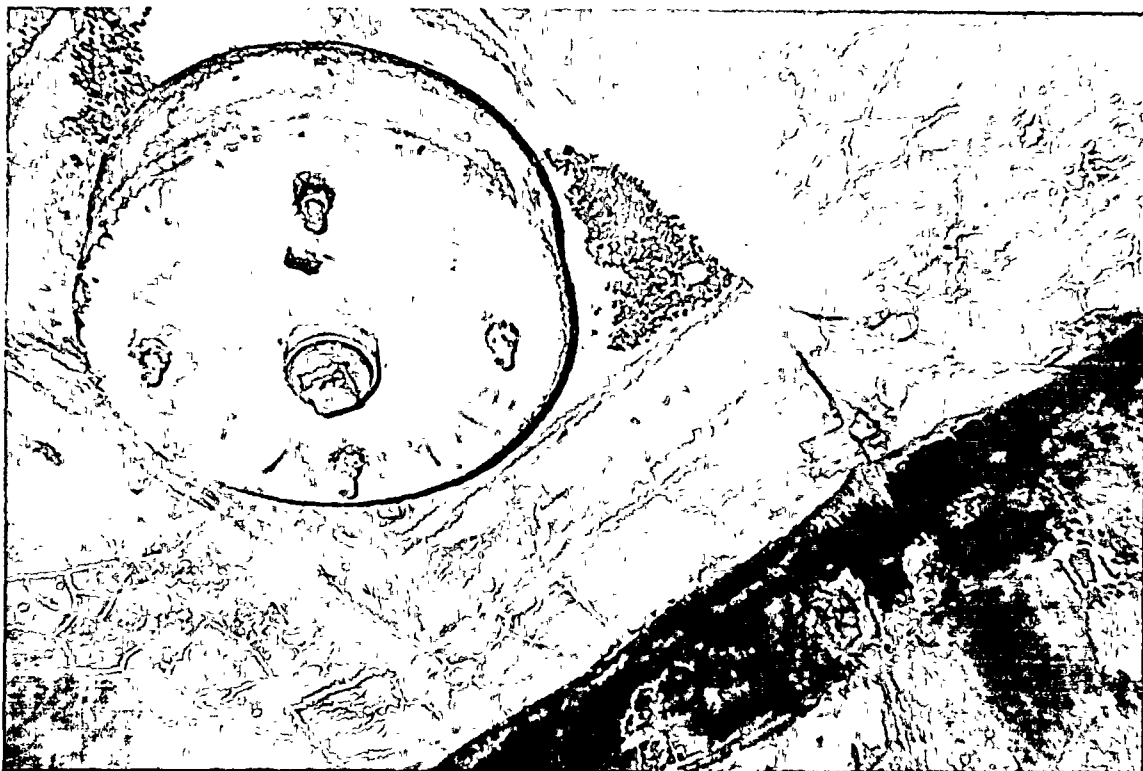
Metal Corrosion and Concrete Cracking at Tendon 12-V-1 (typical)

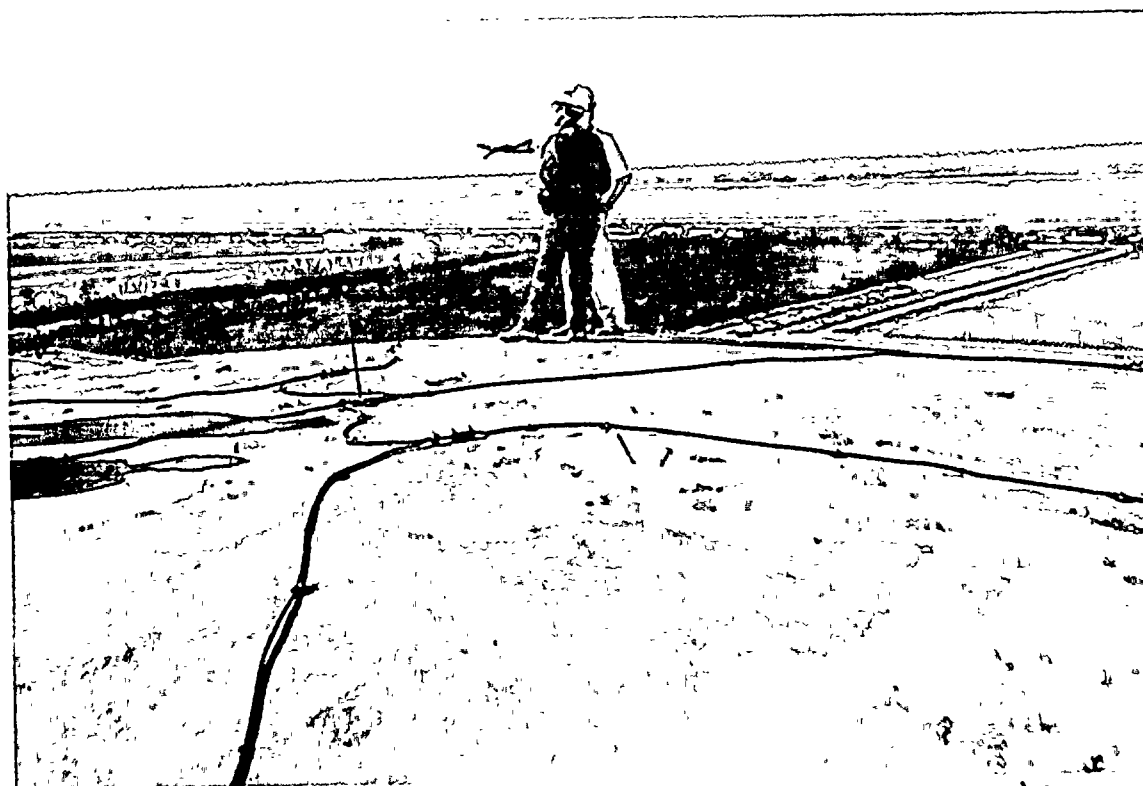
An examination of the Unit 3 containment dome showed no signs of concrete degradation or delamination, which was a problem after original construction. However, the overlay/coating on the dome was peeling. This may also be the cause for some of the clogged drains that have occurred at the base of the dome.

Peeling of Dome Coating Material (White Areas);
Possible Cause of Water Drain Blockage

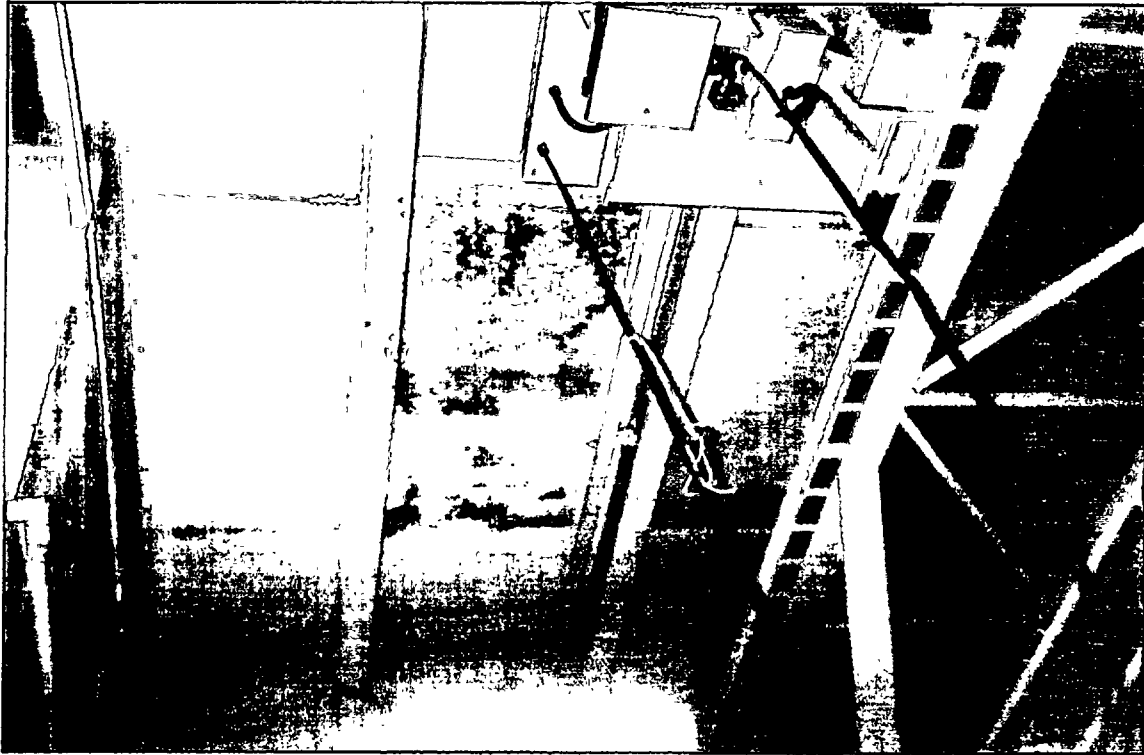
Approx. 3' x 6' Area of Discoloration on Ceiling;
Possible Water Leak from Roof

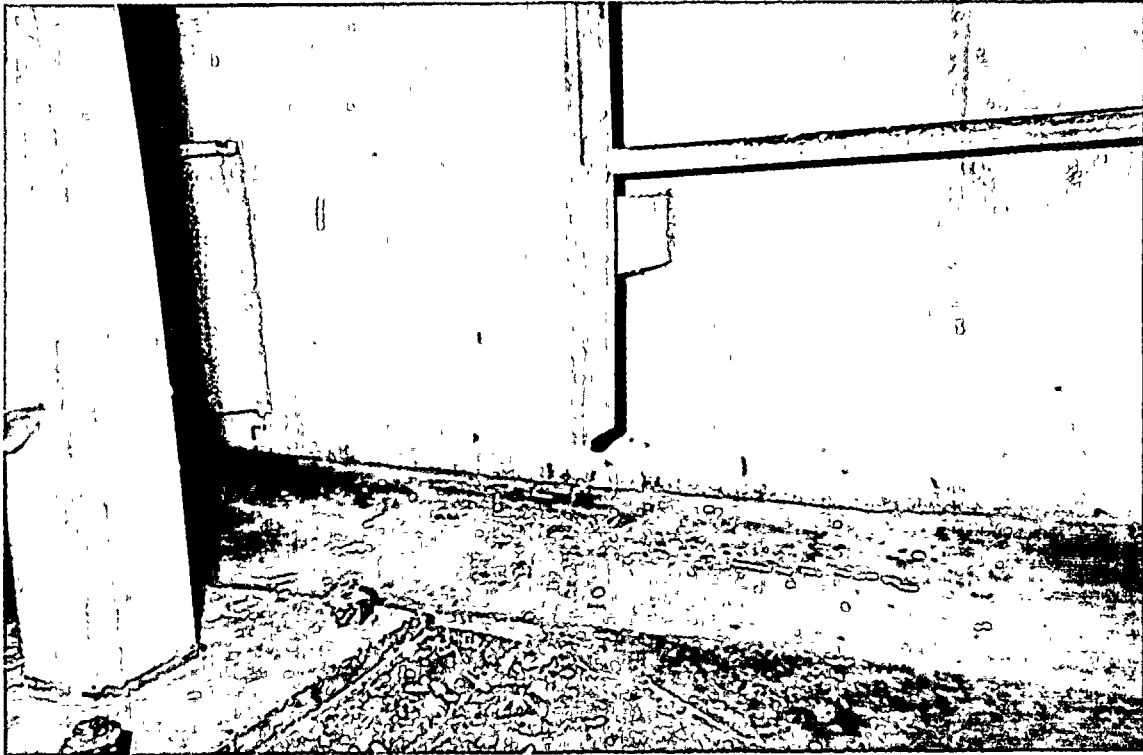
Examination of the condensate storage tank revealed bent plates on the anchor bolt chairs, deterioration of the water seal at the base of the tank coupled with corrosion of the tank bottom plate, and signs of corrosion/scratches/gouges on the tank wall.

Deterioration of the Water Seal at Base of Tank/
Corrosion of Tank Bottom Plate

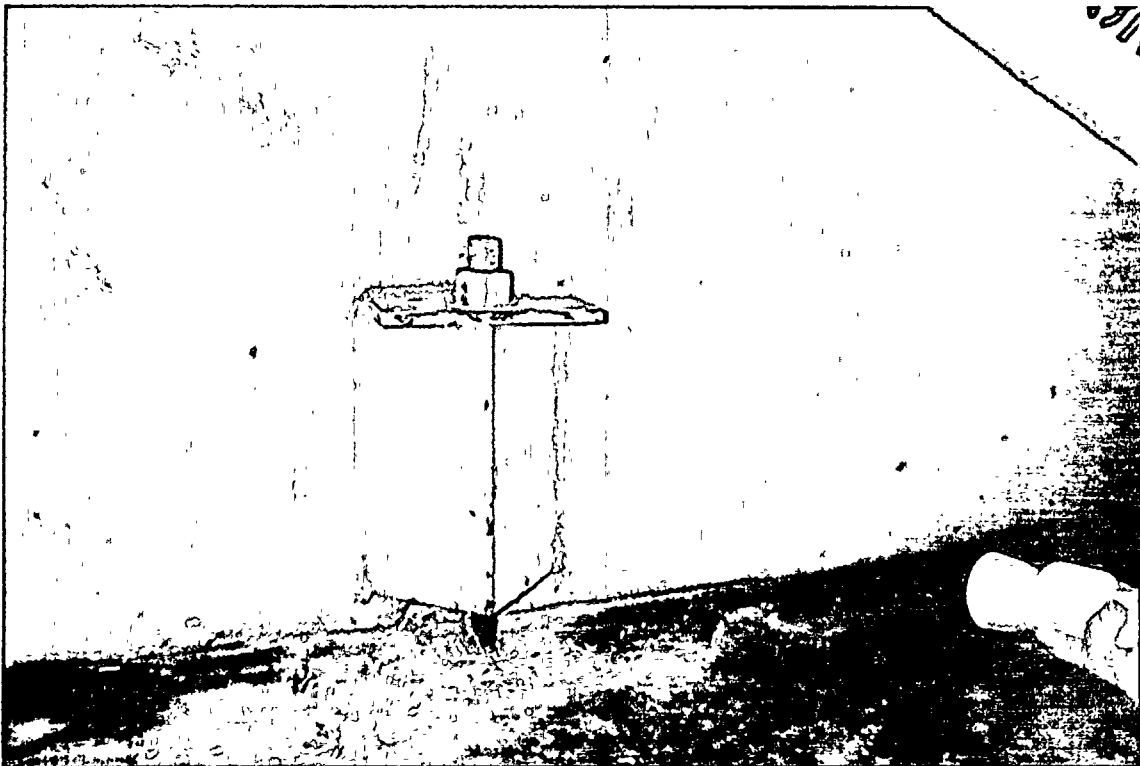
Typical Condition of Anchor Bolt Chairs

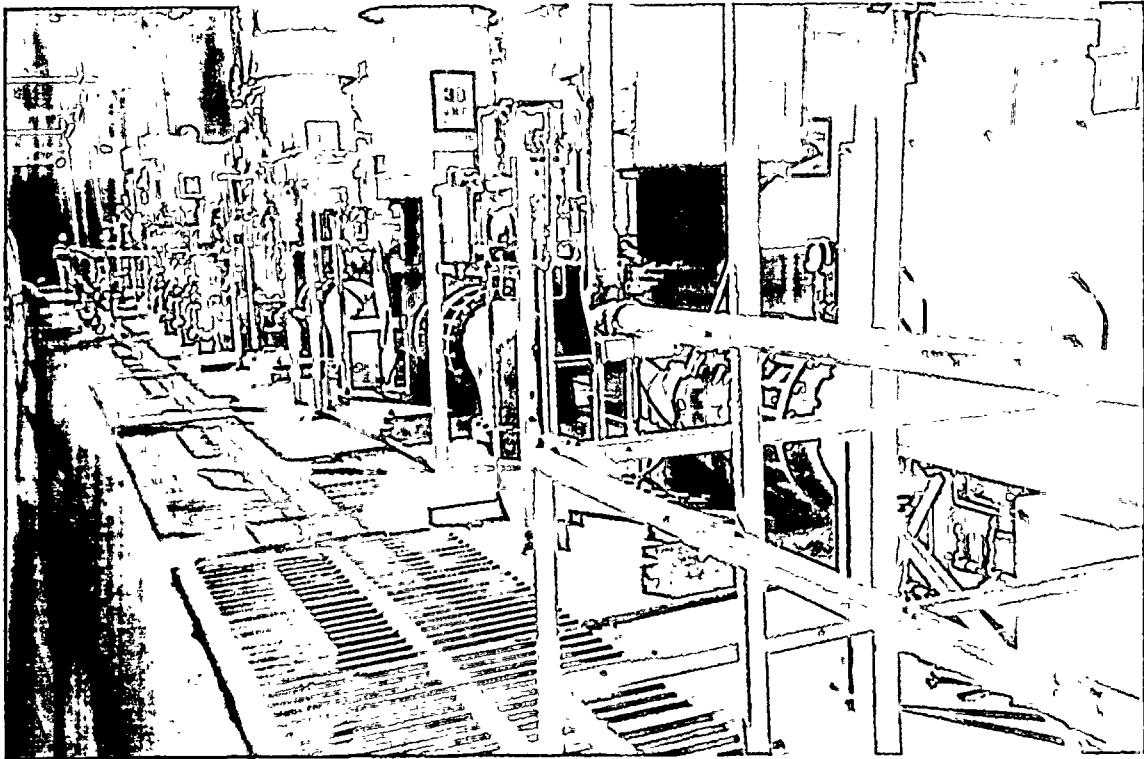
Significant deterioration in the concrete beams supporting the ICW pumps and CW pumps in the intake structure had occurred. This consisted of delamination of concrete cover over the reinforcement and corrosion of the steel reinforcement. FPL was aware of these problems and is in the process of repairing the beams. Repairs began in 1985 and completion is planned by the end of 1996. The audit team reviewed a report on the intake structure prepared by a consultant to FPL. The report indicates that the bay walls are also degrading and experiencing active corrosion of the reinforcing bars. Therefore, the audit team recommended that the Licensee also give close attention to other parts of the intake structure such as the intermediate and exterior walls.

Circulating Water Pumps Mounted On top of Intake Structure;
Supporting Concrete Beams Have Deteriorated
and Currently Being Strengthened

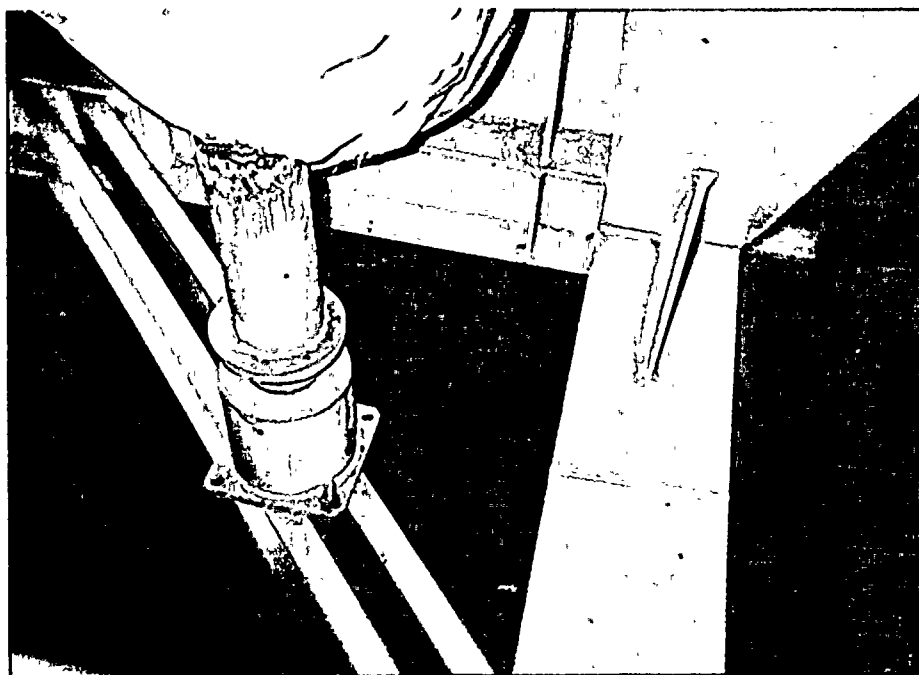
Corrosion at Top of Support to the Main Feed Line A

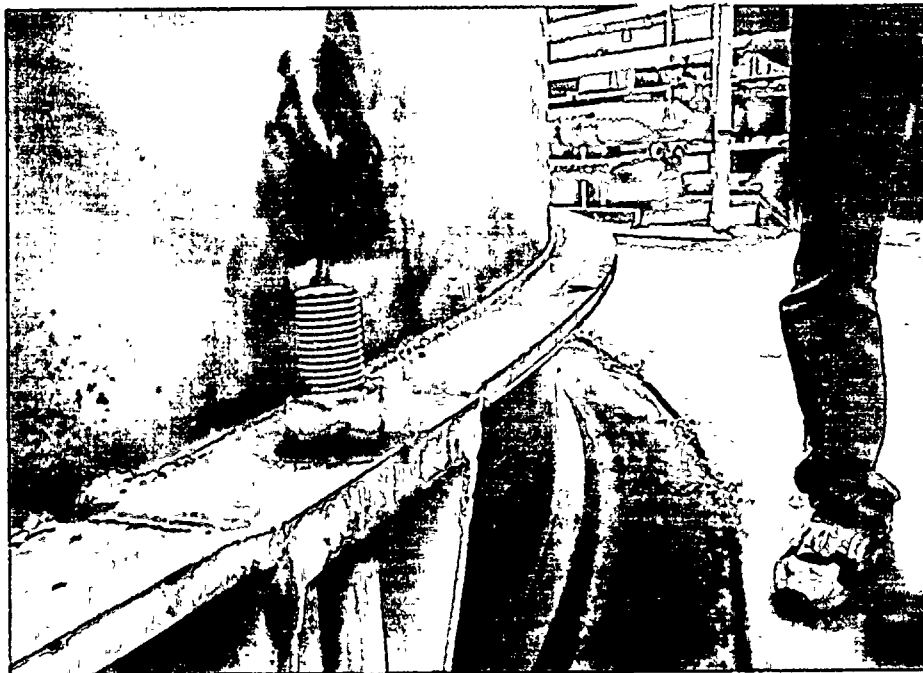
Corrosion of Nut at Beam Seat of Primary Water
Storage Tank

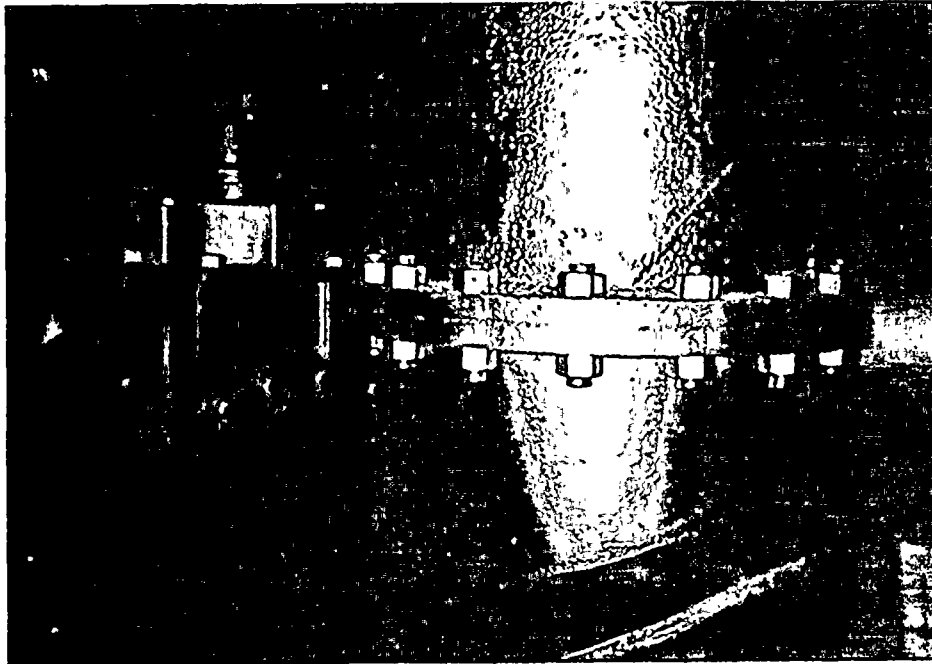
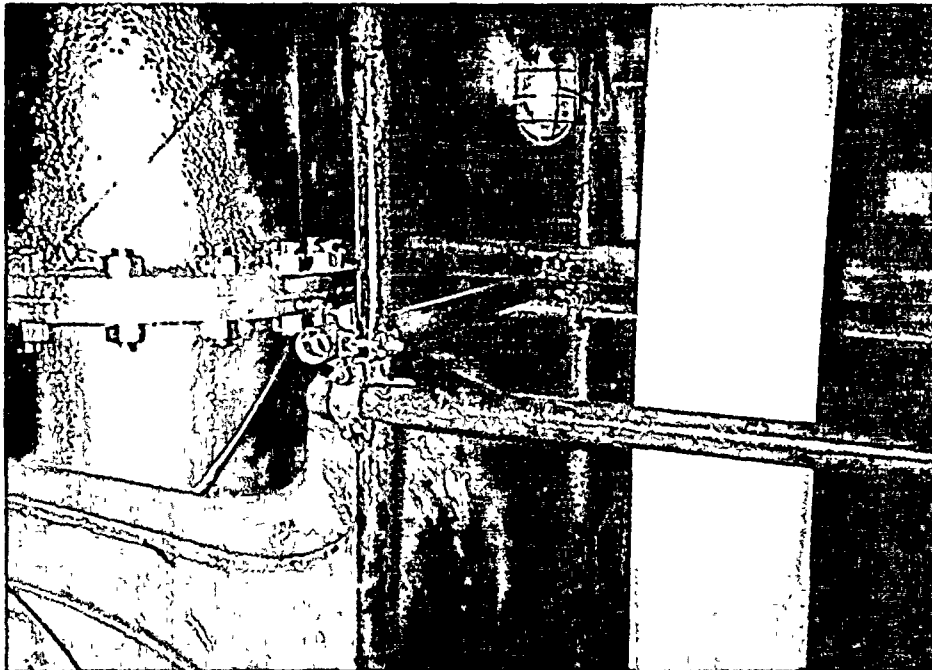
Severe Pitting of Service Water Line - Below Grade Elev.

Corrosion and Degradation of Service Water Line - Above Grade Elev.

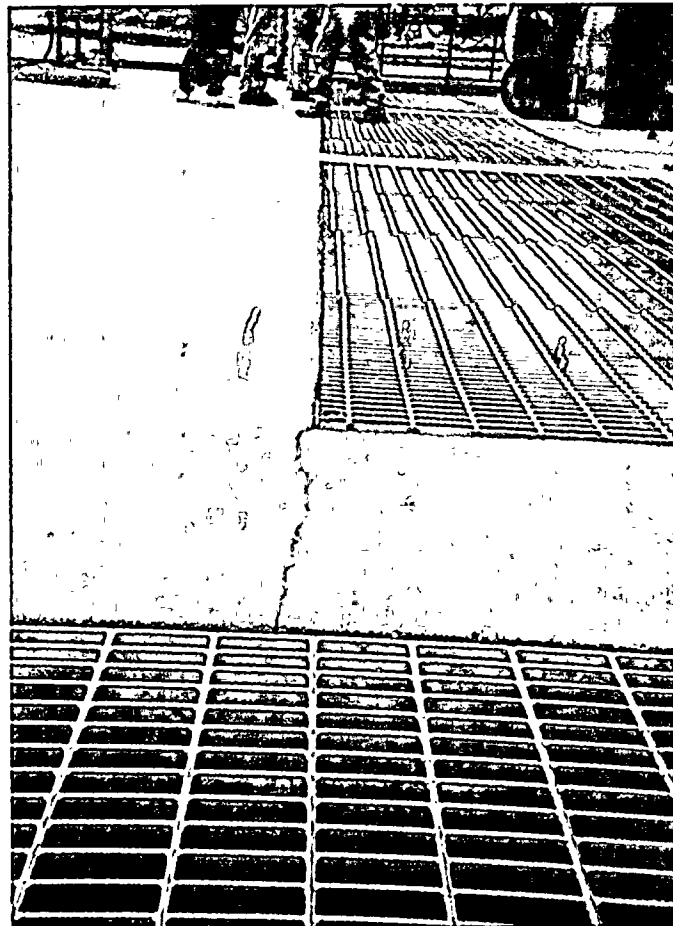
Cracks at Intersection of Concrete Walls

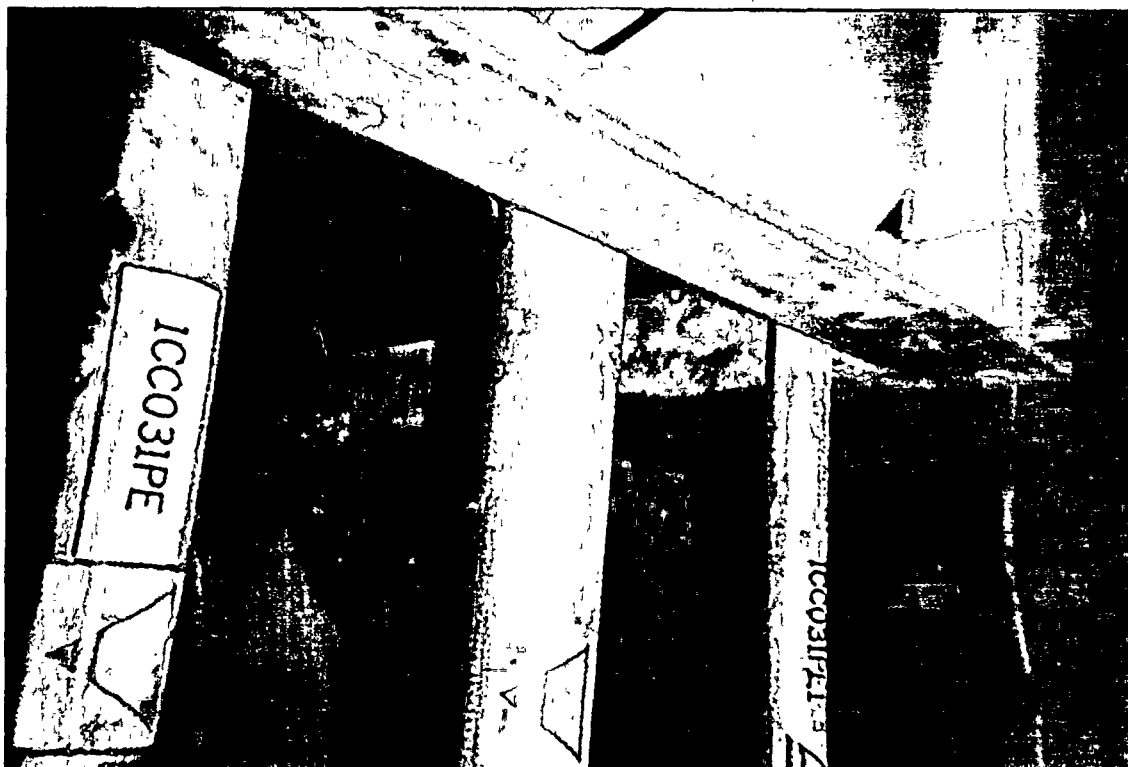
Corrosion of Base/Steel Supports of the Fan Coil Unit

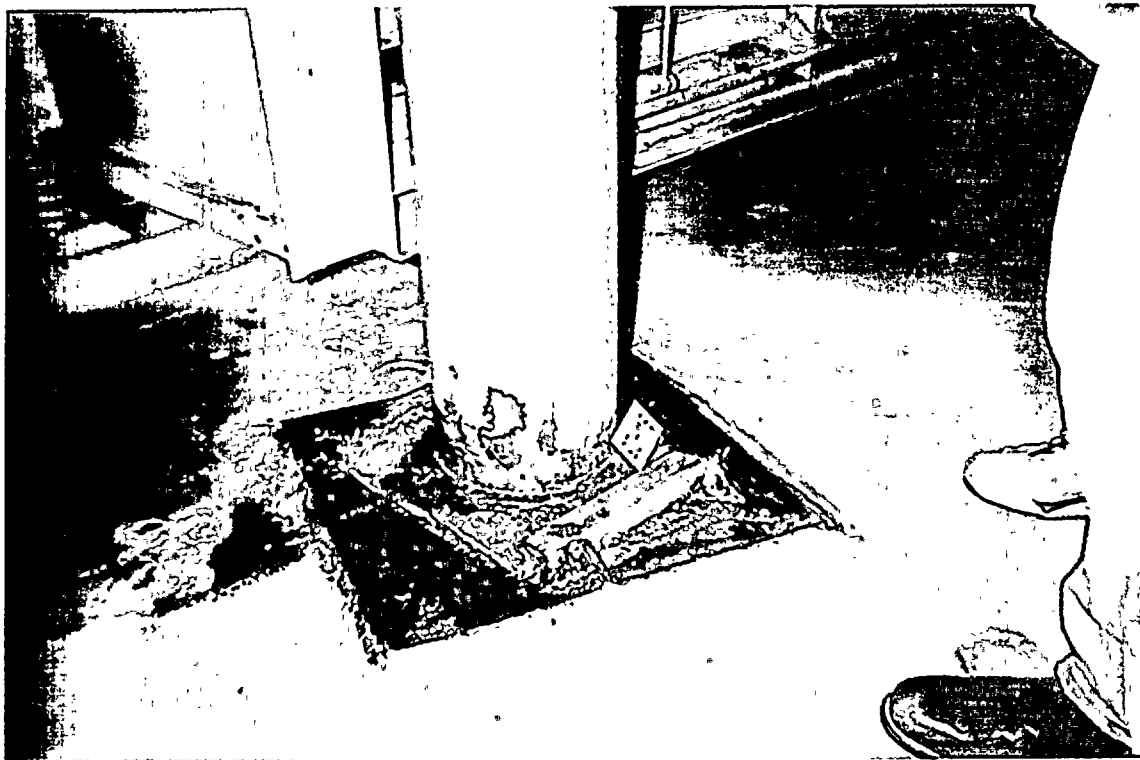
Intake Structure, Service Water Pump Room - Corrosion of Pipe Support

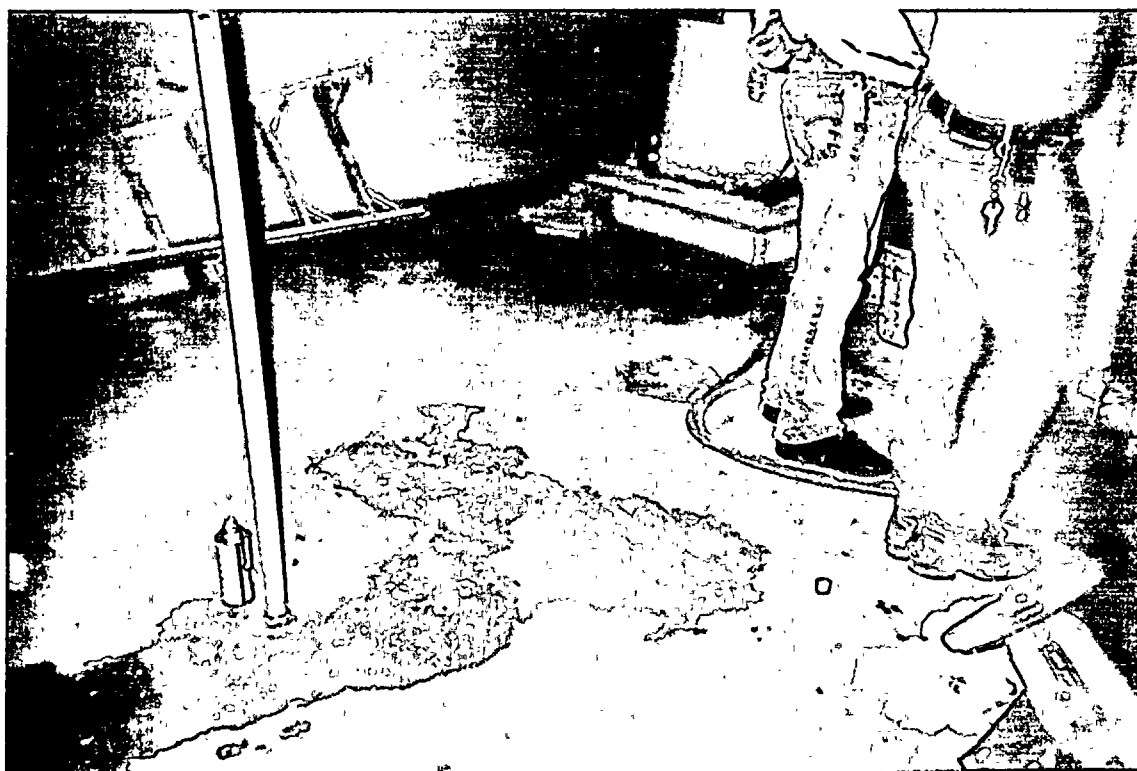
Intake Structure, Service Water Pump Room - Degradation of Floor Coating

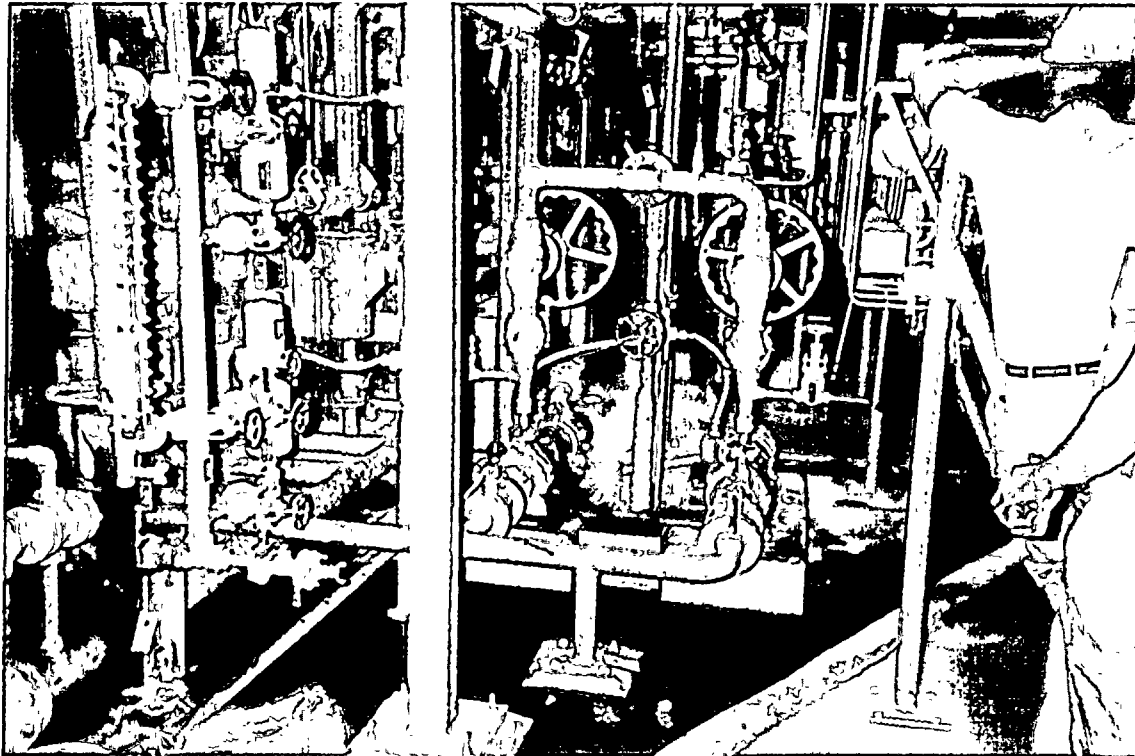
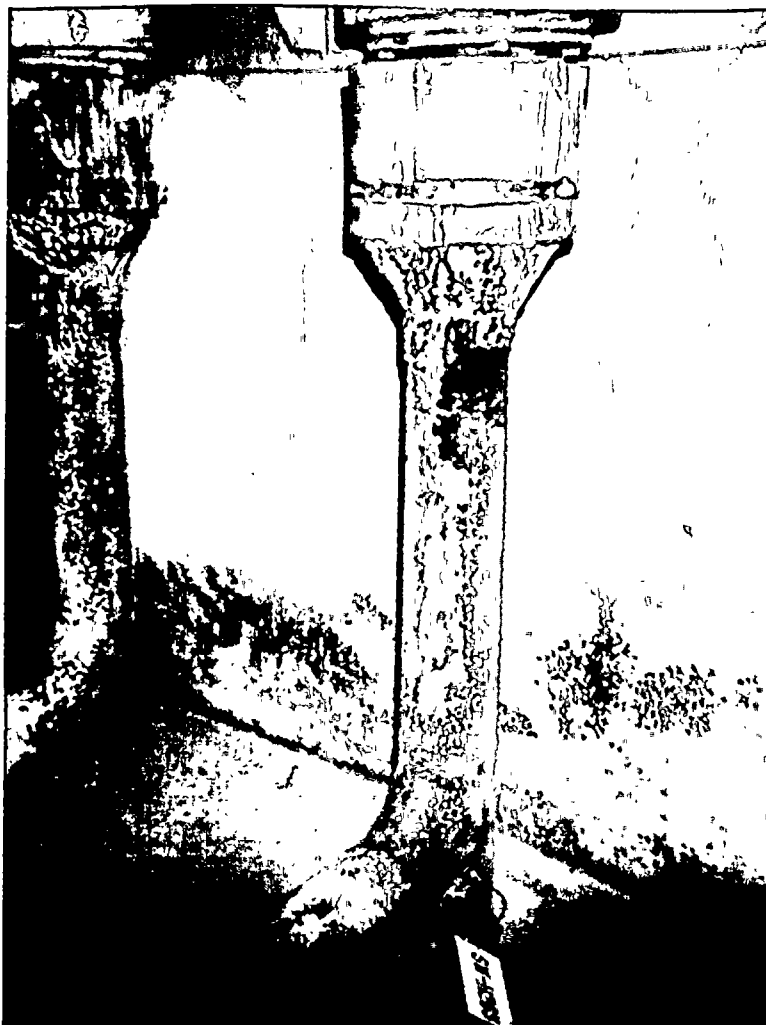
Control Building, Service
Water Gland Water System
Corrosion/Degradation

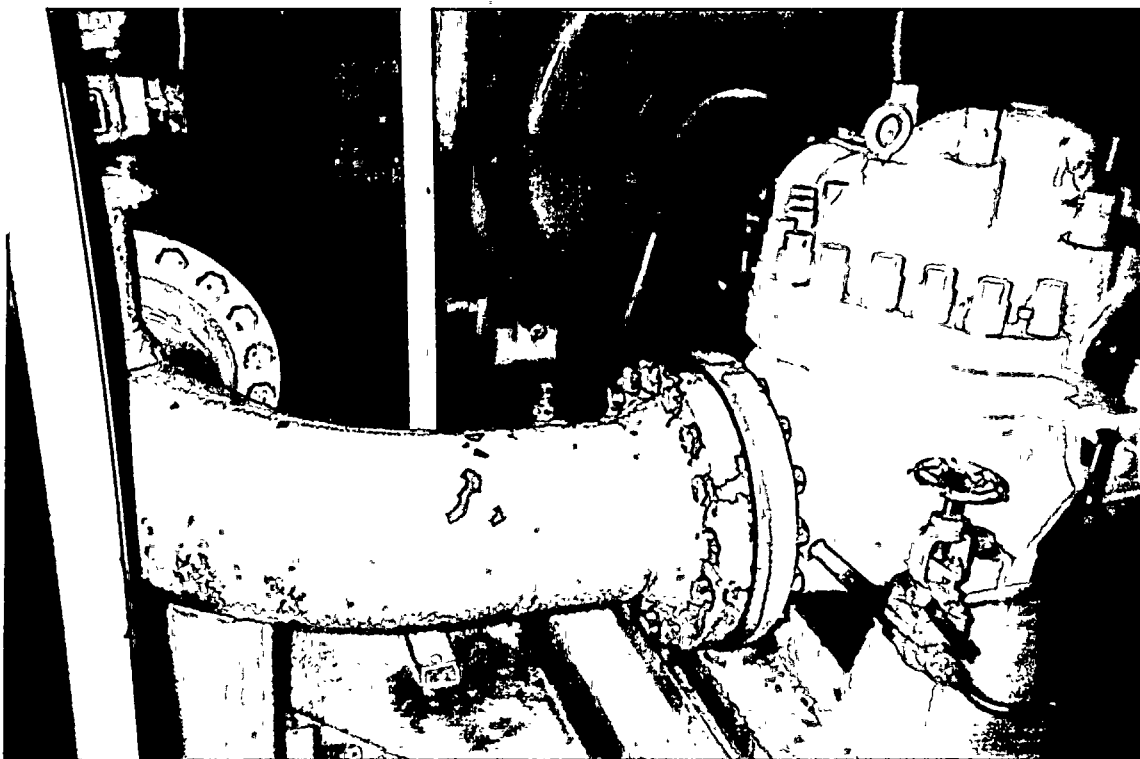
Control Building, RHR Service Water Booster Pump - Piping Corrosion

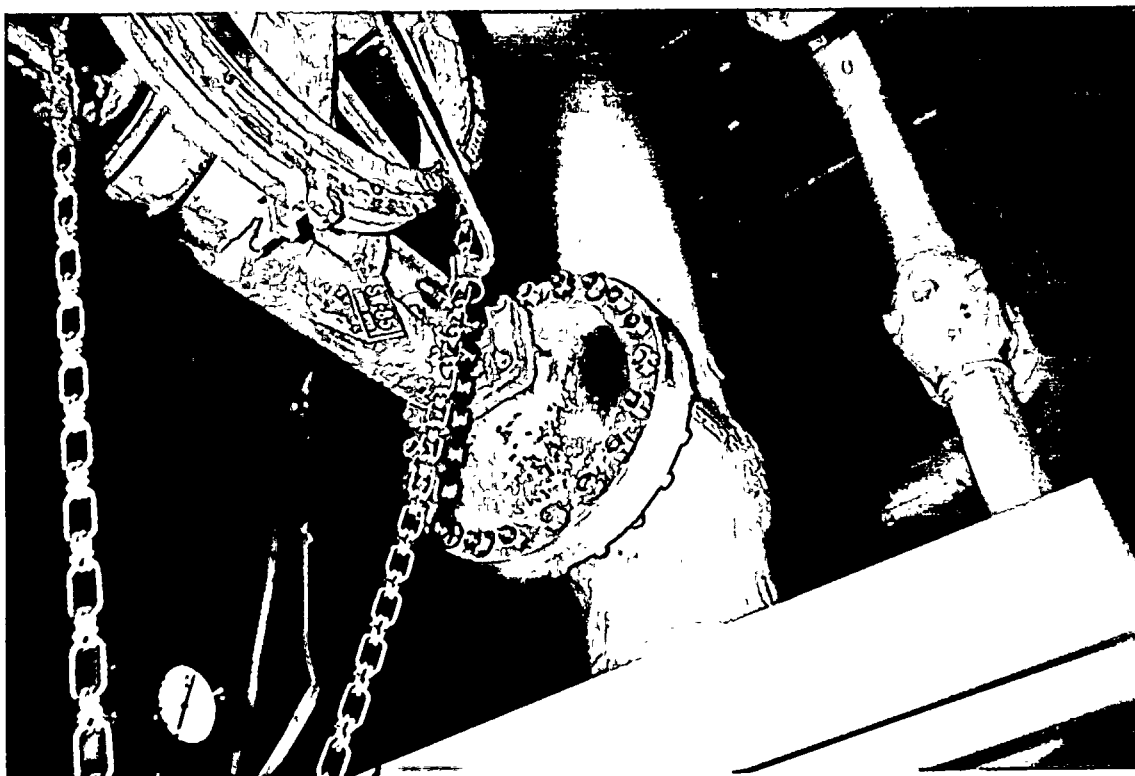
Control Building, RHR Service Water Booster Pump System - Valve Corrosion

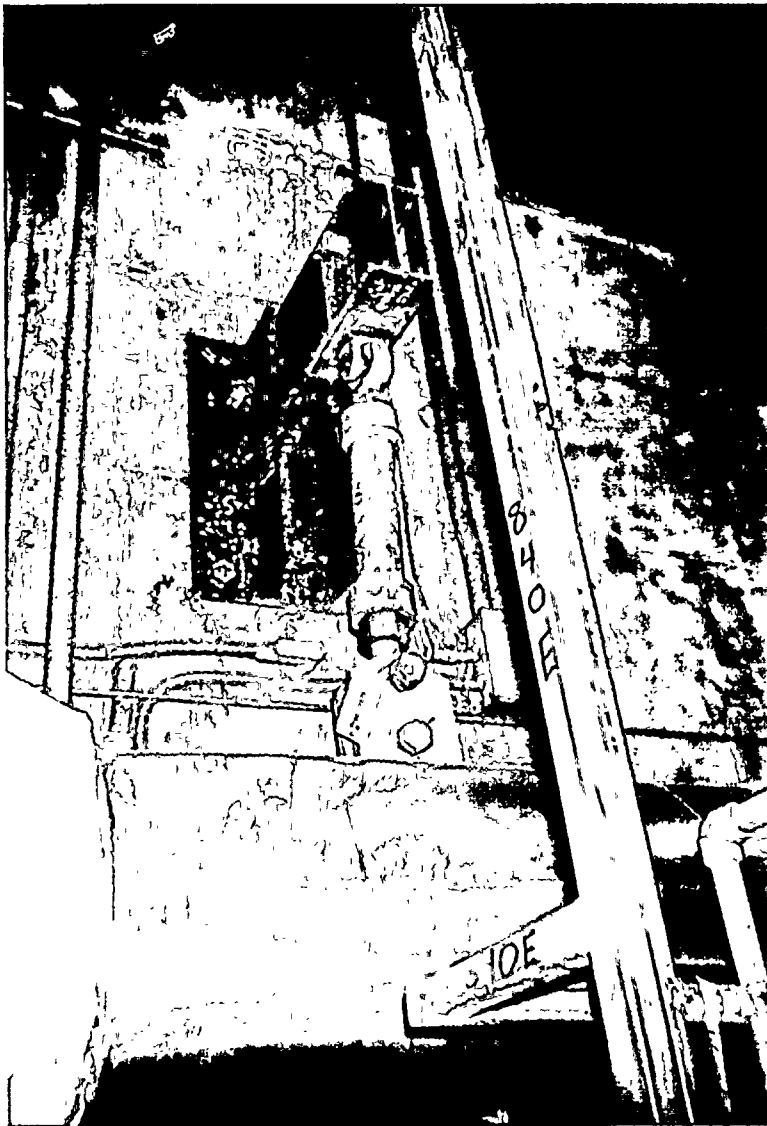
Reactor Building, Pipe Support
At Elev. 904'-Corrosion

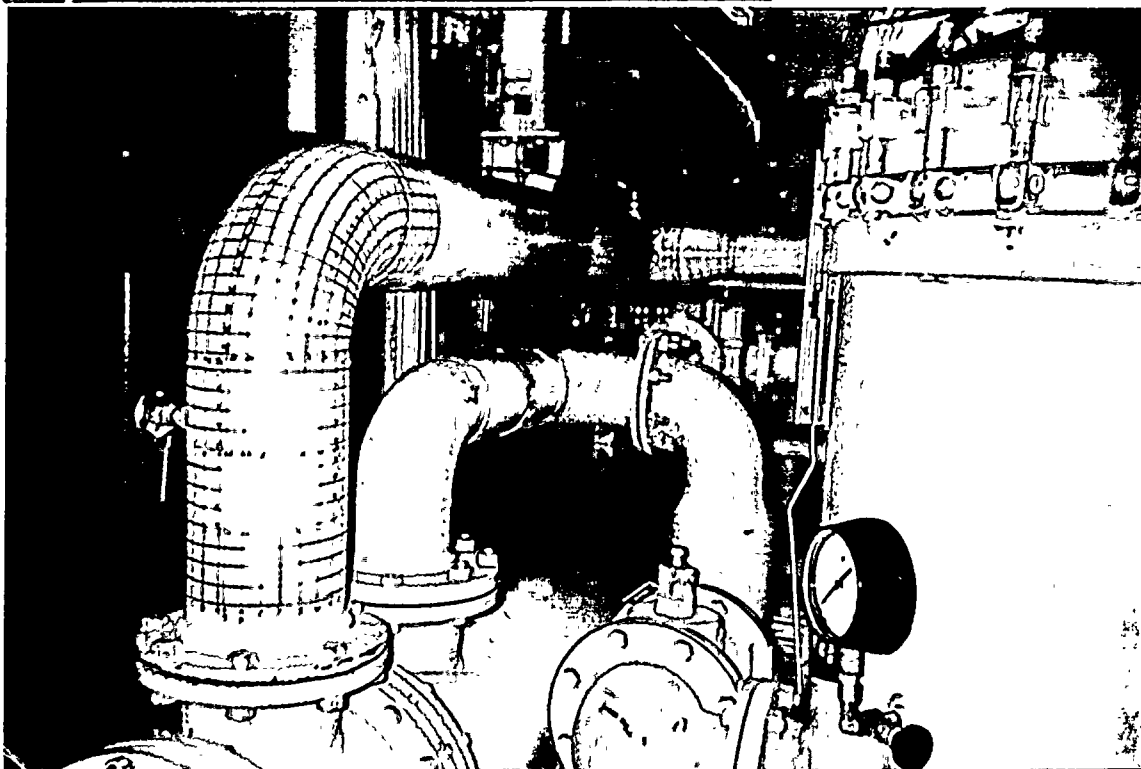
Diesel Generator Room,
Grids on S.W. Piping
For U.T. to Monitor
Internal Erosion
