SUBJECT: LER 96-011-00:on 961009,potential for overpressurizing post
 accident containment vent filter housings occurred.Caused by
 improper change mangement.Monitor sys operating procedures
 were revised.W/961106 ltr.

Potential for Over Pressurizing the Post Accident Containment Vent
Filter Housings

FACILITY NAME (1) <div style="text-align: center;">TURKEY POINT UNIT 3</div>	DOCKET NUMBER (2) <div style="text-align: center;">05000250</div>	PAGE (3) <div style="text-align: center;">1 of 5</div>
---------------------------------------------------------------------------------	----------------------------------------------------------------------	-----------------------------------------------------------

TITLE (4) <div style="text-align: center;">POTENTIAL FOR OVERPRESSURIZING THE POST ACCIDENT CONTAINMENT VENT FILTER HOUSINGS</div>	
-------------------------------------------------------------------------------------------------------------------------------------------	--

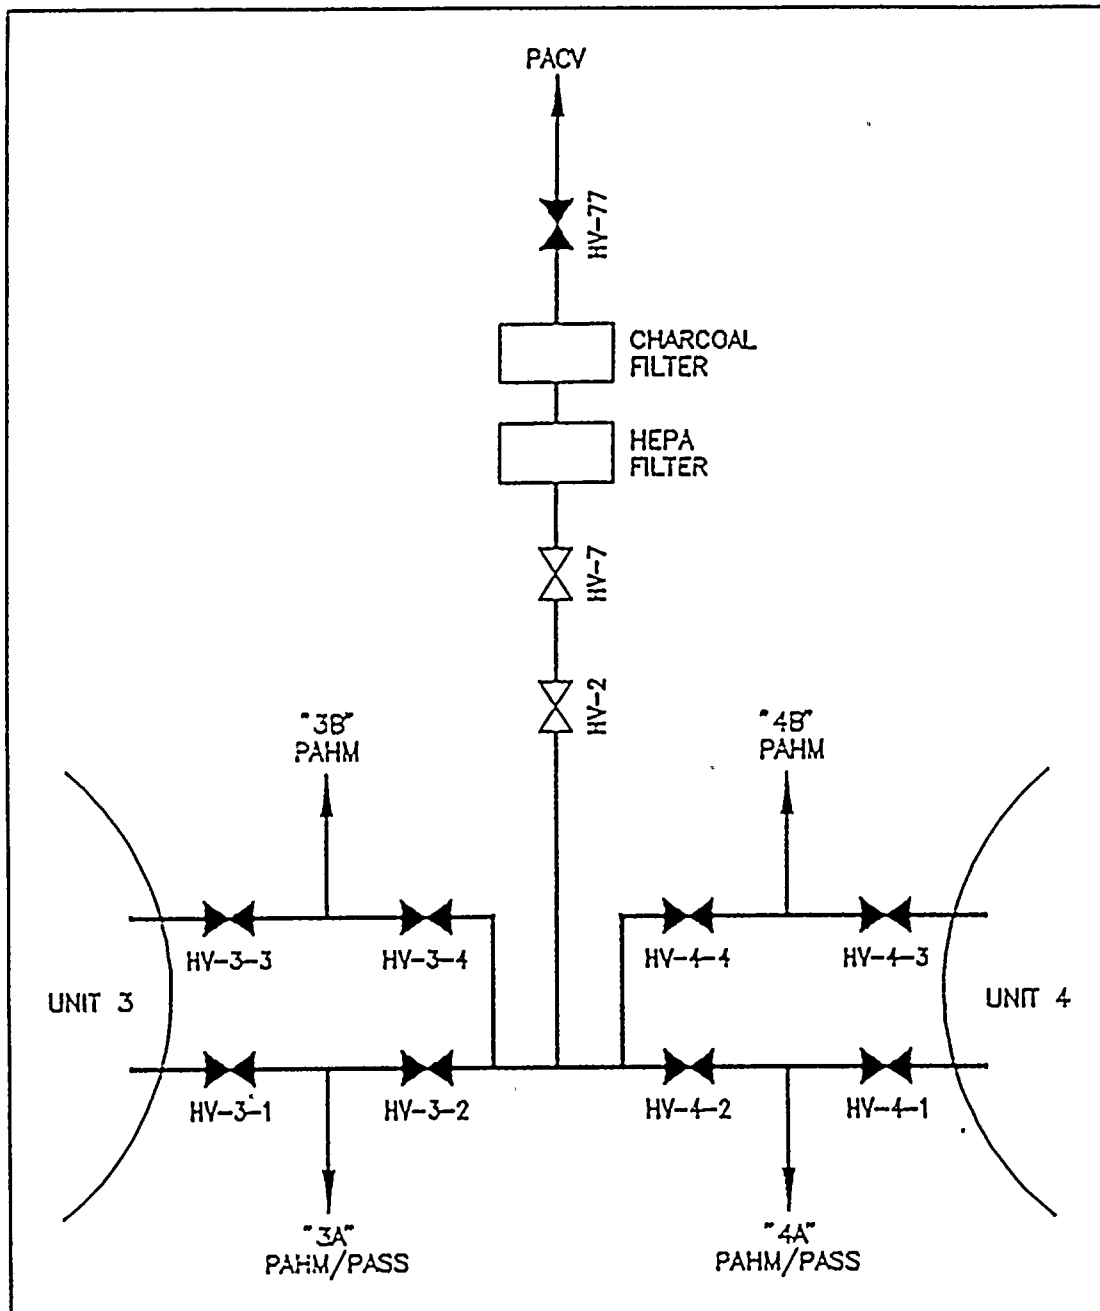
The PACV System is shared between Units 3 and 4. The PACV System consists of a particulate filter [WE:flt] and charcoal filter [WE:flt] with valves and piping to support post accident containment venting. The PAHM and PASS sample supply lines tap into the PACV supply piping, (see Figure 1). The Post Accident Hydrogen Monitors are placed in service within thirty minutes after a valid Engineered Safety Feature actuation. Procedure 3/4-OP-094, "Containment Post Accident Monitoring Systems" directs the opening of HV-3/4-1 [WE:smv] to provide a suction source for the "A" train PAHM/PASS [WE:45]. If valve HV-3/4-1 failed to open the operator was directed to cross-tie the sample suction lines by opening HV-3/4-2 [WE:smv] and HV 3/4-4 [WE:smv]. This action would apply containment pressure to the PACV filter housings via normally open HV-2 [WE:isv] and HV-7 [WE:isv]. The PACV filter housings had a design pressure of 5 psig. If pressure in excess of 5 psig were applied to the PACV filter housings, the housings would likely have failed. The PACV filter housings failure would have resulted in an unanticipated monitored release. Based on this sequence of events, at 1620 on October 9, 1996, FPL determined procedural guidance for potentially overpressurizing the PACV filter housings did exist. The NRCOC was notified at 1732 on October 9, 1996 in accordance with 10 CFR 50.72(b)(2)(iii)(C).

Figure 1 shows the basic relationships between PACV, PAHM, and PASS.
