SUBJECT: Forwards requests relief from requirement of ASME Section XI, 1989 Edition, Paragraph IWA-5250(a)(2) to remove all bolting (studs) on 4B RCP.

Re: Turkey Point Units 3 and 4
Docket Nos. 50-250 and 50-251
Inservice Inspection Program
Third Ten Year Summary
Relief Request No. 19

RELIEF REQUEST NO. 19

Turkey Point Unit 4
"4B" Reactor Coolant Pump Studs

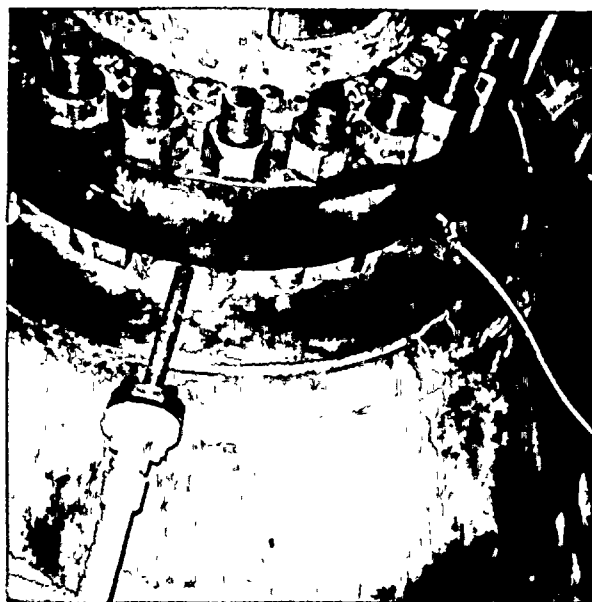
FIGURE 3

Figures 1-4 are scanned photographs of the 4B Reactor Coolant Pump studs in place show the minor boric acid accumulation. These photographs were taken during the initial inspections.

Figure 3 is another view of the CCW outlet piping. Much of what appears white is flash glare. Boric acid is visible under the outlet piping.

FPL proposes to perform a VT-1 visual examination on the remaining reactor coolant pump studs while they are still installed. This is deemed reasonable, since preliminary examinations have shown no visible corrosion damage at the interface between the threaded stud and the flange top surface. Based on the tight thread fit, measurable corrosion damage is not credible in the engaged threaded stud hole without corresponding indication of damage at the first exposed threads. Approximately five inches of each stud is threaded into the pump flange. The remainder of the studs (84% of the surface area) are accessible for visual examination. This VT-1 visual examination will be used as part of the evaluation in order to determine whether the studs are acceptable for continued service or must be removed. If boric acid degradation is found on any of the in place studs, that stud will be evaluated for continued service or replacement.
