# LICENSEE EVENT REPORT (LER)

FACILITY NAME (1) <div style="text-align: center;">TURKEY POINT UNIT 3</div>	DOCKET NUMBER (2) <div style="text-align: center;">05000250</div>	PAGE (3) <div style="text-align: center;">1 OF 6</div>
---	--	---

TITLE (4)      Console Switch Position Disabled Auxiliary Feedwater Auto Start Logic on 3B Steam Generator Feedwater Pump Trip

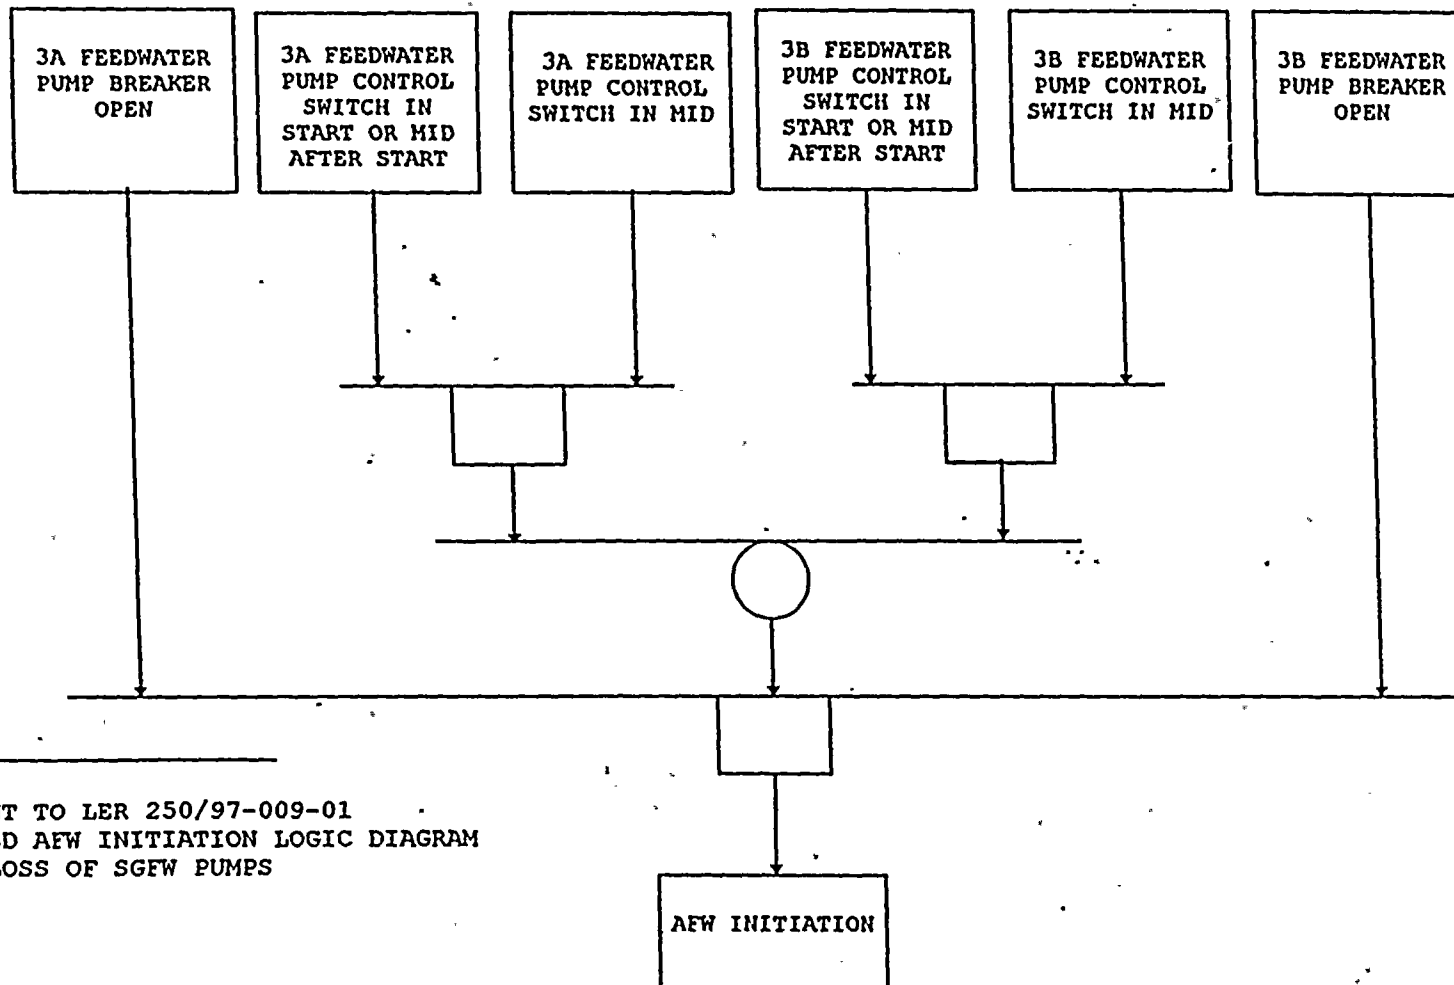
ATTACHMENT TO LER 250/97-009-01  
SIMPLIFIED AFW INITIATION LOGIC DIAGRAM  
FOR THE LOSS OF SGFW PUMPS

Starting a SGFW pump locally does not enable the AFW automatic start logic. Using the local push-button, AFW automatic start would not be actuated if a pump breaker failed to close. Following the SGFW pump start using the local push-button, the CR console switch must be cycled to the start position in order to enable the AFW automatic actuation circuit as evidenced by the red flag.

The AFW Initiation logic diagram for the loss of SGFW pumps is attached.
