LICENSEE EVENT REPORT (LER)

FACILITY NAME (1) <div style="text-align: center;">TURKEY POINT UNITS 3 & 4</div>	DOCKET NUMBER (2) <div style="text-align: center;">05000250</div>	PAGE (3) <div style="text-align: center;">1 OF 7</div>
--	--	---

TITLE (4) Potential LOCA-Initiated Electrical Fault Places ECCS Outside Design Basis

LER NUMBER
98-002-00

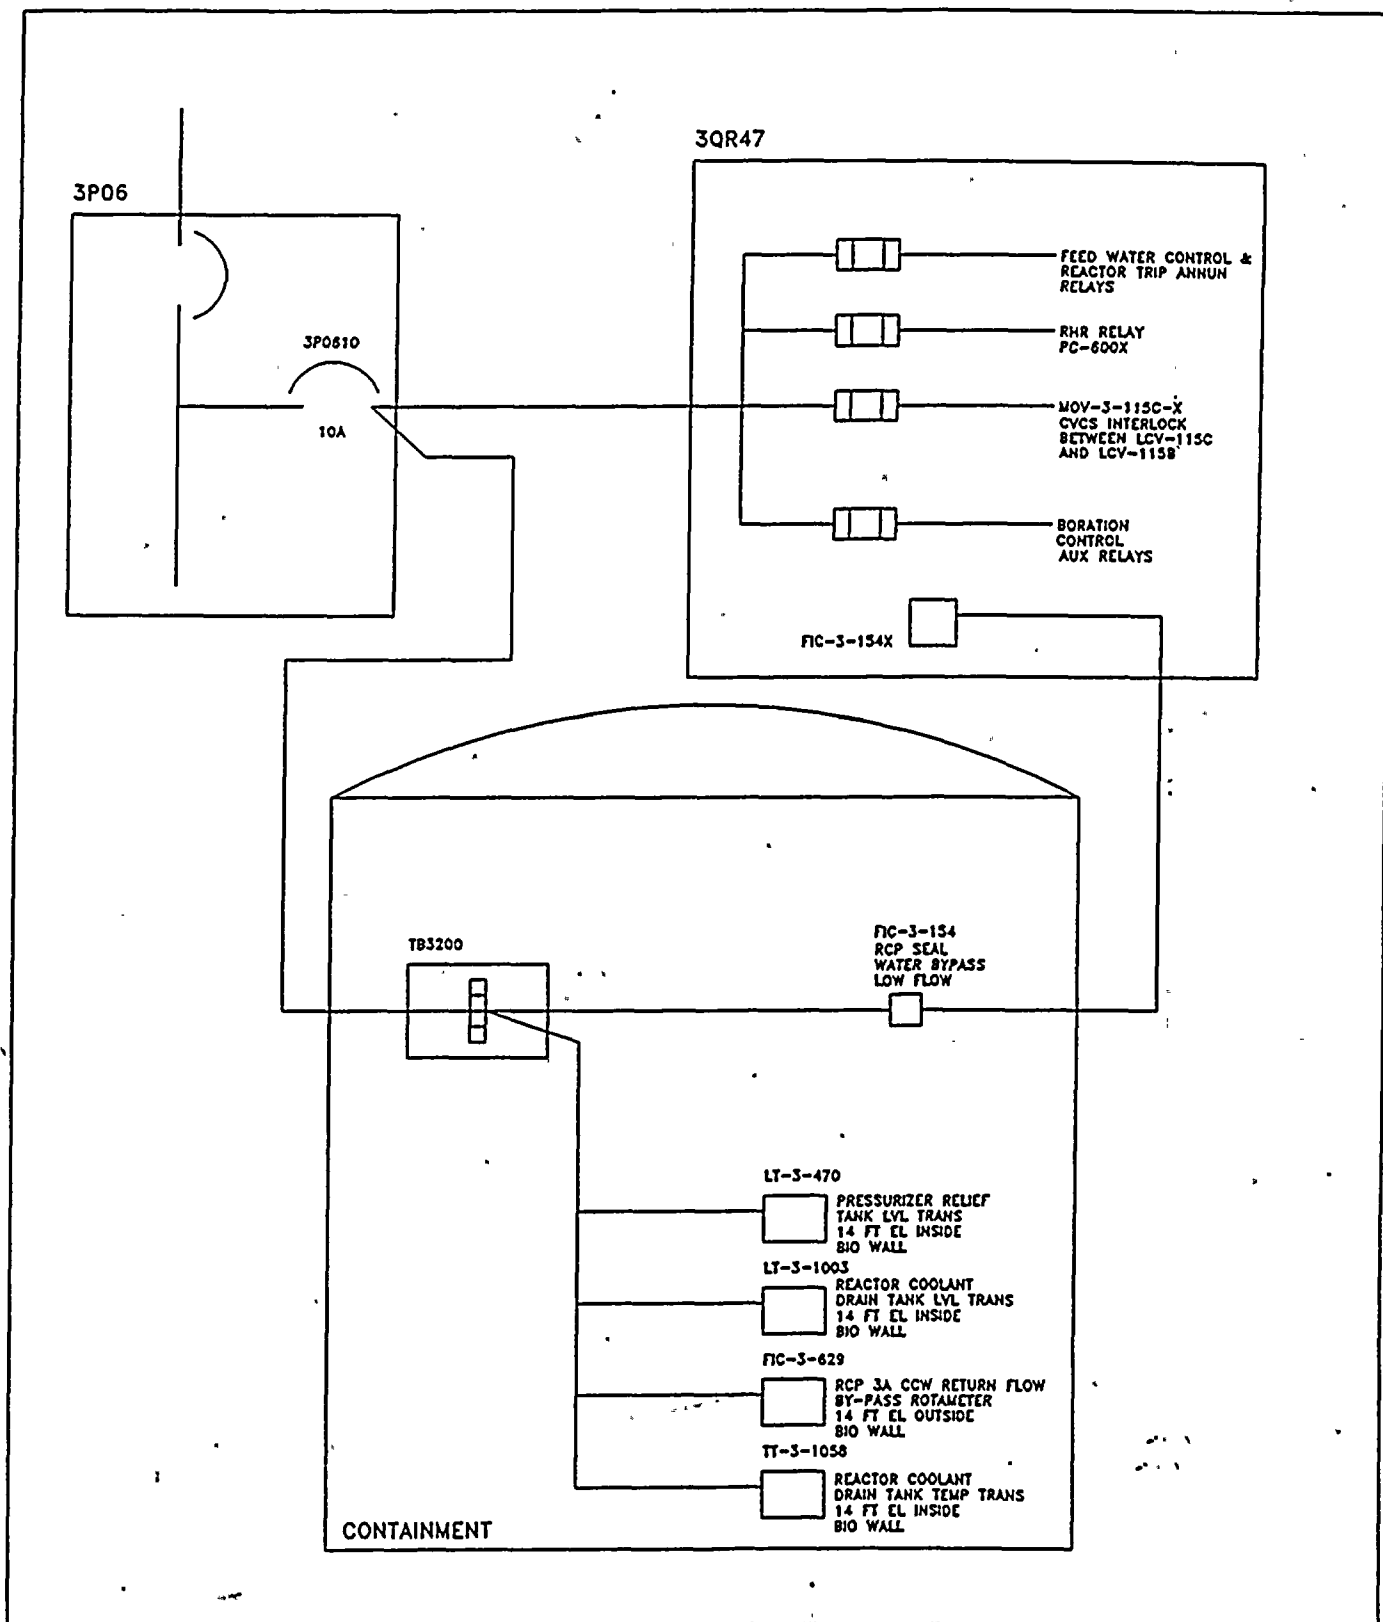
The condition reported herein involves a specific set of devices powered from vital instrument breaker 3(4)P06-10 (a 10 amp high speed breaker). These are shown on the attached simplified diagram (page 7). Each of these devices was evaluated, and only the loss of PC-*600X resulted in a reportable condition.

In the event of a LOCA, the containment recirculation sump will fill with water as the RWST is depleted. The LOCA may submerge the Reactor Coolant Drain Tank (RCDT) instrumentation powered from 3(4)P06-10 and would expose all of the non-safety related instruments inside containment to environmental conditions for which they have not been qualified. The submergence or environmental conditions affecting these non-safety related, non-qualified devices would be expected to result in a fault that would open 3(4)P06-10.

- A. Similar events: LER 250/84-18 reported the original design deficiency in the control circuitry for MOV-*-863A and B.
- B. EIIS Codes are shown in the format [EIIS SYSTEM: IEEE component function identifier, second component identifier (if appropriate)].
- C. A simplified one-line wiring diagram showing the devices powered from breaker 3(4)P6-10 is attached, to aid in understanding the reported condition.

- 1) PC-*-600X has been repowered from a dedicated, appropriately protected, safety related power supply (breakers 3P21-09 and 4P23-05). There are no other loads on these breakers.
