Callaway Plant

ULNRC-06404

**DOCKET NUMBER 50-483  
CALLAWAY PLANT UNIT 1  
UNION ELECTRIC CO.  
RENEWED FACILITY OPERATING LICENSE NPF-30  
LICENSEE EVENT REPORT 2017-003-00  
VIOLATION OF TECHNICAL SPECIFICATION 3.6.3  
CONTAINMENT ISOLATION CHECK VALVE FOUND IN OPEN POSITION**

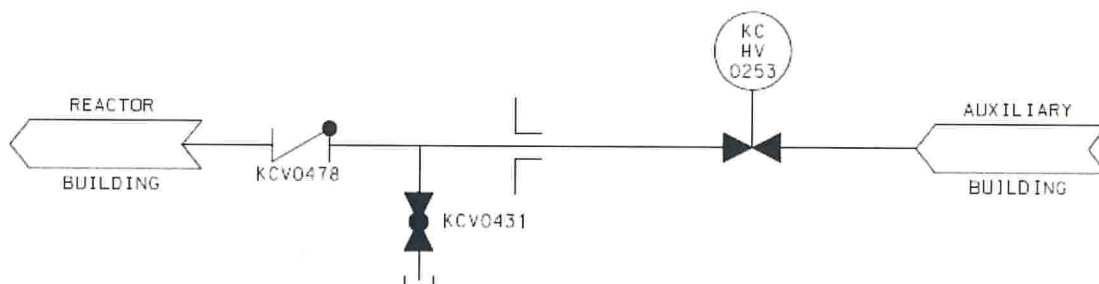
Figure 1 - Containment Penetration P-67 Diagram

The administrative containment leakage limit for penetration P-67 is 9,000 standard cubic centimeters per minute (scm) for KCHV0253 and KCV0478. When KCHV0253 is opened for LLRTs or stroke testing, the upstream manual isolation valves are closed to maintain the Reactor Building FP piping in a dry condition.

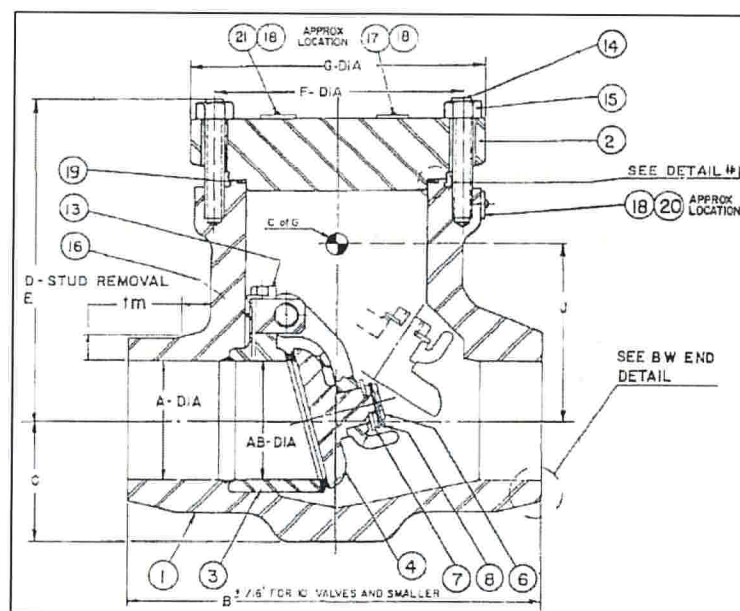
Figure 2 - KCV0478 Design Drawing Side View (M-223C-00021)

KCV0478 is an ASME III Class 2, safety related, swing style check valve. The valve was supplied by Velan Engineering Companies.

The major internal components of valve KCV0478 consist of a disc and hanger which are attached to the valve body. The valve is designed to open with fire water flow from the fire header to the associated containment building hose racks / sprinkler and to close or be closed in the event of increased containment pressure that may occur in an accident in containment. The valve body is carbon steel, and the hanger and disc assembly are stainless steel. The original valve disc was carbon steel. Due to susceptibility to corrosion and challenges with seat leakage during LLRT testing, the disc was replaced with a stainless steel disc in 1999 (Refuel 10).

Per discussion with the vendor representative during the root cause investigation for the identified valve failure, it was identified that the dimensions of the disc were too large for the application and had the potential to cause the valve to stick in the open position. In addition, operating experience was documented in which it was identified/inferred or suggested that the tolerances of the hanger assembly could result in the hanger assembly sticking in the open position.

The reported condition is the result of dimensional interferences due to inadequate design clearances in the vendor supplied internal assembly (i.e. hanger / disc) for KCV0478. The inadequate design clearances resulted in excessive (i.e. outside of approved design) contact of the KCV0478 internal assembly with the valve body.

The immediate corrective action was to clean the valve, disc, and hanger assembly and successfully re-perform the LLRT. The planned corrective action to prevent recurrence (CAPR) is to replace check valve KCV0478 with a new design utilizing corrosion resistant materials (e.g. stainless steel). Critical dimensions are to be requested and obtained from the vendor for the new valve and they will be incorporated into applicable work instructions to be used for verification of proper design clearances during initial inspection/installation and future maintenance on KCV0478.
