**North Wall of Containment Enclosure Ventilation Area (CEVA)
Near-Surface Delamination (Concrete Cover Separation)**

(DRAFT 30 October 2017)

Project 170444 – License Amendment Request & NRC Review Support, NextEra Energy
Seabrook Station, Seabrook, NH

Document Number: 170444-L-001

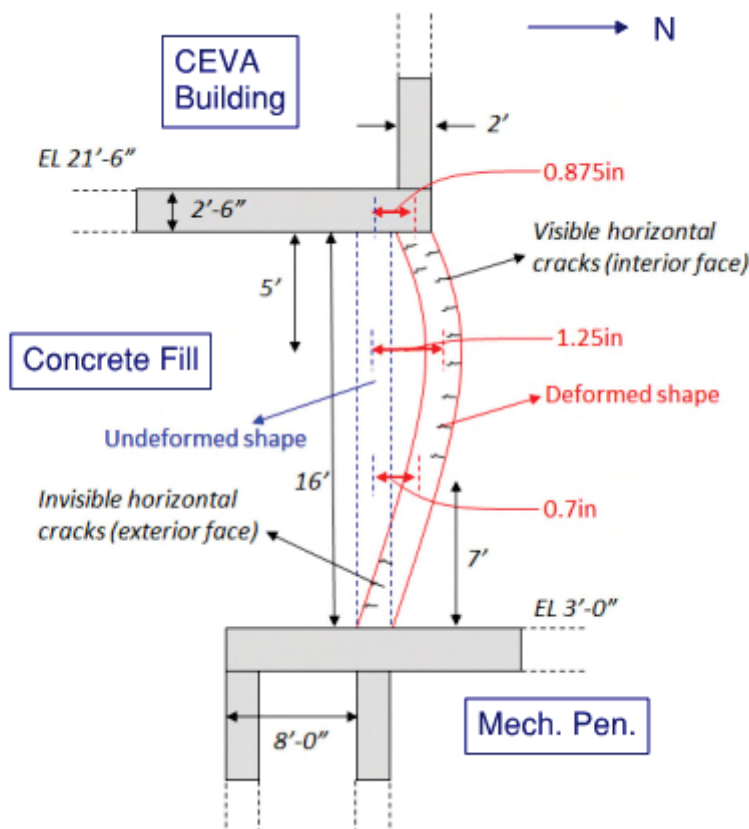
At the north side of the CEVA, a wall extends from the CEVA base slab (EL +19 ft) to the Mech. Pen. Floor slab (EL +3 ft), referred here as "lower portion" of CEVA north wall. The north side of this wall is accessible from within the West Pipe Chase Stairs, and the south (back) side of the wall abuts the concrete fill below the CEVA Building, schematically shown in Figure 1.

Figure 1 – CEVA North Configuration and Measured Deformed Shape [3].
