Client: NextEra Energy-Seabrook **Project No.** 170444.02
Project: Support for Prompt Operability Determinations (PODs), NextEra Energy Seabrook Station, NH

Report No.: 170444-SVR-01-R0
Report Type: Site Visit Report
Title: September 2017, Threshold Inspections for the North Wall of the Containment Enclosure Ventilation Area (CEVA), NextEra Energy Seabrook Facility, Seabrook, NH

To report September 2017 threshold measurement results of the lower portion of the North Wall of the Containment Enclosure Ventilation Area (CEVA) and to determine whether the threshold limits for the CEVA North Wall have been exceeded.

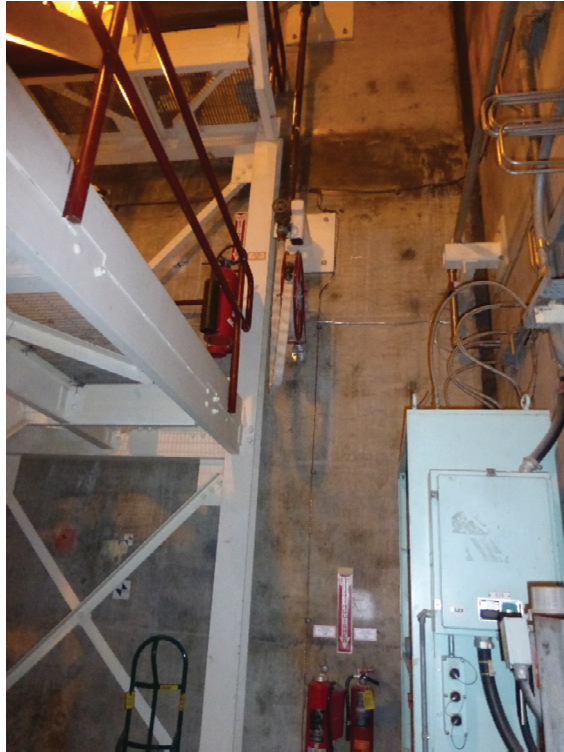
Photo 3

SGH visually observed the entire face of the north wall where accessible (Photo 3). SGH noted frequent prominent horizontal cracks from EL +11 ft to EL +19 ft across the entire north wall. The cracking condition is most obvious on the east side of the wall adjacent to the CEB, where it is above the equipment; this portion of the wall was inaccessible for close observation at the time of inspection. SGH did not note any apparent significant changes in the cracking condition as compared to SGH's prior survey in November 2016 [3].

- The concrete surface of the north wall between EL +3 ft and EL +18.5 ft exhibits extensive horizontal cracks. SGH noted no signs of significant changes in cracking condition as compared to the prior inspection in November 2016 [3].

Overall view of the north face of the north wall.

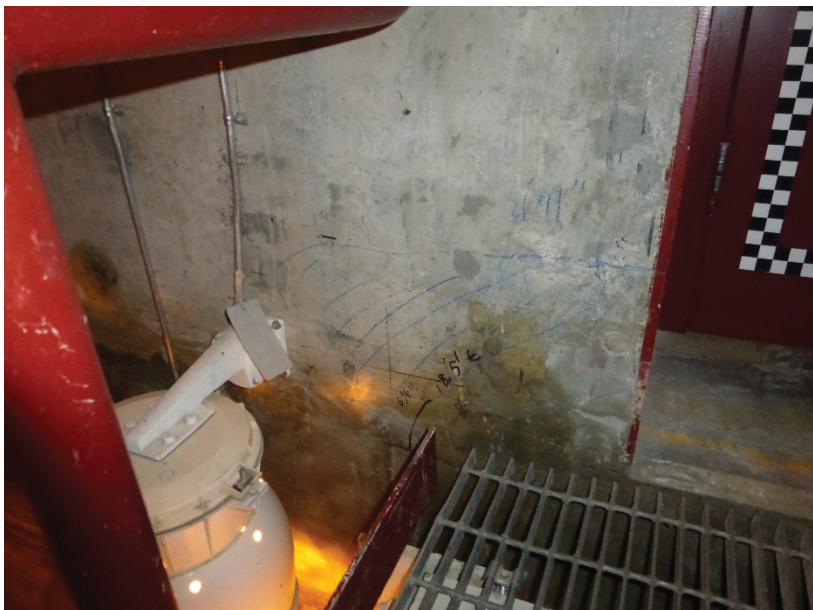
Photo 4

- Two localized areas at the bottom corners of the CEVA door, approximately 2 sq ft and 1 sq ft, respectively, next to the stair platform grating at EL +21 ft-6 in. (Photos 4 and 5).
- Multiple localized areas along cracks from EL +13 ft to +18 ft at the wall above the middle landing area of the stairs. The cracks at the hollow-sounding areas exhibit widths greater than 0.060 in. (Photos 6 through 8). The portions of the concrete wall above the equipment could not be sounded due to access restrictions. The cracks at the inaccessible locations (particularly on the east side adjacent to the CEB) appear to be wider than the cracks associated with the hollow-sounding areas at the stairs.

- Based on a delamination survey using conventional hammer sounding (which is limited in detection range to near-surface/shallow (typically 1 to 3 in. deep) delaminations [4]), SGH noted localized near-surface concrete delaminations at the accessible areas from the stairwell that are primarily associated with visible horizontal cracks. SGH could not perform a delamination survey above the equipment; however, based on the observed cracking condition, it is likely that additional near-surface delaminations are present at the prominent horizontal cracks above the equipment. The near-surface delaminations may further develop into concrete spalls that could break off from the wall and fall onto the stairs and equipment below.

Concrete delamination at the stair platform (EL +21.5 ft) to the left of the door, as shown by the blue hatching.

- SGH recommends that concrete repairs of the north wall of CEVA be planned for the near future to address near-surface delaminations and potential future spalling. In the meantime, temporary protection or concrete restraints could be proactively and conservatively installed to prevent potential concrete spalls from contacting sensitive portions of the equipment and cabling.

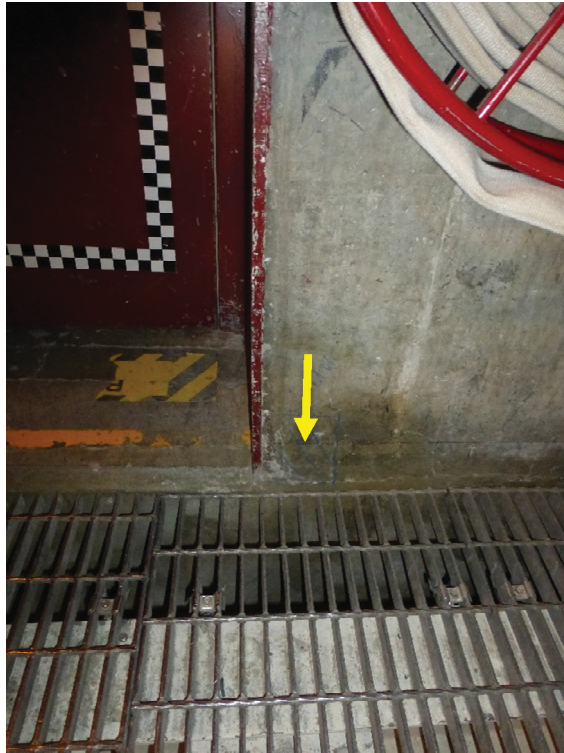
Photo 5

Concrete delamination at the stair platform (EL +21.5 ft) to the right side of the door, as indicated by the yellow arrow.

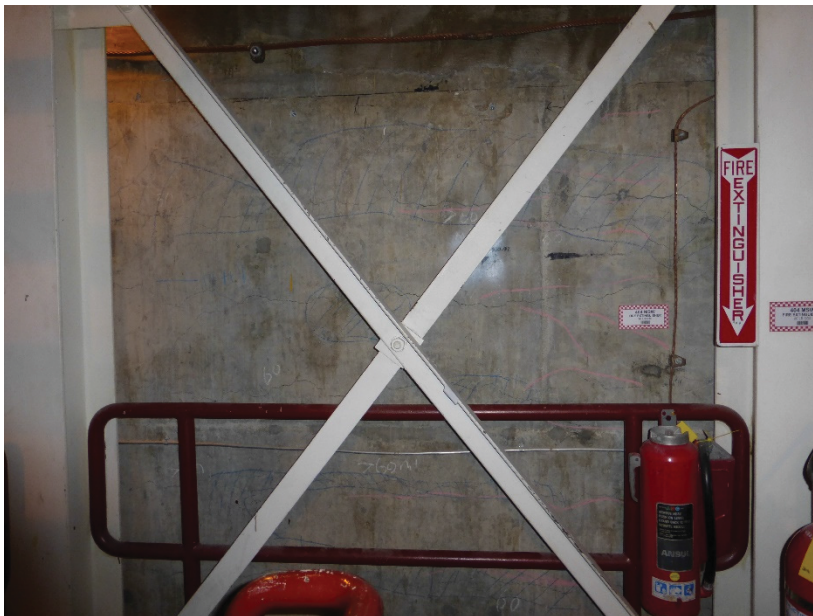
Photo 6

SGH surveyed the portion of the wall between EL +13 ft and +18 ft from the middle stair landing.

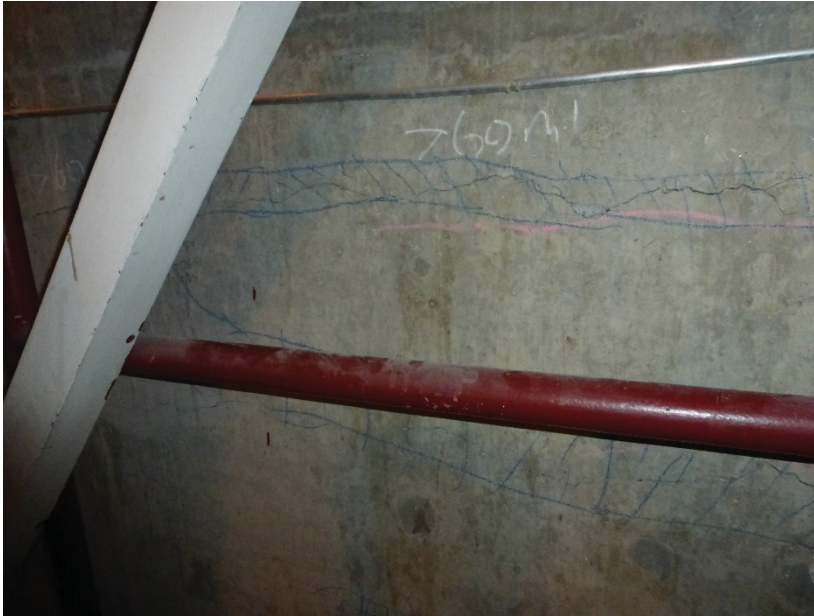
Photo 7

Concrete delamination along cracks on the wall, shown in blue-hatched area.

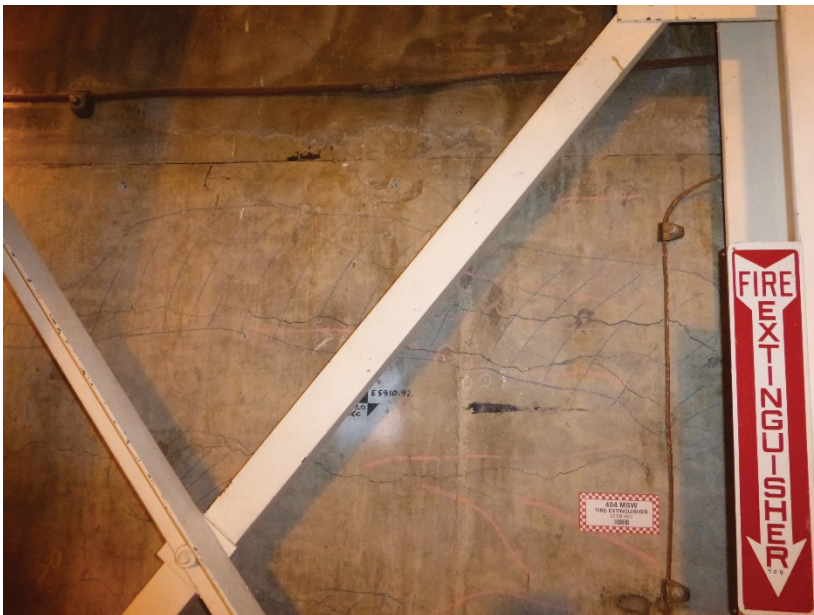
Photo 8

Concrete delamination along cracks on the wall, shown in blue-hatched area.

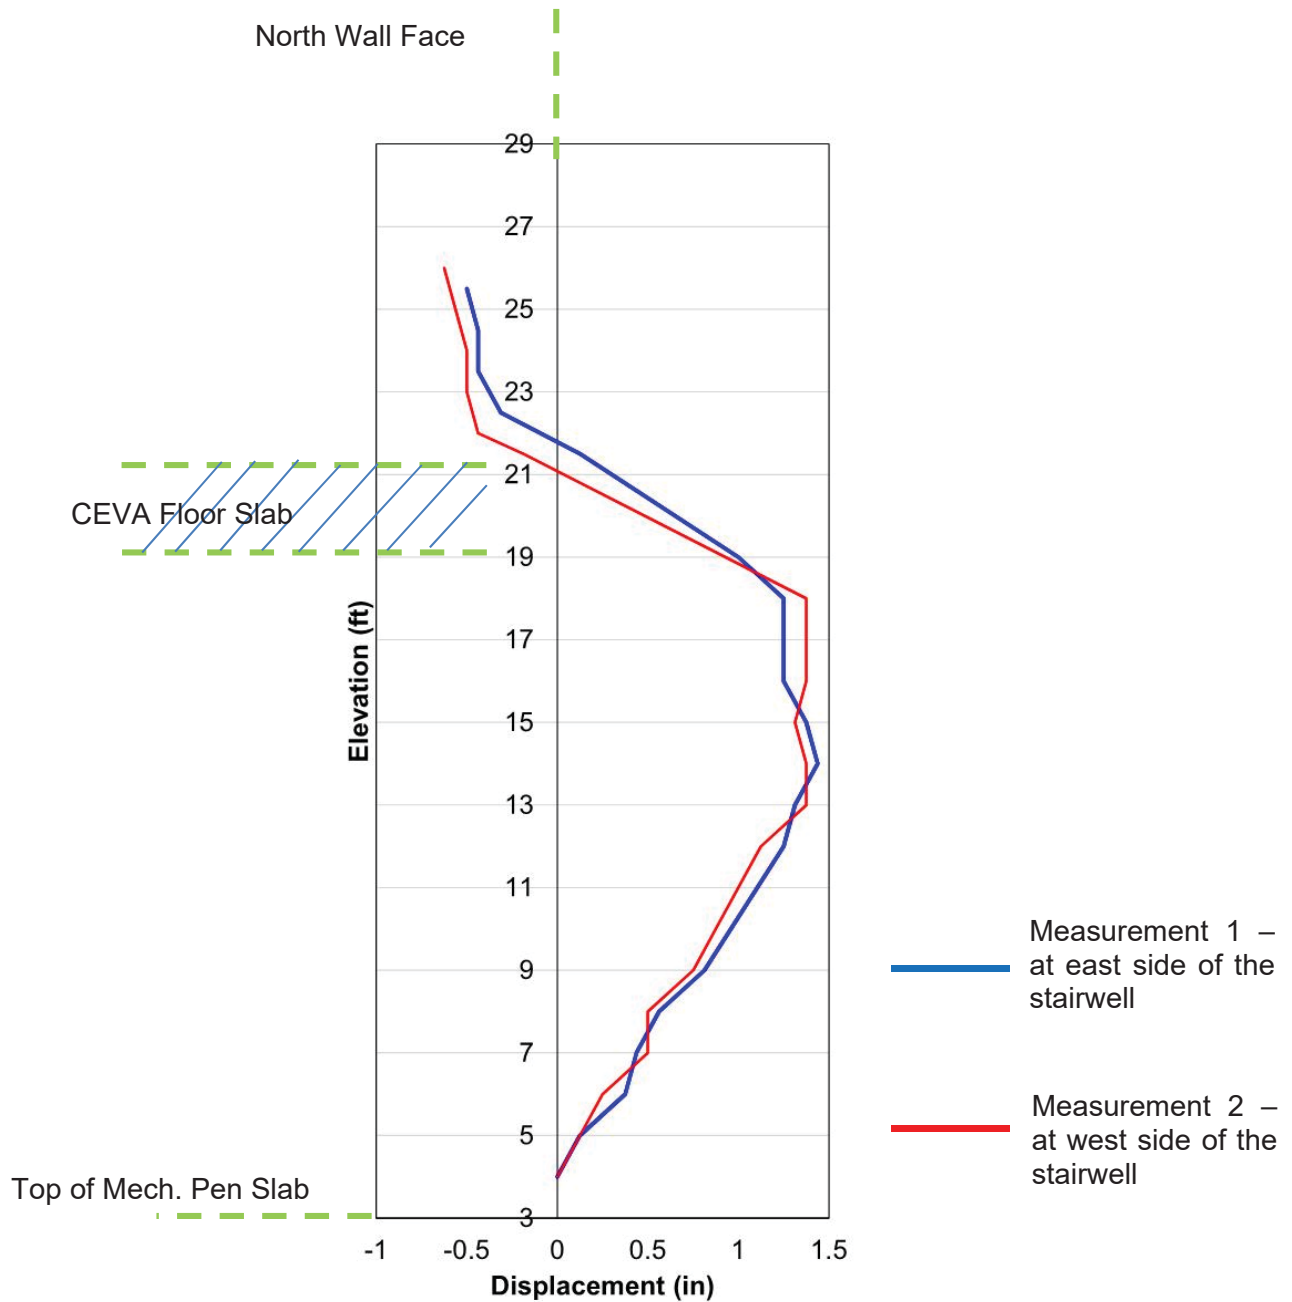
The plumbness profile of the north face of the north wall, as illustrated in Figure 1, indicates outward bulging (relative to the face of the wall at EL +4 ft) with a zone of relatively uniform bulging present from EL +13 ft to EL +18 ft, with the maximum outward bulging of 1-7/16 in. occurring at EL +14 ft.

- The results of wall plumbness measurements (between EL+4 ft to EL +26 ft) indicate an outward bulging of the wall with a maximum displacement of 1-7/16 in. at EL +14 ft, relative to the near-base of the north wall at EL +4 ft. The maximum outward bulging appears to have increased from the November 2016 inspections, when it was 1-1/4 in. occurring at EL +13 ft to +17 ft. The maximum bowing remains within the threshold limit (1.5 in.)

Figure 1 Plumbness profile of the north face of the North Wall of CEVA from EL +4 ft to EL +26 ft.
