REFERENCE: Docket No. 50-186
University of Missouri-Columbia Research Reactor
Renewed Facility Operating License No. R-103

SUBJECT: Written communication as required by University of Missouri Research
Reactor Technical Specification 6.6.c(3) regarding a deviation from
Technical Specifications 3.4.b and 3.4.a(6)

Licensee Event Report No. 17-06 – December 30, 2017
University of Missouri Research Reactor

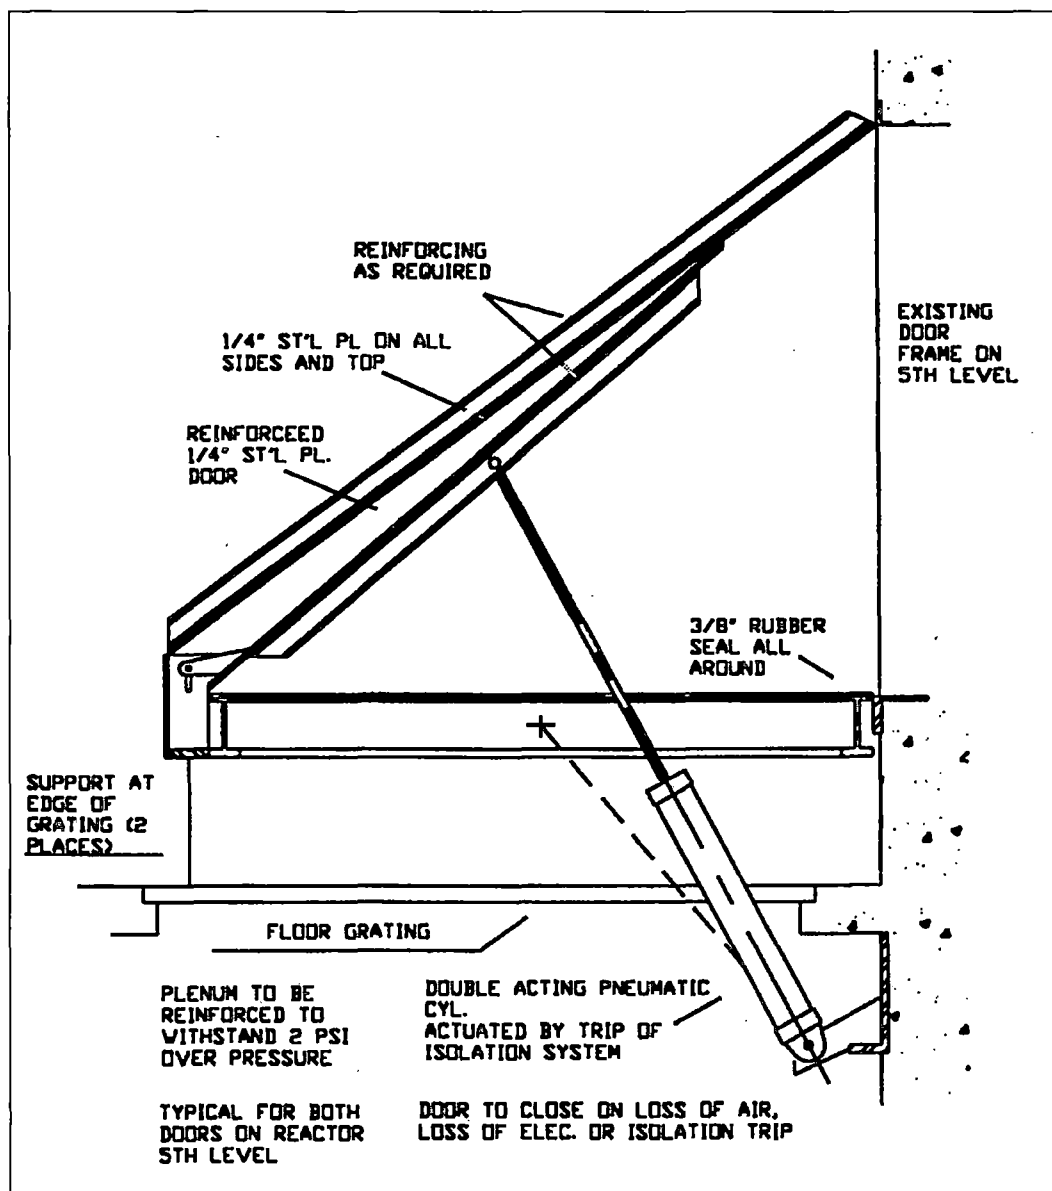
FIGURE 1
BACKUP DOOR

The backup doors are constructed of ¼-inch (0.64-cm) thick metal plate and reinforced to withstand 2.0-psig overpressure (13.8-kPa above atmosphere) (see Figure 1). Each door is held open against gravity by a pneumatic cylinder. Compressed air is supplied to the pneumatic cylinders from the facility main air compressors and the emergency air compressor. A ¾-inch (0.95-cm) rubber gasket installed in the door facing creates a seal for the backup doors when in the closed position.

Closure of the exhaust plenum backup door blocked the path for air to exit the reactor containment building. The supply fan continued to run, and the supply plenum was still open; therefore, air continued to be supplied to the building without air exhausting, which increased pressure in the reactor containment building, thus driving differential pressure to zero (0).

Though the backup door was closed and unable to open due to ice blockage of its compressed air supply line, the reactor isolation and facility evacuation systems were fully operational and capable of isolating the reactor containment building from the surrounding areas. In addition, the air supply lines to all the other components of the reactor containment system are housed inside the building in controlled temperature environments. Therefore, reactor isolation and facility evacuation systems could perform their safety functions as described in the SAR. The backup doors failed to their 'fail safe' position, which is closed.

The cause of this event was lower than normal air temperatures surrounding the compressed air piping combined with moisture in the piping. This combination allowed ice to form and slowly block off the air supply to the exhaust plenum backup door air cylinder. As the air pressure slowly bled out of the cylinder, the weight of the door overcame the upward force of the air cylinder, and the exhaust backup door closed. Prior to reactor startup on December 30, 2017, the water was drained from the compressed air lines, and heat trace with insulation was applied to the piping to prevent ice from forming in the lines as a short-term solution. Until the compressed air quality is improved, Reactor Operations staff are also draining condensation for the air supply

pipng near the cylinders every week. MURR is currently investigating possible improvements to the main air system to reduce the amount of moisture in the compressed air piping.

If Reactor Operations staff had continuous indication of reactor containment building differential pressure in the Control Room, they may have be able to prevent the deviation of TS 3.4.b by taking action to secure the reactor prior to the negative pressure decreasing below the TS 3.4.a(6) specification of 0.25 inches of water. MURR will be installing a continuous Control Room indication with a low differential pressure alarm in the future. In addition, a Reactor Emergency Procedure will be developed to provide Reactor Operations staff direction in case of a lowering reactor containment building differential pressure.
